Reclamation Inspection

01/27/2017

Operator: Conoco Phillips #19160

Location ID: 426630

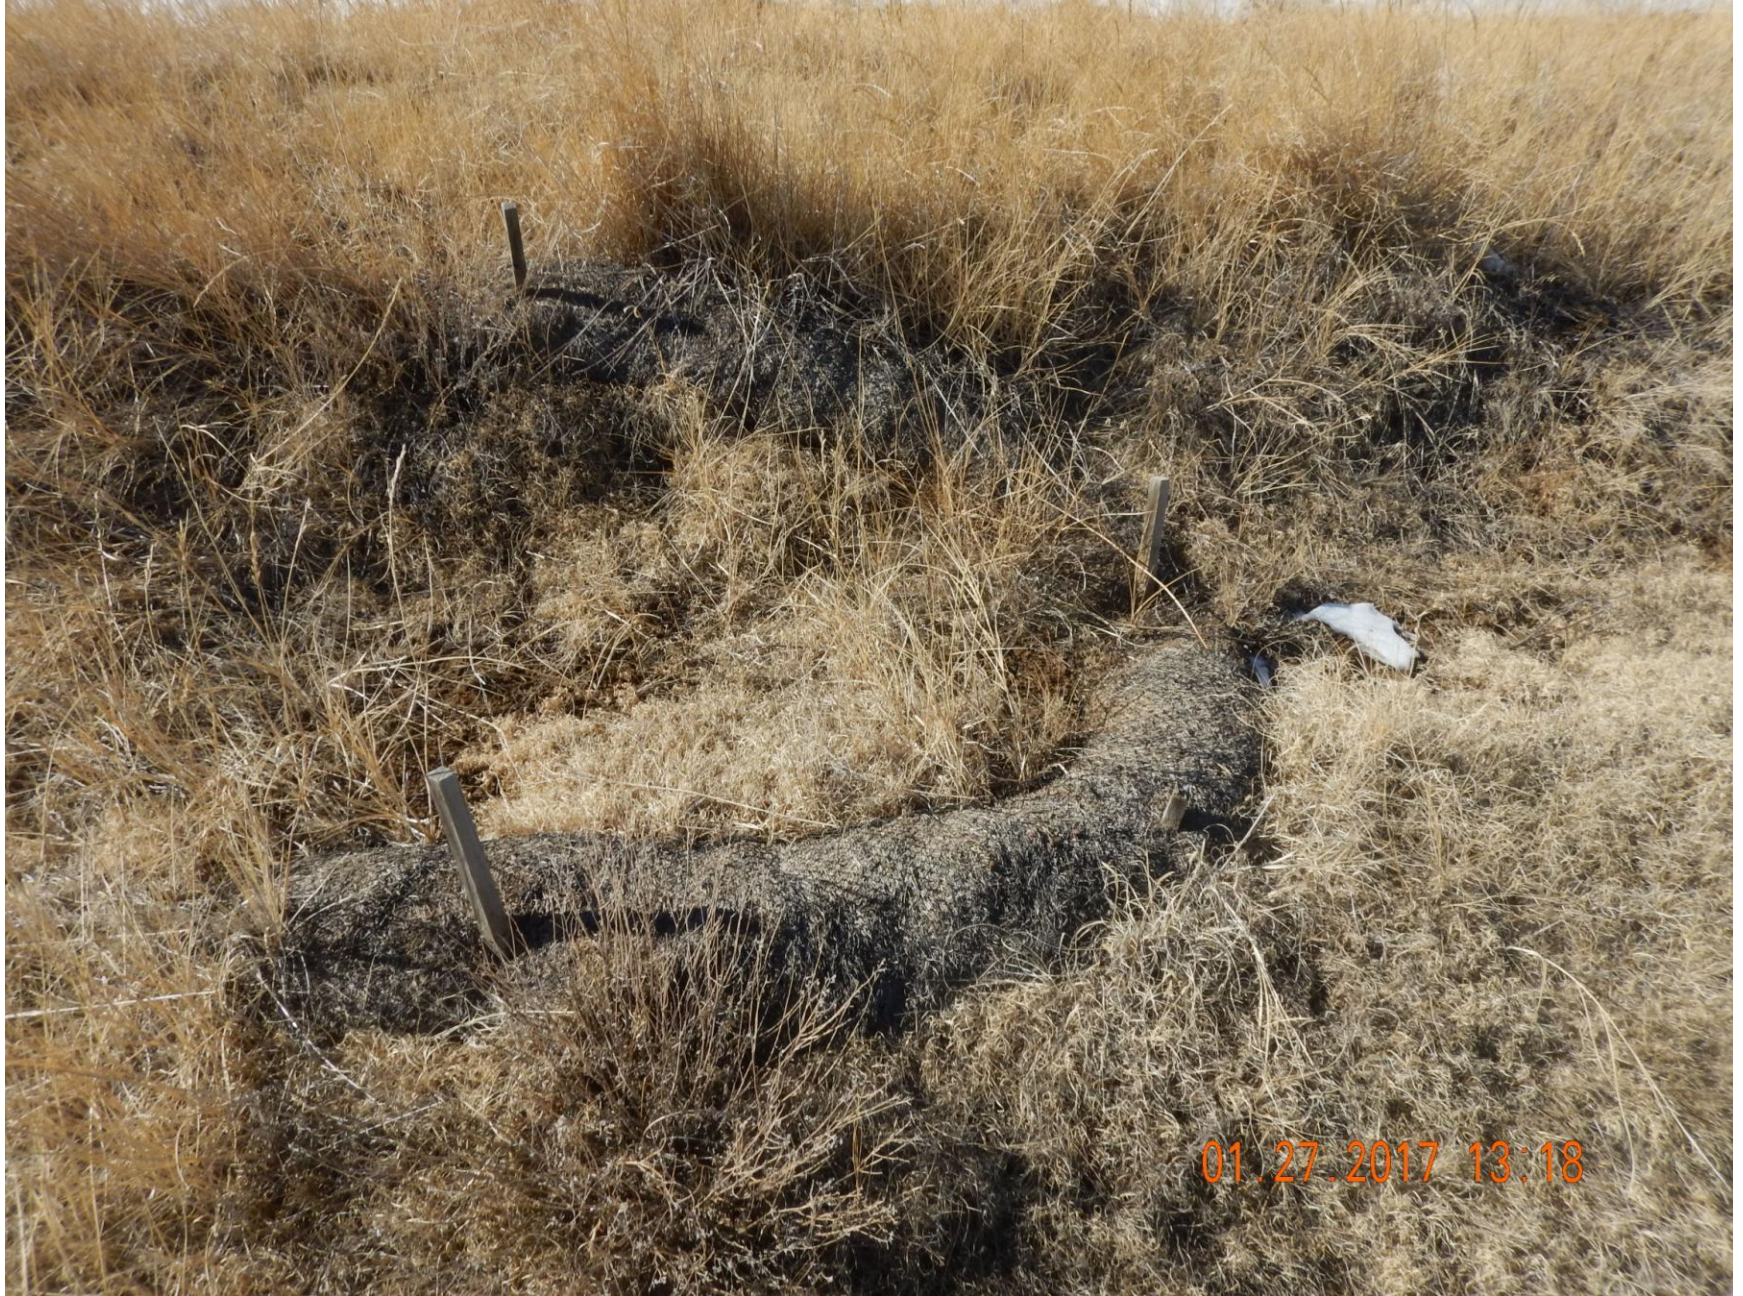
Figure 21: Photo taken from the southeast corner of the location,. Photo shows wattle used as a stormwater and sediment control BMP.

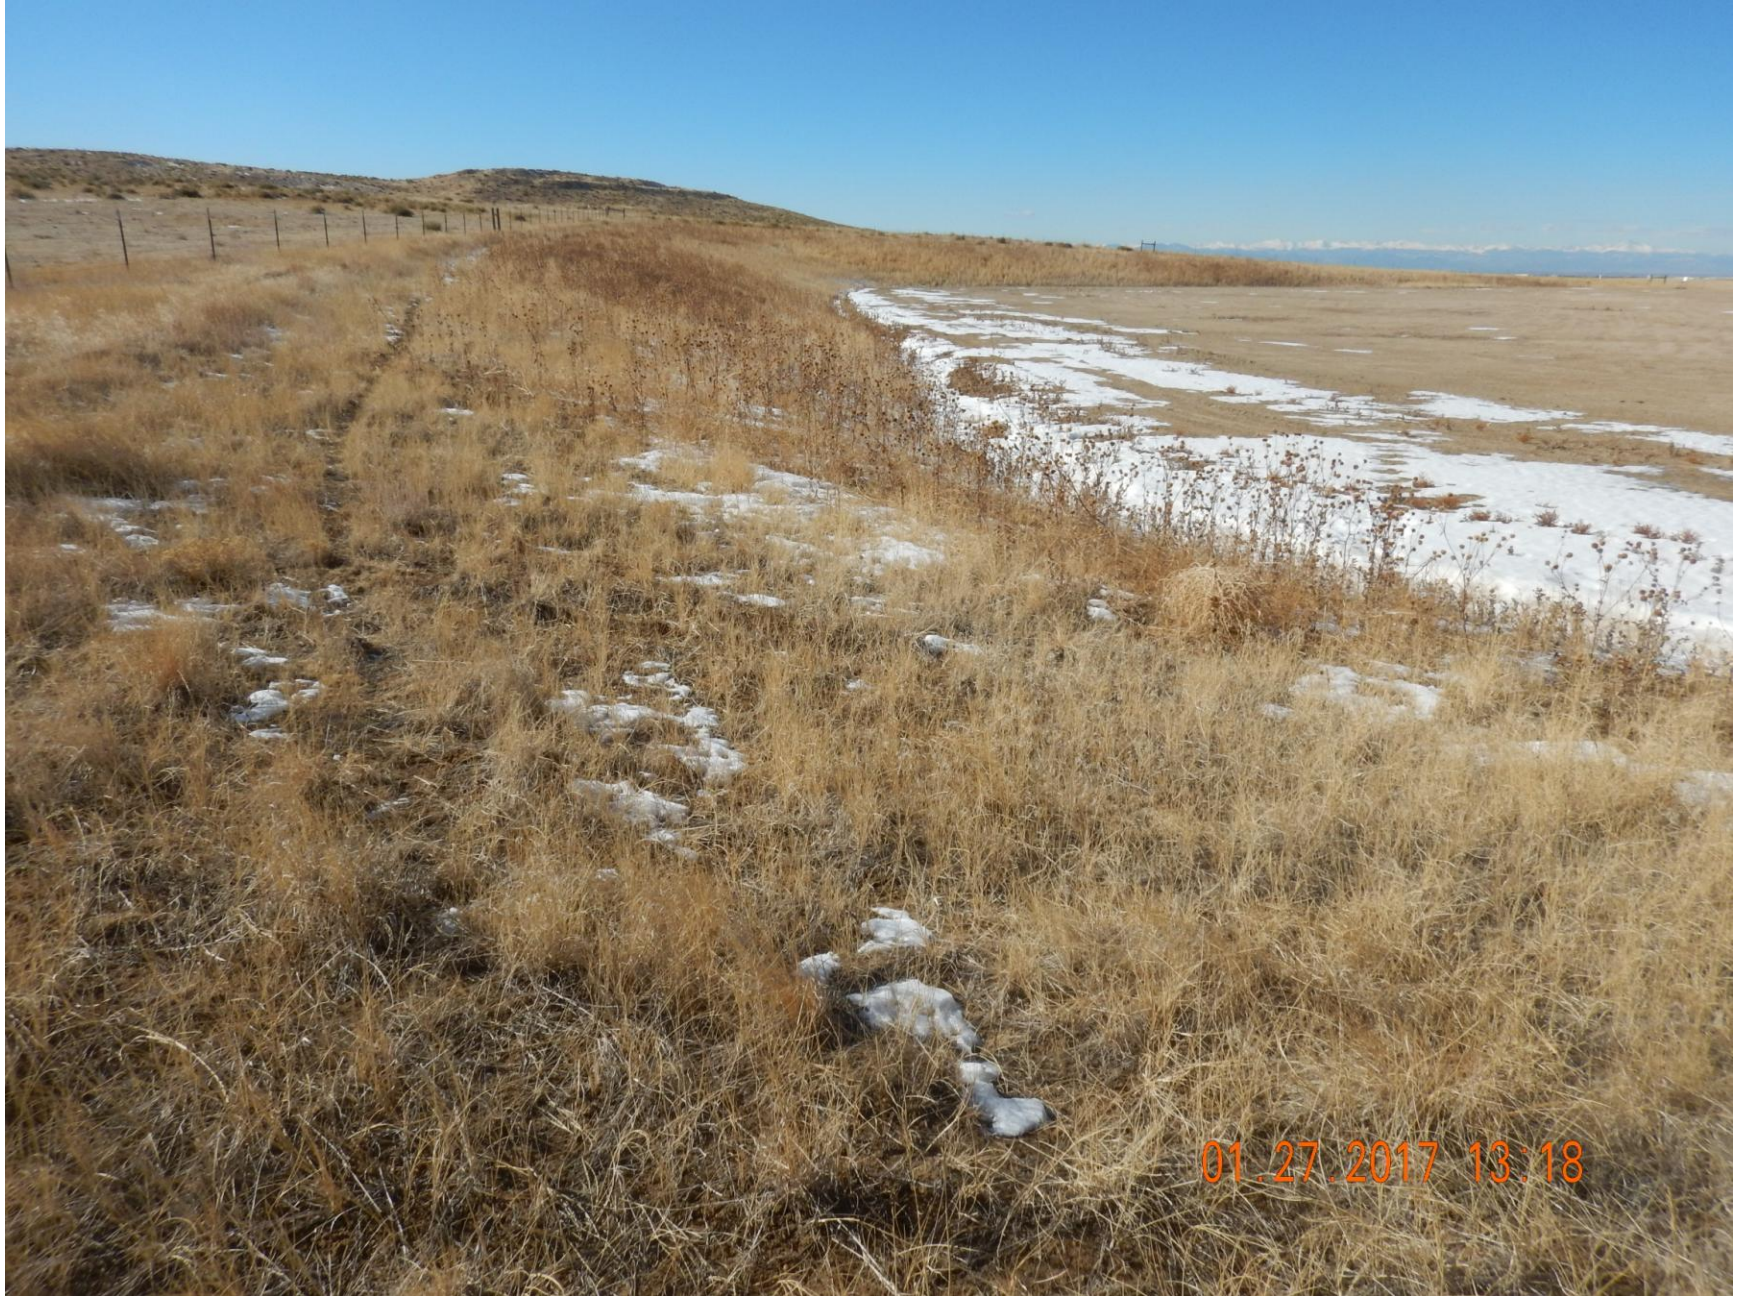
Figure 22: Photo taken from the southeast end of the location, facing west. Photo shows the project and current interim areas.

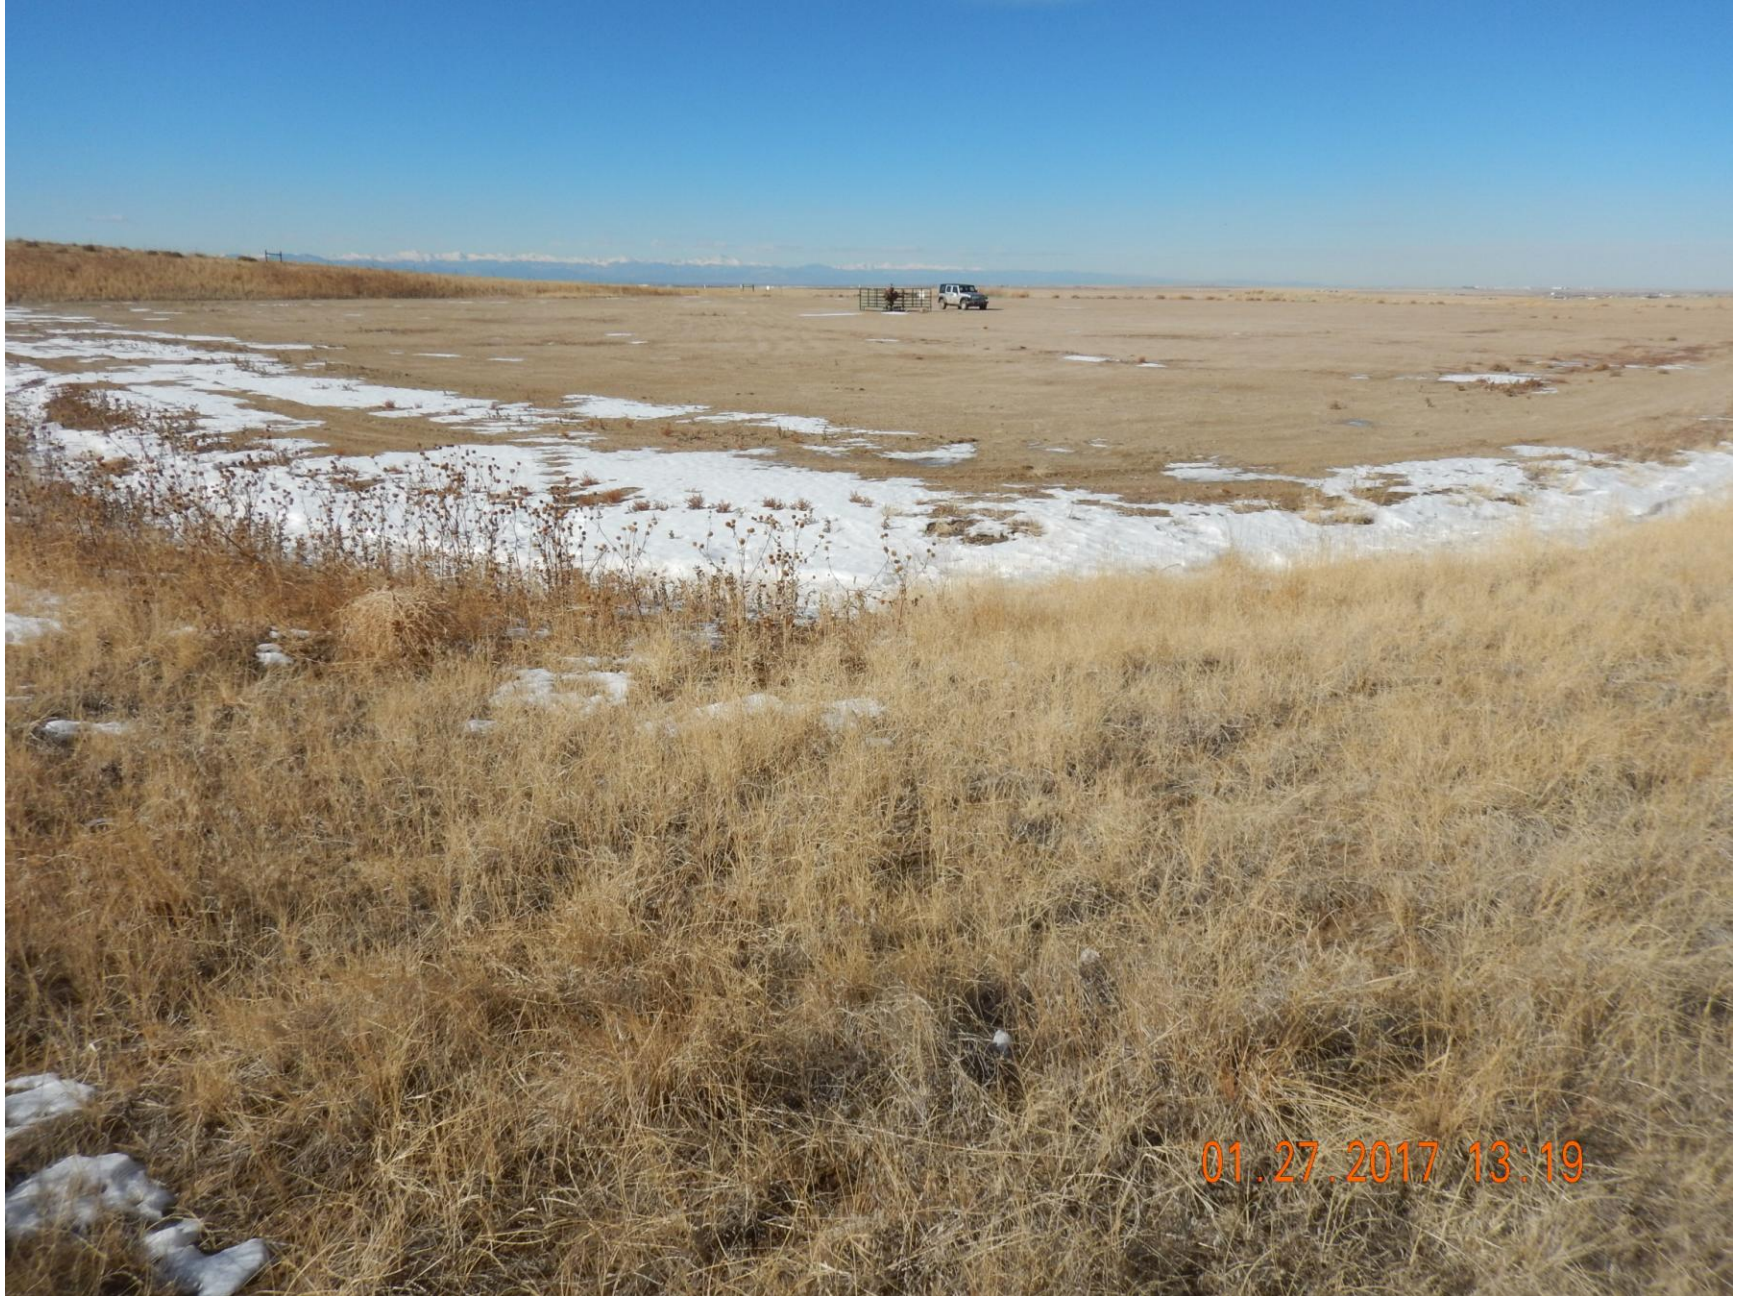
Figure 23: Photo taken from the southeast end of the location, facing northwest. Photo shows the project and current interim areas.

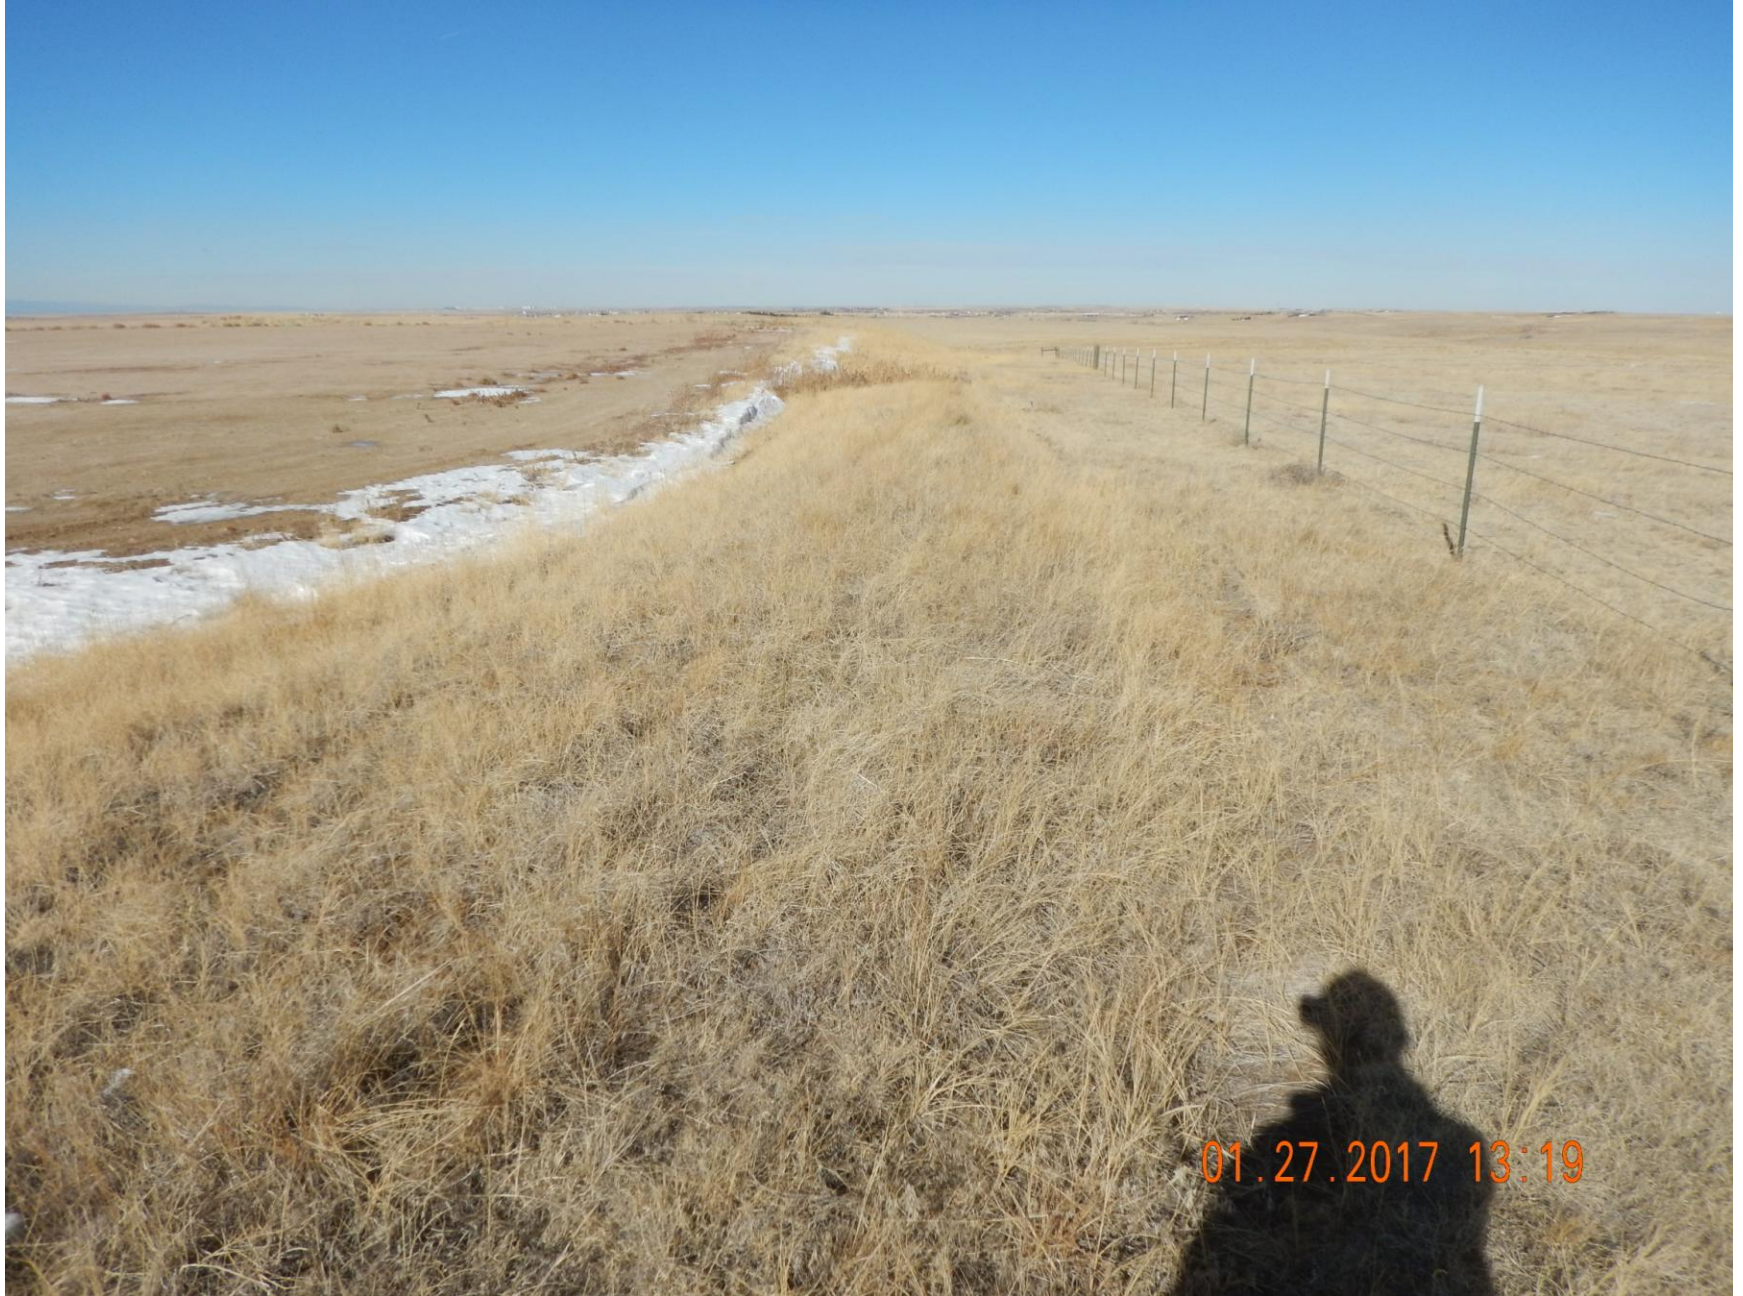
Figure 24: Photo taken from the southeast end of the location, facing north. Photo shows the project and current interim areas.
