January 30, 2017

Inspection Photos: Ursa Weinreis ALS

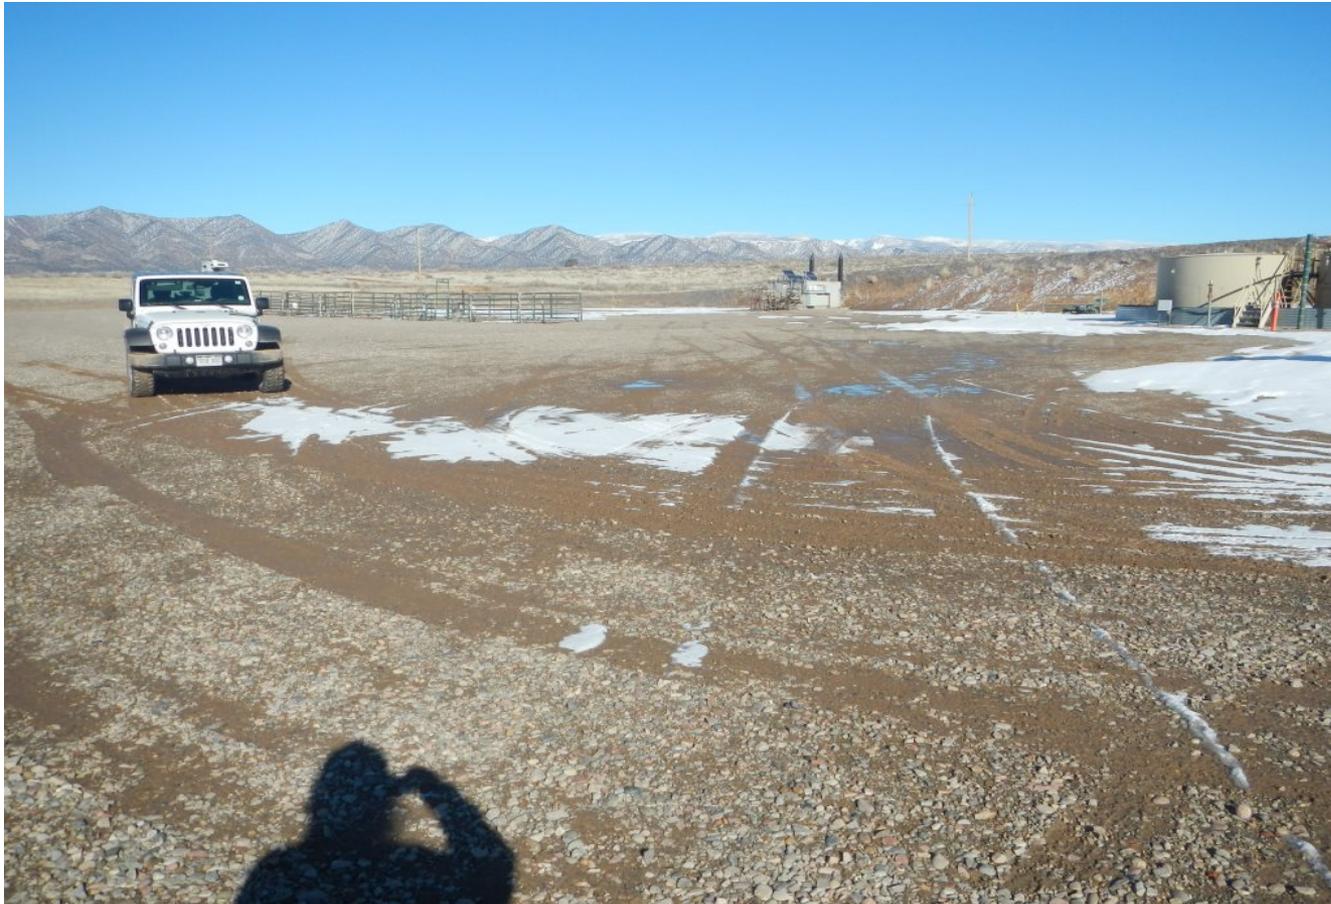
Photo#1: View of Location from Entry to NE.

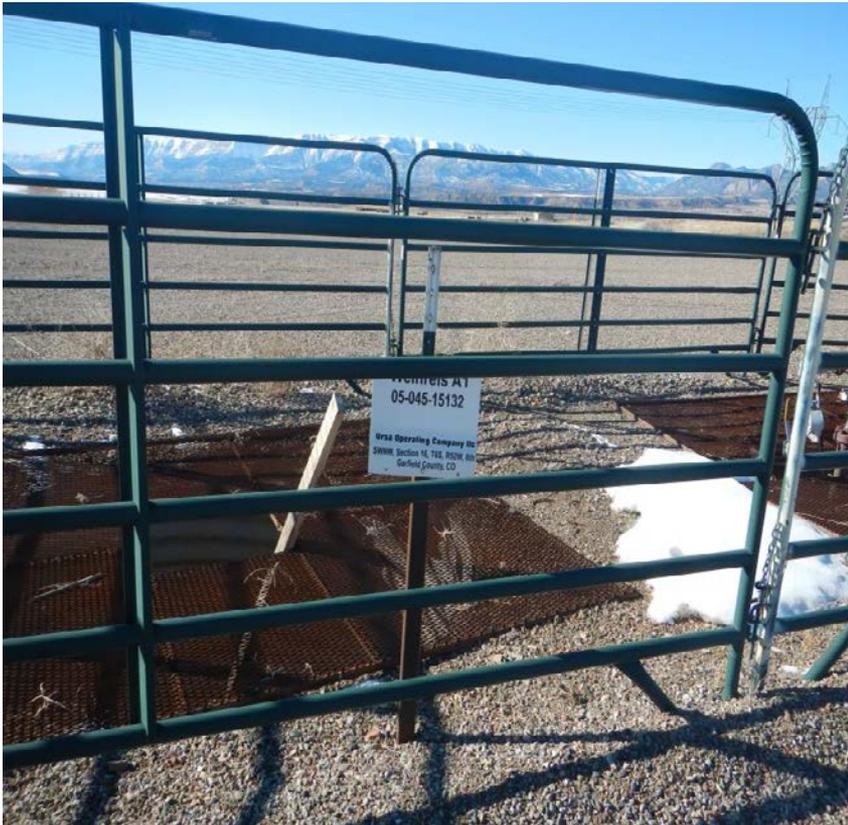
Photo#2:

AL Well with Conductor Set ; Operator has met Safety Standards for Maintaining a Preset Conductor.

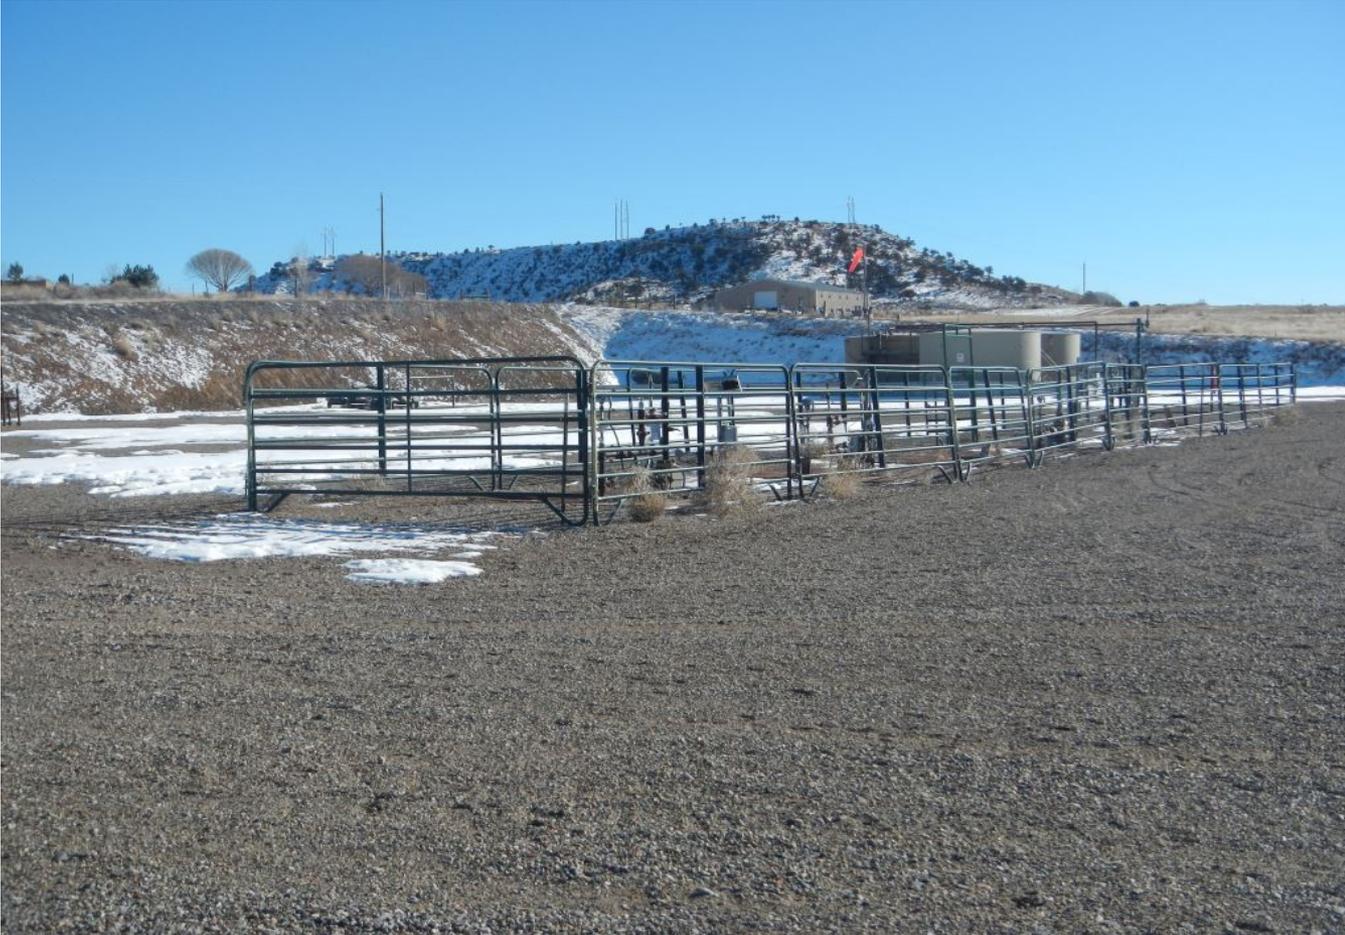
Photo#4: View of Well Corral to SE.

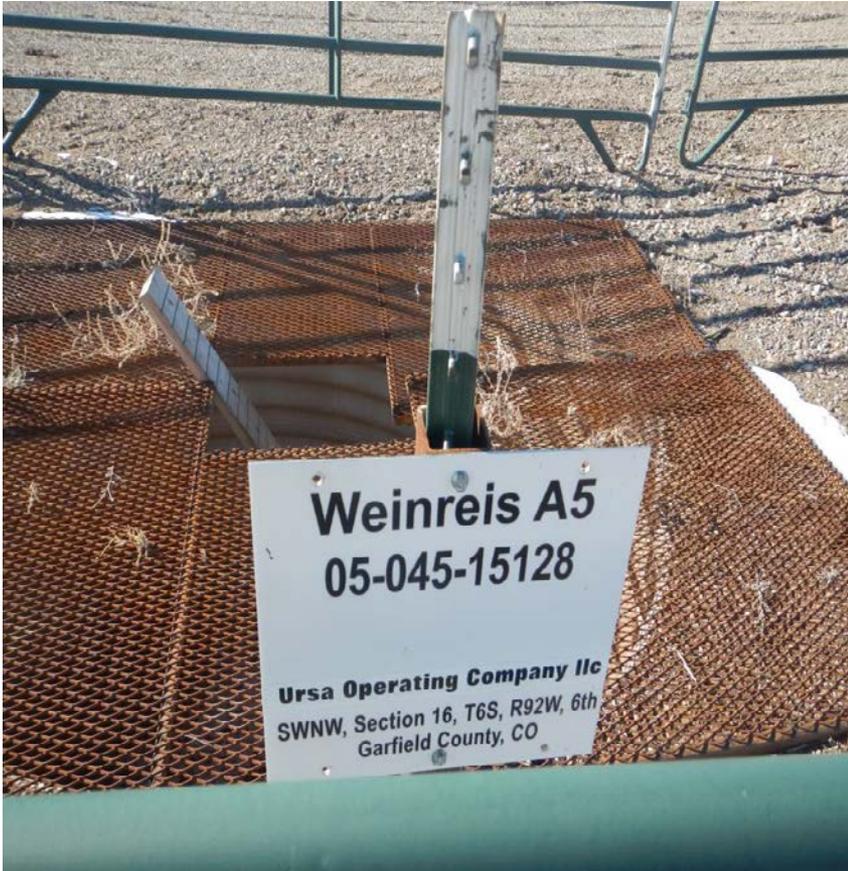
Photo#5:

AL Well with Conductor Set ; Operator has met Safety Standards for Maintaining a Preset Conductor
