Final Reclamation and Stormwater Inspection

01/26/2017

Operator: Noble

Location ID: 310184

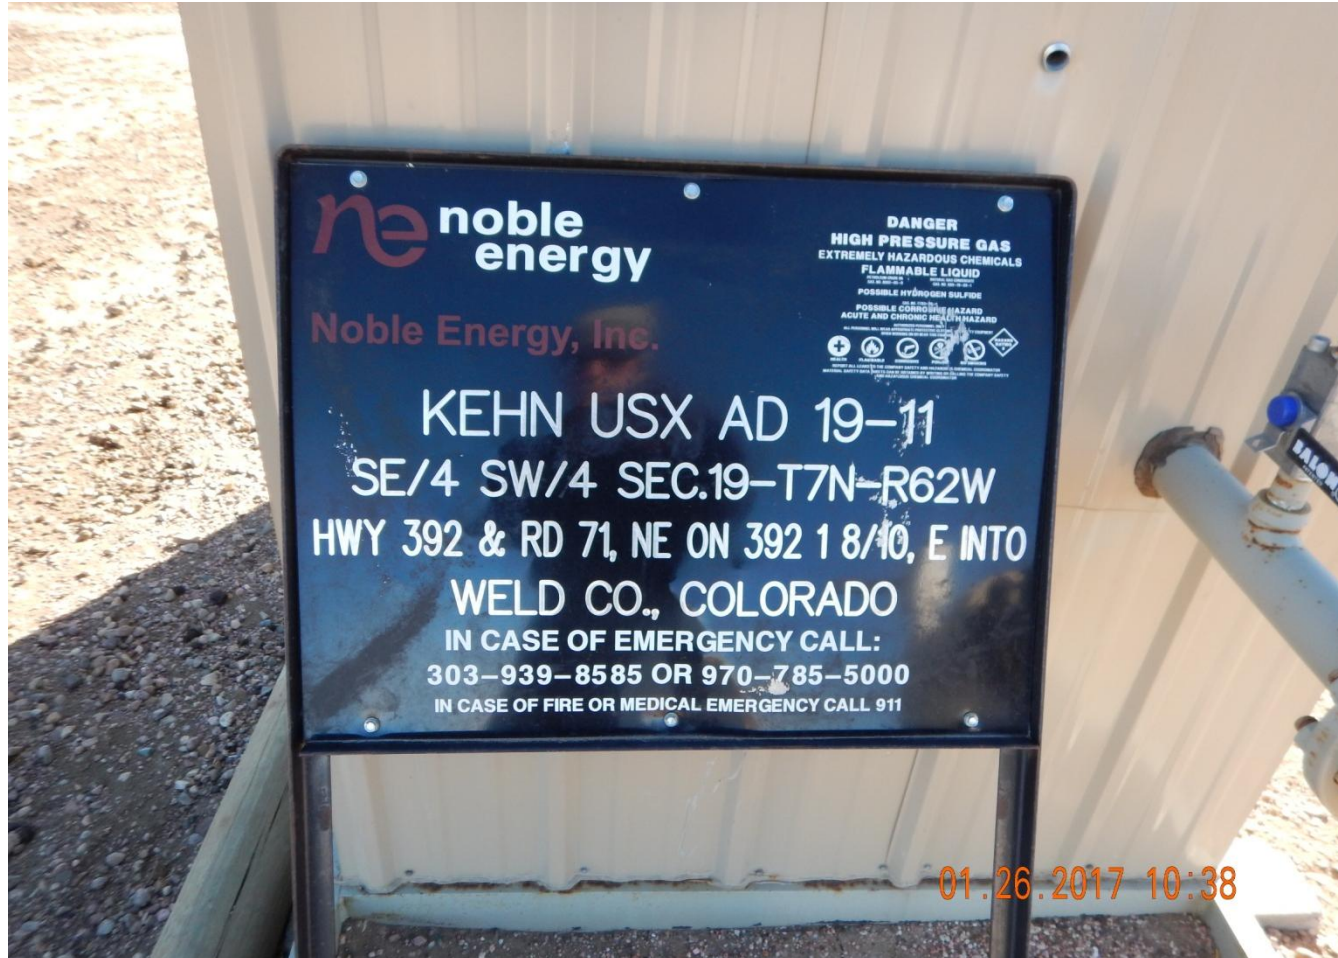
Photo 1. Photo taken of the PR well sign left behind with equipment at location.

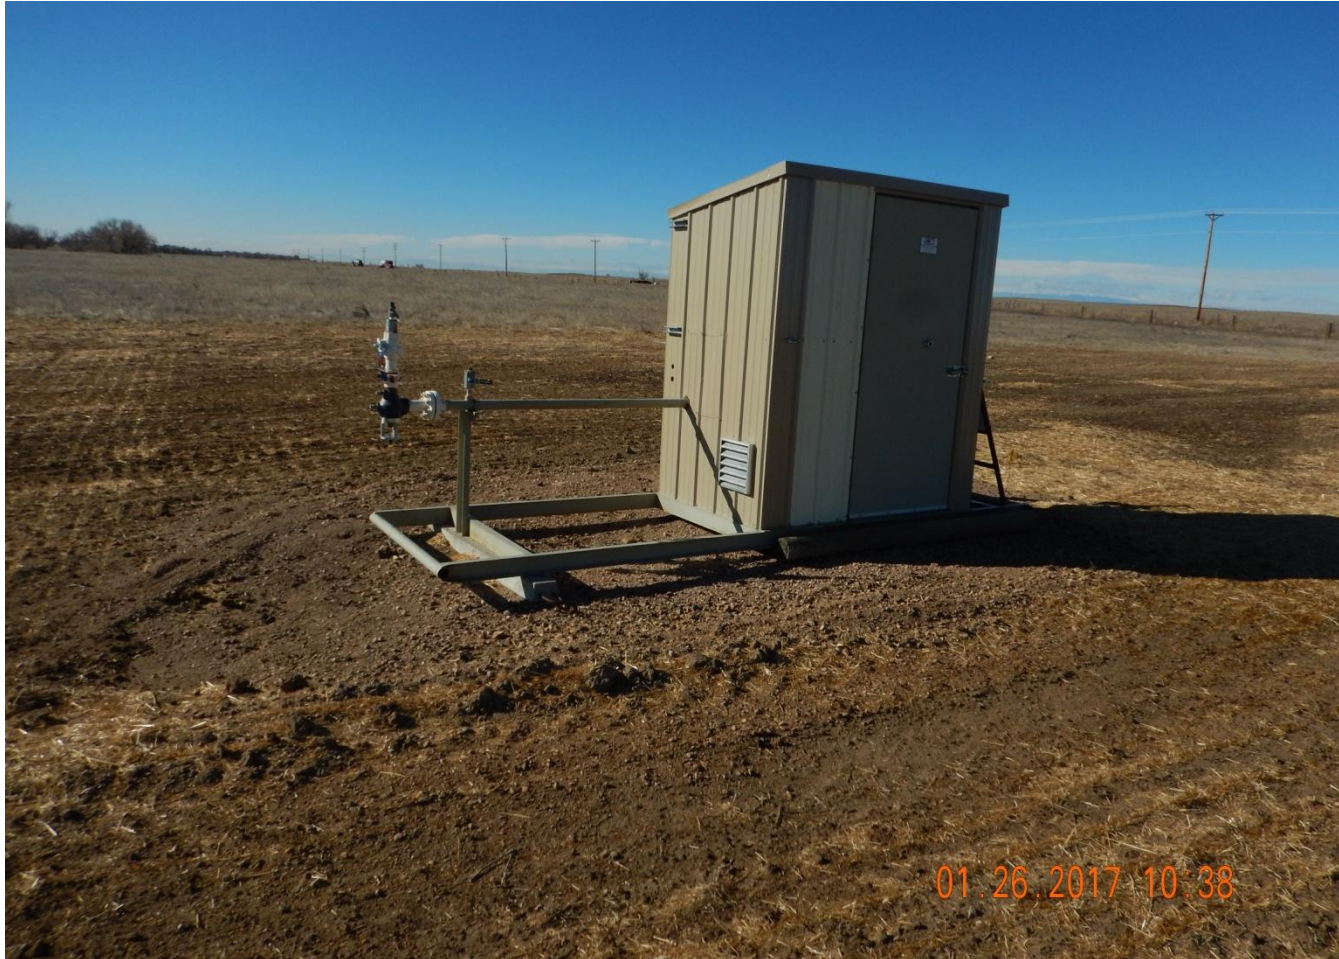
Photo 2. Photo taken of the equipment left behind at location. Equipment should have been removed first before performing final reclamation activities. This small, unreclaimed area will still need final reclamation activities to be performed, and if any additional disturbance is created from removing the equipment, final reclamation activities should also be performed.

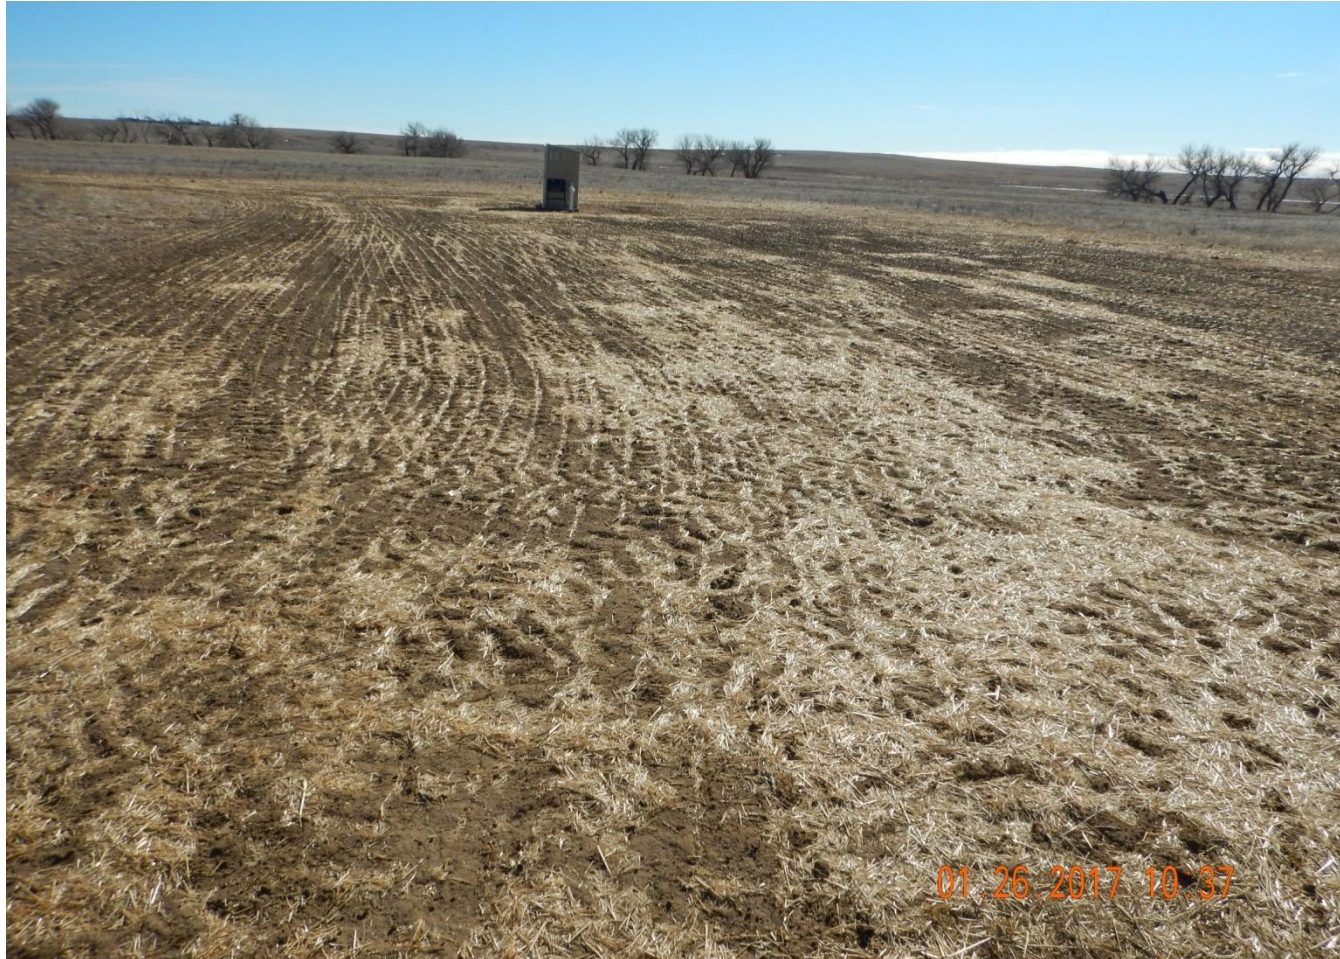
Photo 3. Photo taken from the entrance of location, facing East. Evidence of final reclamation activities apparent along the access road. Mulch does not appear to be sufficiently crimped. Mulch was observed in the rangeland areas adjacent to the disturbance area. Refer to the following photo.

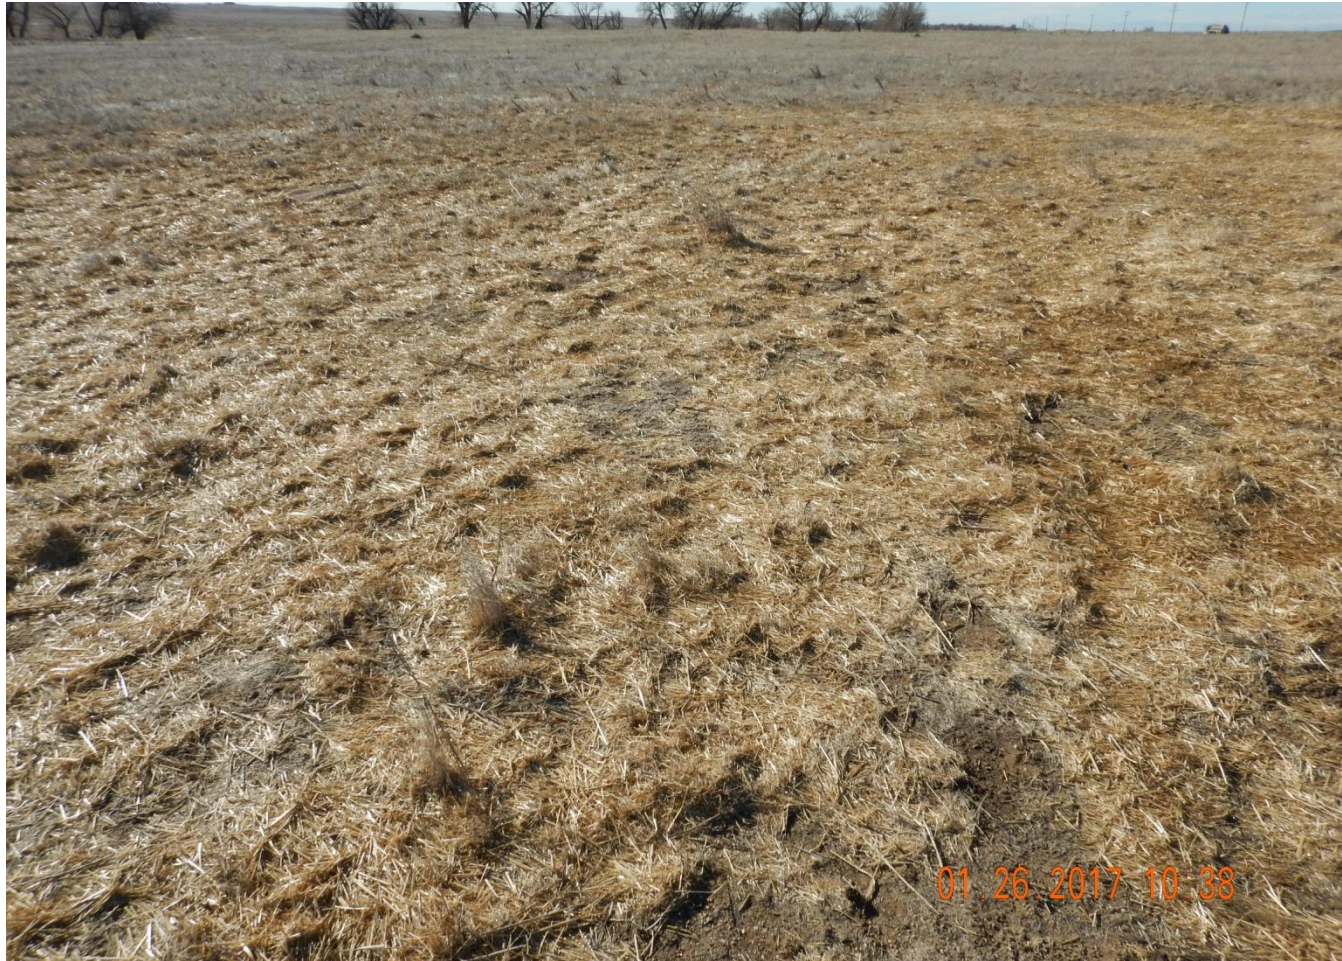
Photo 4. Photo taken from the east of the equipment along the border of the disturbance area and rangeland area, facing South. Accumulations of mulch apparent suggesting crimping was not sufficiently implemented.

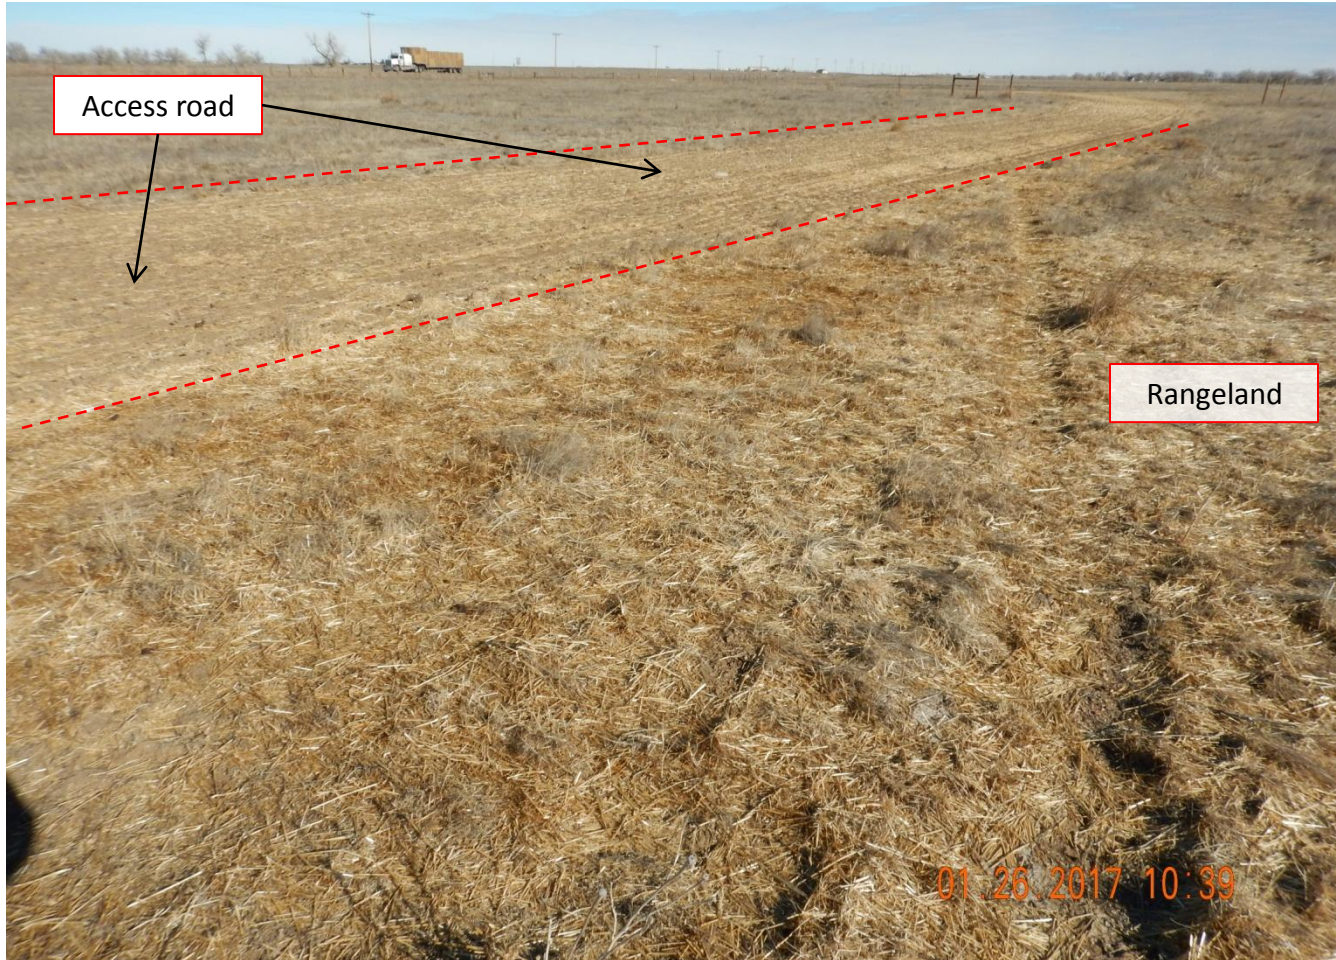
Photo 5. Photo taken along the access road north of the equipment, facing North. Accumulations of mulch apparent suggesting crimping was not sufficiently implemented.

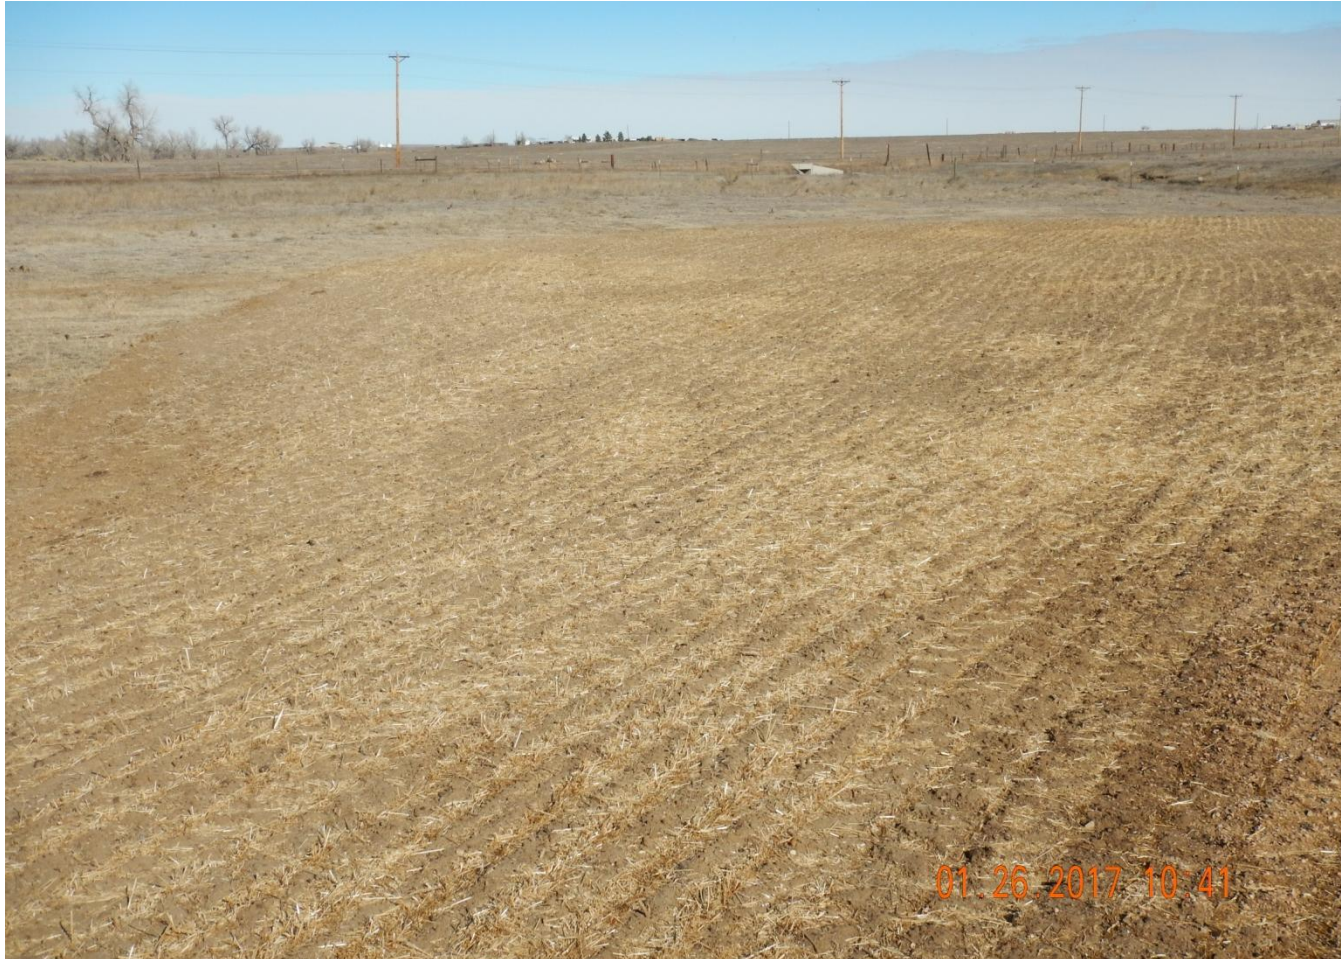
Photo 6. Photo taken from the south well location, facing Northwest. Evidence of final reclamation activities apparent throughout the disturbance area. It should be noted the well location still has fencing material around well location which might be used to keep cattle out during the reclamation process.

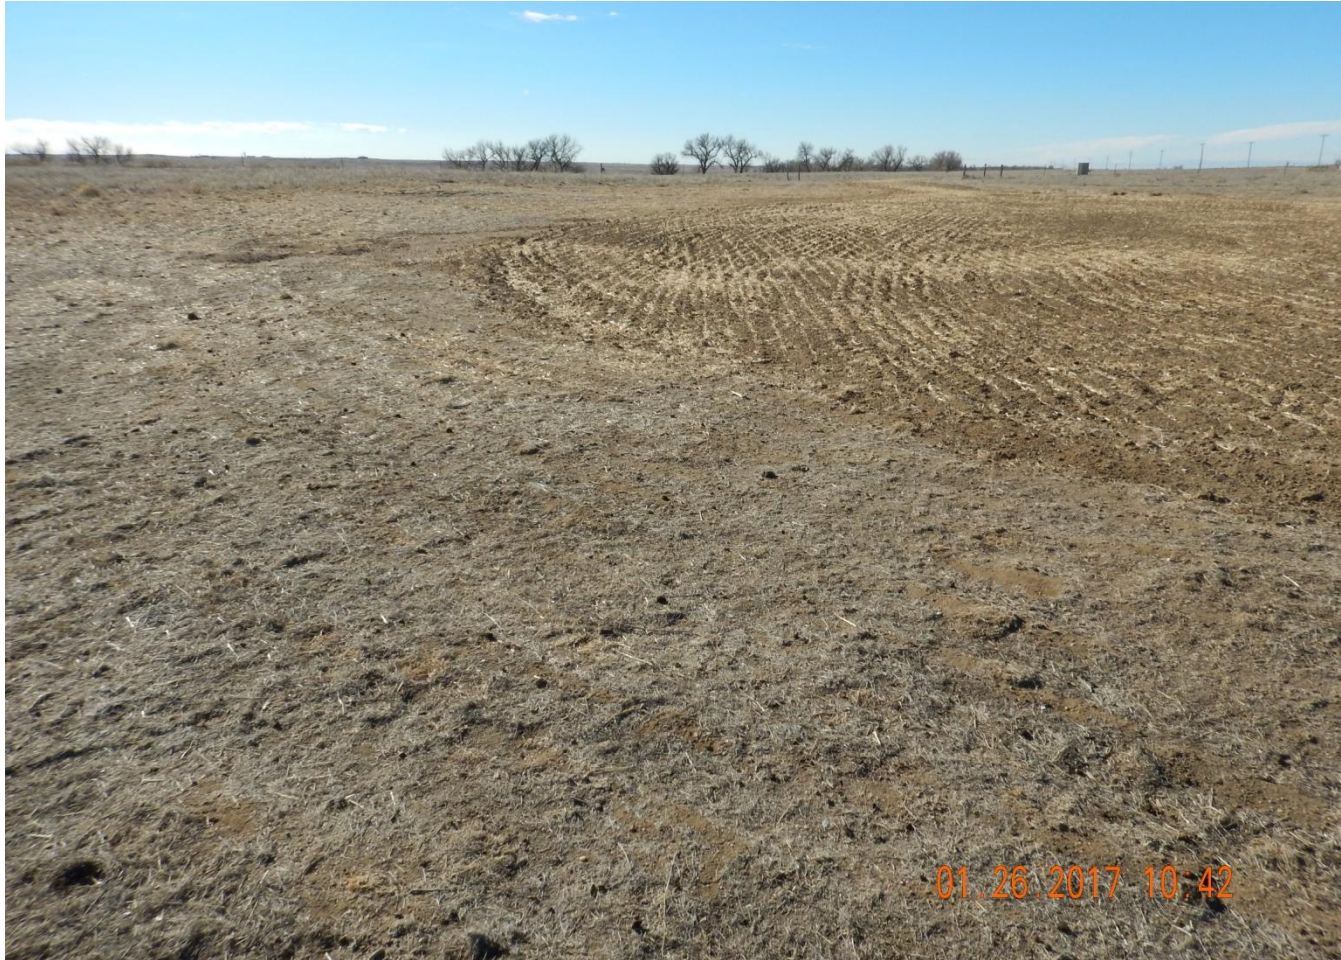
Photo 7. Photo taken from the north well location, facing South. Evidence of final reclamation activities apparent throughout the disturbance area.
