Complaint and Stormwater Inspection

02/03/2017

Operator: Kerr McGee #47120

Location ID: 444427

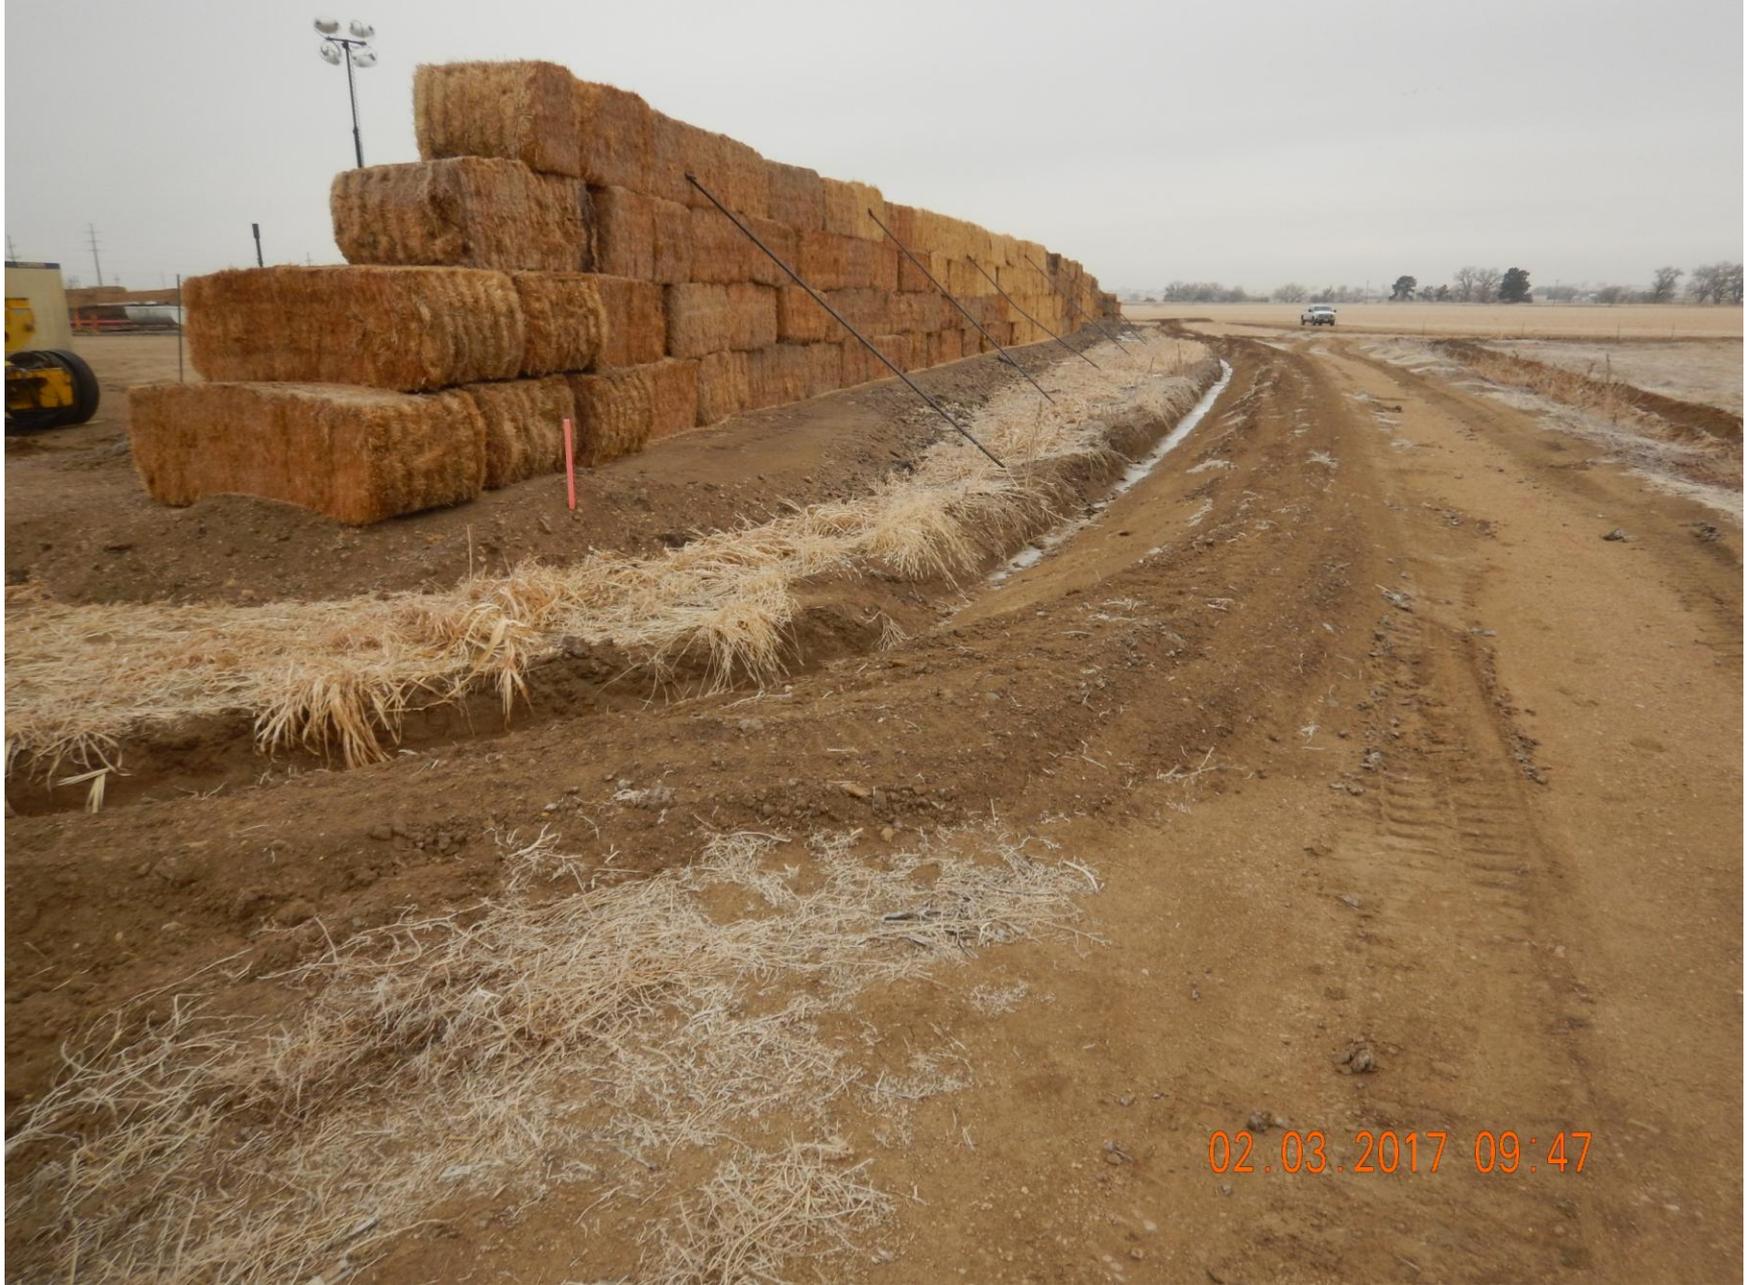
Figure 1: Photo taken from the northeast corner of the location, facing west. Photo shows ditch along the perimeter of the location constructed as a stormwater and sediment control BMP.

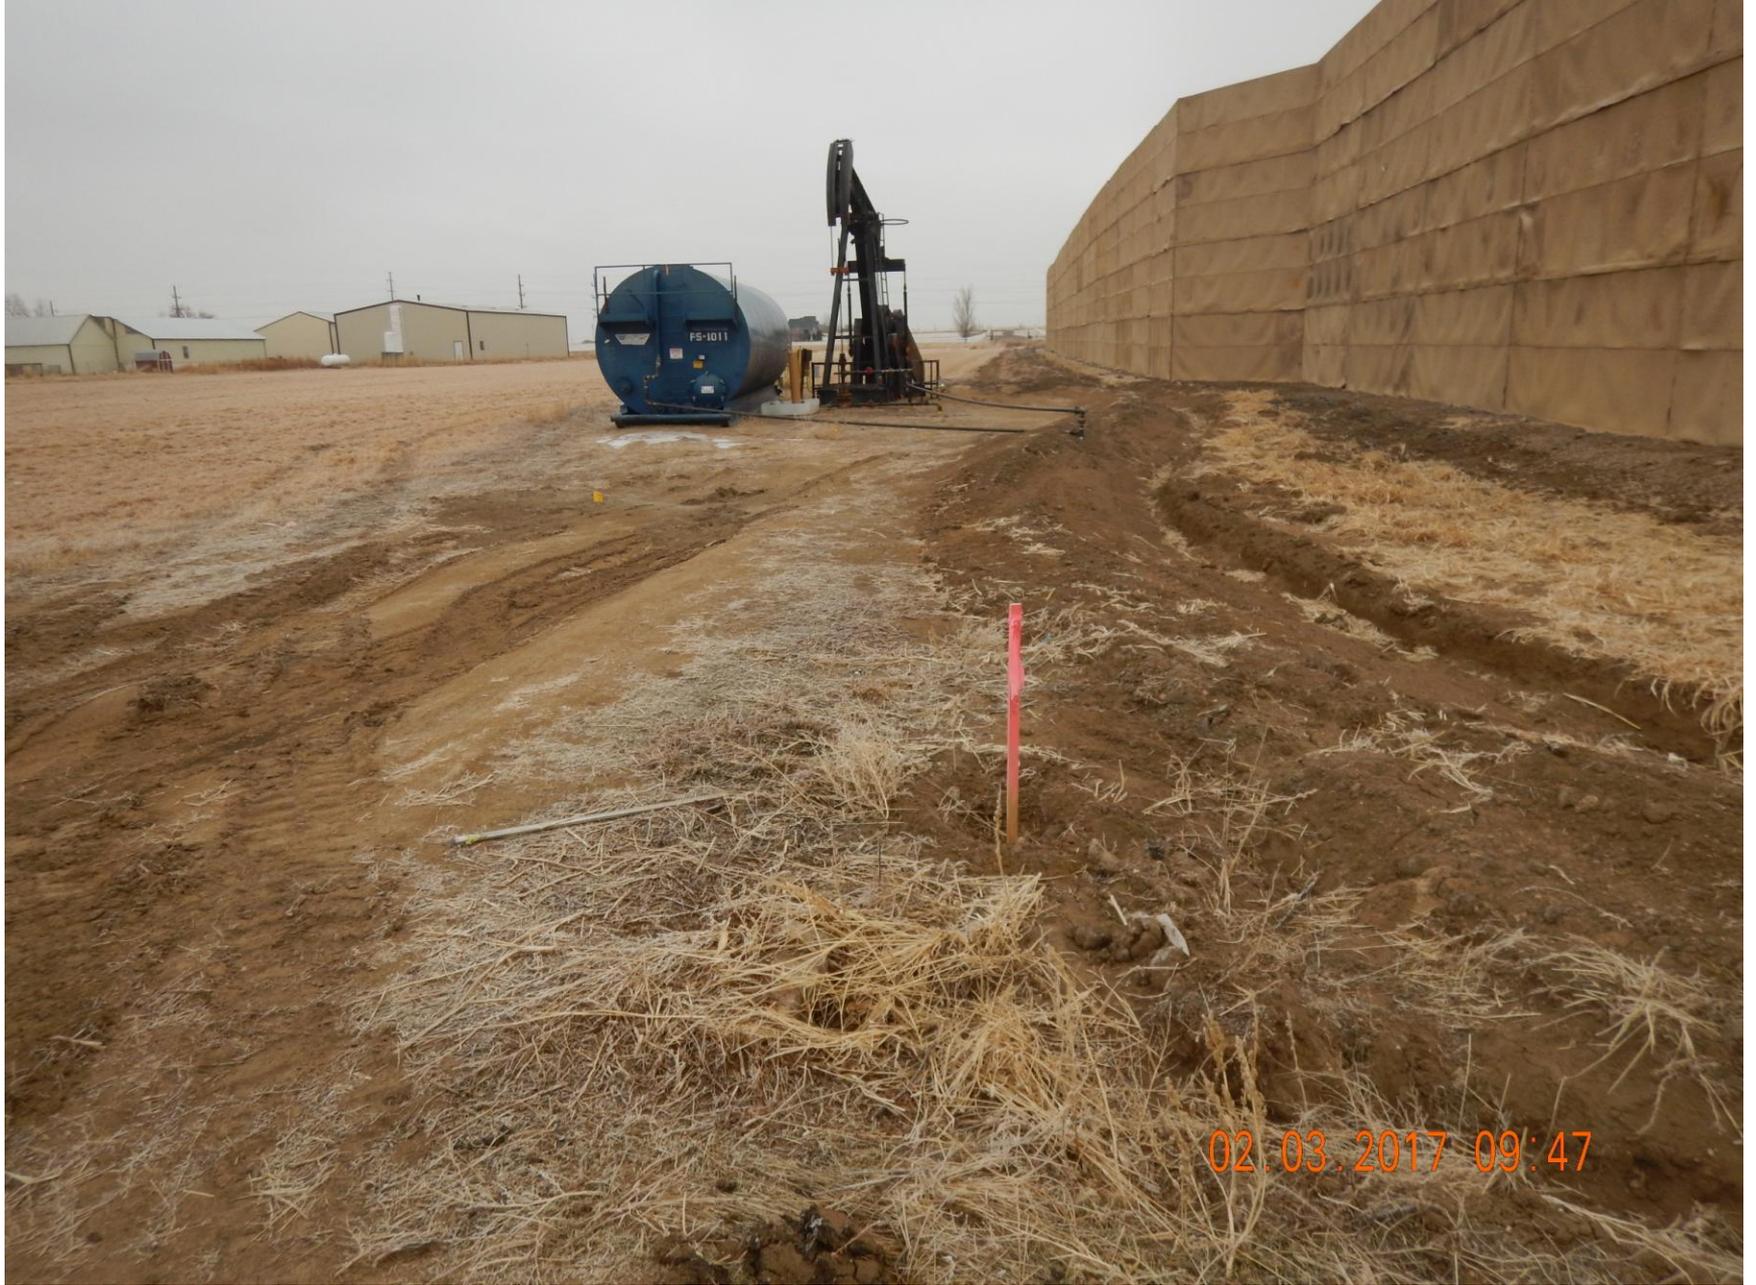
Figure 2: Photo taken from the northeast corner of the location, facing south. Photo shows ditch along the perimeter of the location constructed as a stormwater and sediment control BMP. Pump jack and well seen in photo not associated with the location in this inspection.

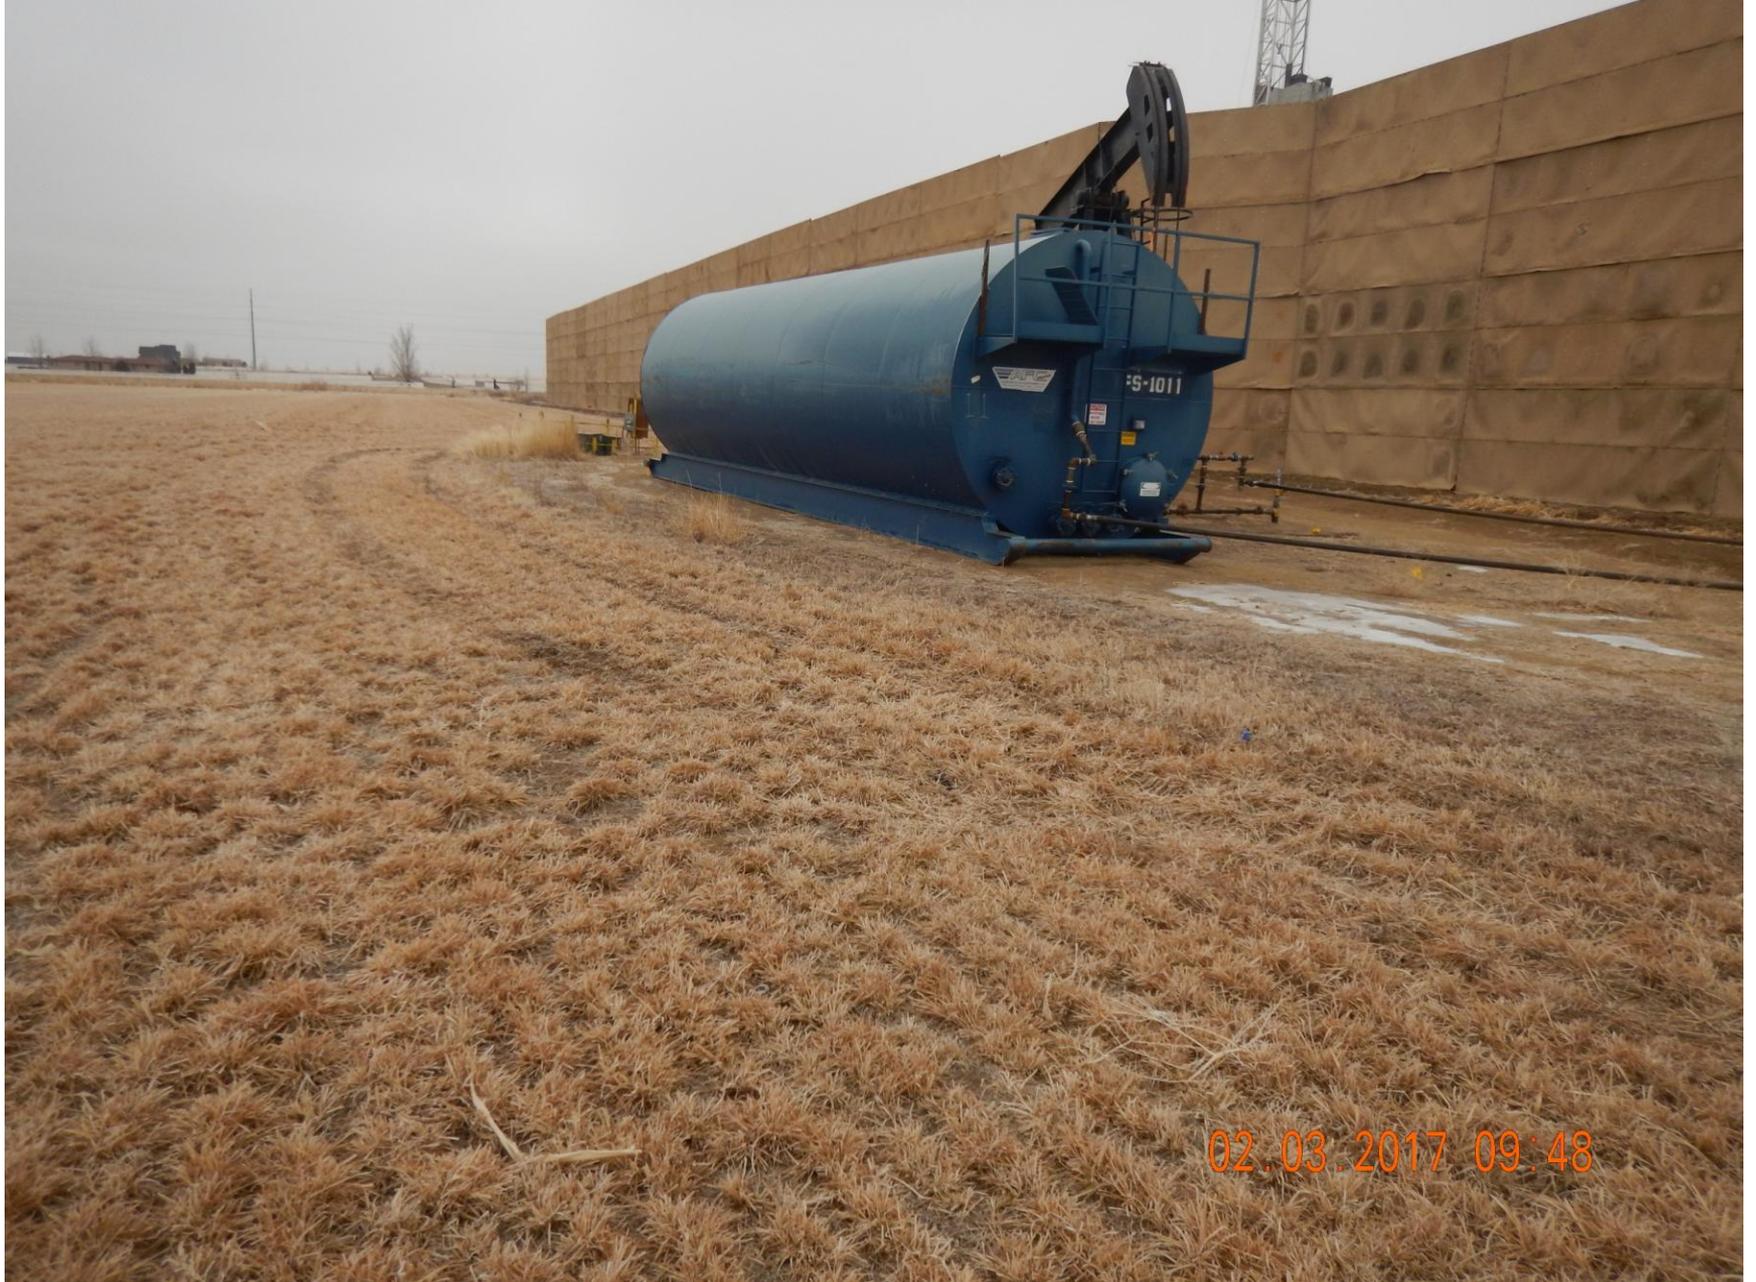
Figure 3: Photo taken east of the location, facing south. Photo shows hay field on the adjacent surface owners property, the location, and a Pump jack and well not associated with location in this inspection.

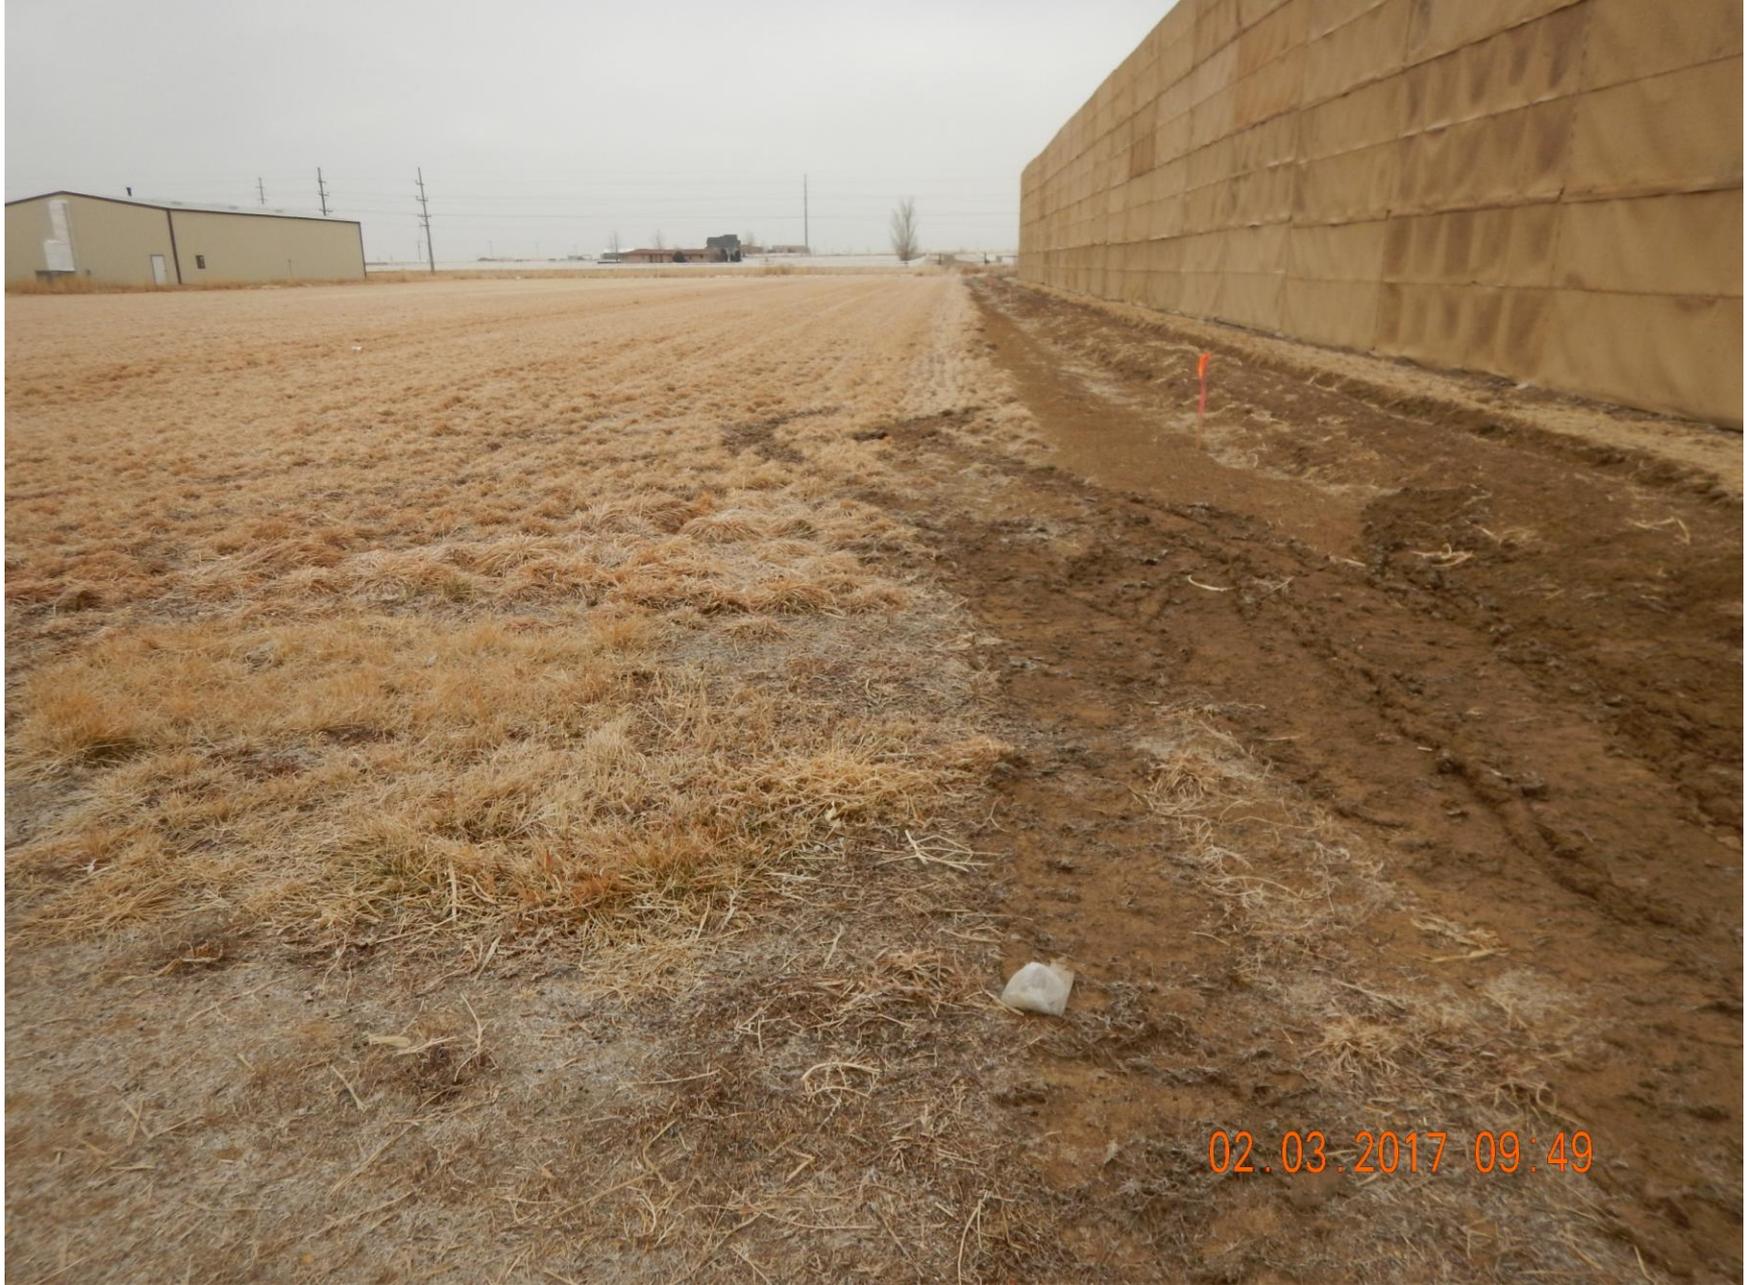
Figure 4: Photo taken from the northeast end of the location, facing south. Photo shows soil and disturbances from the location had encroached onto the adjacent surface owners hay field.

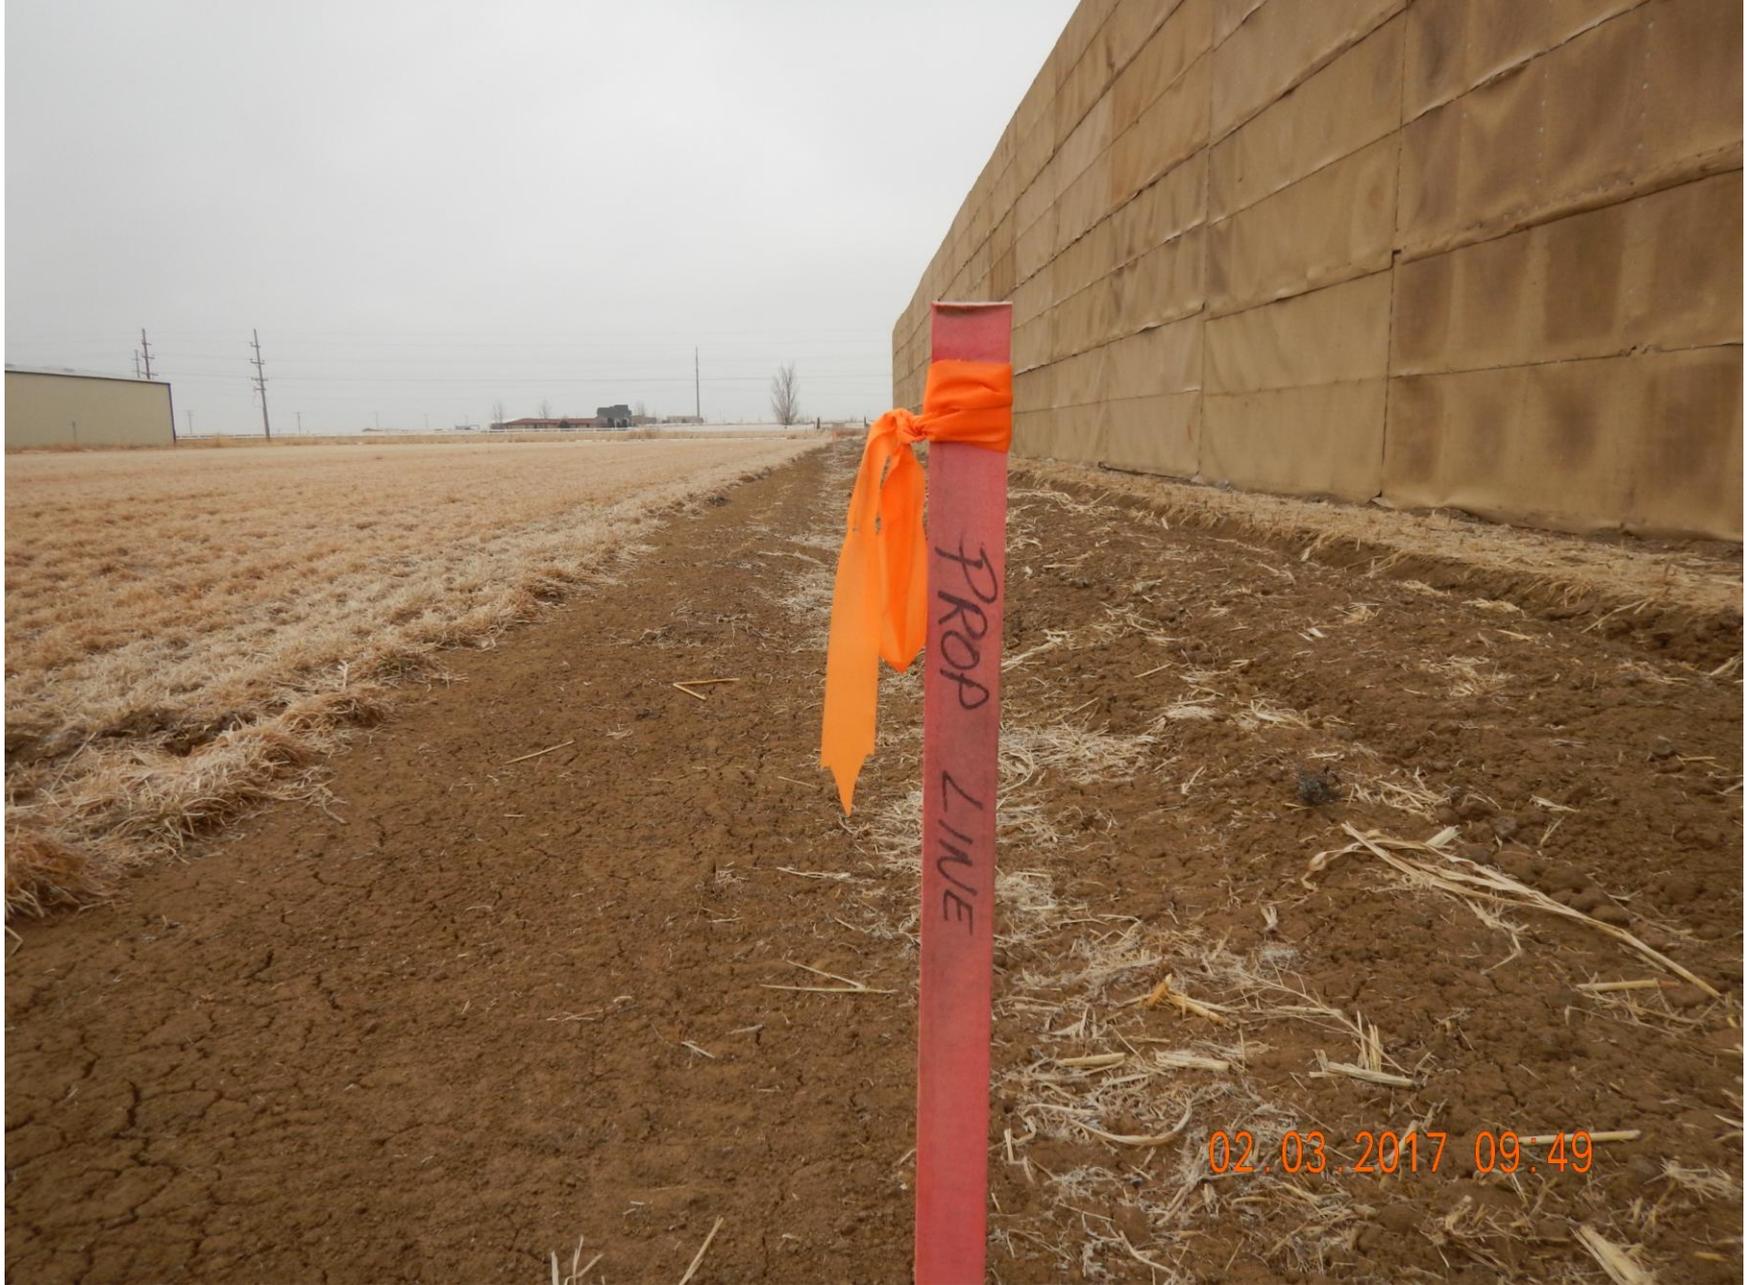
Figure 5: Photo taken from the east end of the location, facing south. Photo shows stakes used to define the property lines. Note disturbances had encroached upon the adjacent surface owners property.

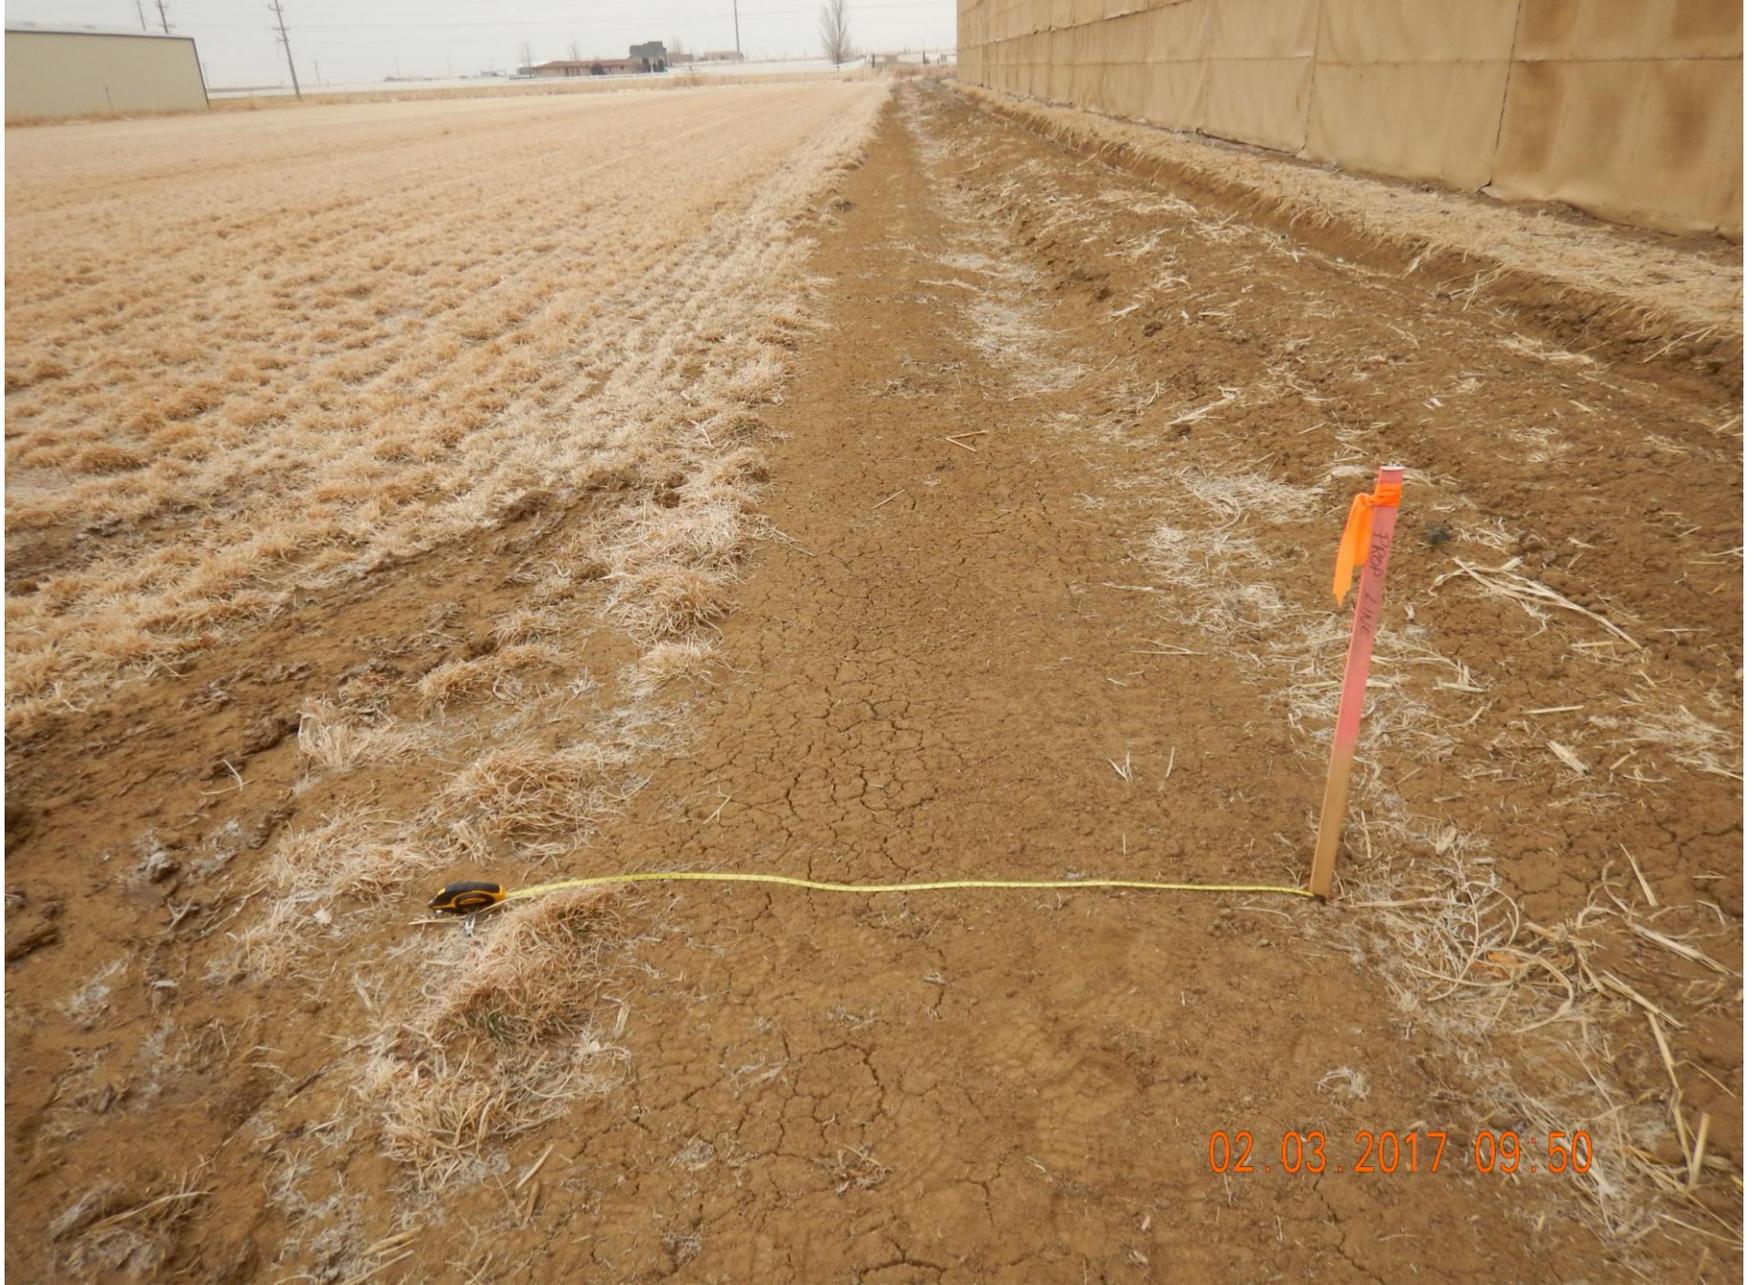
Figure 6: Photo taken from the east end of the location, facing south. Photo shows a five (5) foot wide strip on the adjacent surface owner's land that is void of vegetation due to disturbances caused during construction.

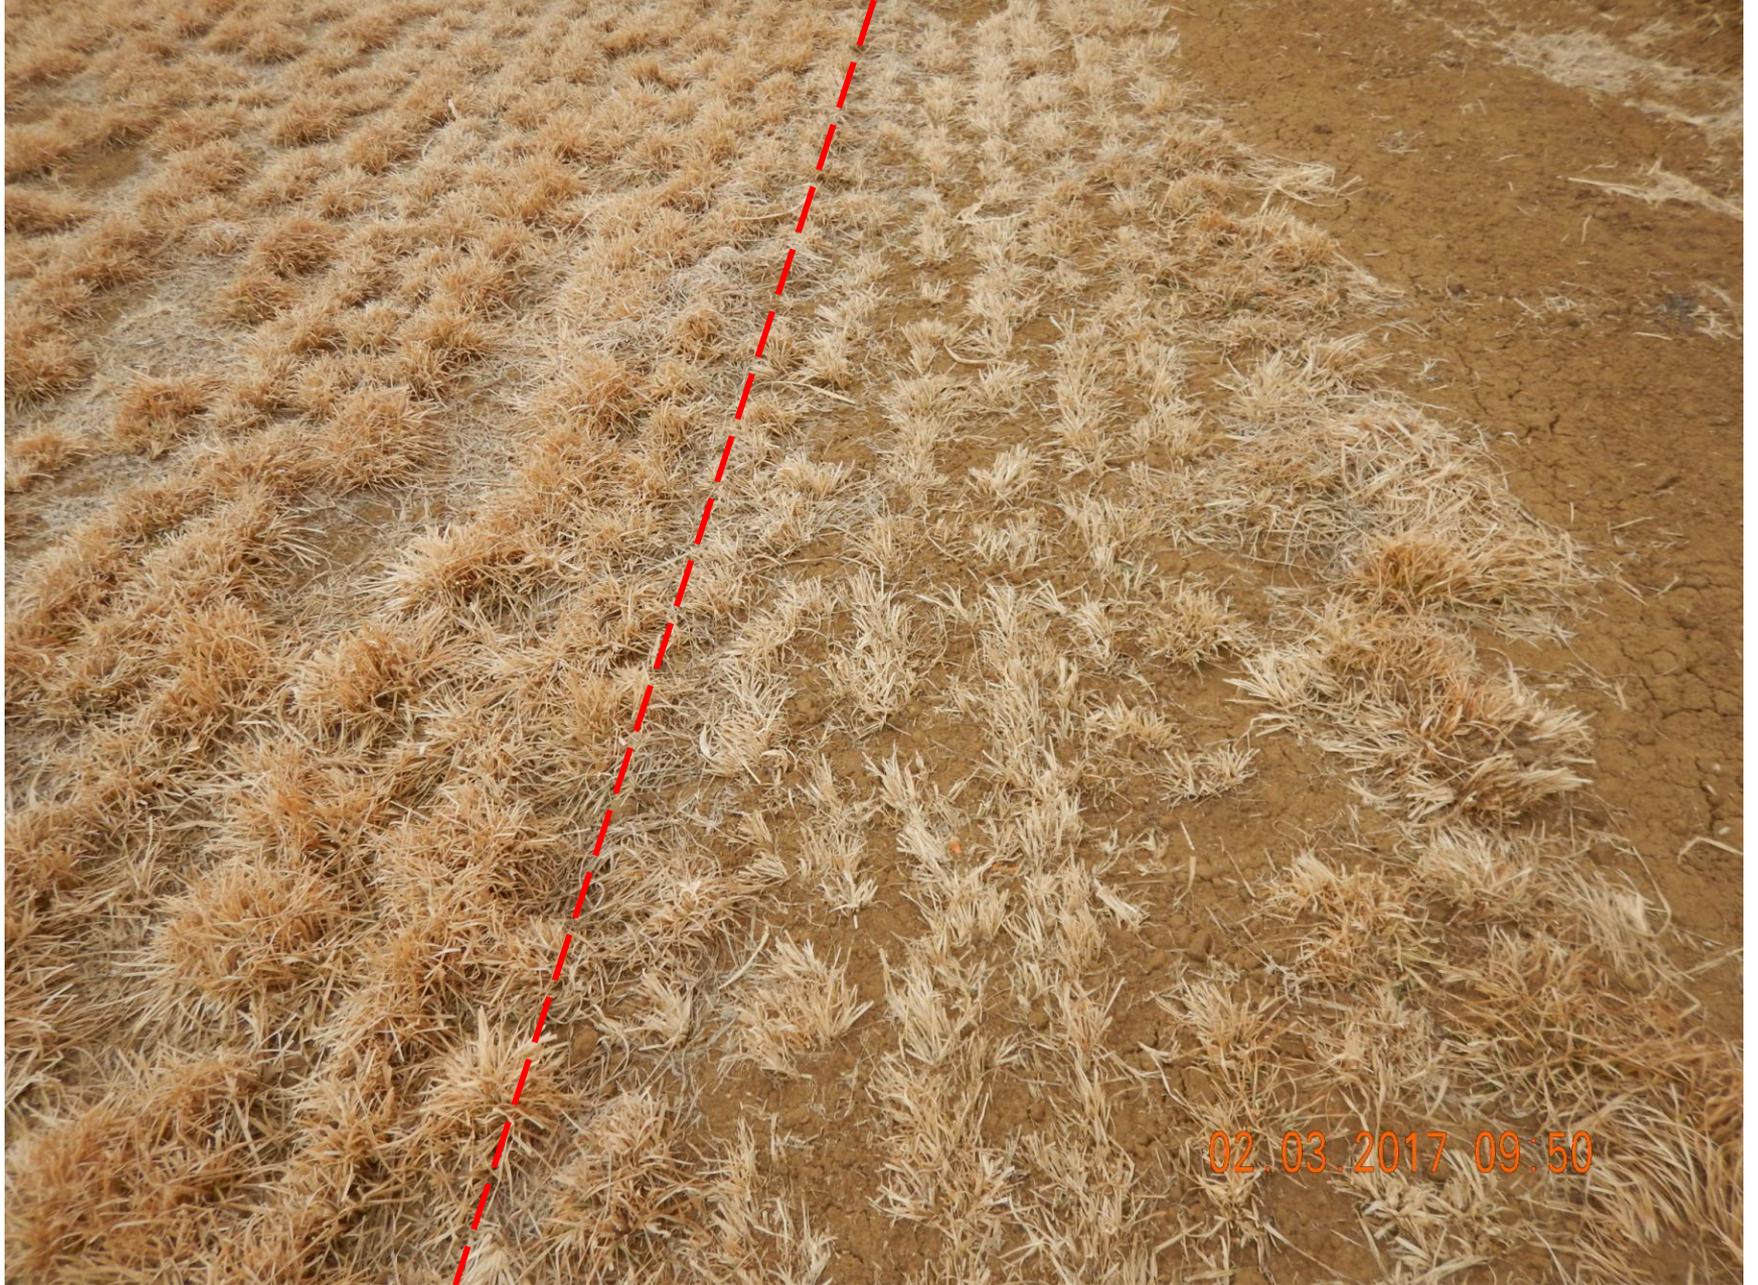
Figure 7: Photo taken from the east end of the location. Photo shows an additional 3 foot wide strip (right of red line) of grass further into the complainant's property that appears to have been impacted from the disturbance.

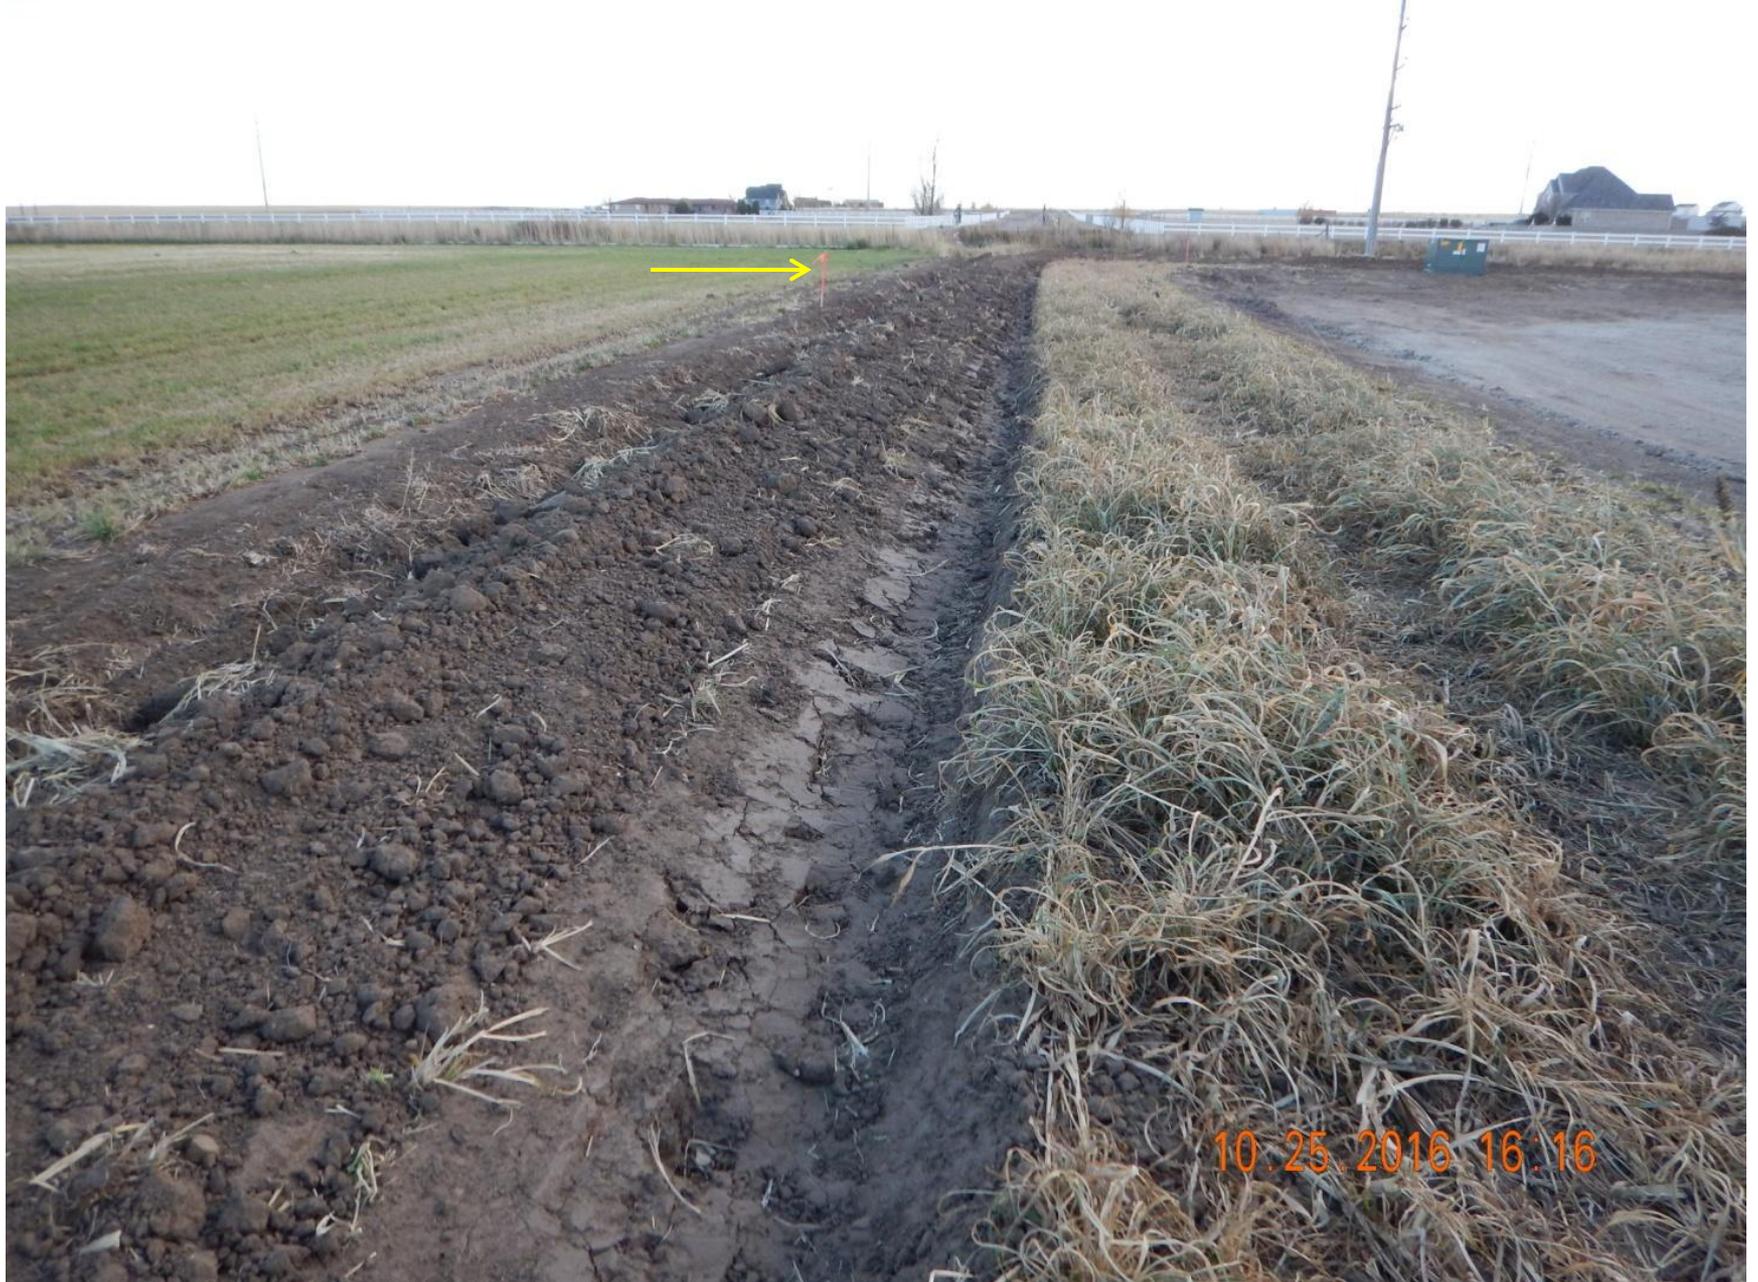
Figure 8: Photo taken from inspection doc. #682401425. This was a construction, pre-drill inspection. Photo shows ditch on the east end of the location, and the soil deposited on the adjacent surface owners property. Stakes shown with yellow arrow marks property line.

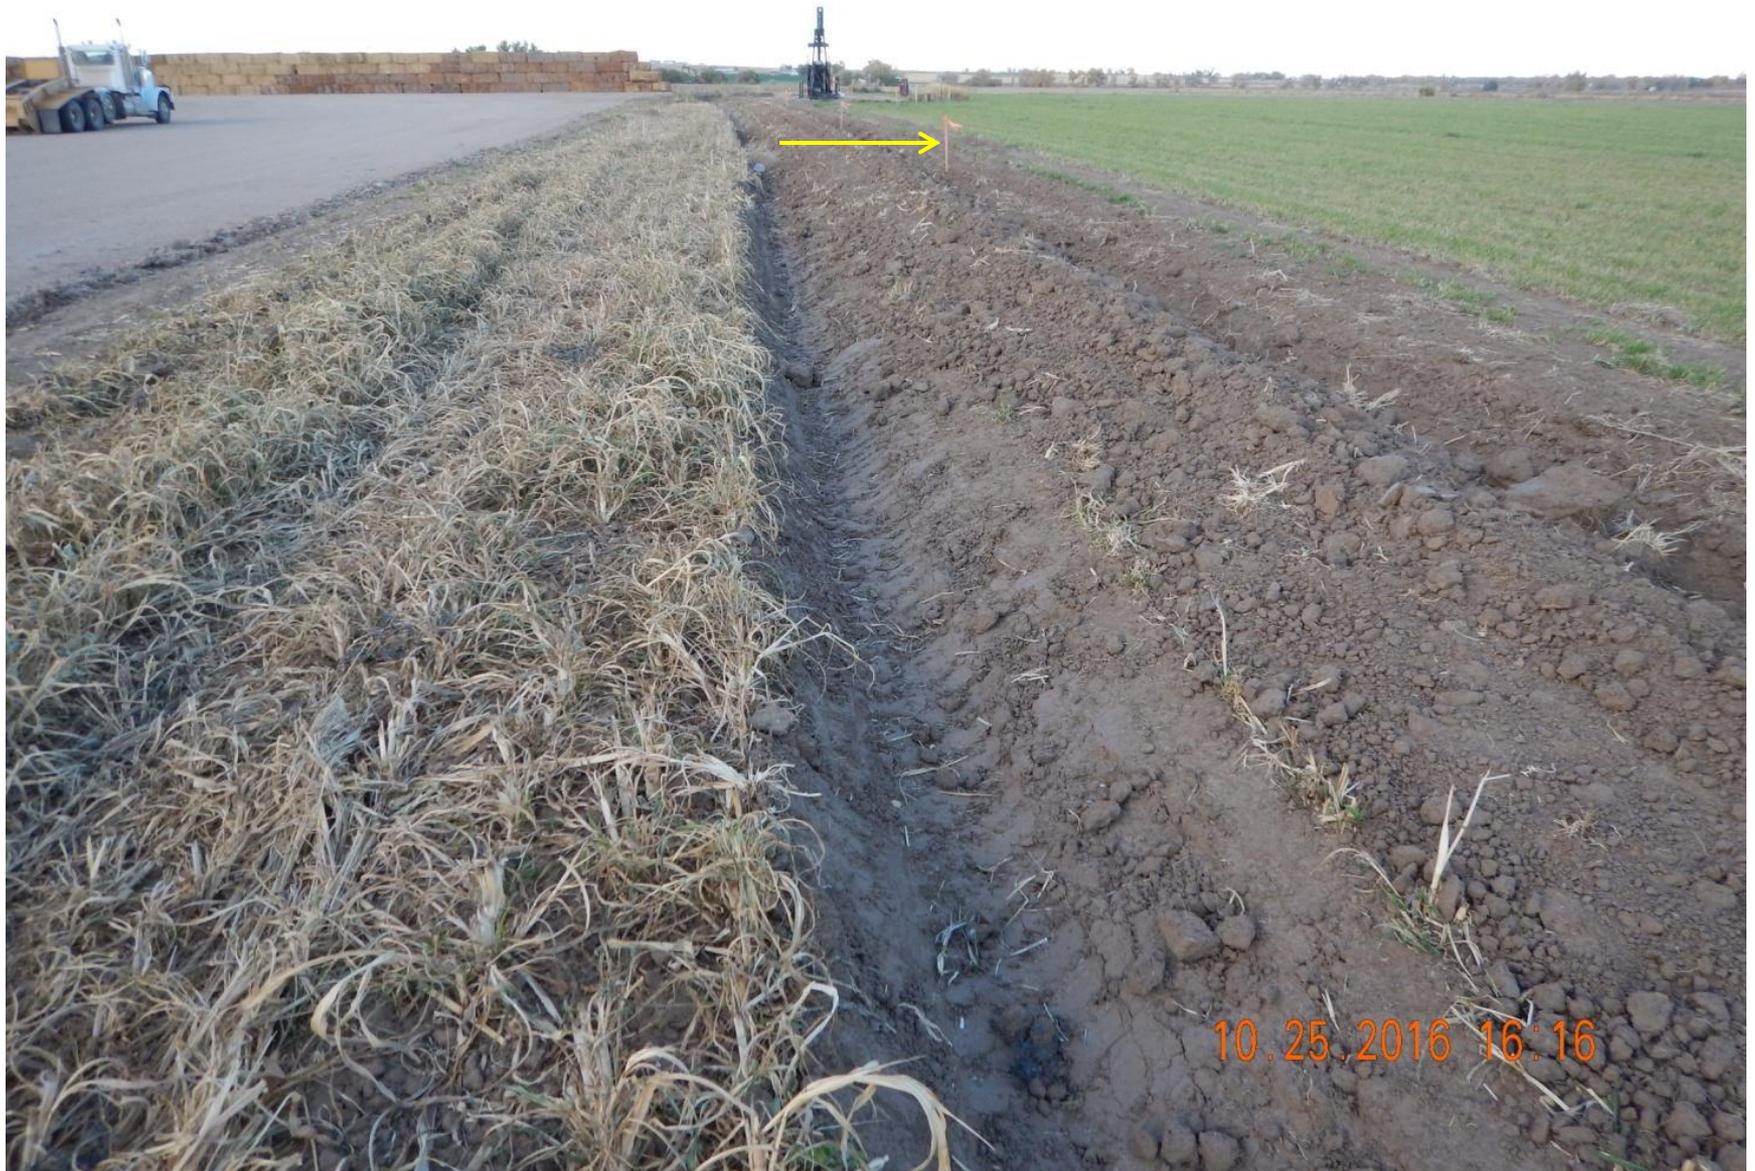
Figure 9: Photo taken from inspection doc. #682401425. This was a construction, pre-drill inspection. Photo shows ditch on the east end of the location, and the soil deposited on the adjacent surface owners property. Stakes shown with yellow arrow marks property line.

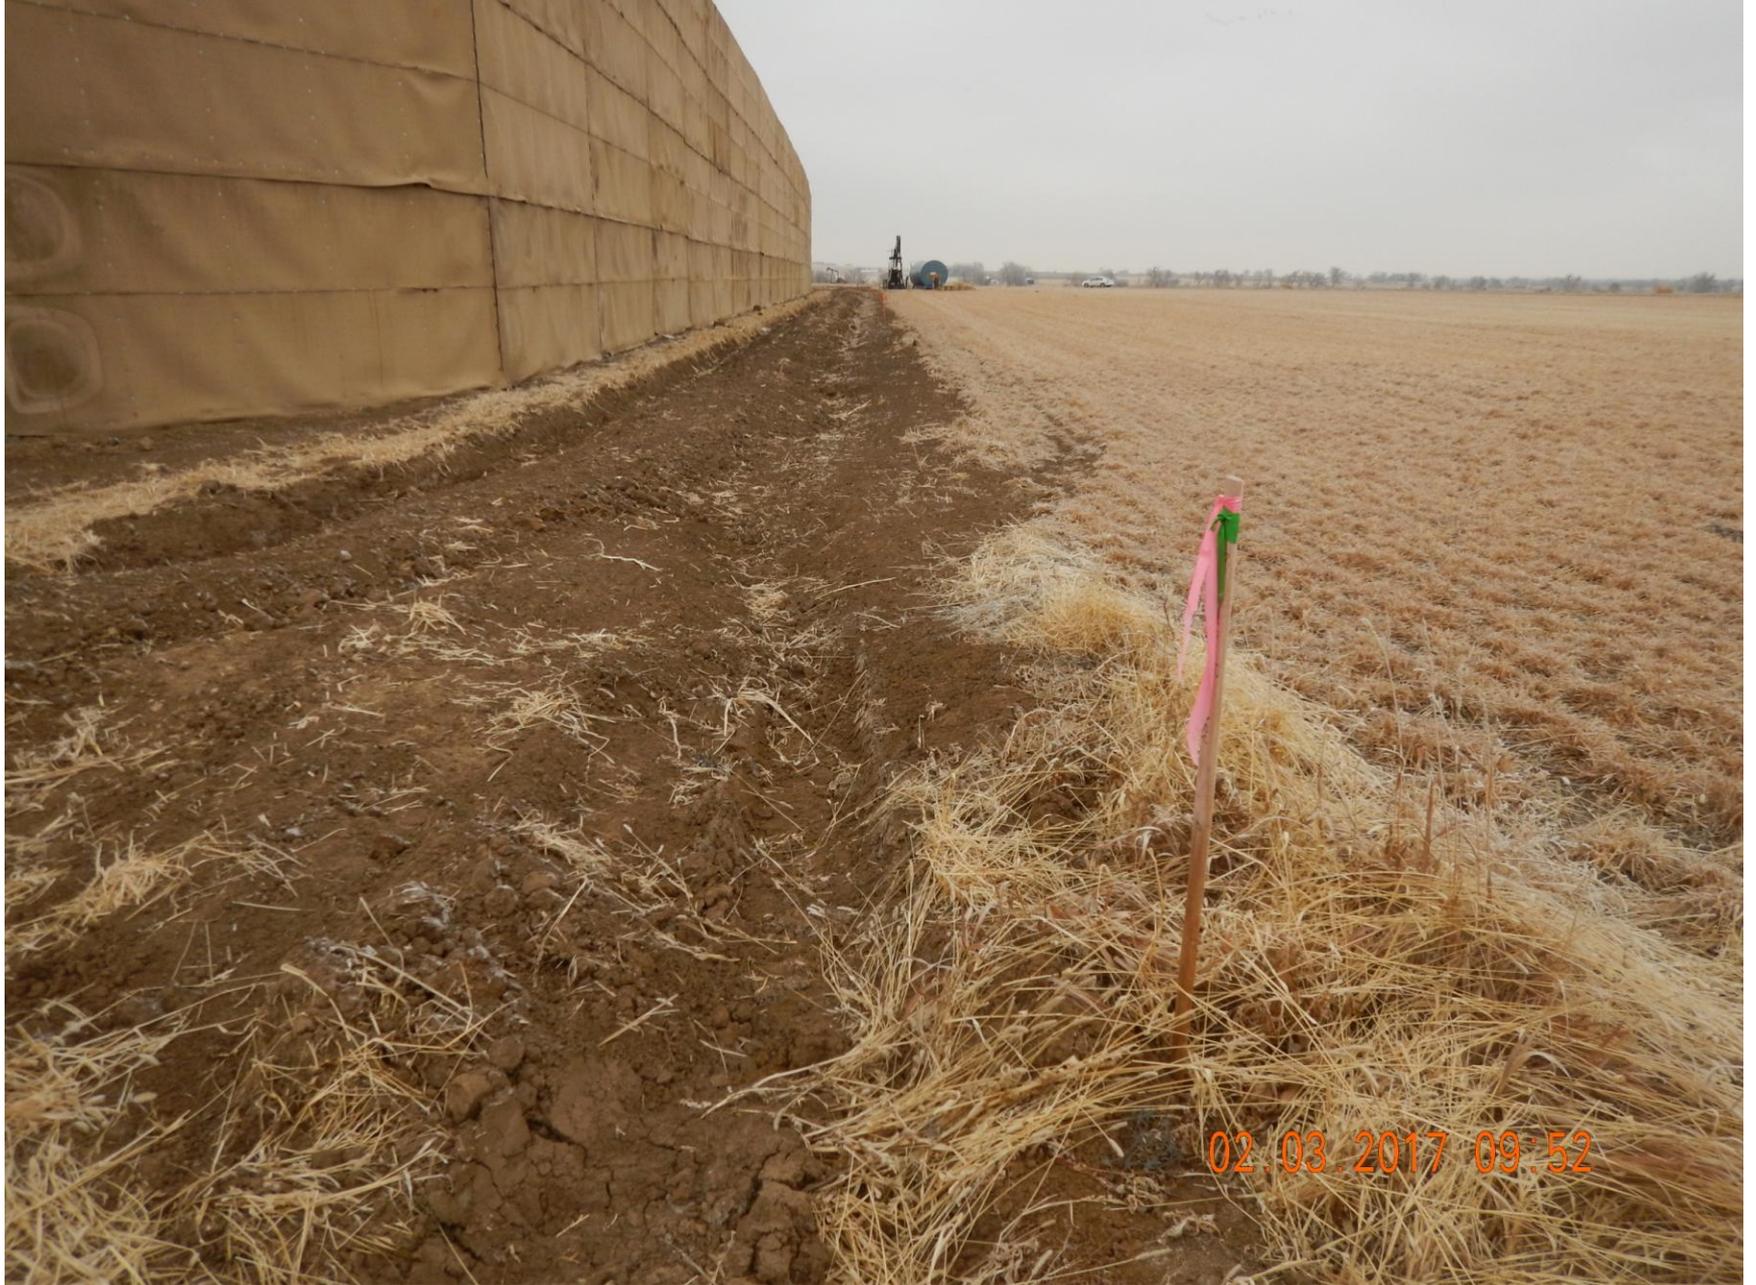
Figure 10: Photo taken from the southeast end of the location, facing north. Photo shows soil and disturbances from the location had encroached onto the adjacent surface owners hay field.
