Complaint and Stormwater Inspection

02/03/2017

Operator: Kerr McGee #47120

Location ID: 444427

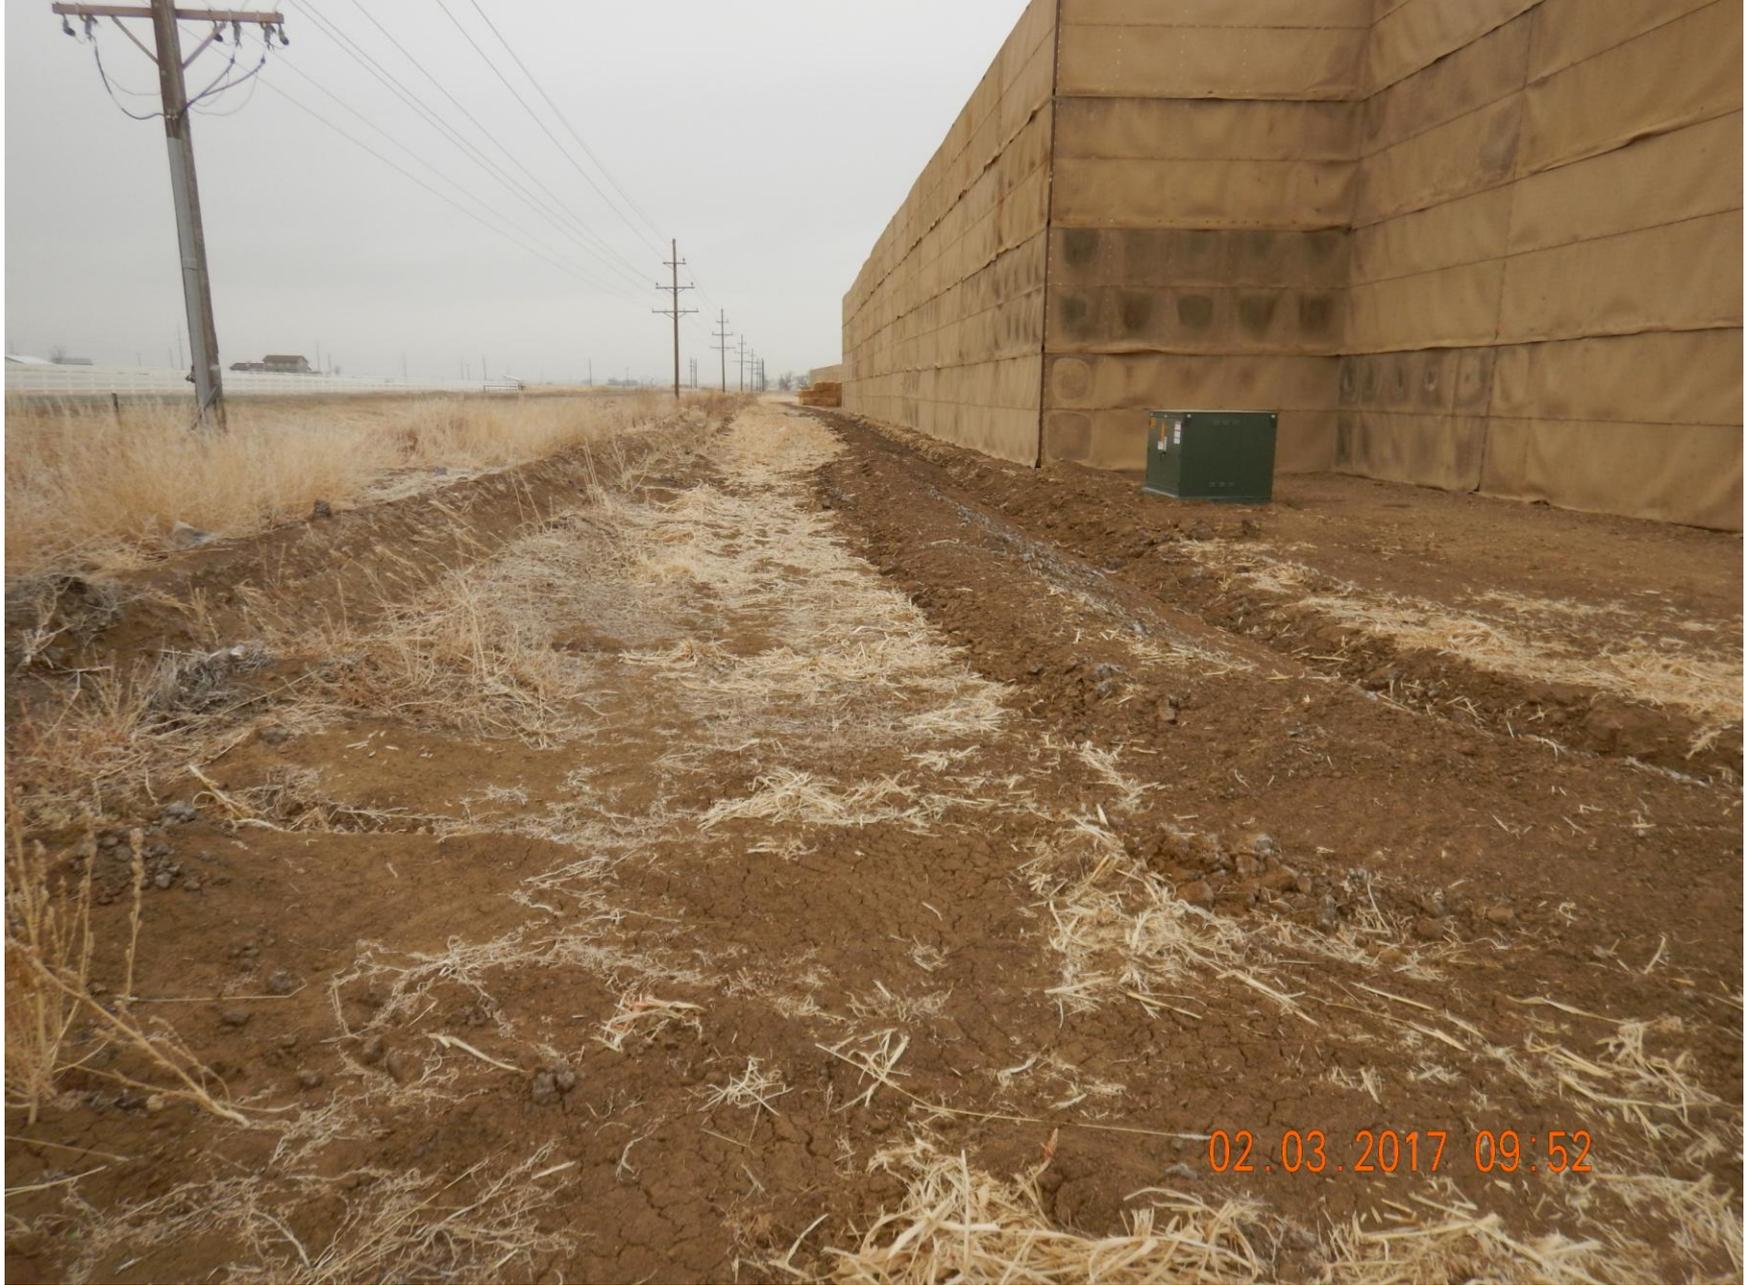
Figure 11: Photo taken from the southeast corner of the location, facing west. Photo shows ditch along the perimeter of the location constructed as a stormwater and sediment control BMP.

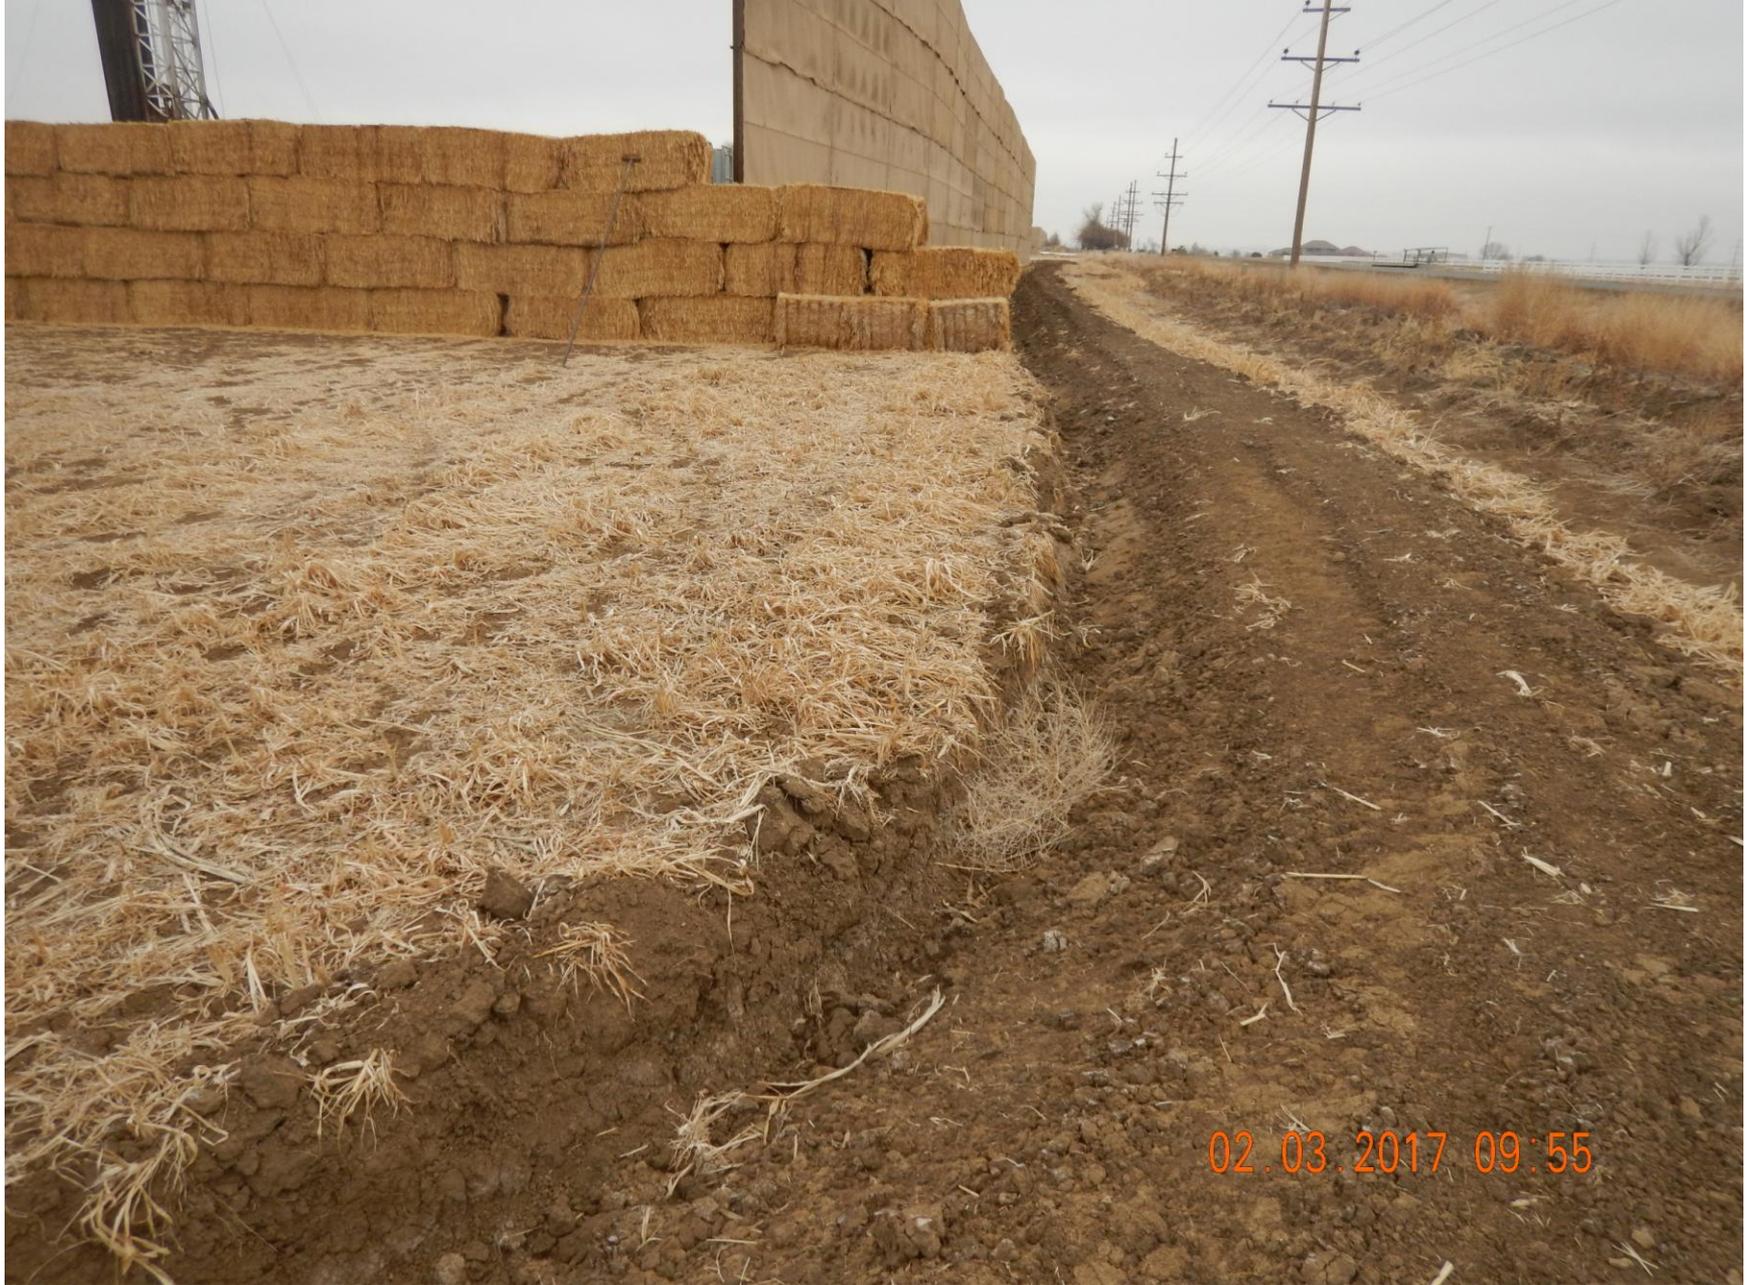
Figure 12: Photo taken from the southwest corner of the location, facing east. Photo shows ditch along the perimeter of the location constructed as a stormwater and sediment control BMP

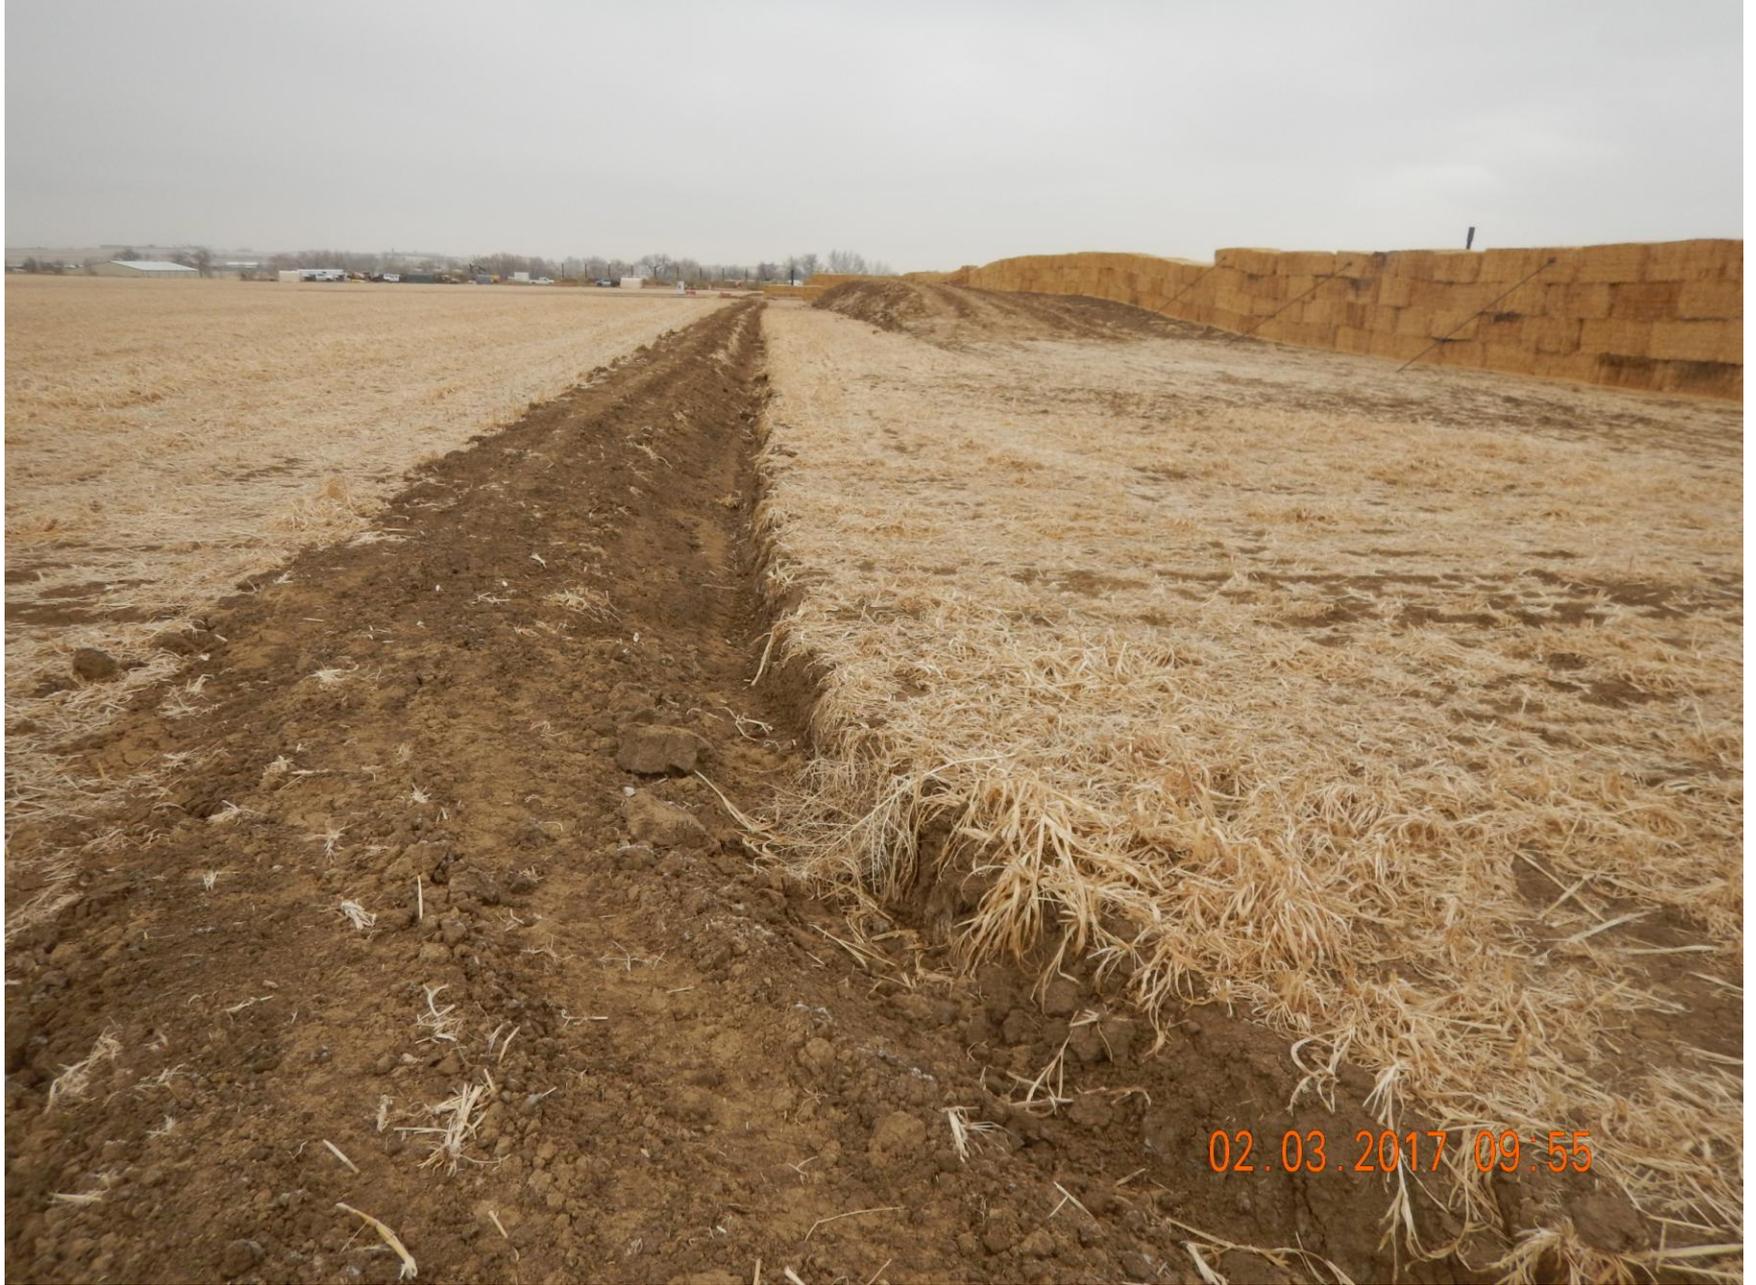
Figure 13: Photo taken from the southwest corner of the location, facing north. Photo shows ditch along the perimeter of the location constructed as a stormwater and sediment control BMP. Photo also shows topsoil stockpile.

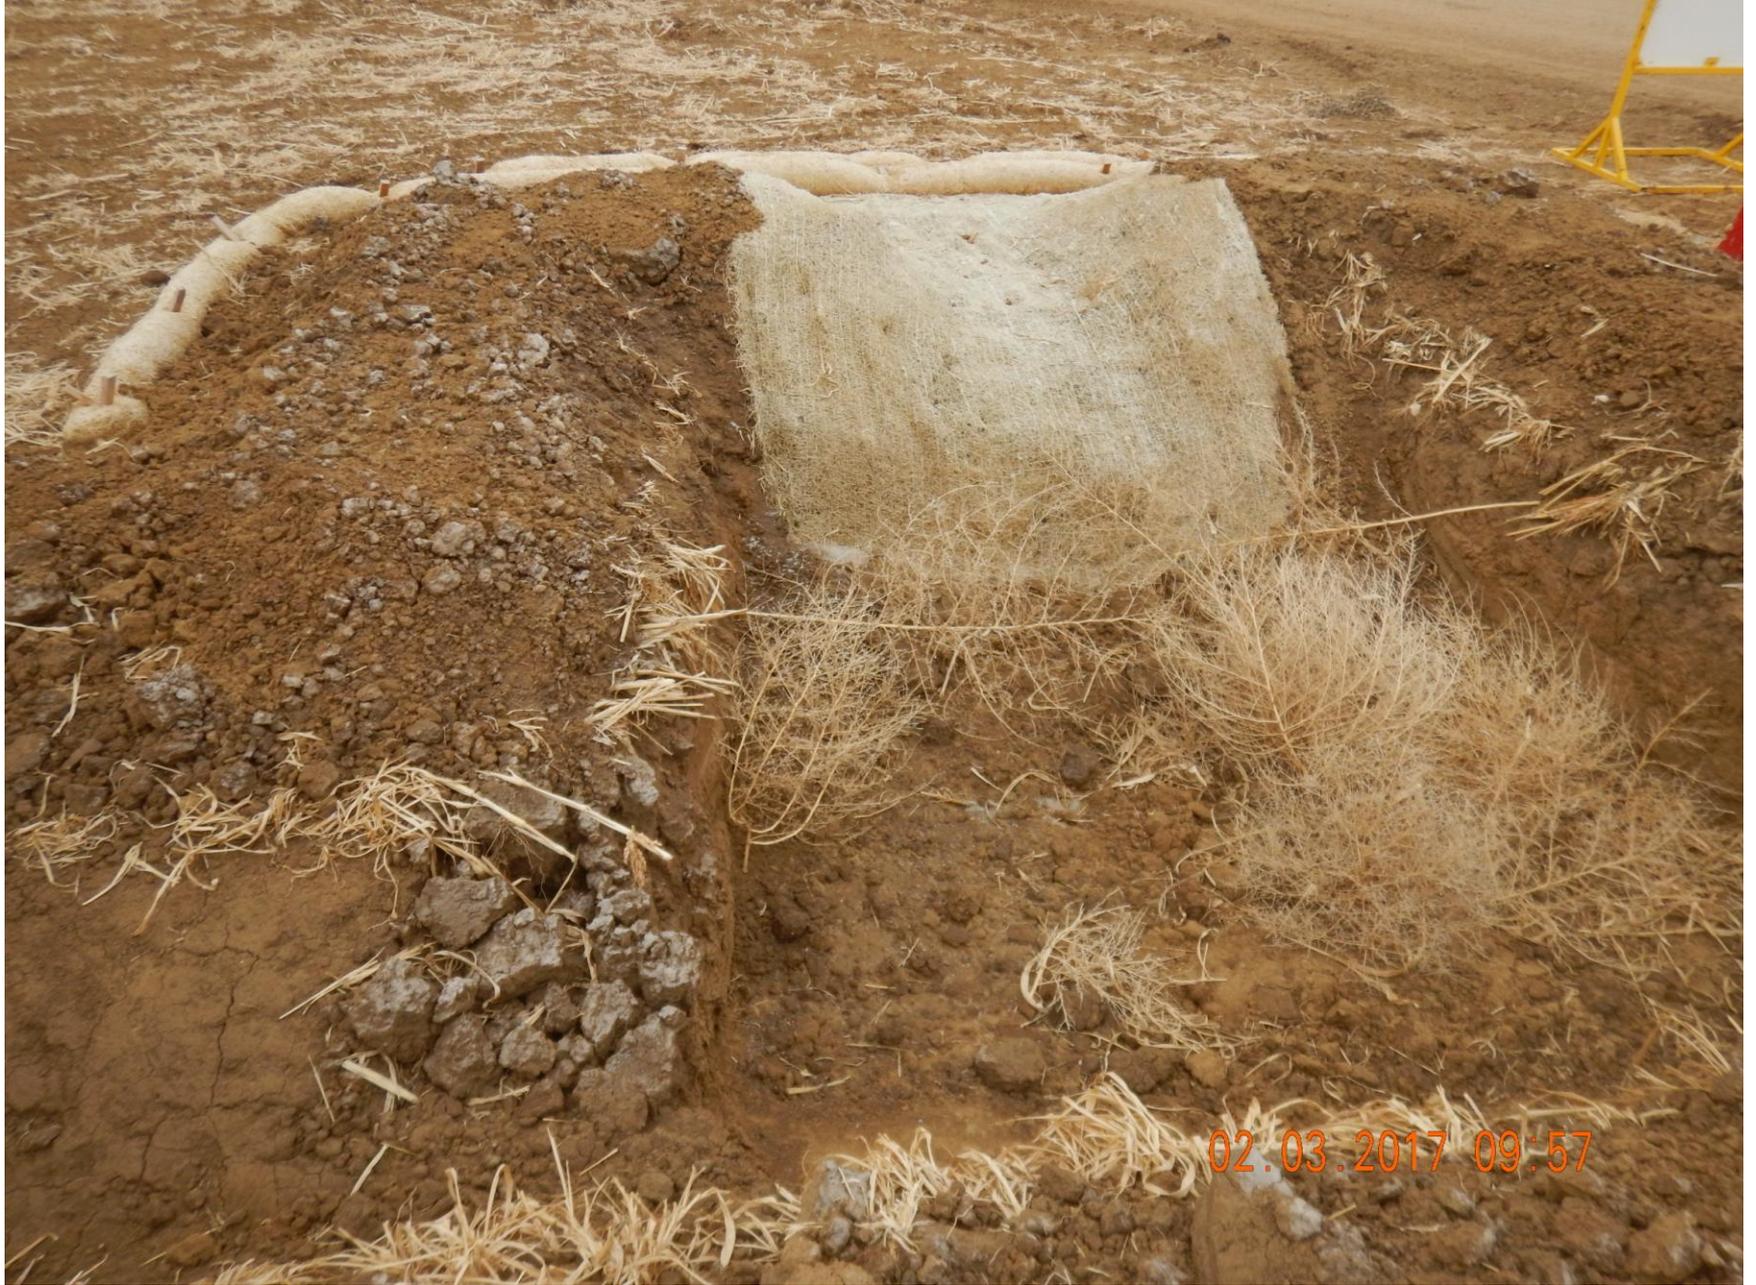
Figure 14: Photo taken from the northwest end of the location, near location entrance. Photo shows one of two sediment traps used as a stormwater and sediment control BMP.

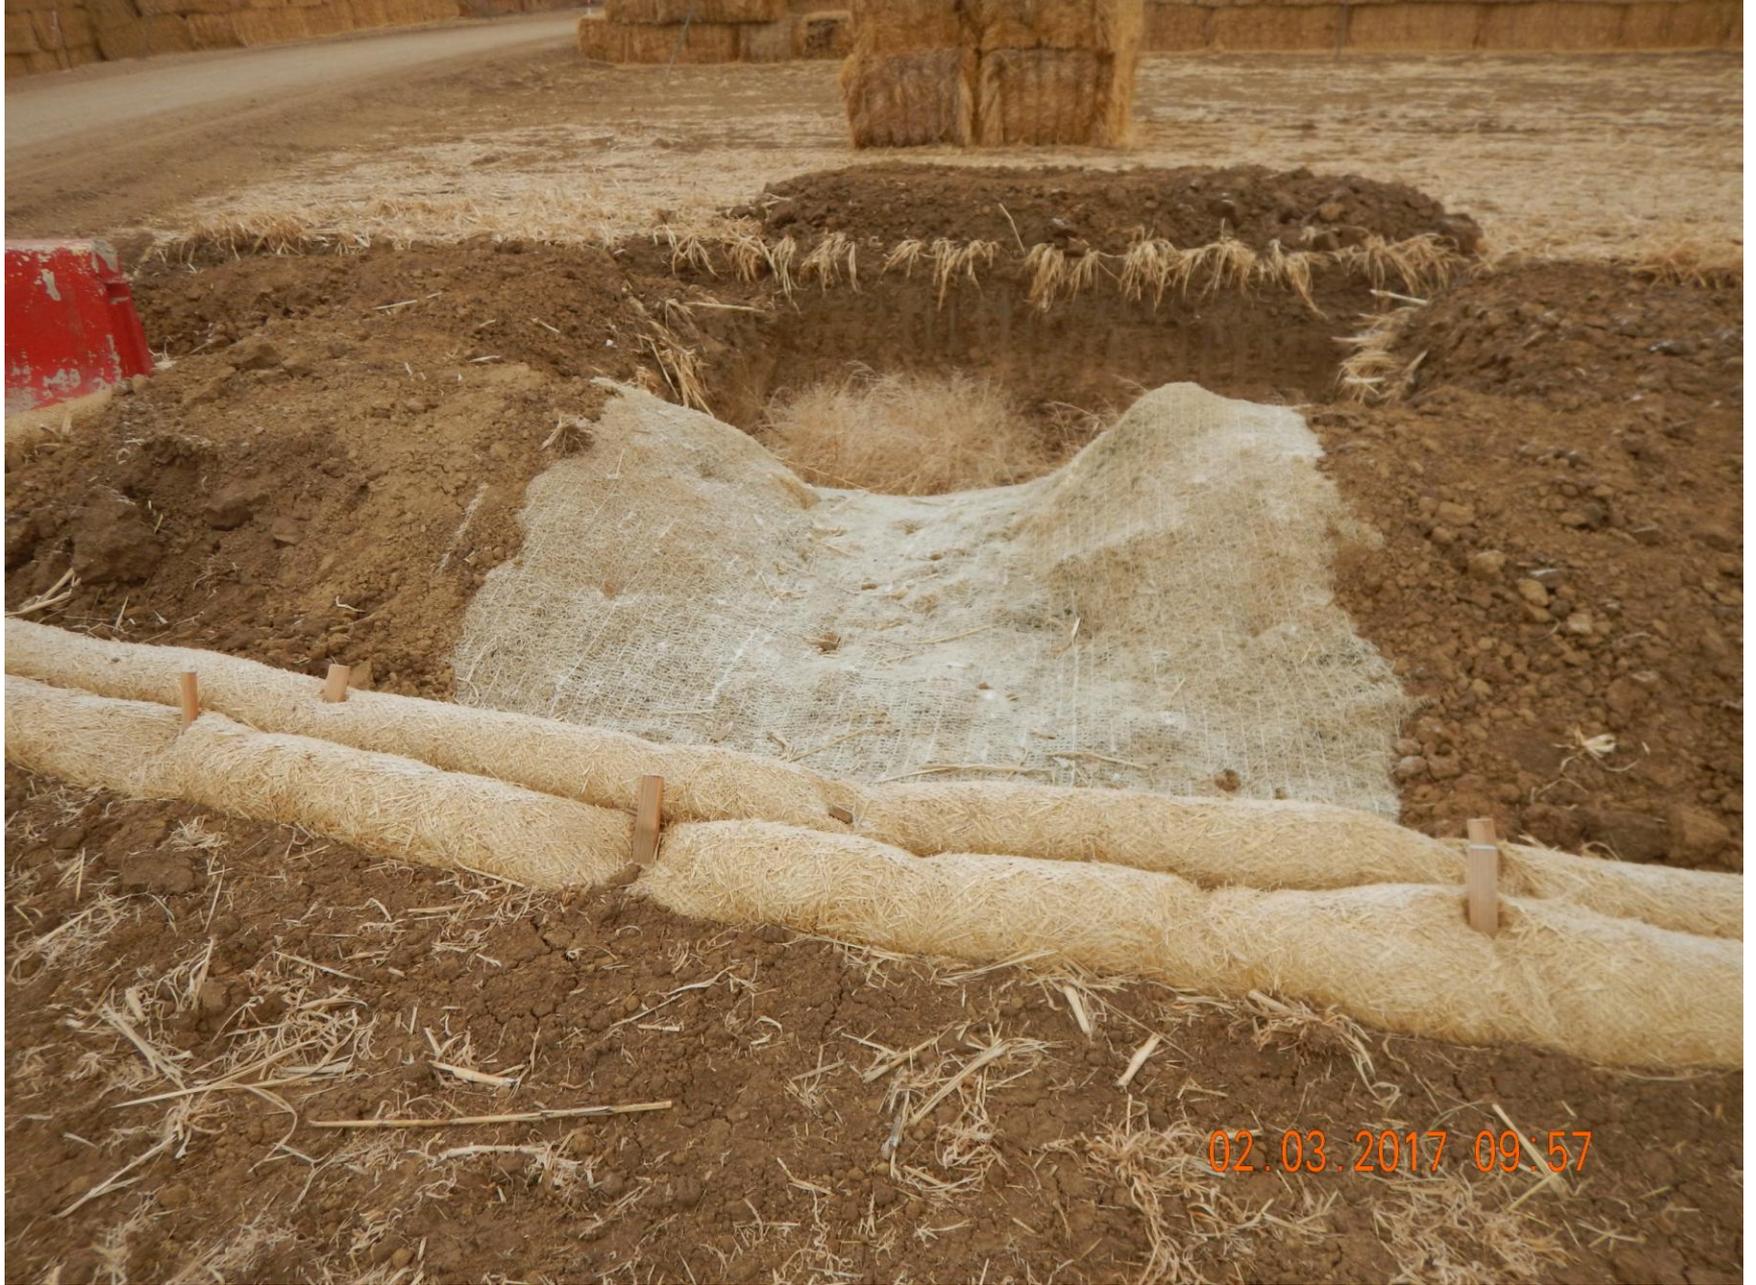
Figure 15: Photo taken from the northwest end of the location, near location entrance. Photo shows one of two sediment traps used as a stormwater and sediment control BMP.

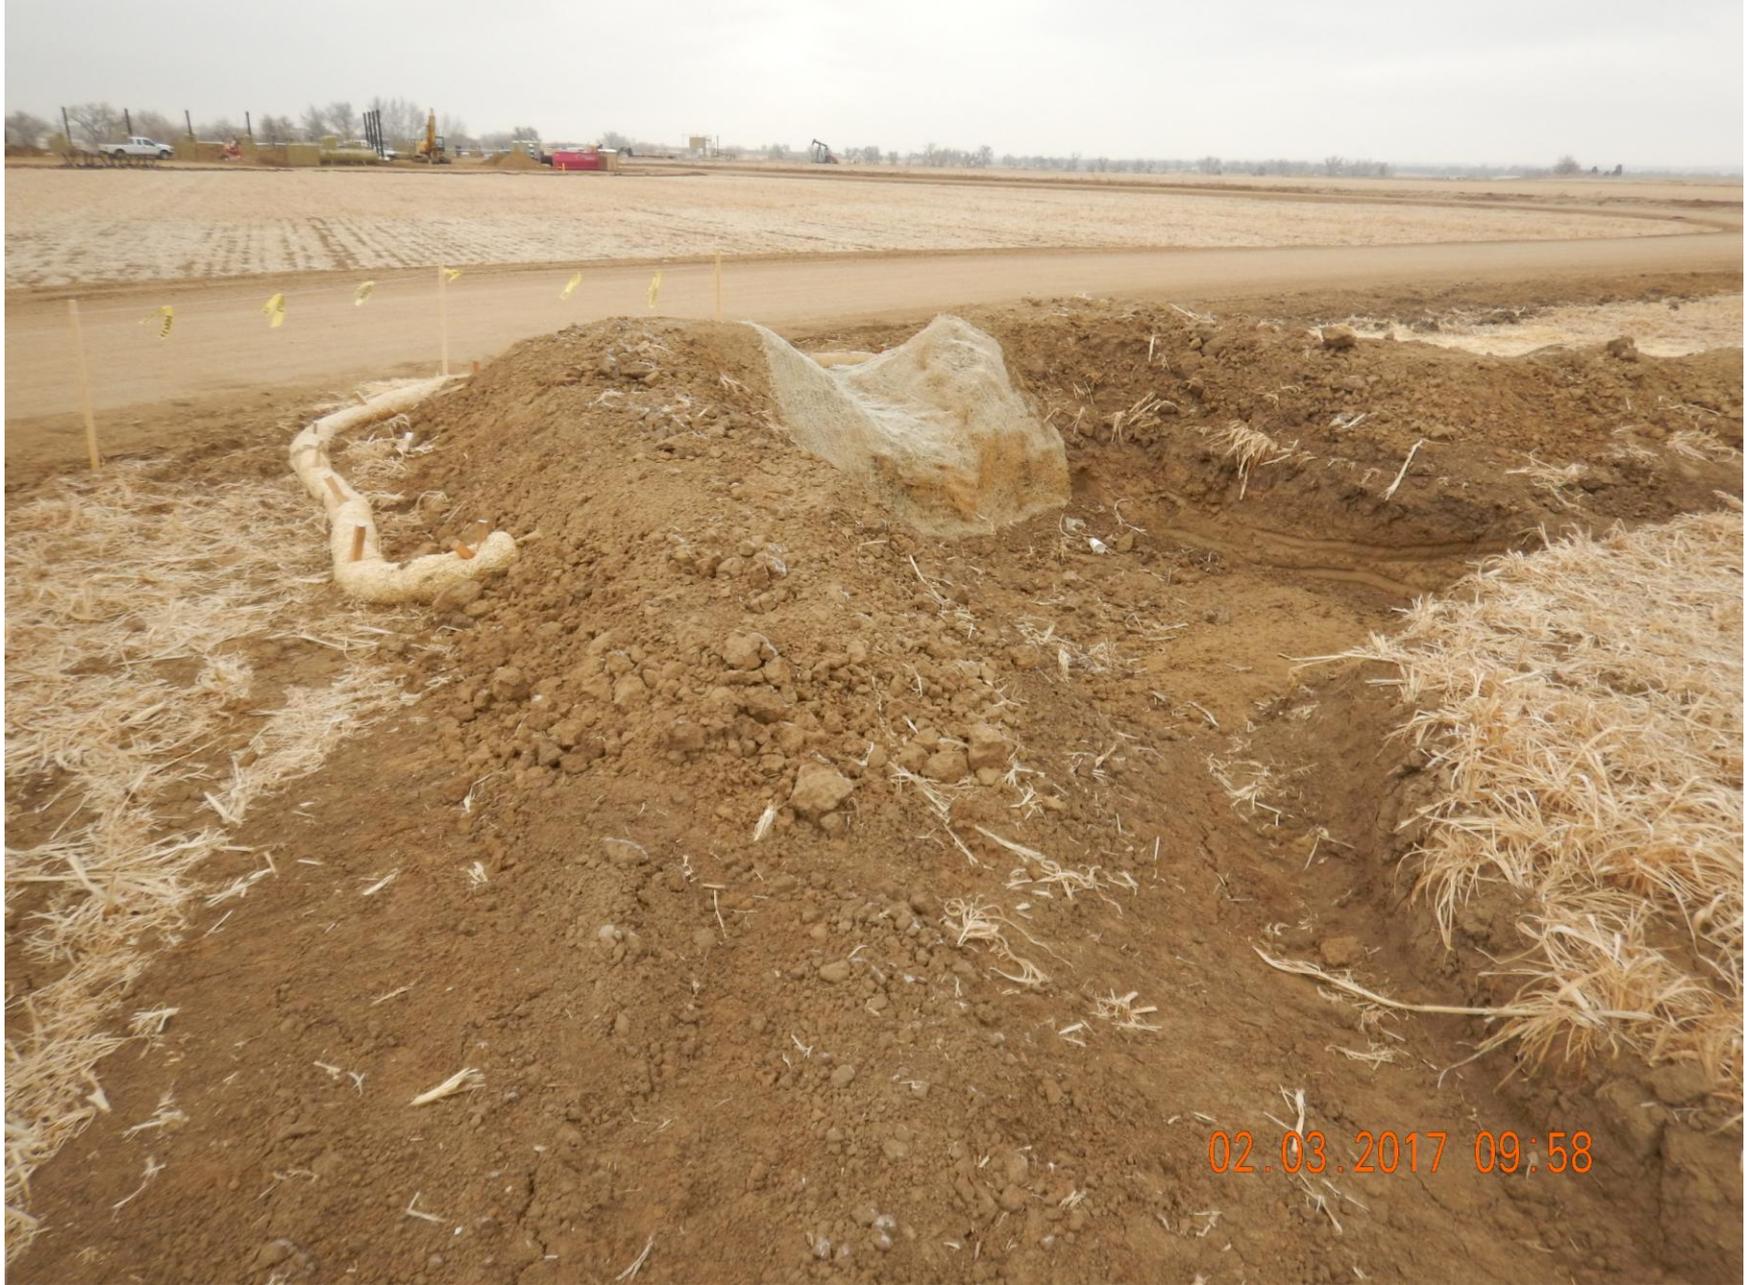
Figure 16: Photo taken from the northwest end of the location. Photo shows second sediment trap use as a stormwater and sediment control BMP.

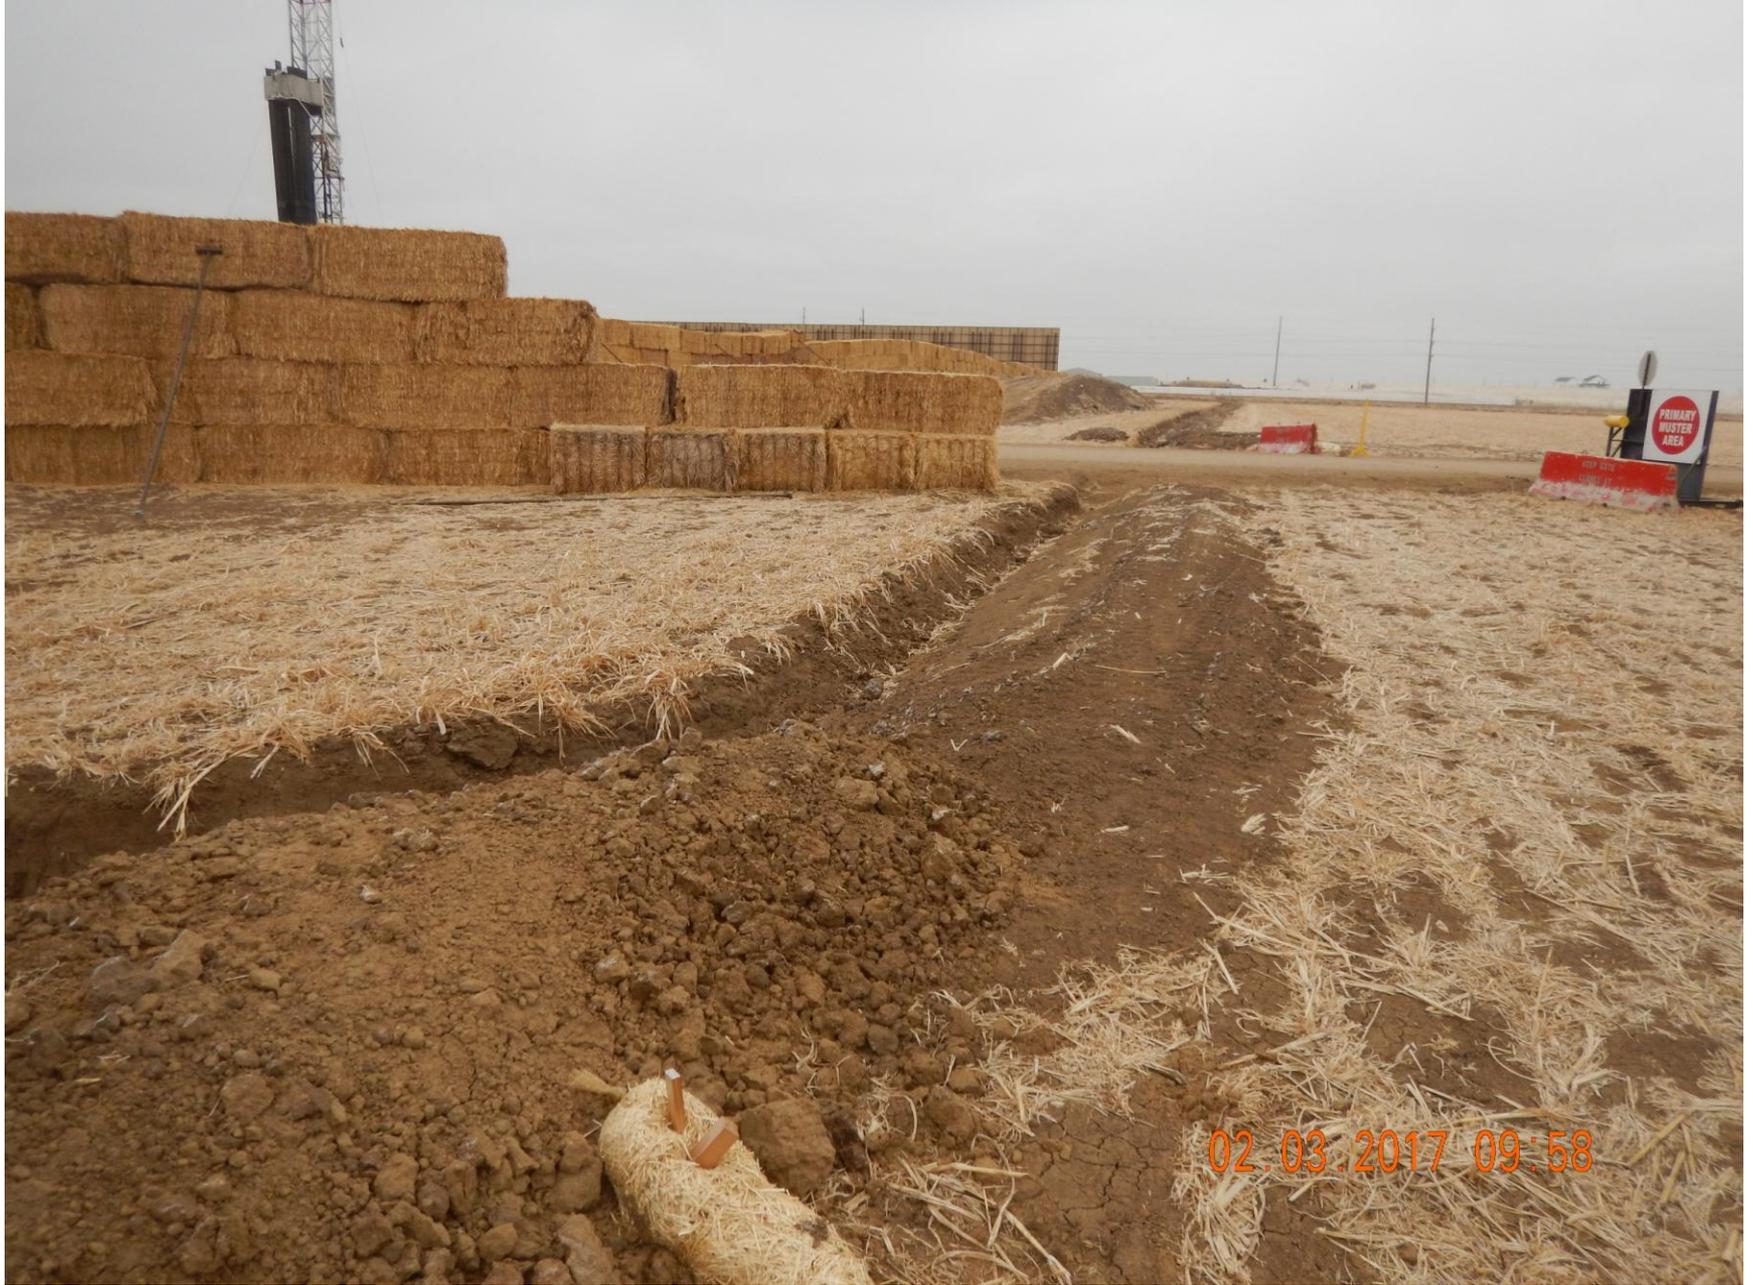
Figure 17: Photo taken from the northwest corner of the location, facing south. Photo shows ditch along the perimeter of the location constructed as a stormwater and sediment control BMP.

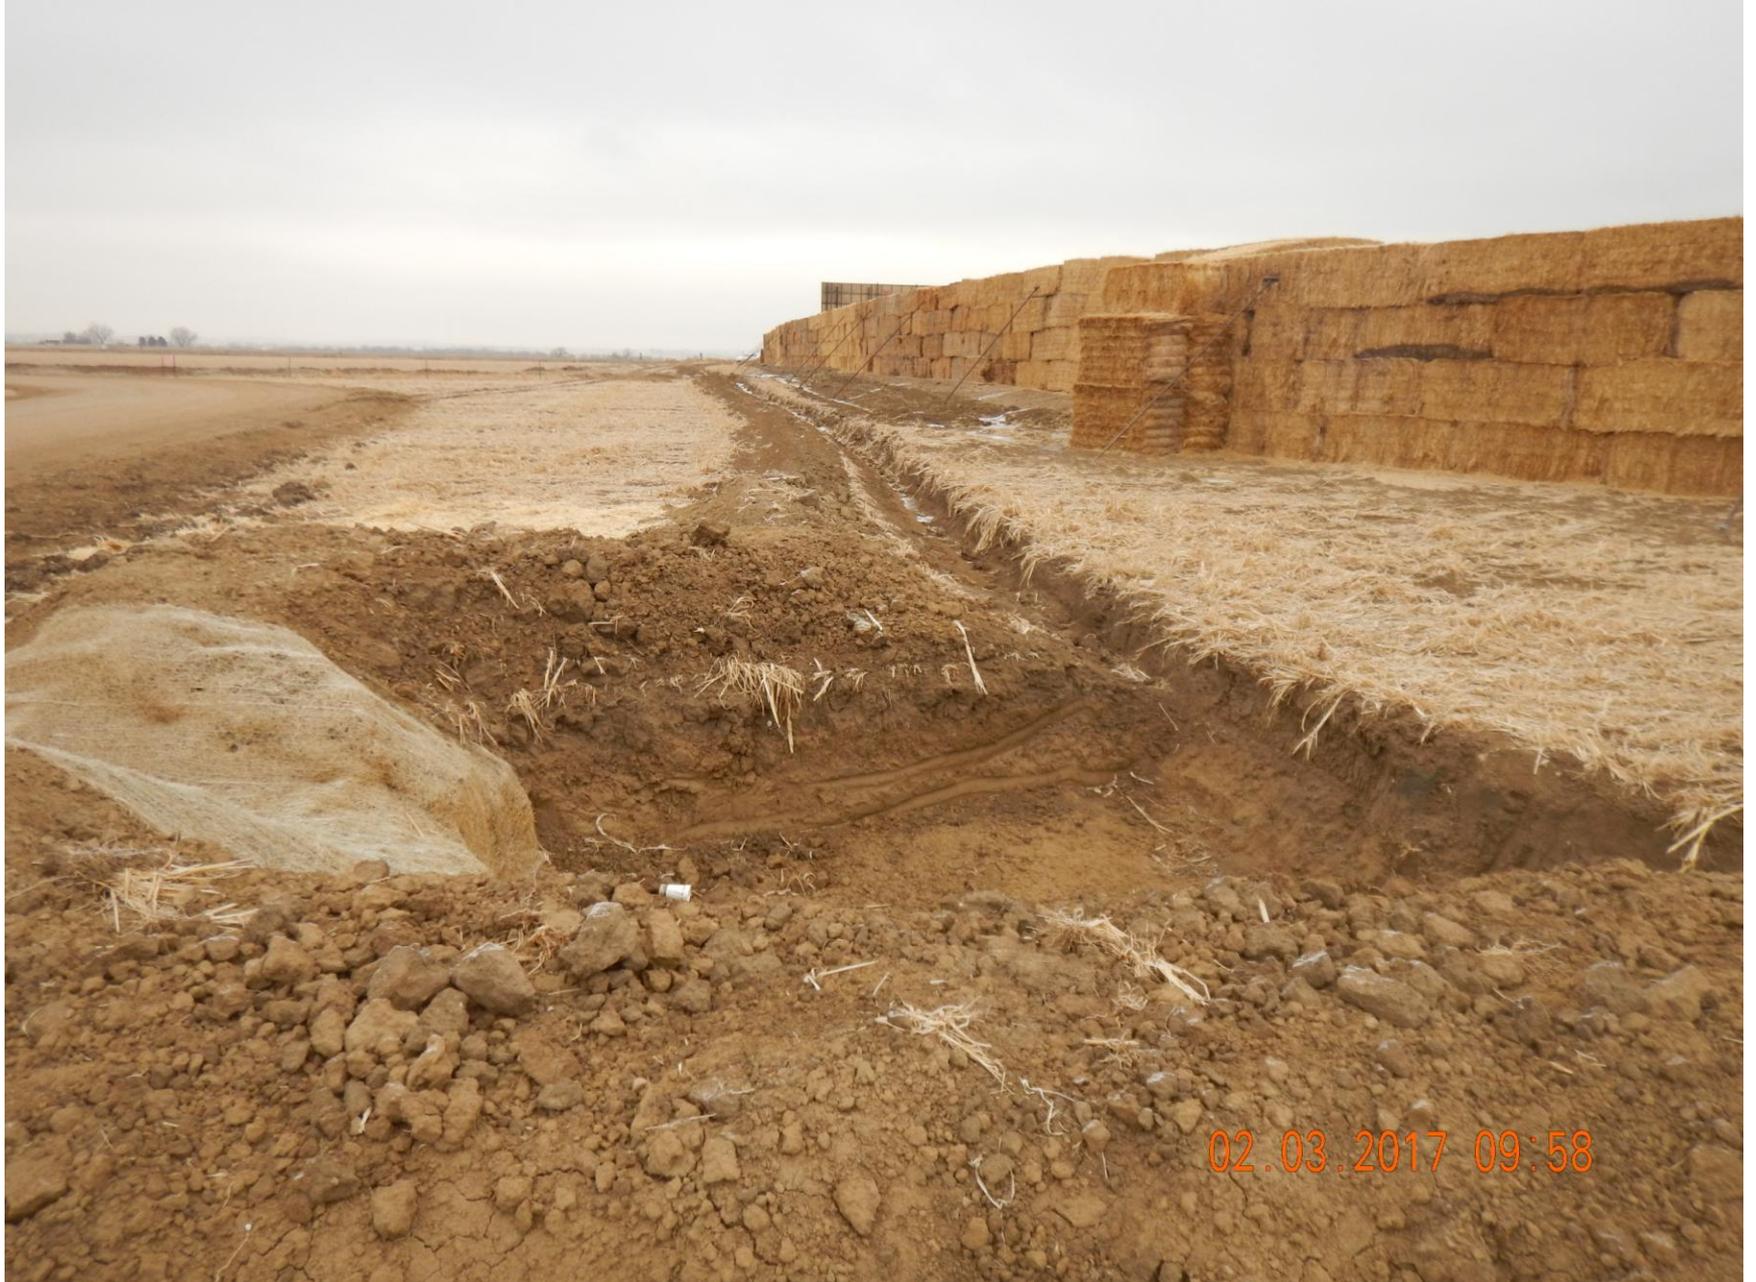
Figure 18: Photo taken from the northwest corner of the location, facing east. Photo shows ditch along the perimeter of the location, and sediment trap constructed as a stormwater and sediment control BMPs.
