Interim Reclamation and Stormwater Inspection

01/26/2017

Operator: Bonanza Creek

Location ID: 159489

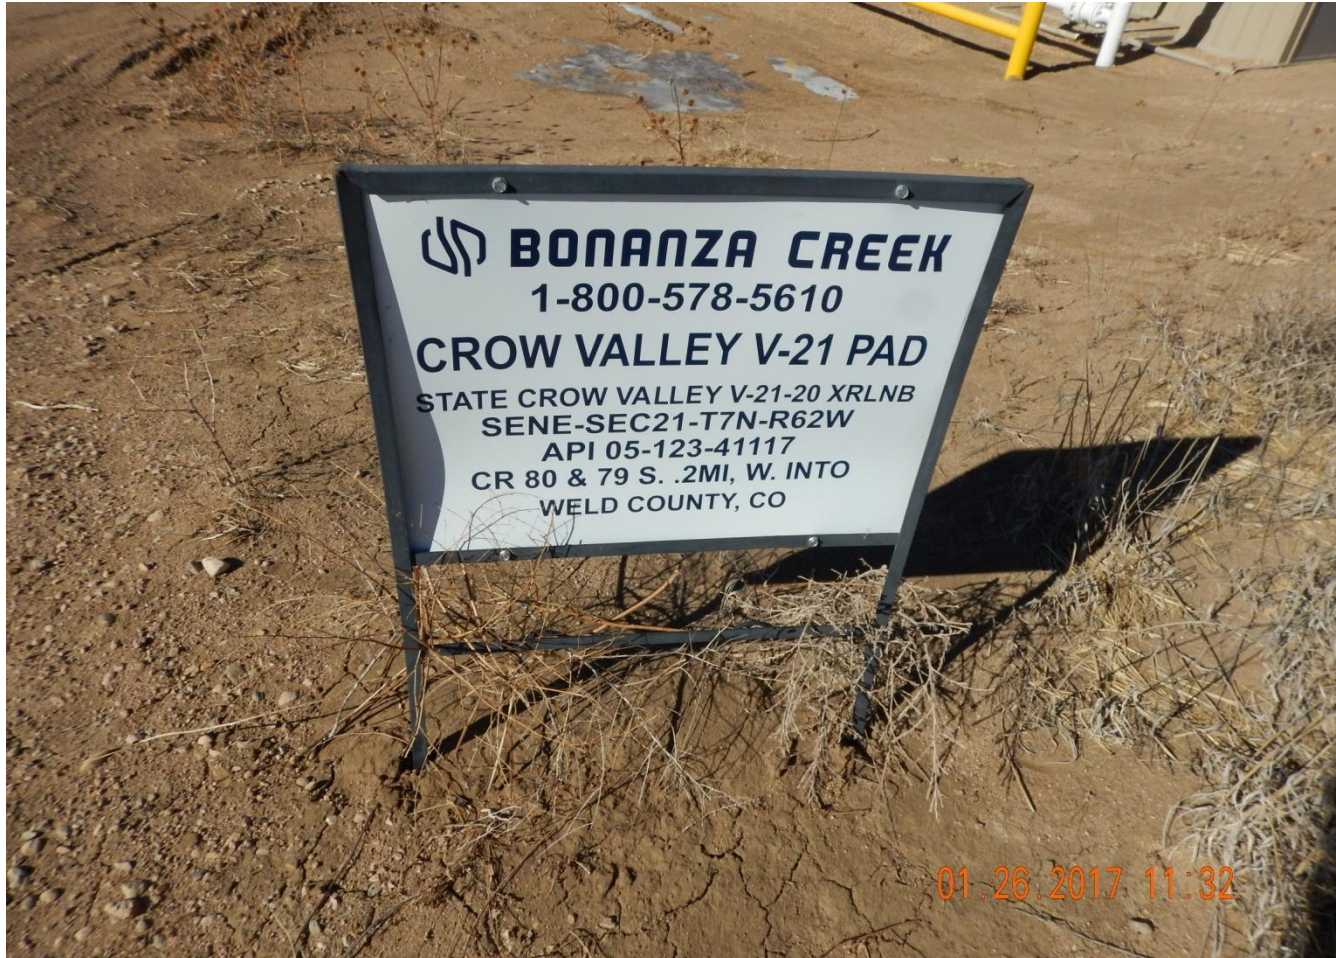
Photo 1. Photo taken of Operator sign at entrance of location. The sign references API 05-123-4117 which is an expired permit number and the quarter quarter is not correct.

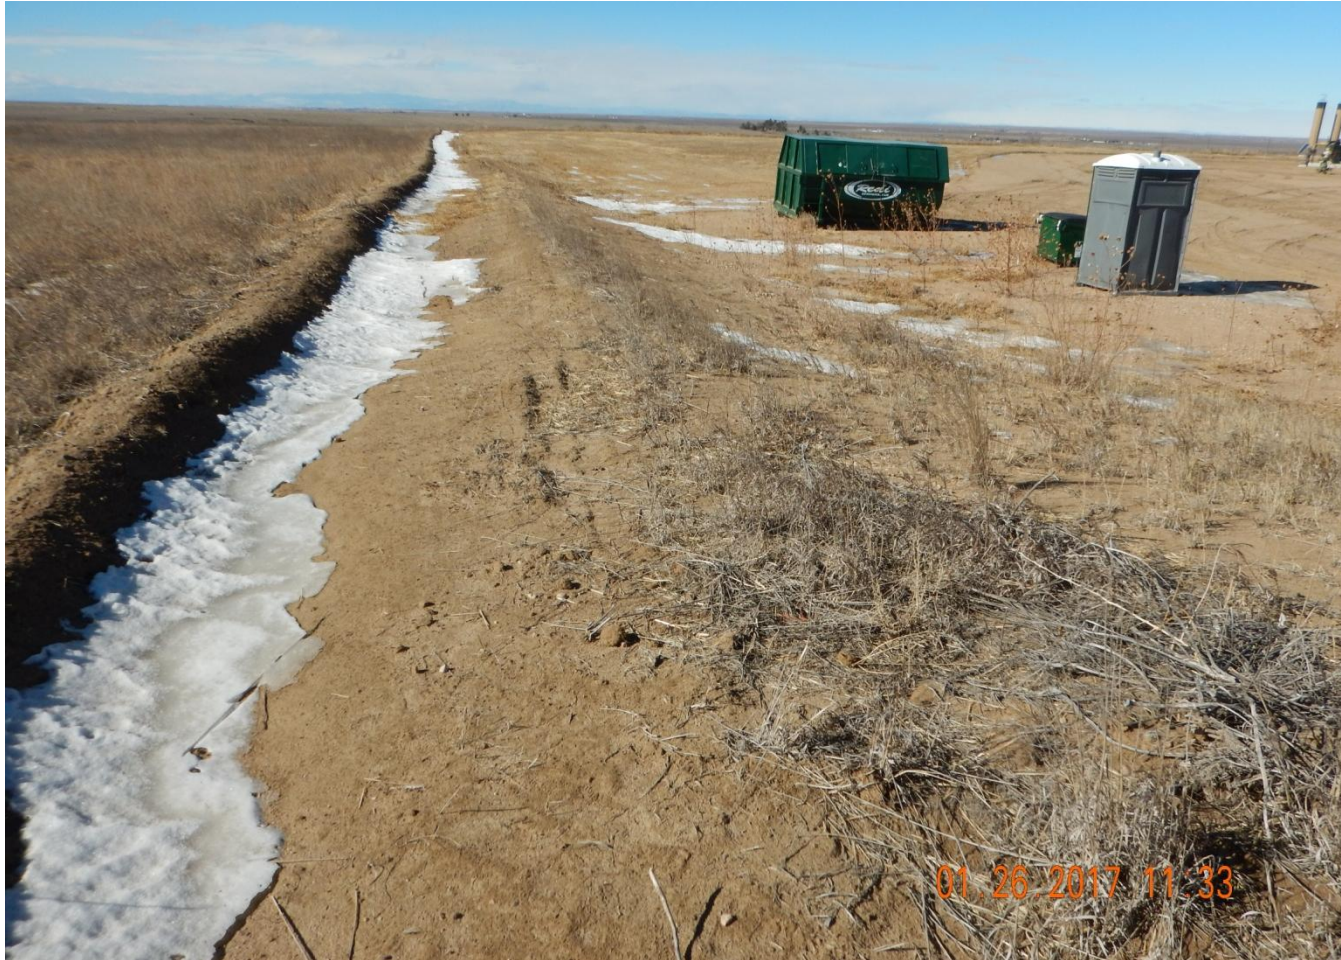
Photo 2. Photo taken from the southeast location, facing West. Ditch and berm BMP installed along the southern location.

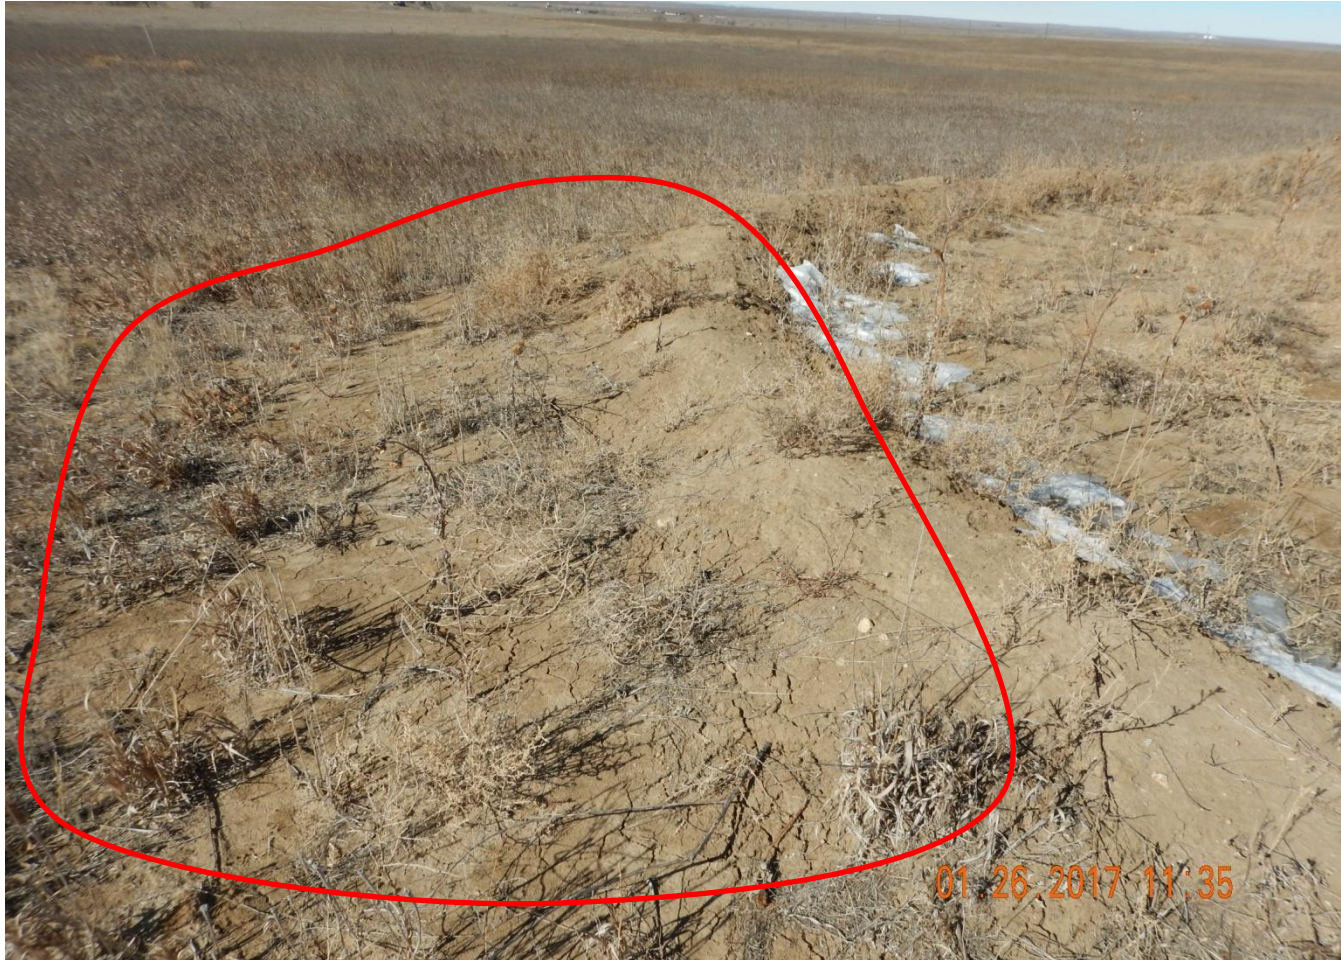
Photo 3. Photo taken from the southwest location, facing Northwest. Appears sediment has either discharged from location or sediment erosion has occurred because the berm BMP was never compacted properly.

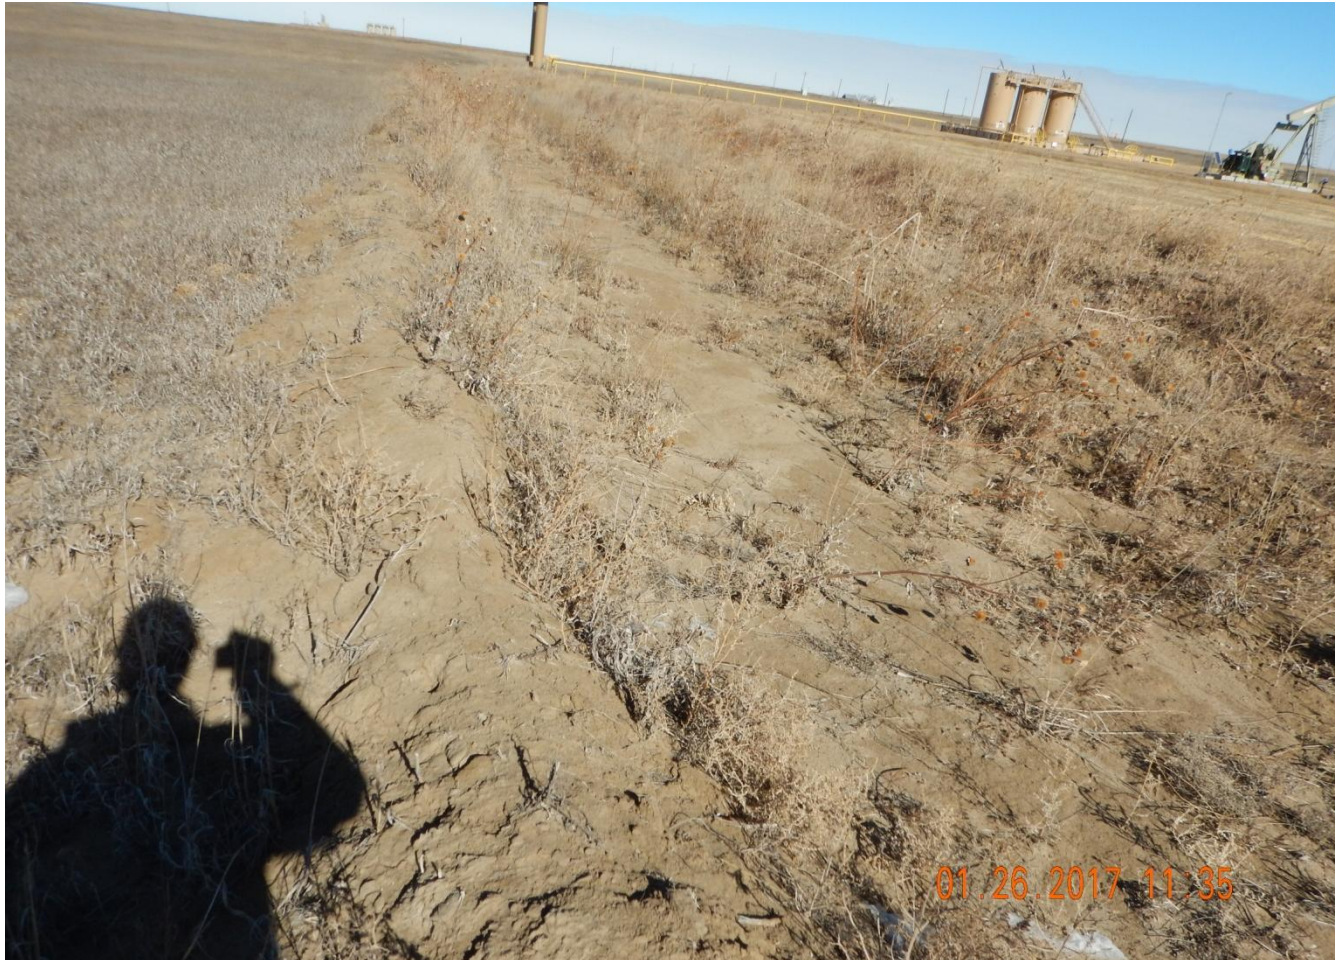
Photo 4. Photo taken from the southwest corner of location, facing North. Appears a retention area was constructed along the western location. The outer berm does not appear to be compacted and active erosion is occurring.

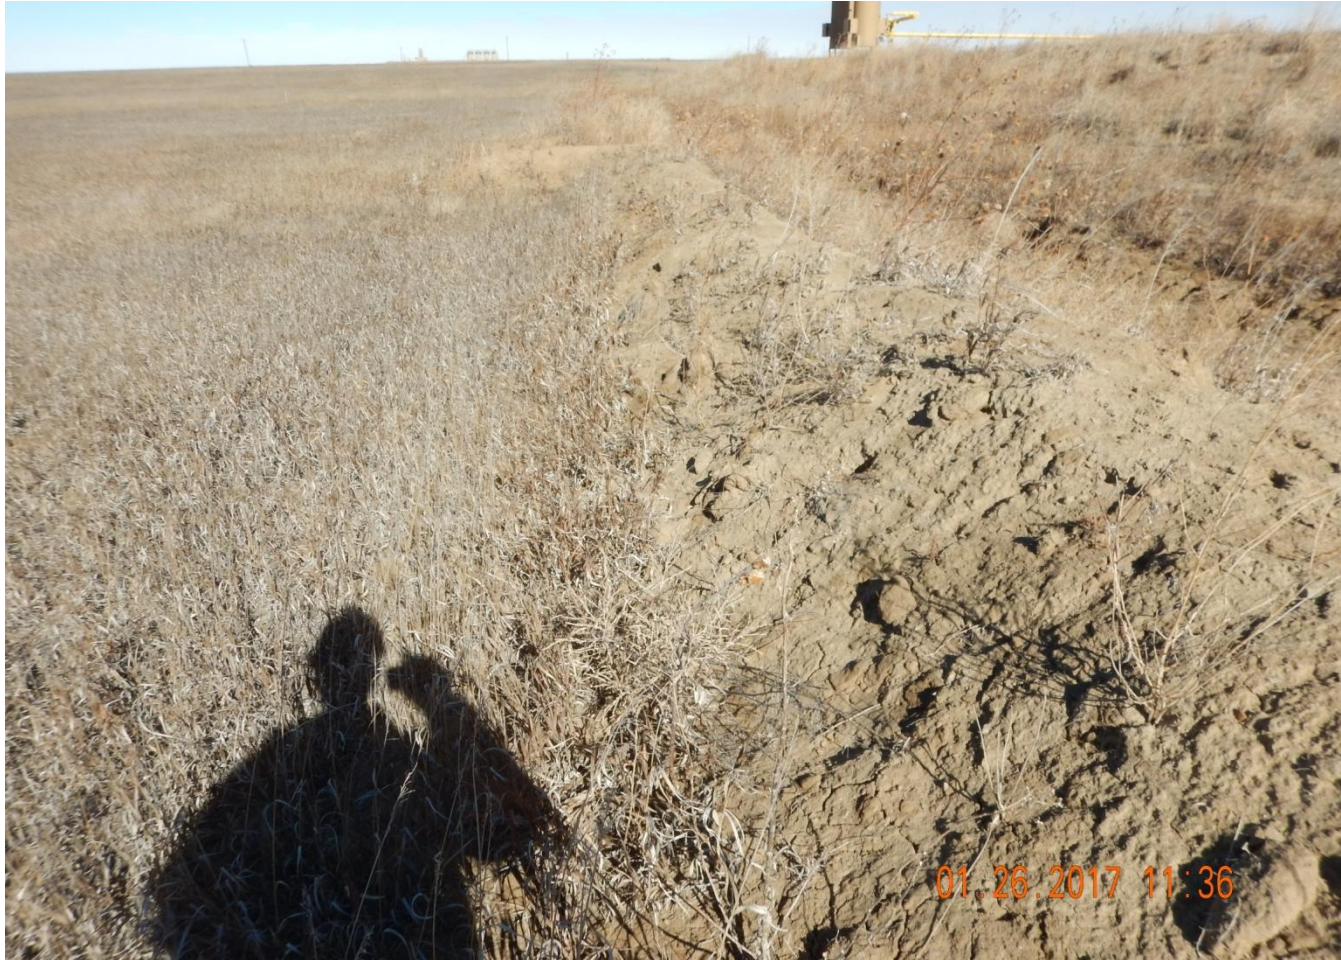
Photo 5. Photo taken from the western location, facing North. The outer berm does not appear to be compacted and active rill erosion is occurring.

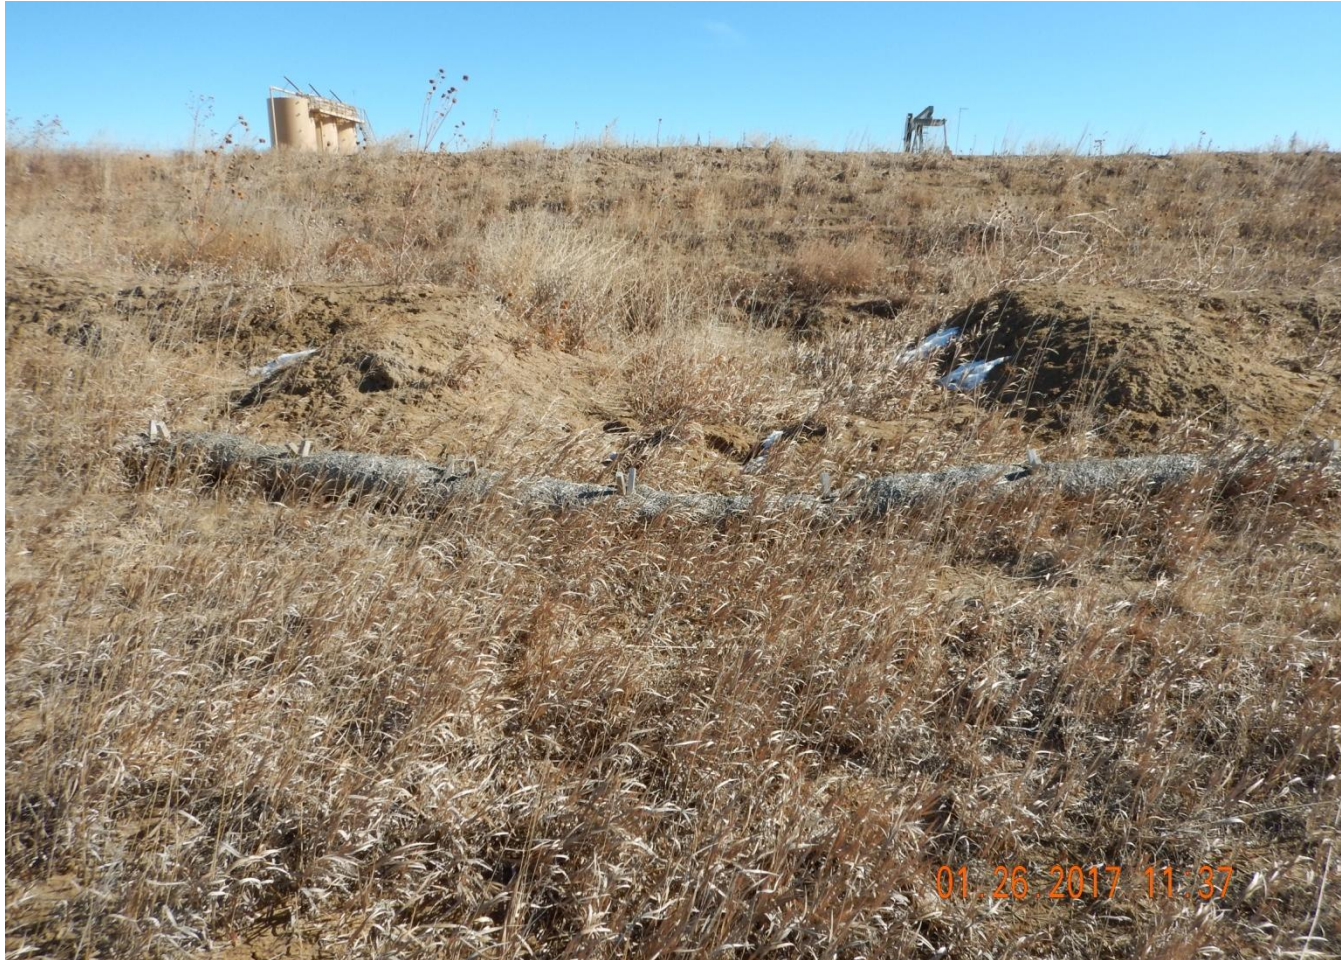
Photo 6. Photo taken from the southern sediment trap along the western location, facing East. Sediment was observed outside of containment area beyond the wattle.

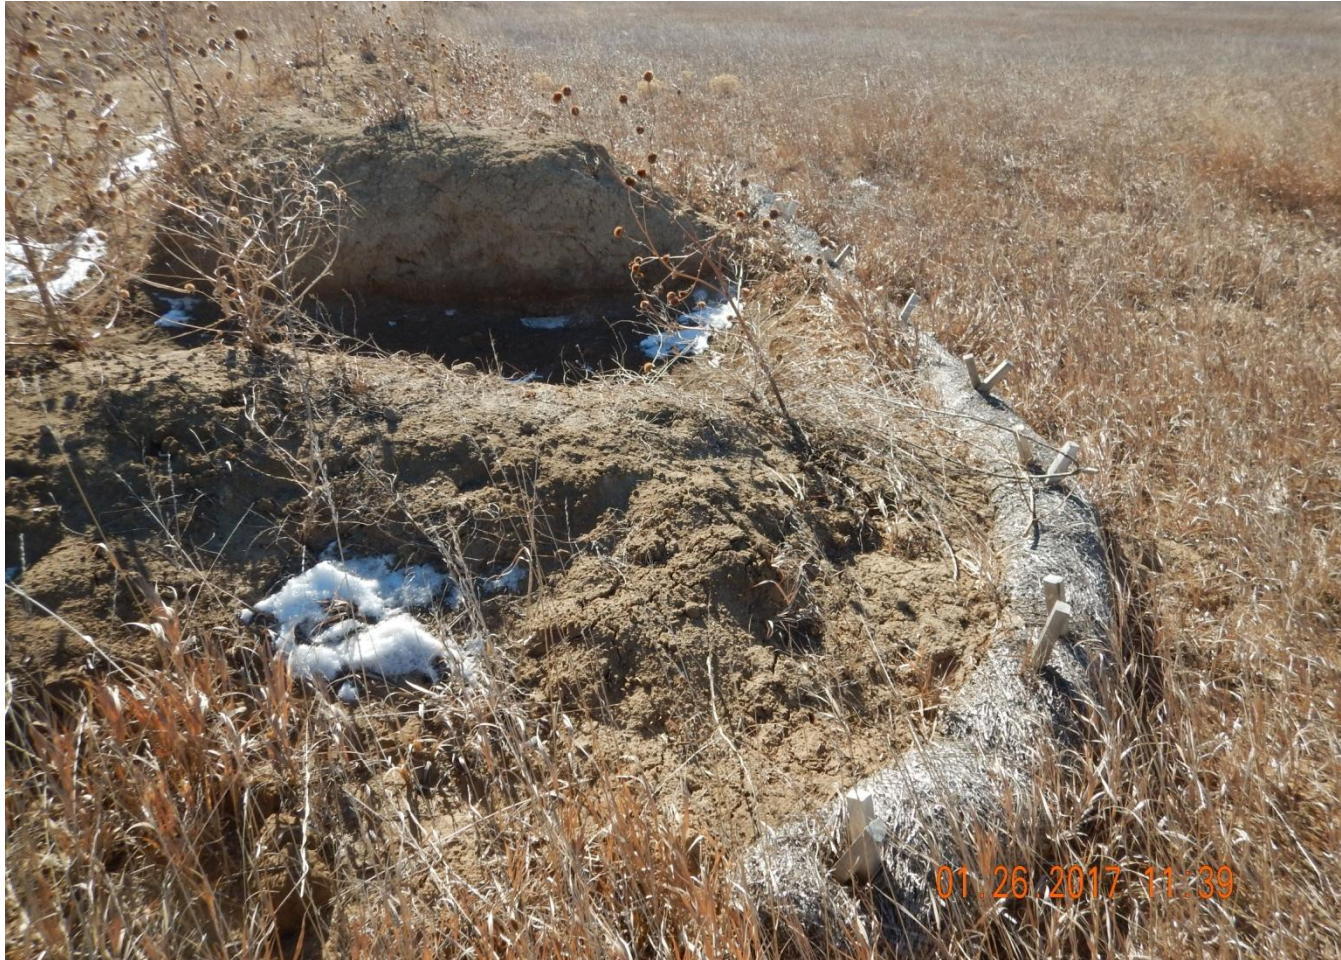
Photo 7. Photo taken from the northern sediment trap along the northwest location, facing South. Sediment was observed outside of containment area beyond the wattle.

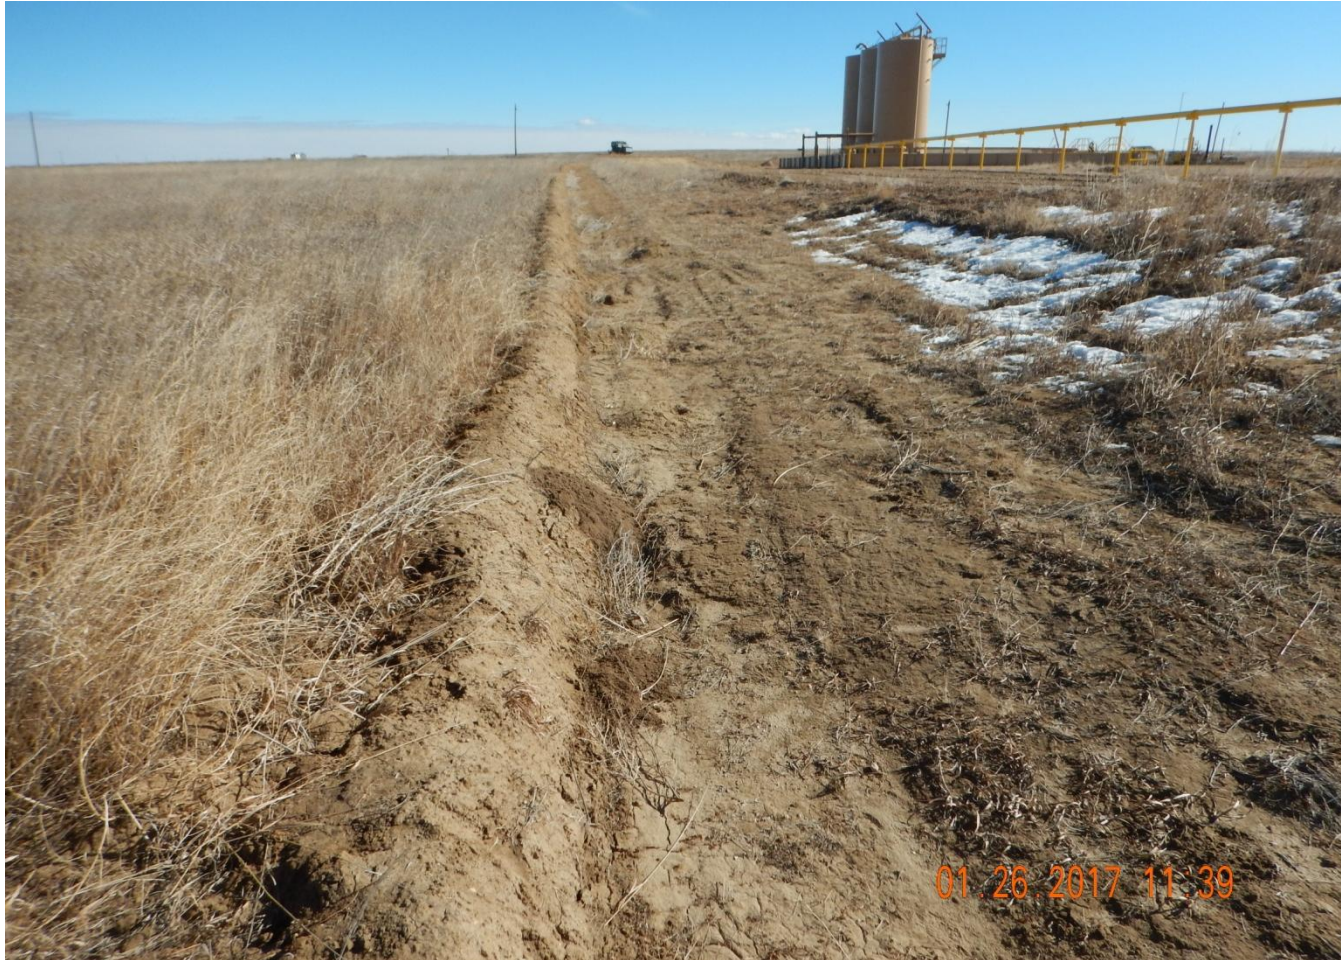
Photo 8. Photo taken from the northwest corner of location, facing East. Berm BMP installed along the northern location.

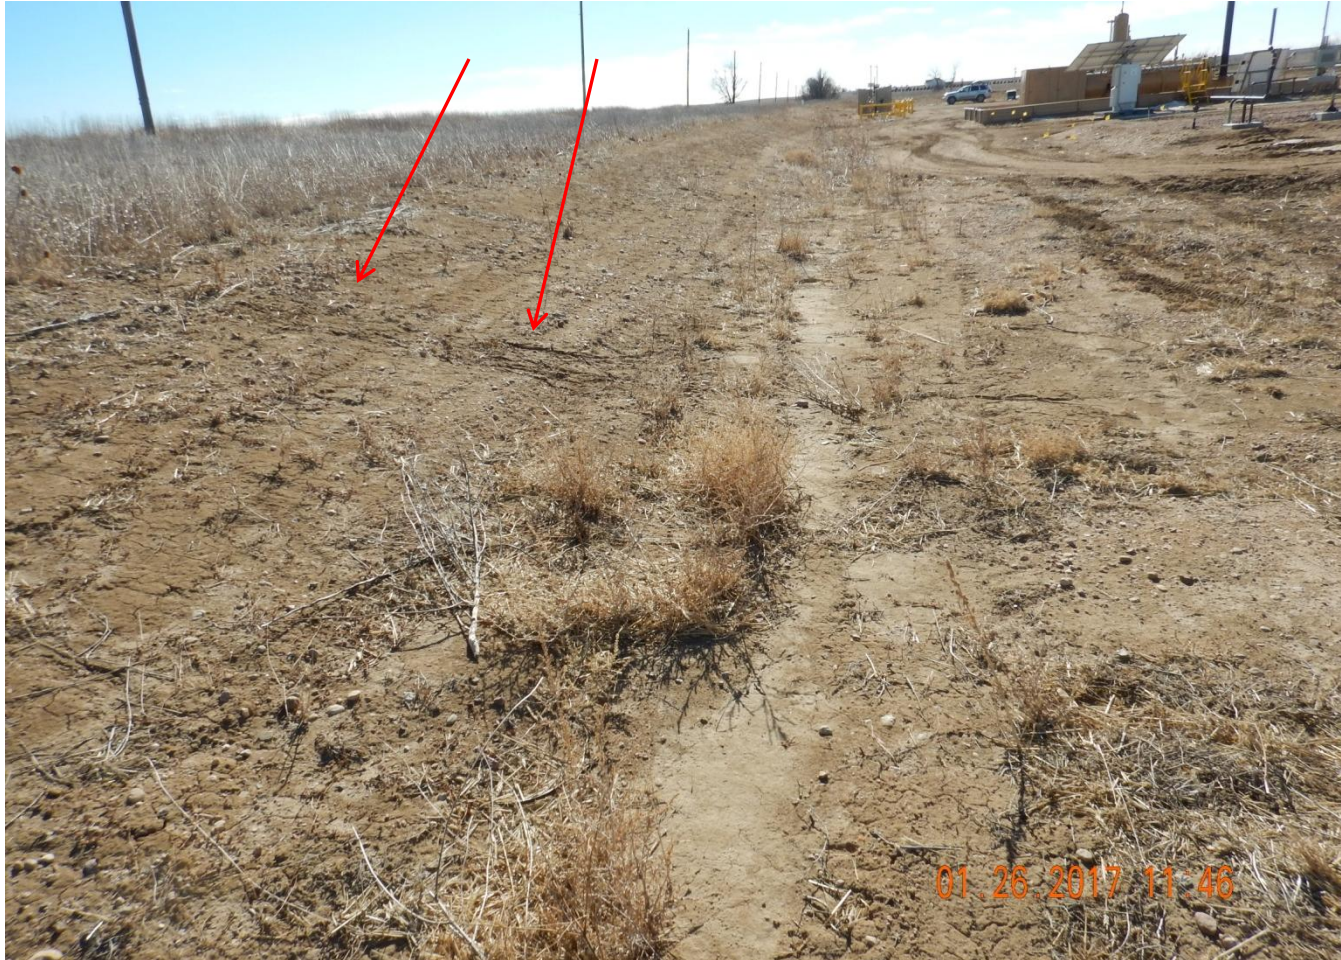
Photo 9. Photo taken from the eastern location, facing South. May need to monitor cut slope for erosion as it appears rill erosion is starting to form.

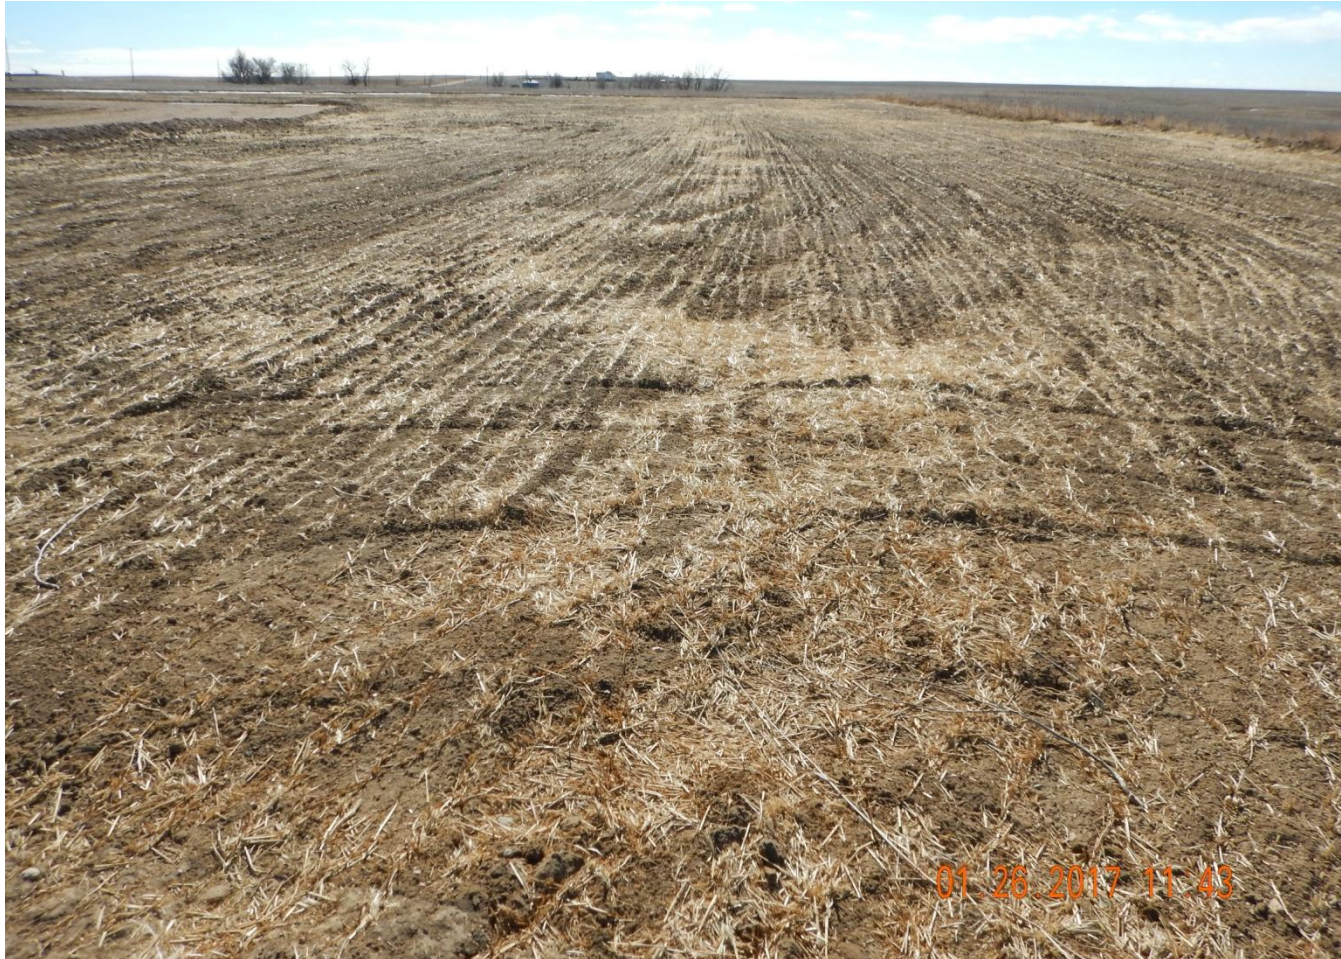
Photo 10. Photo taken of the northern interim area, facing South. Evidence of reclamation activities apparent but mulch does not appear to be sufficiently crimped. Mulch was observed in throughout the perimeter of the disturbance area. May need to monitor interim areas to ensure areas are protected from erosion.

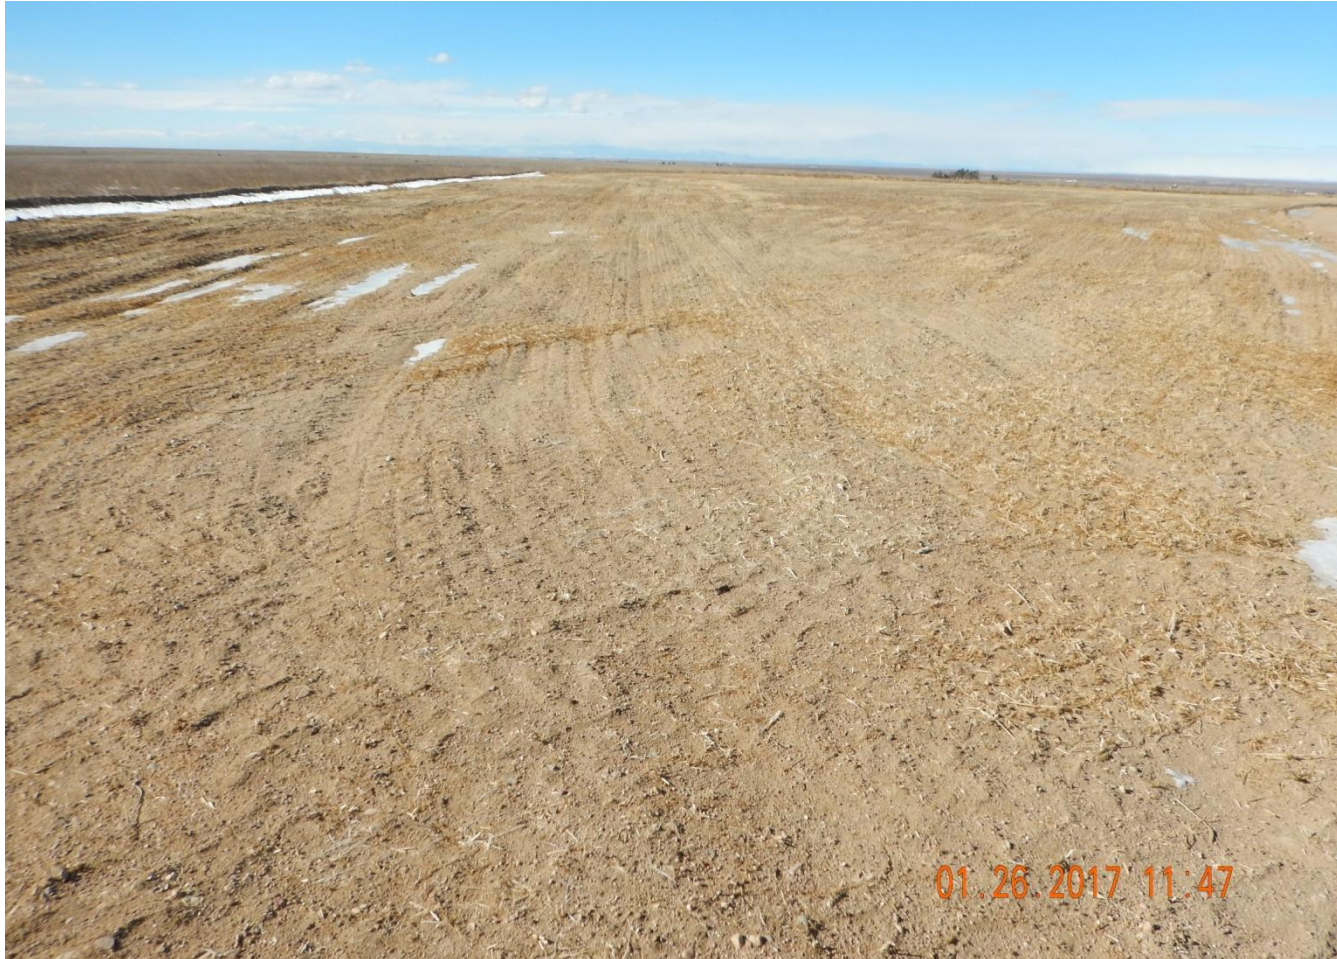
Photo 11. Photo taken of the southern interim area, facing West. Evidence of reclamation activities apparent but mulch does not appear to be sufficiently crimped. Mulch was observed in throughout the perimeter of the disturbance area. May need to monitor interim areas to ensure areas are protected from erosion.
