Interim Reclamation and Stormwater Inspection

01/26/2017

Operator: Bonanza Creek

Location ID: 428002

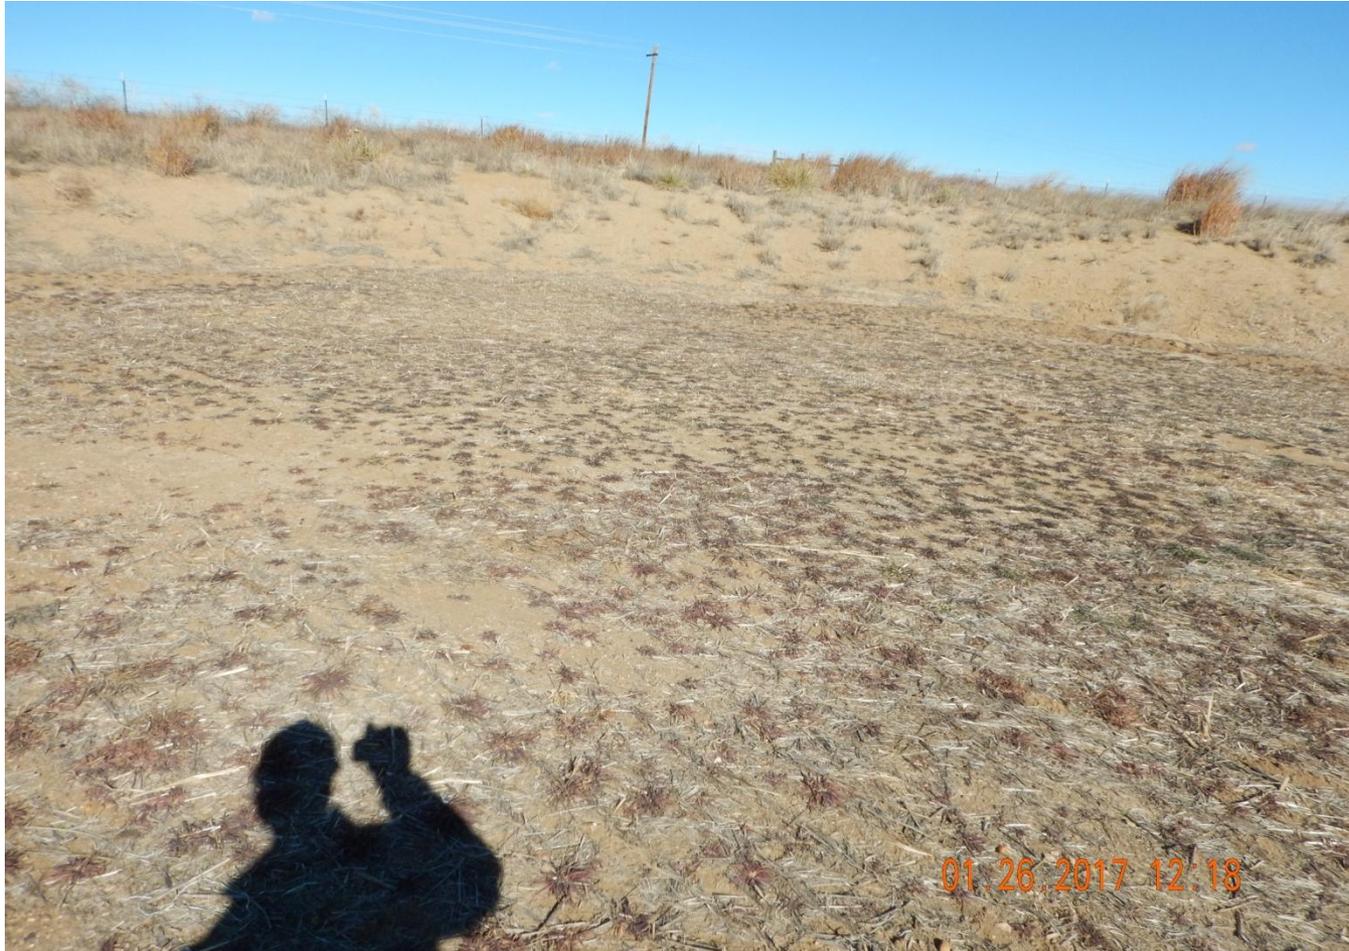
Photo 1. Photo taken from the northeast interim area, facing Northeast. Cut slope lacks vegetative growth for stabilization but did not observe any erosion occurring.

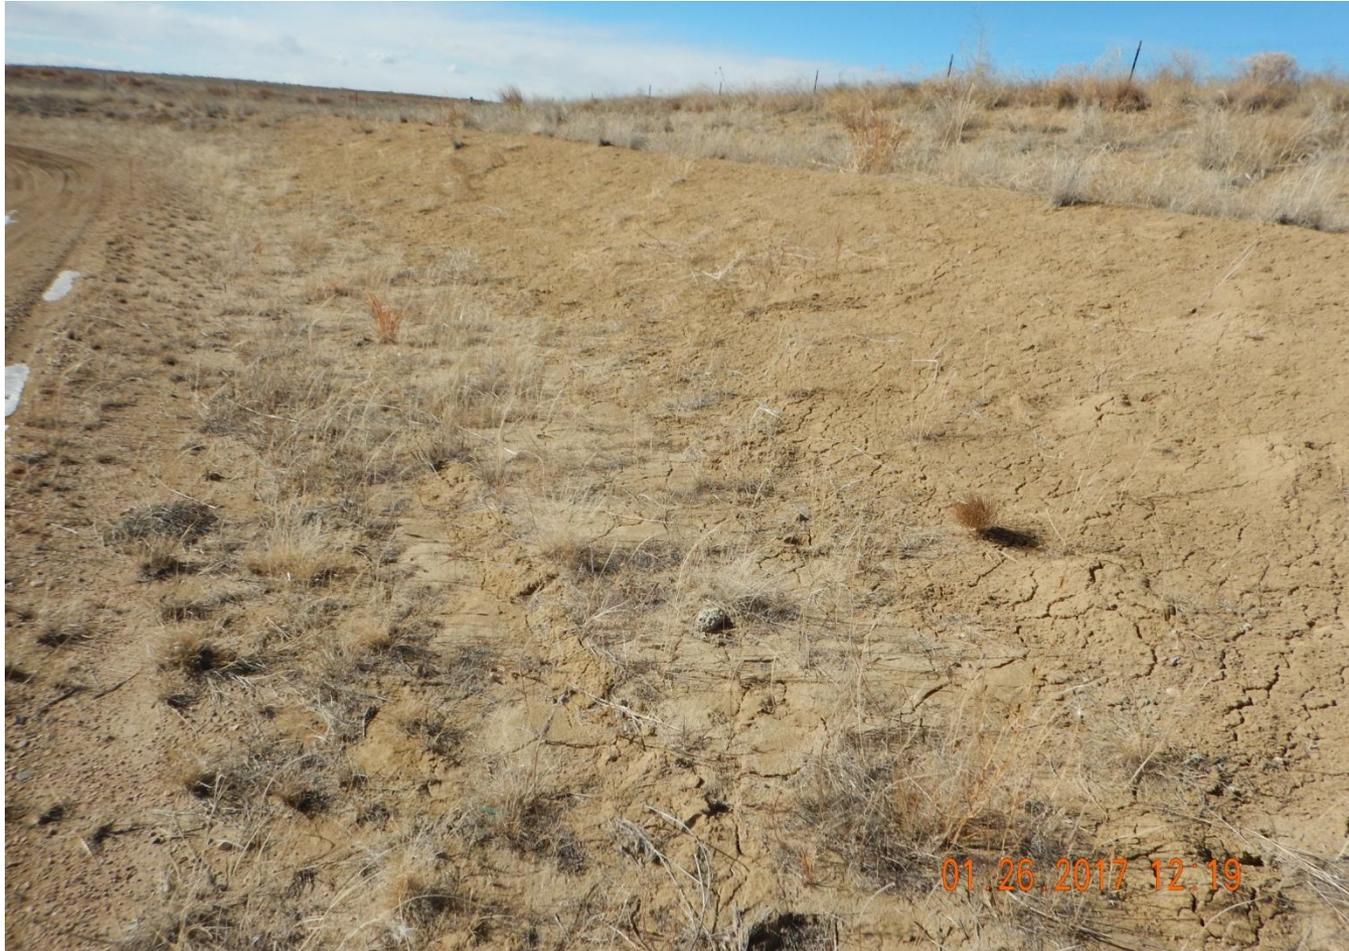
Photo 2. Photo taken from the northern location, facing West. Cut slope lacks vegetative growth for stabilization but did not observe any erosion occurring.

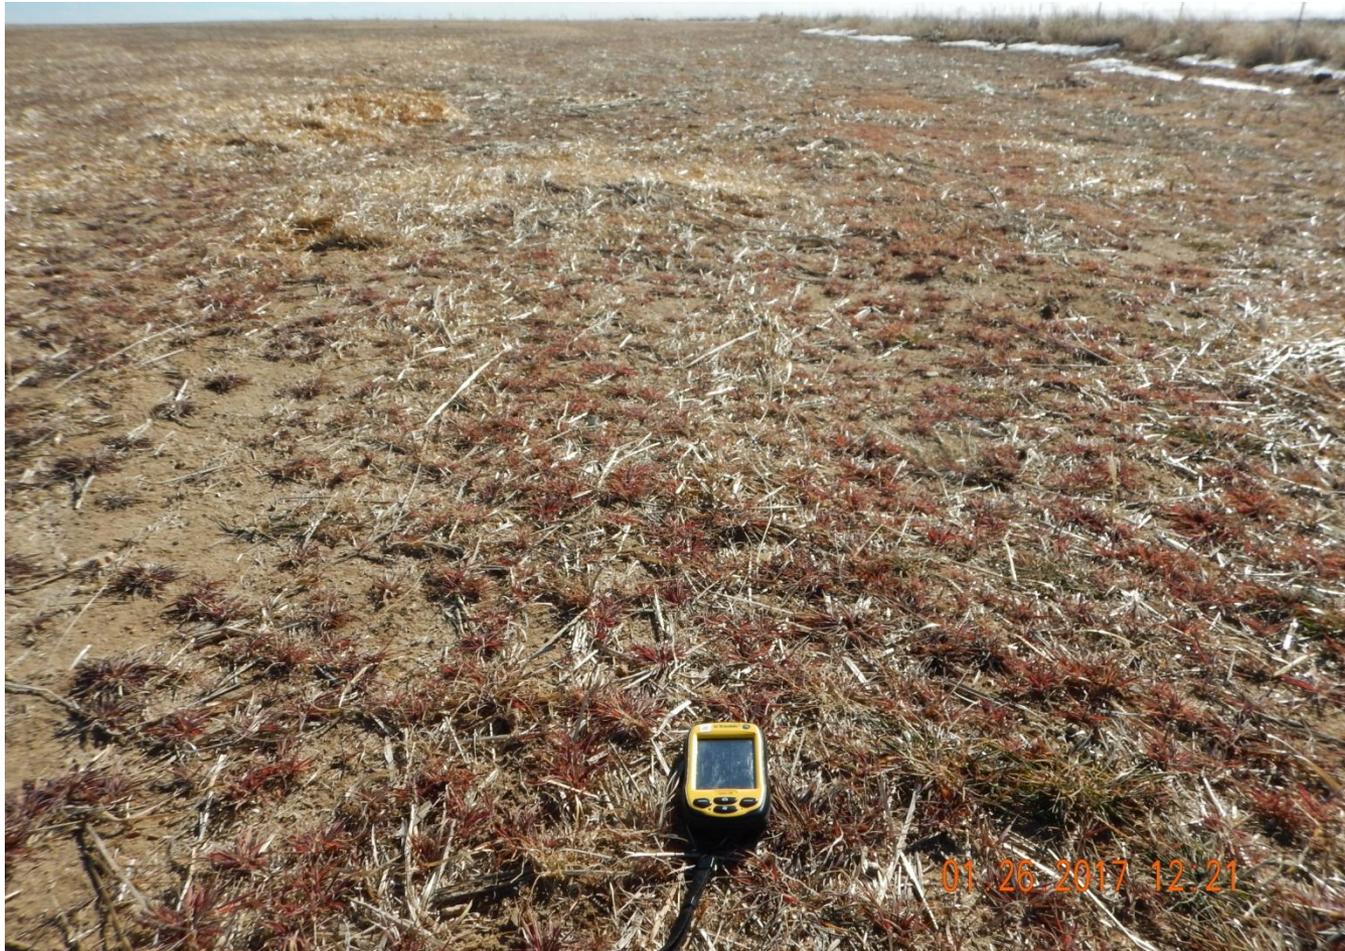
Photo 3. Photo taken from the northwest interim area, facing South. Germination apparent throughout most of the interim area.

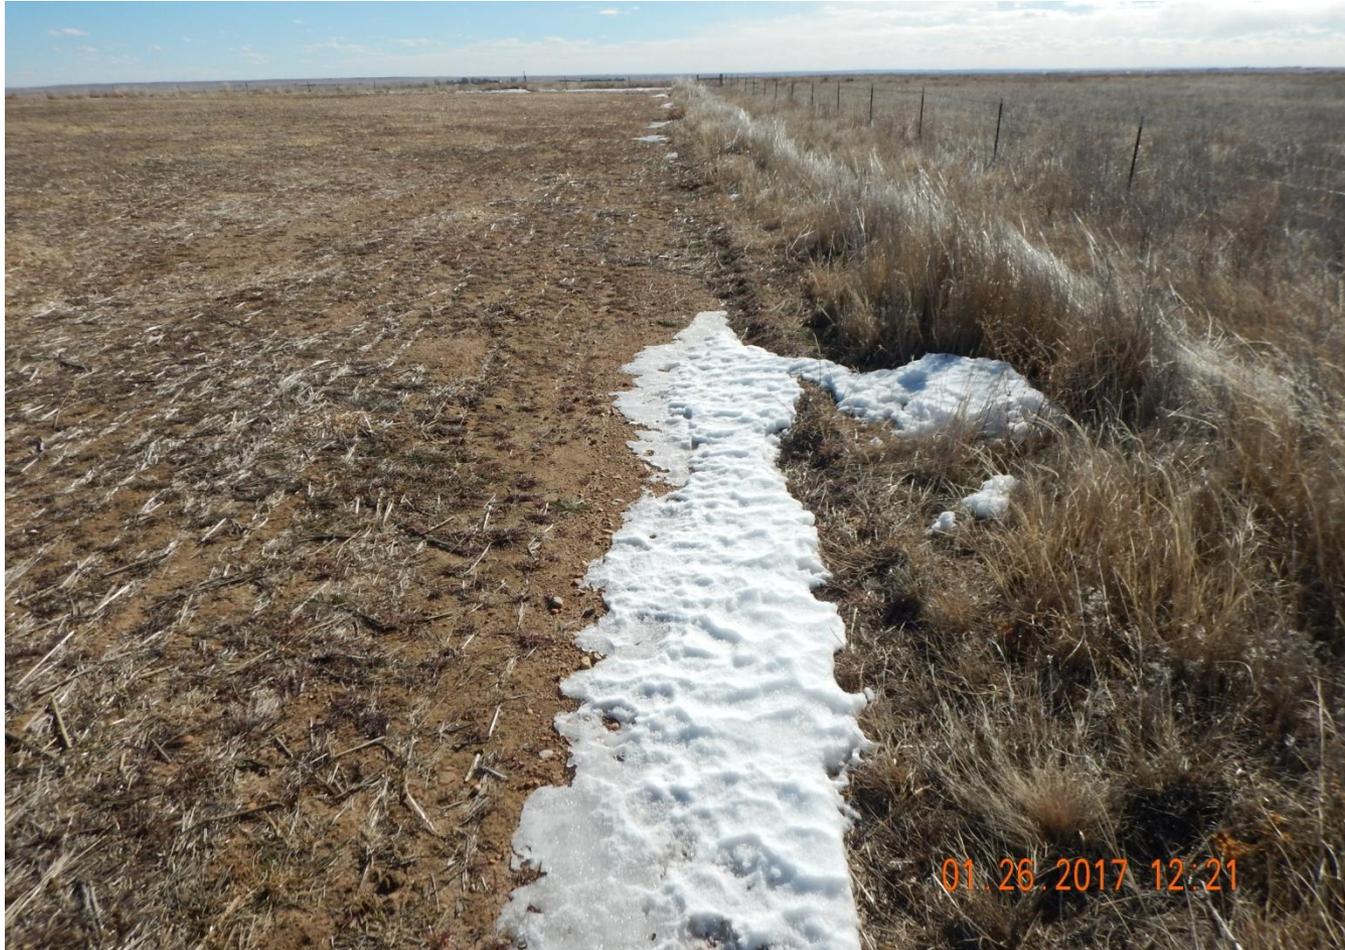
Photo 4. Photo taken from the western interim area, facing South. Germination apparent throughout most of the interim area. Perennial vegetative growth established along entire perimeter of location to help stabilize location from erosion.

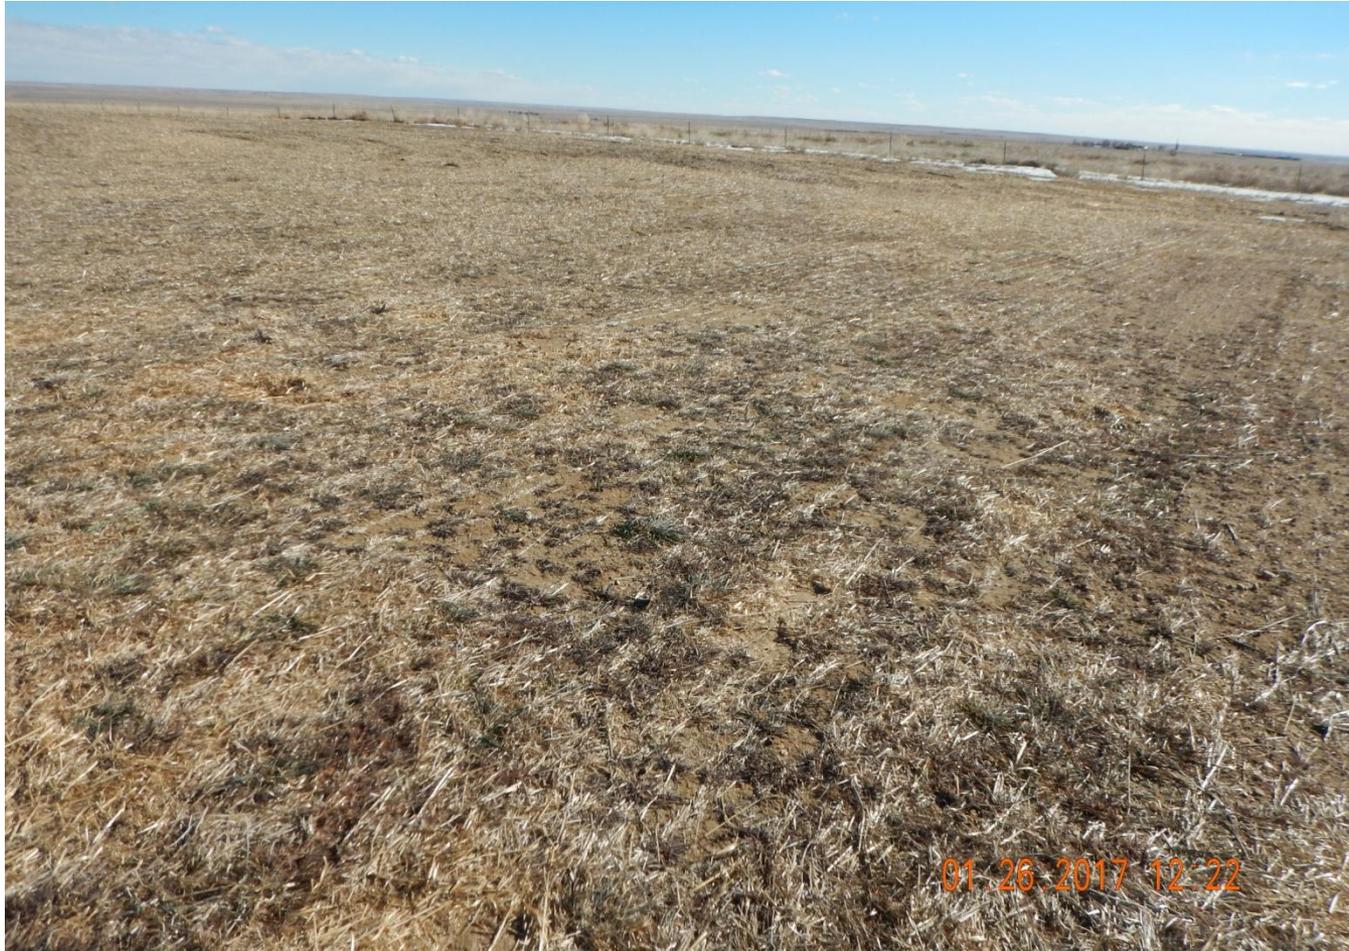
Photo 5. Photo taken from the southwest interim area, facing Southeast. Germination apparent throughout most of the interim area.

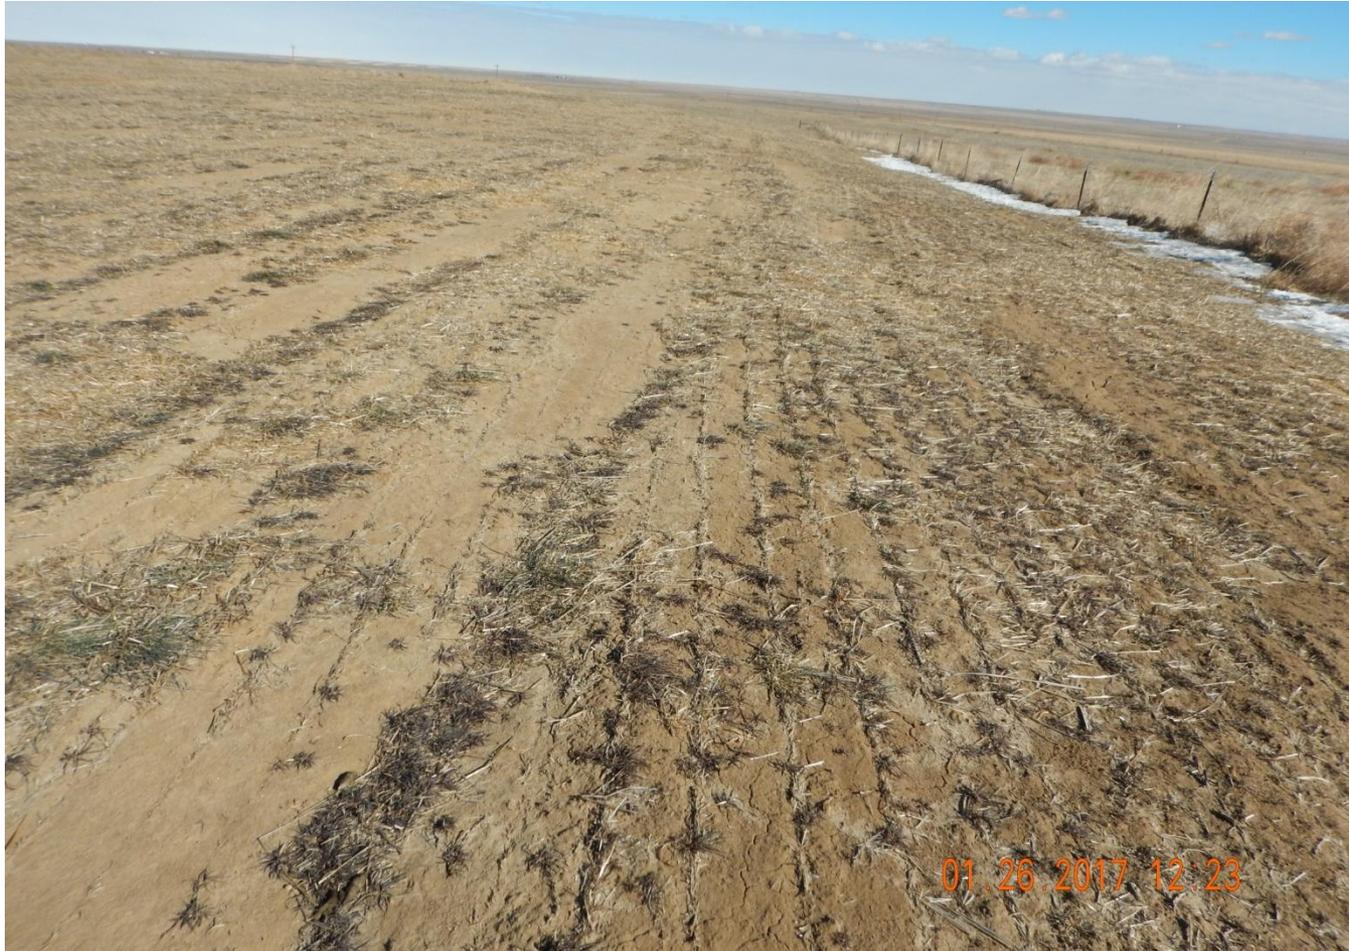
Photo 6. Photo taken from the southern interim area, facing East. Germination lacks along portion of this interim area. May need additional reclamation activities to be performed to achieve Rule 1003 standards.

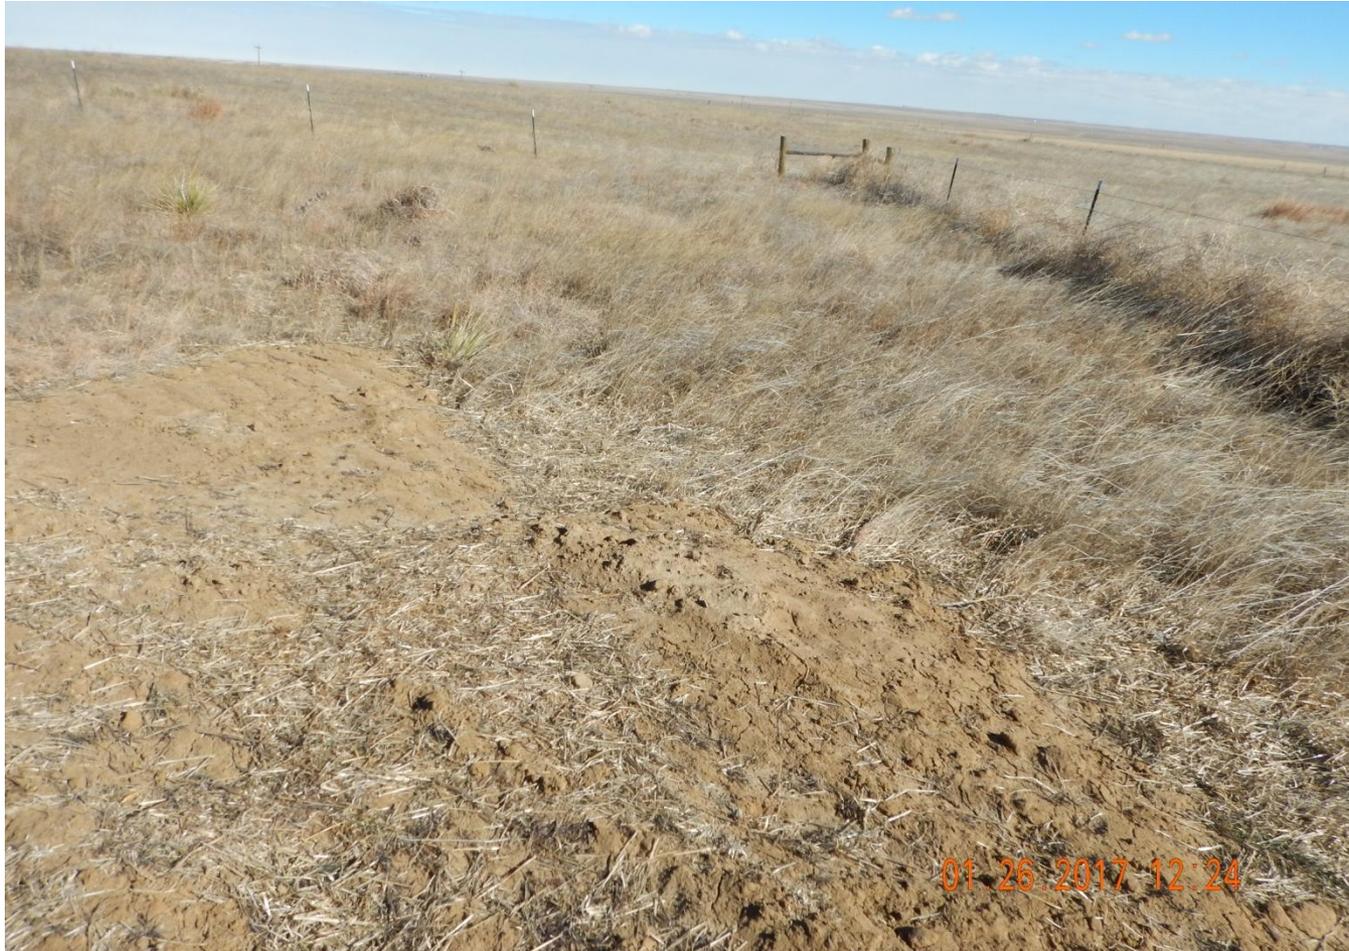
Photo 7. Photo taken from the southeast location, facing East. Perennial vegetative growth established along entire perimeter of location to help stabilize location from erosion.

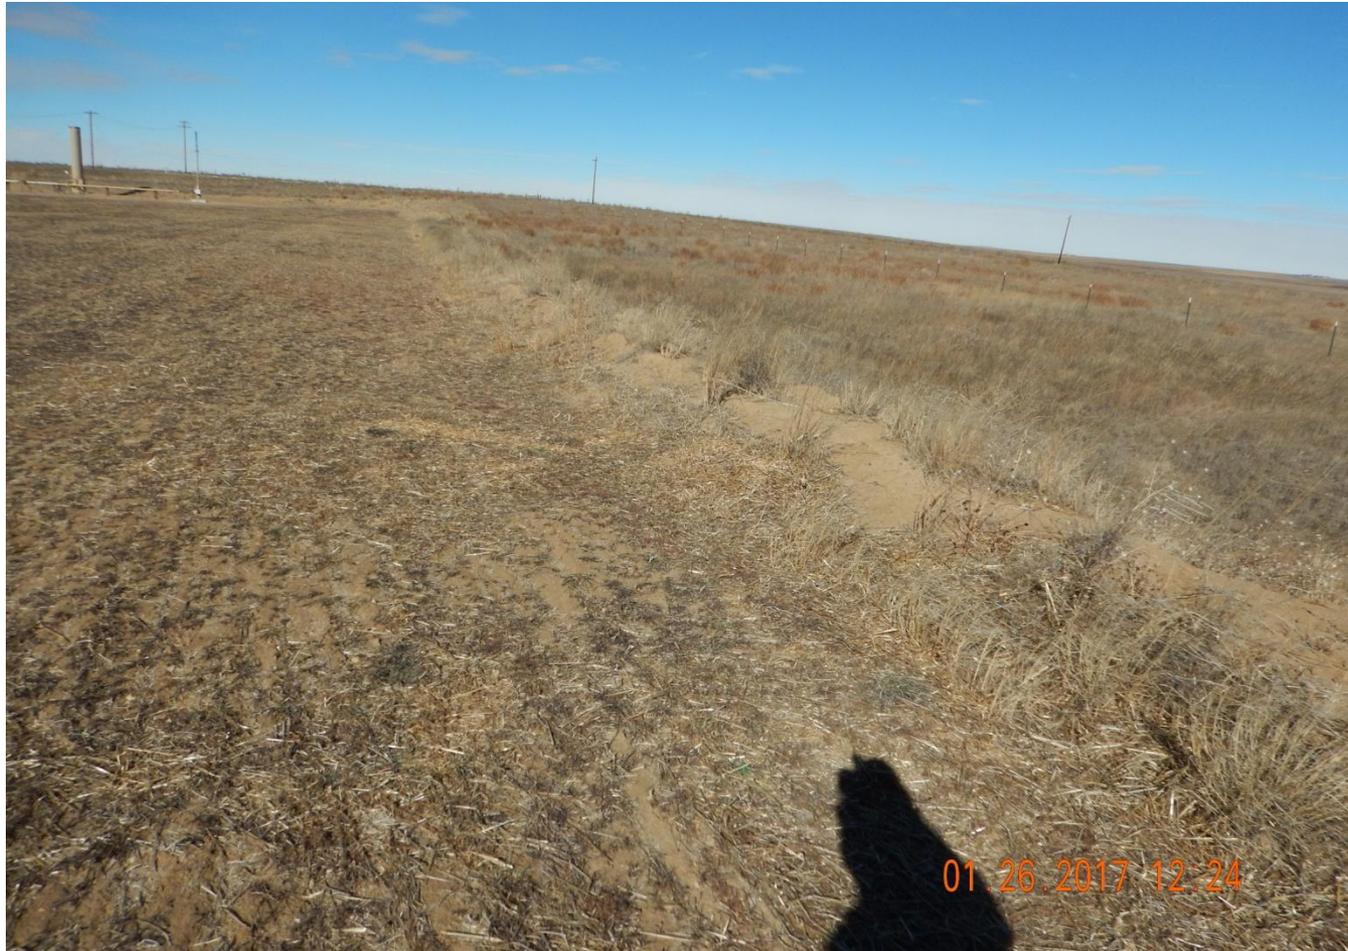
Photo 8. Photo taken from the eastern interim area, facing North. Germination apparent throughout most of the interim area. Perennial vegetative growth established along entire perimeter of location to help stabilize location from erosion.

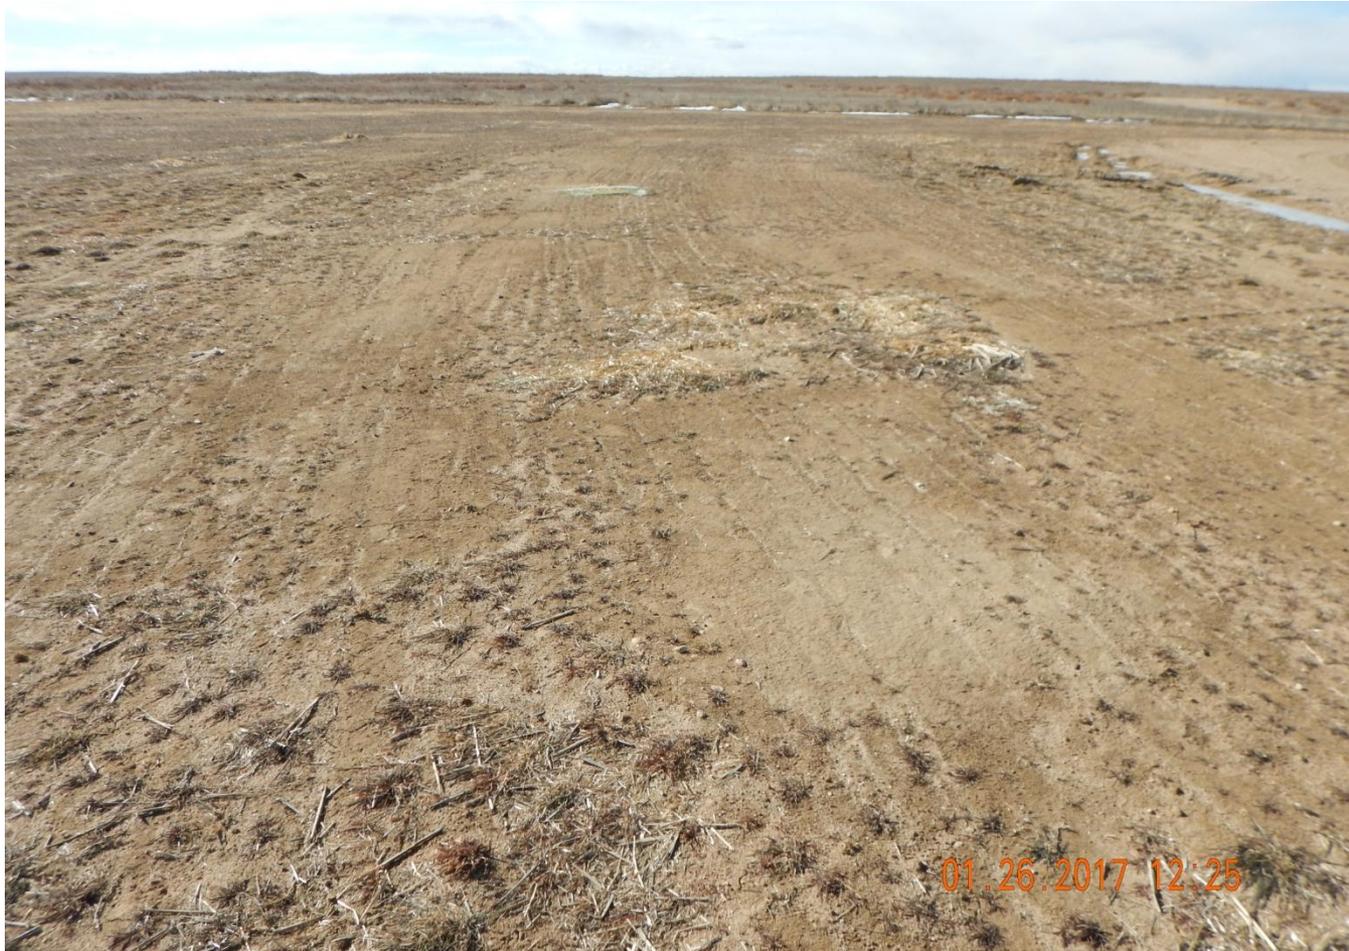
Photo 9. Photo taken from the northern interim area, facing West. Germination lacks along portion of this interim area. May need additional reclamation activities to be performed to achieve Rule 1003 standards.
