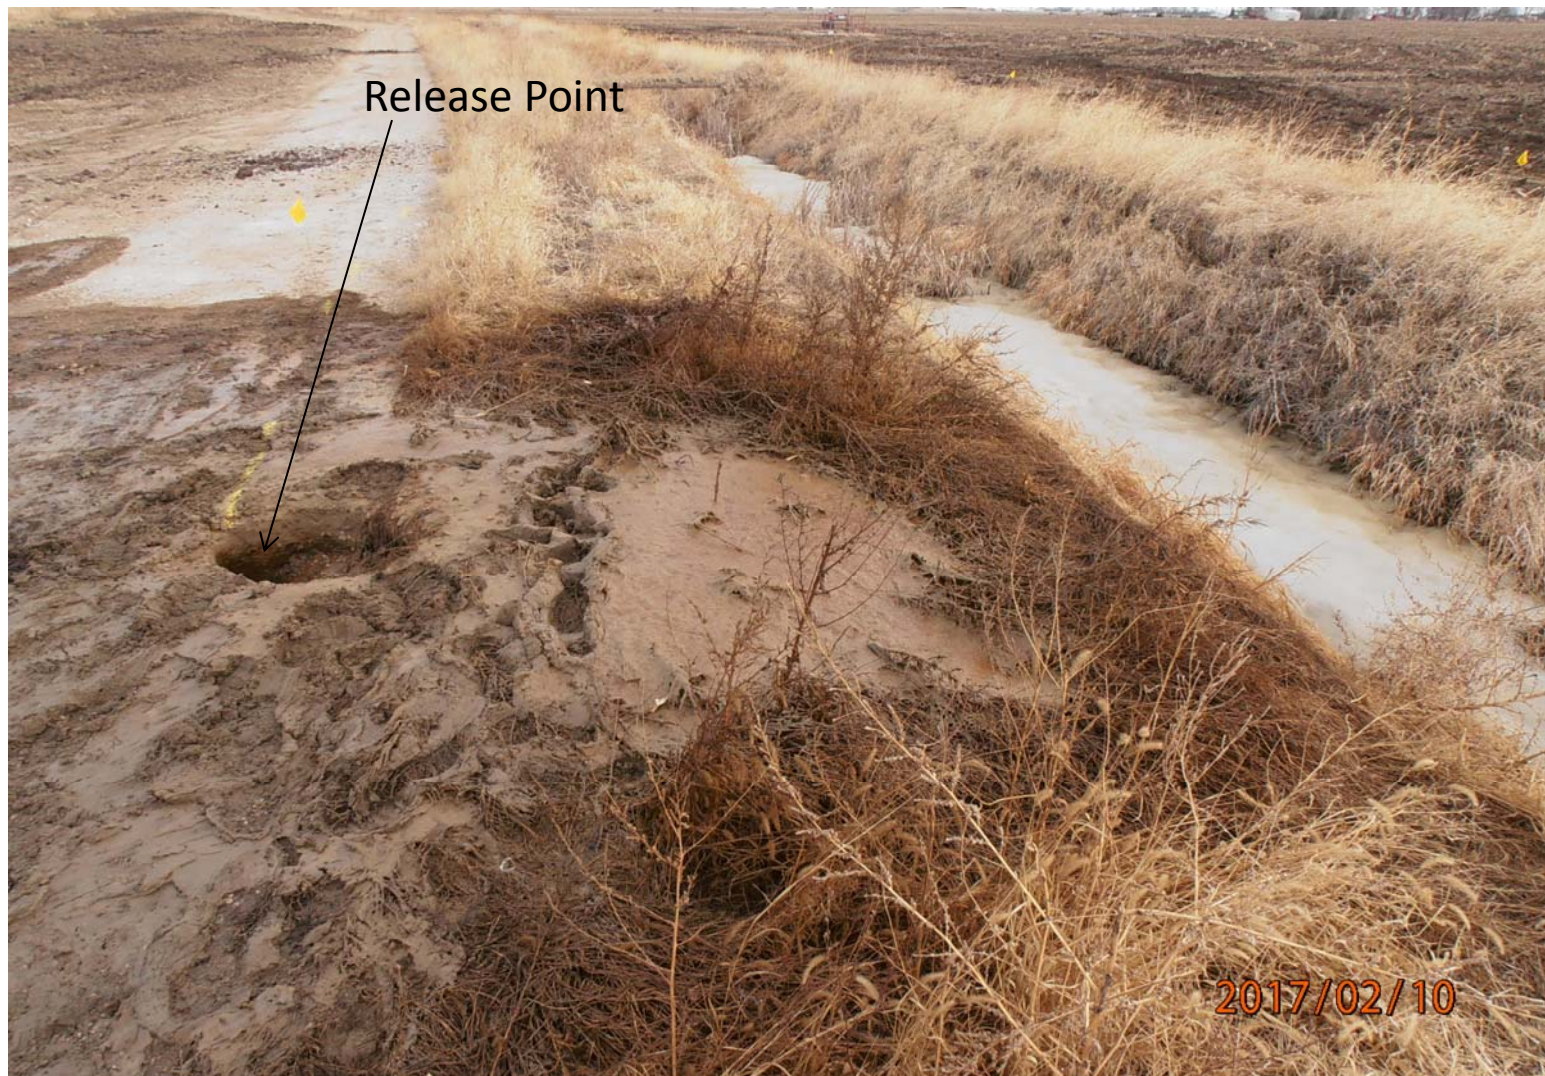
Release point and surface entry into Owl Creek. Photo looking north and upgradient.

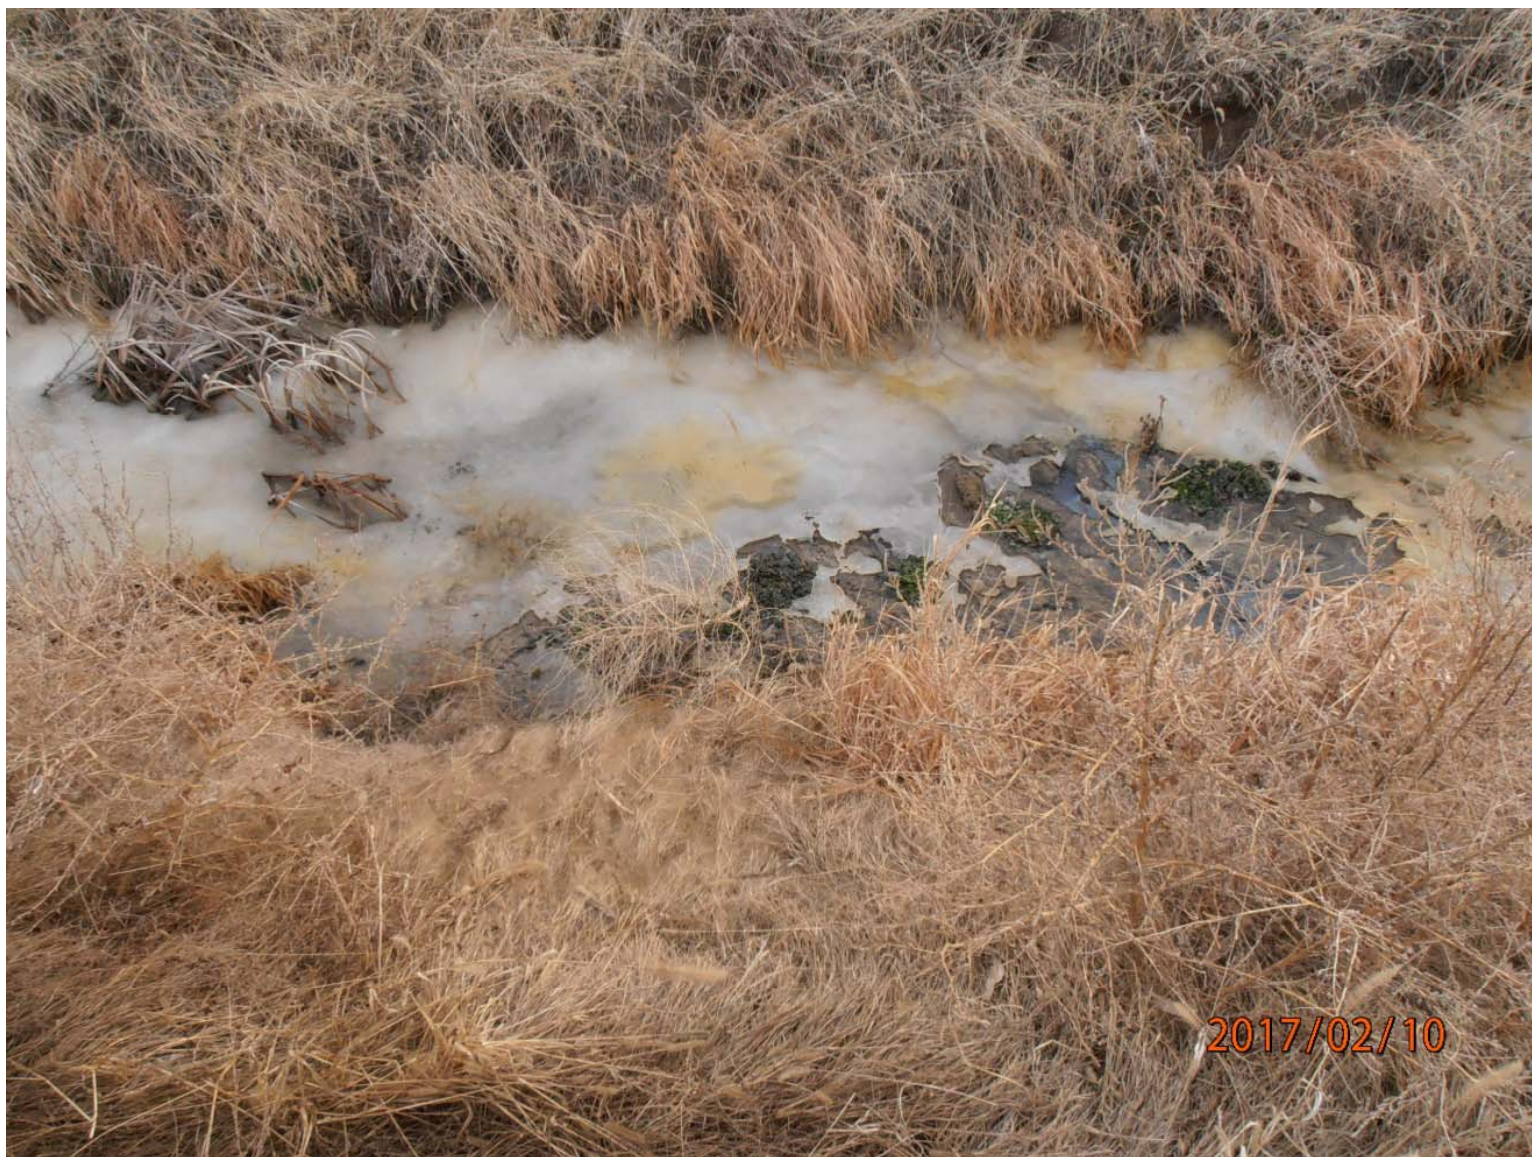
Visible condensate on ice in Owl Creek adjacent to flowline release point.

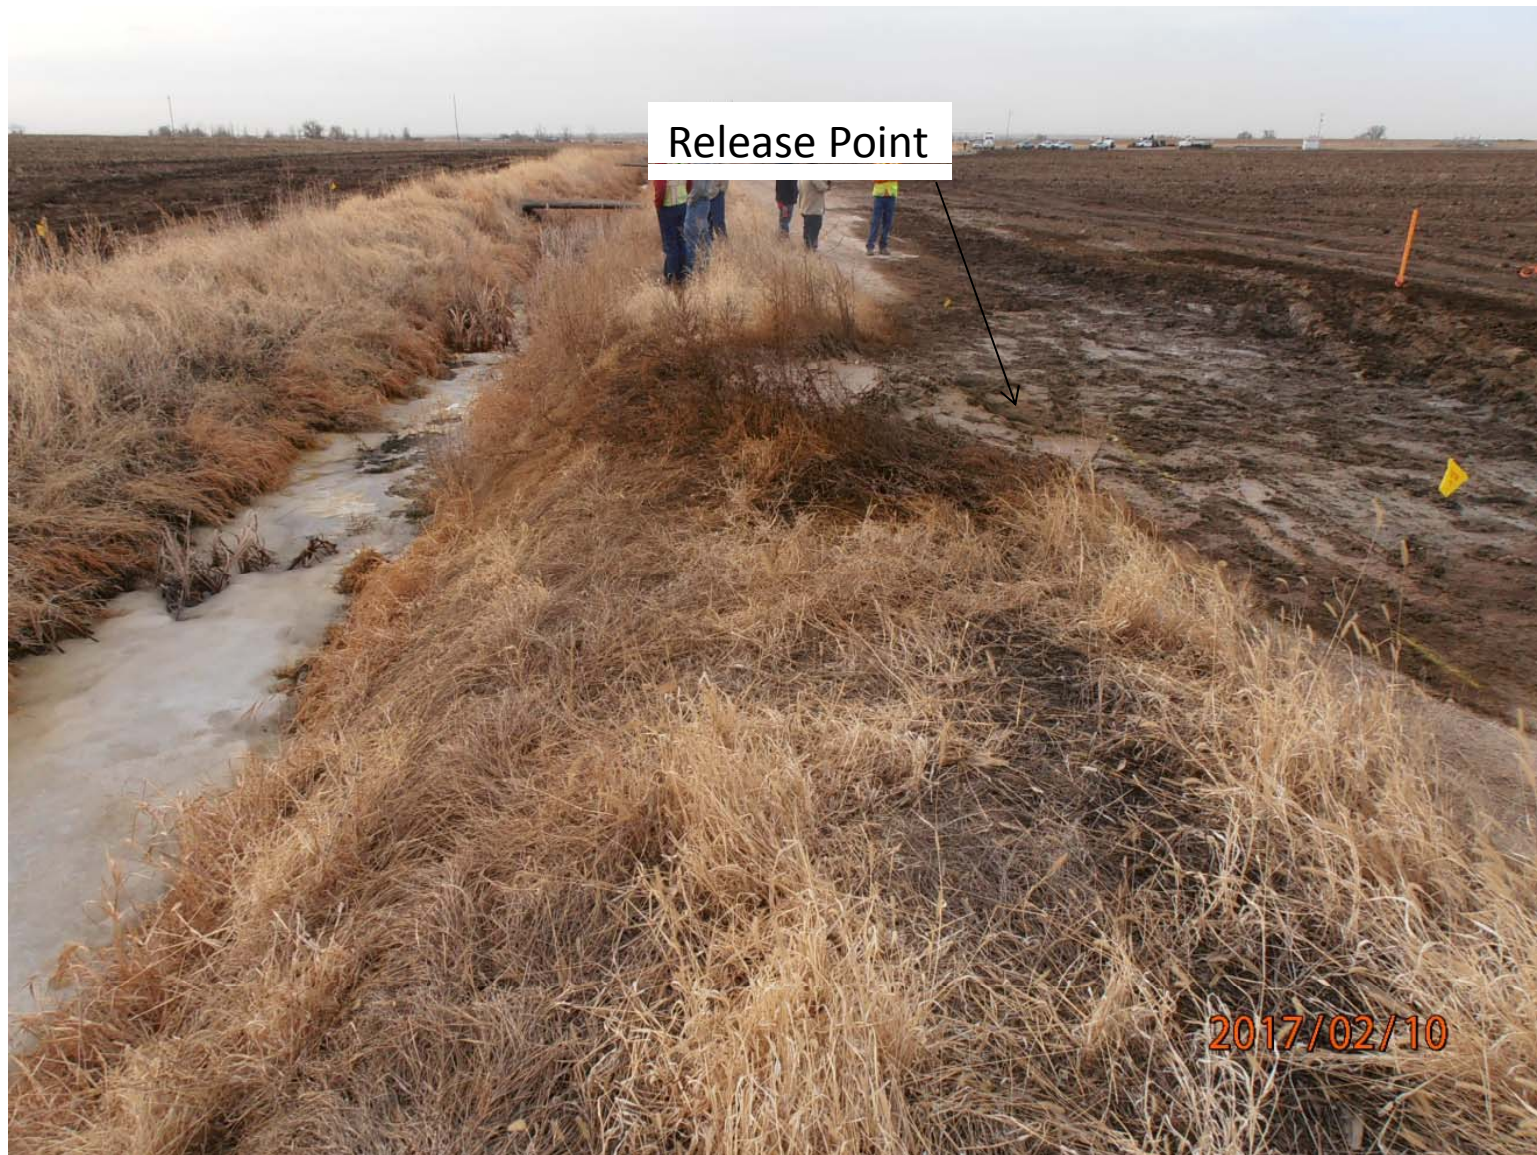
View of release point and surface entry to Owl Creek. Photo is looking south and downgradient.

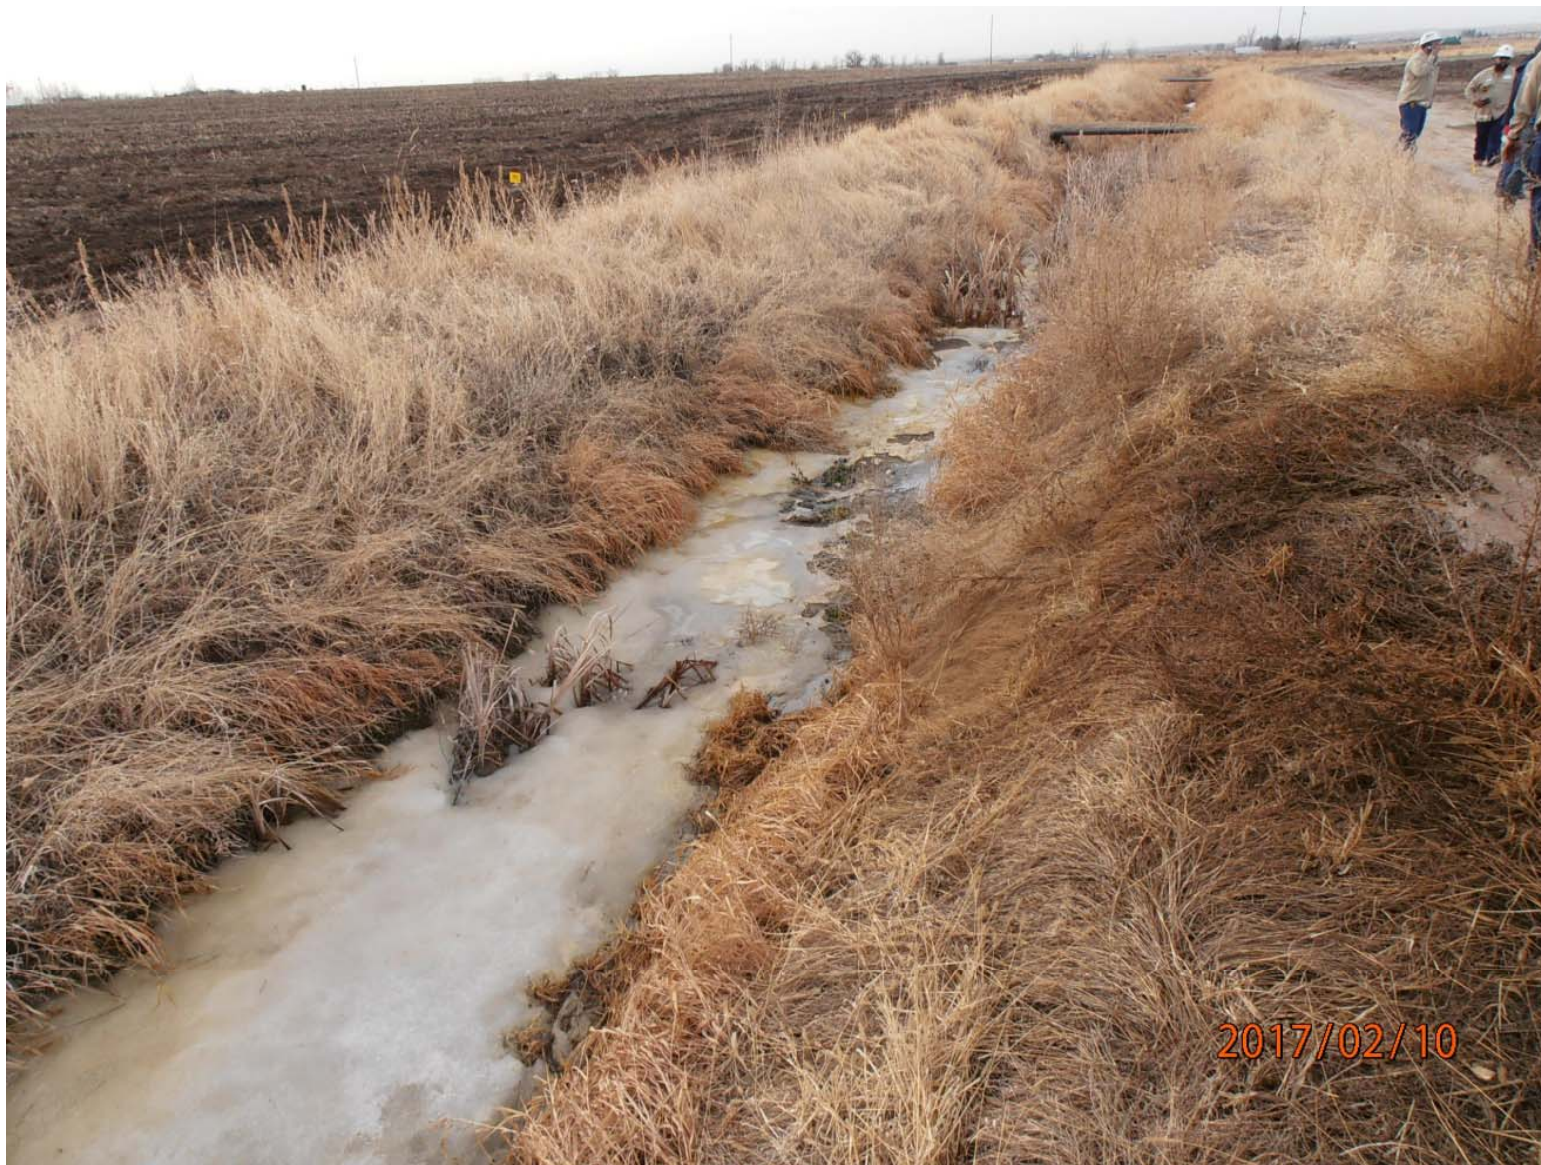
Surface entry into Owl Creek. Photo looking south and downgradient.

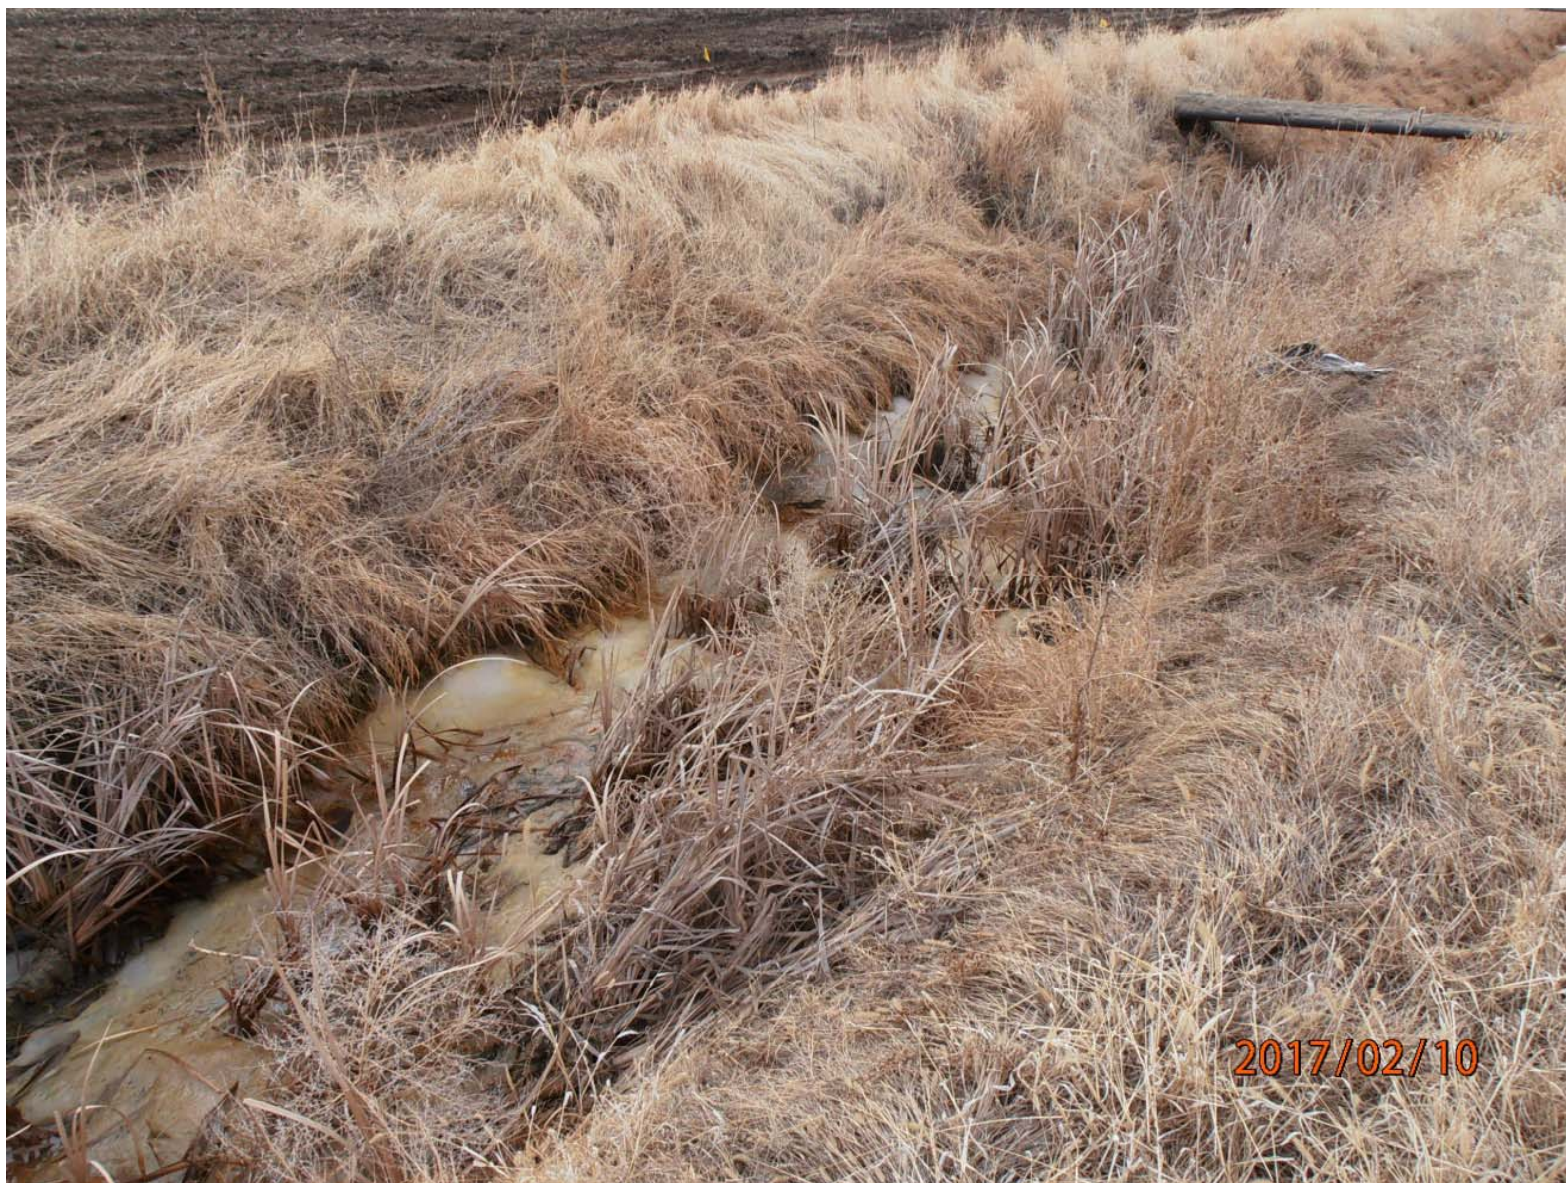
View of Owl Creek, approximately 200 feet downgradient from release point.

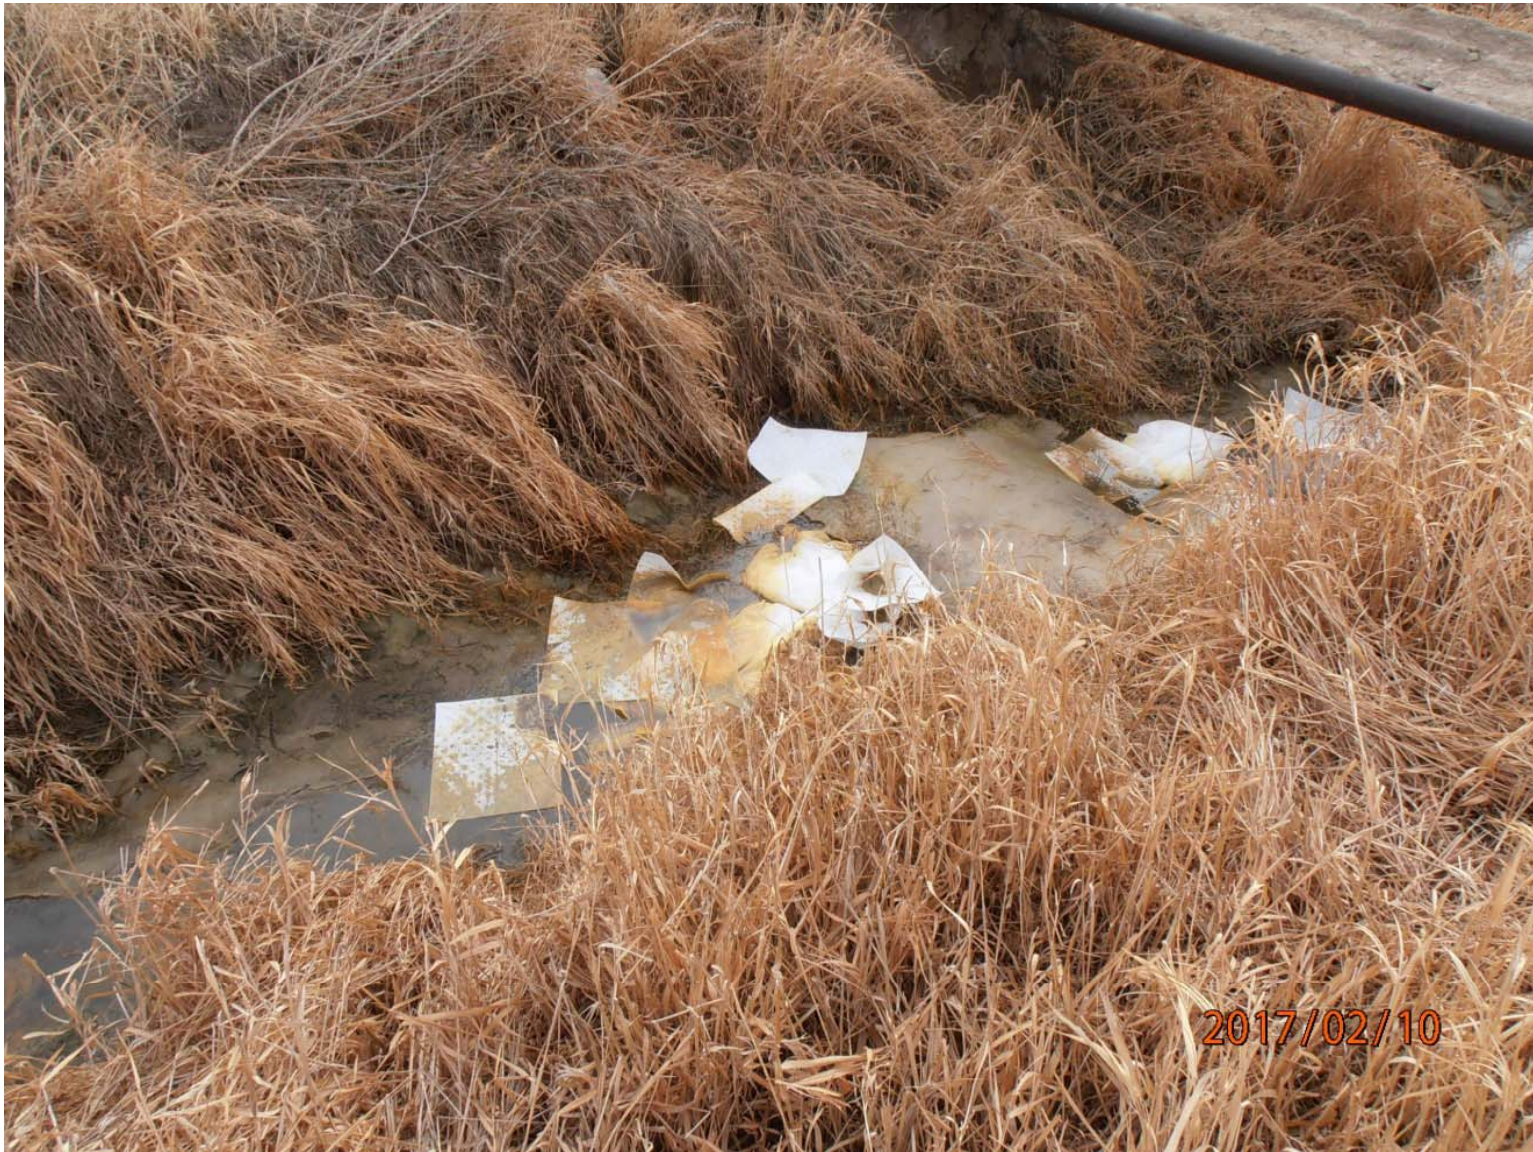
Absorbent material in Owl Creek near terminus of visible impacts to surface water in Owl Creek, approximately 300 feet downgradient of release point.

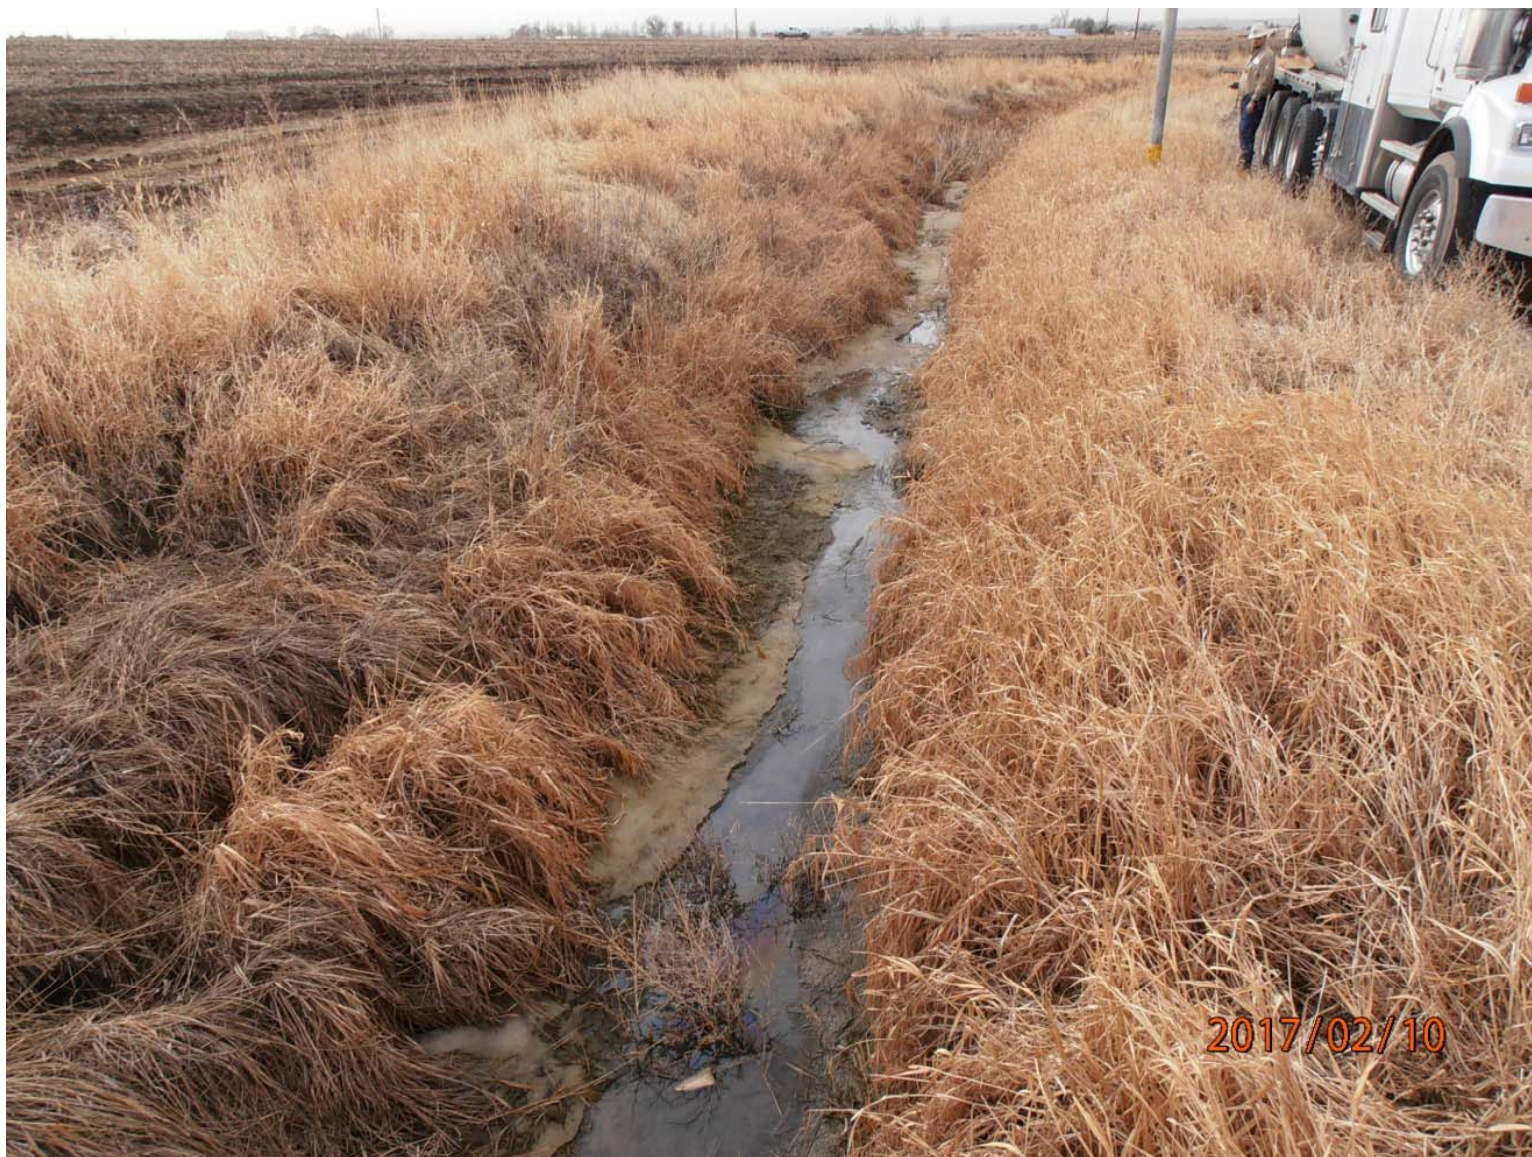
Vacuum truck preparing to recover free liquid hydrocarbons and surface water exhibiting visual impacts, stationed approximately 400 feet downgradient of release point. Photo is looking south and downgradient.

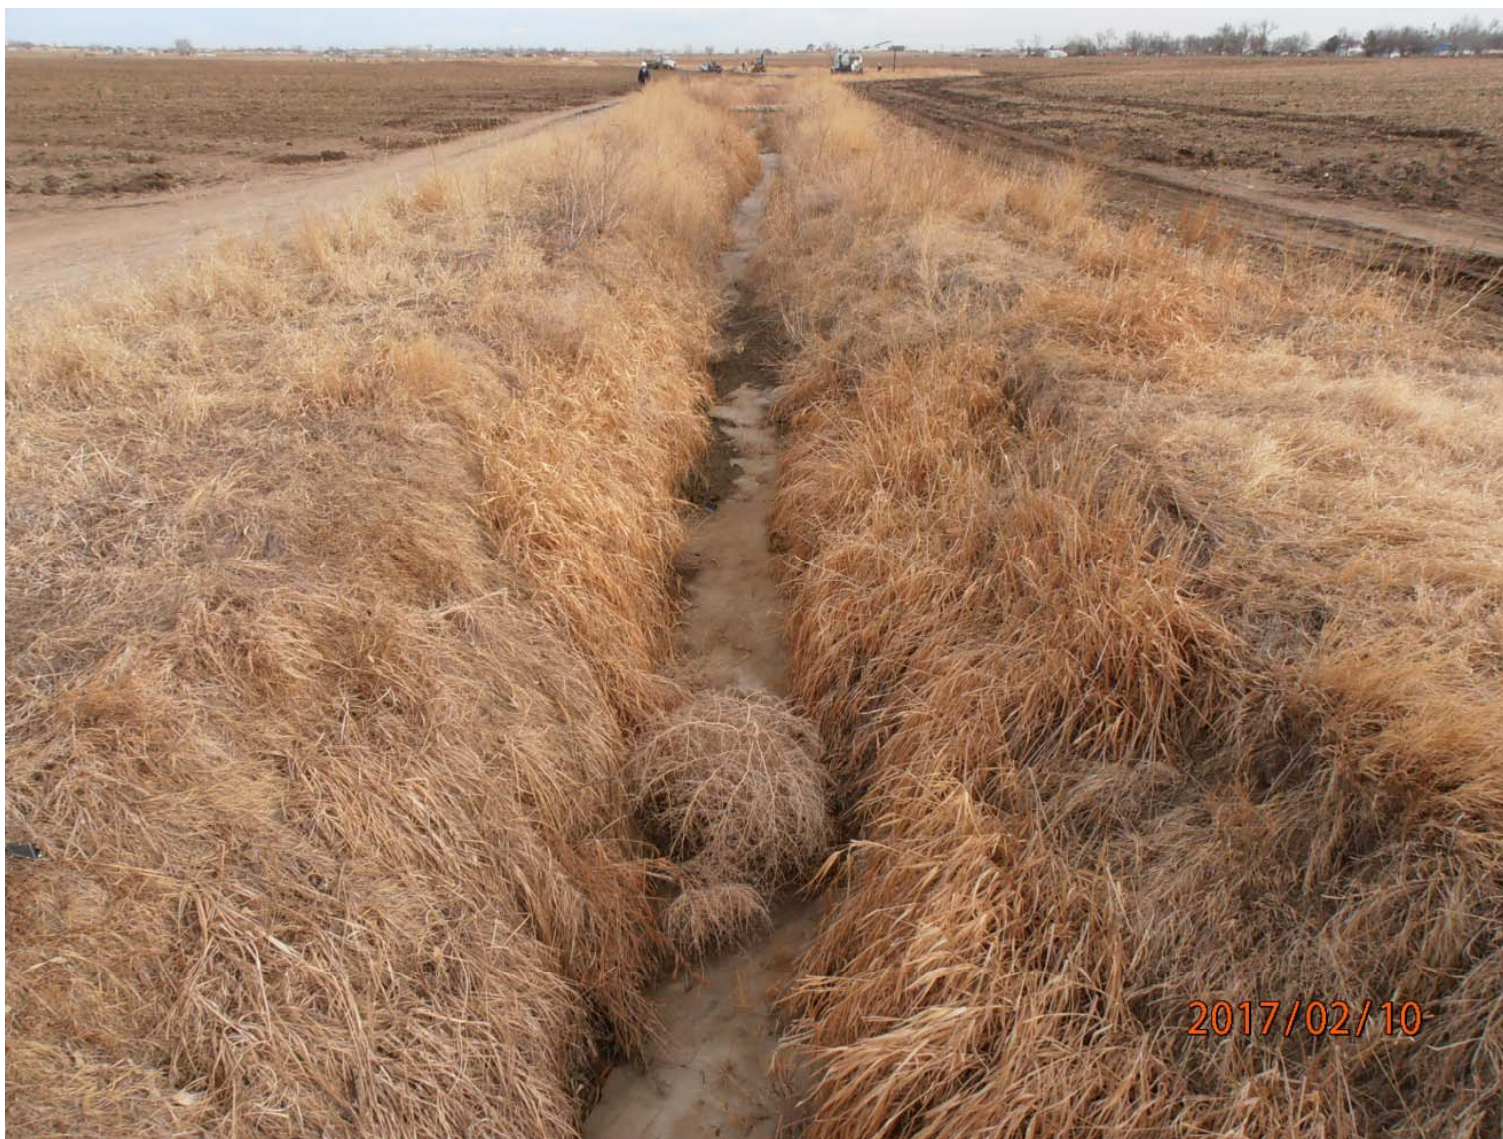
Photo looking of Owl Creek from near County Road 64 and looking north, upgradient. No visible hydrocarbons were observed at this location.

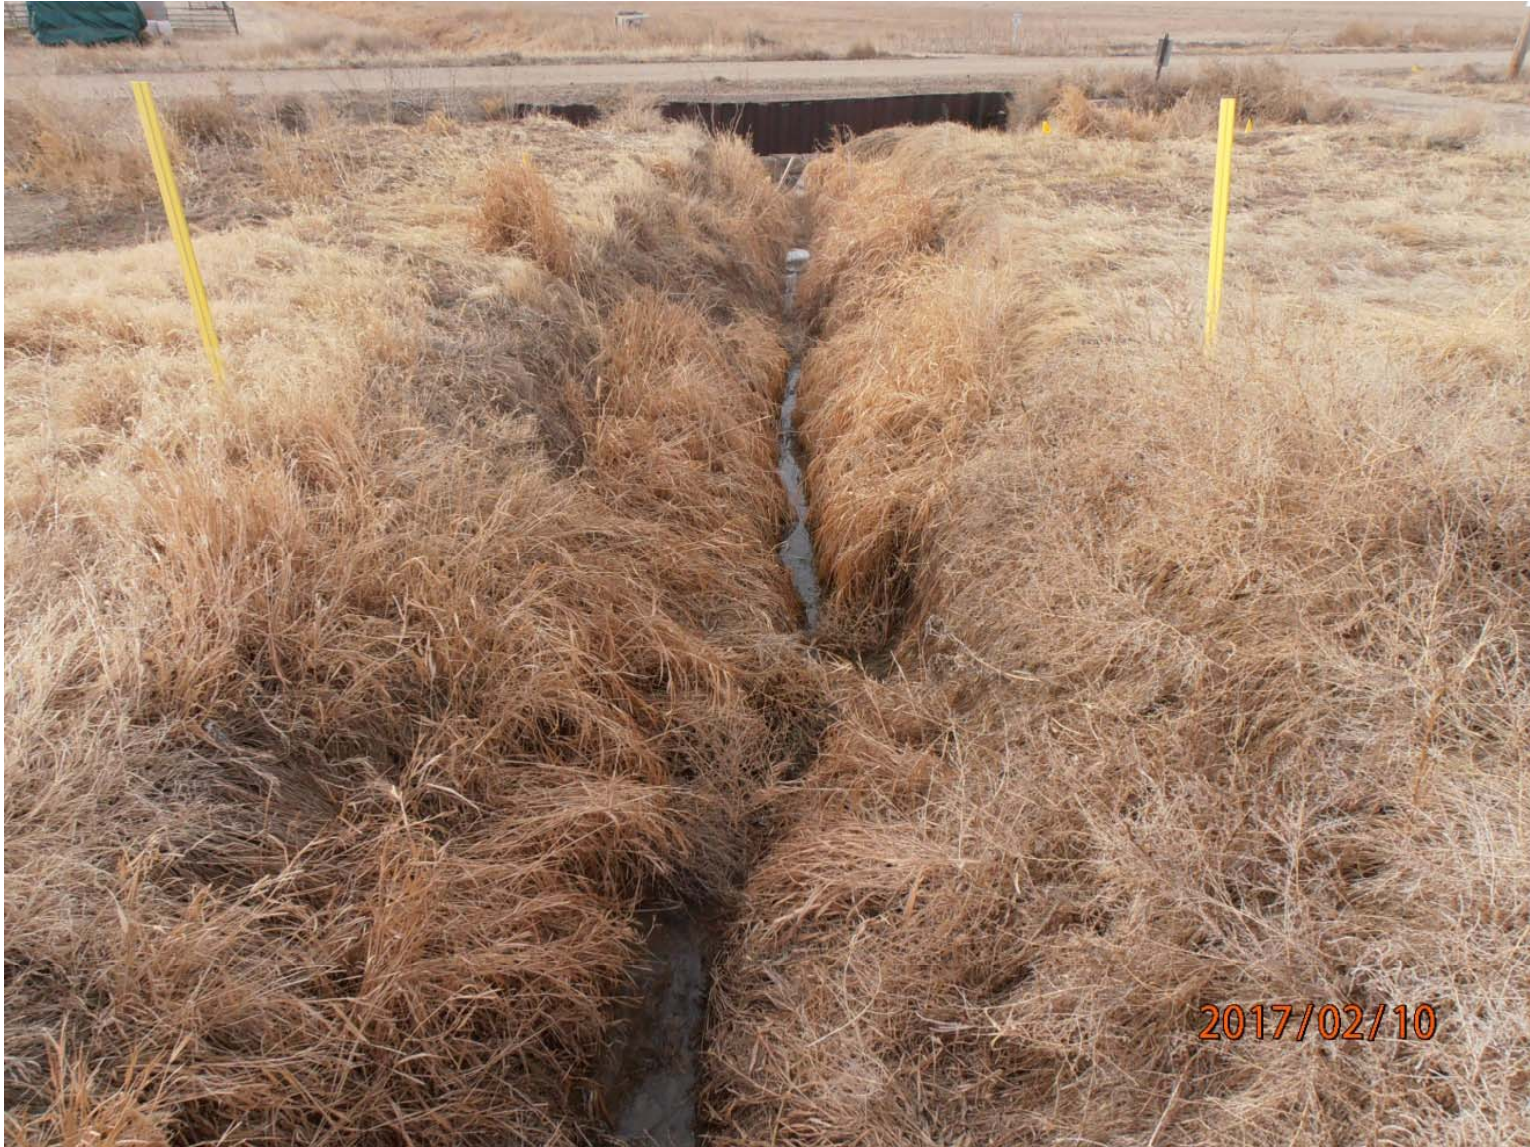
Photo of Owl Creek looking south and downgradient toward culvert beneath County Road 64.

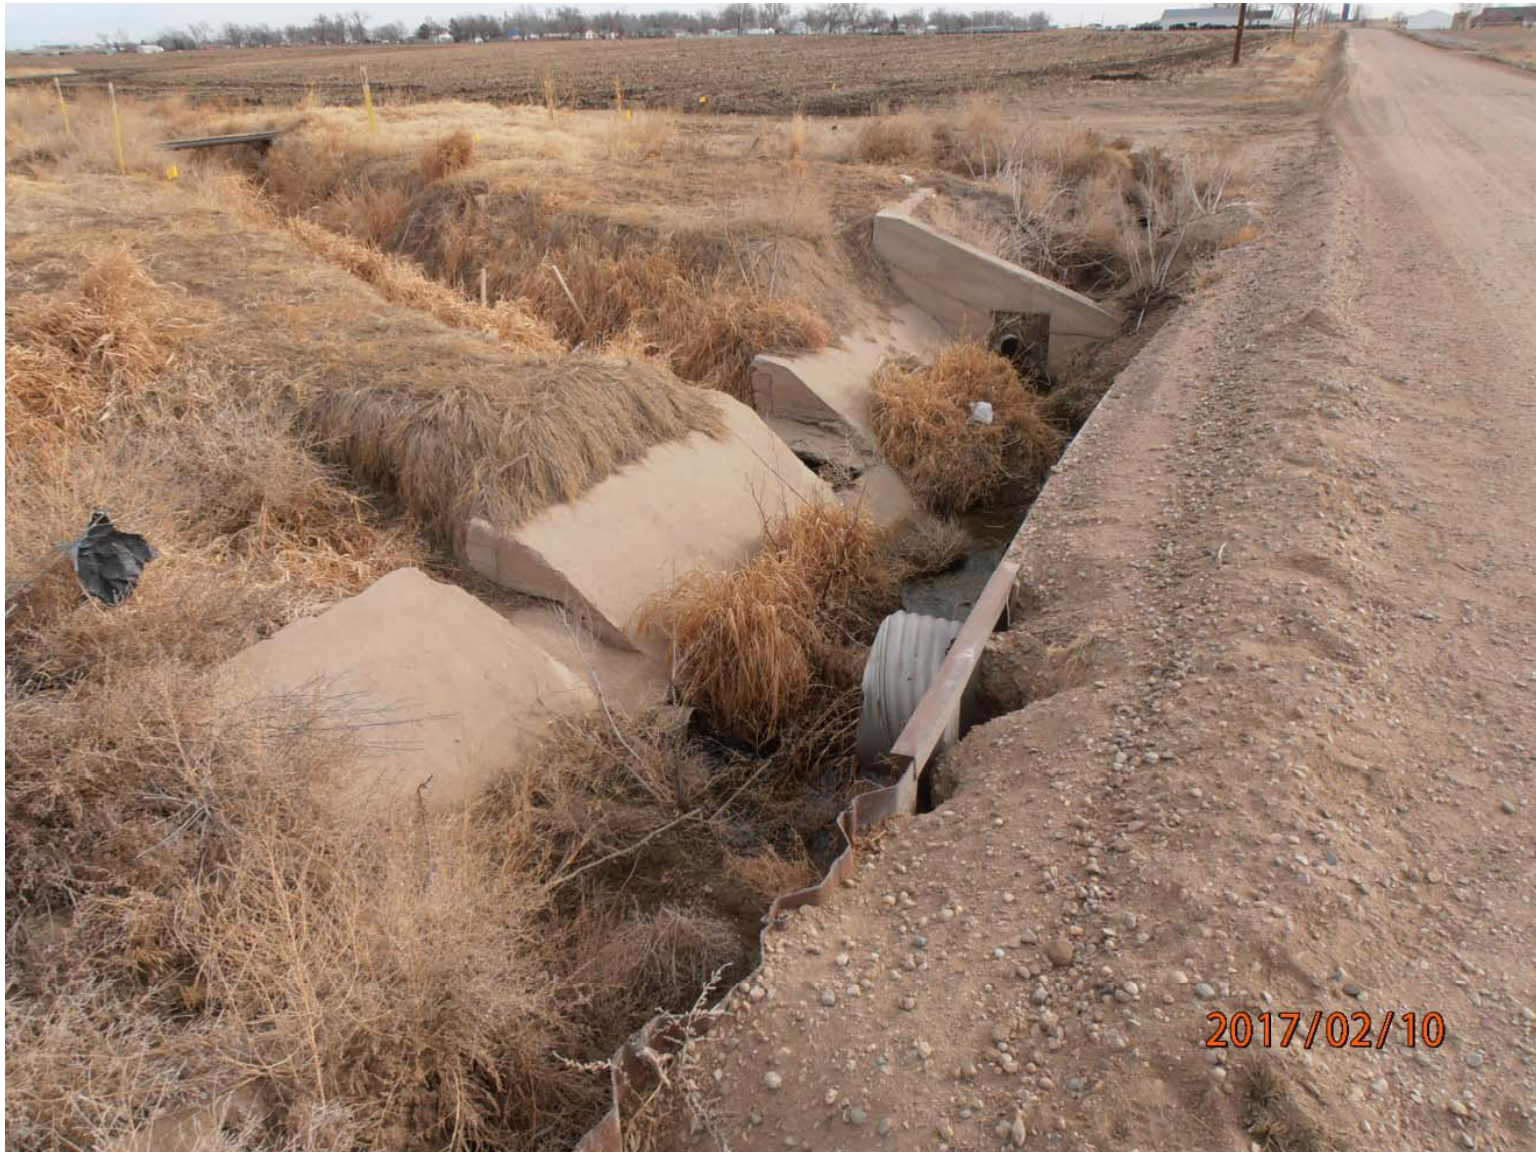
Photo of culvert for Owl Creek on north side of County Road 64. Camera is facing East. Additional field drains enter the creek at this location.

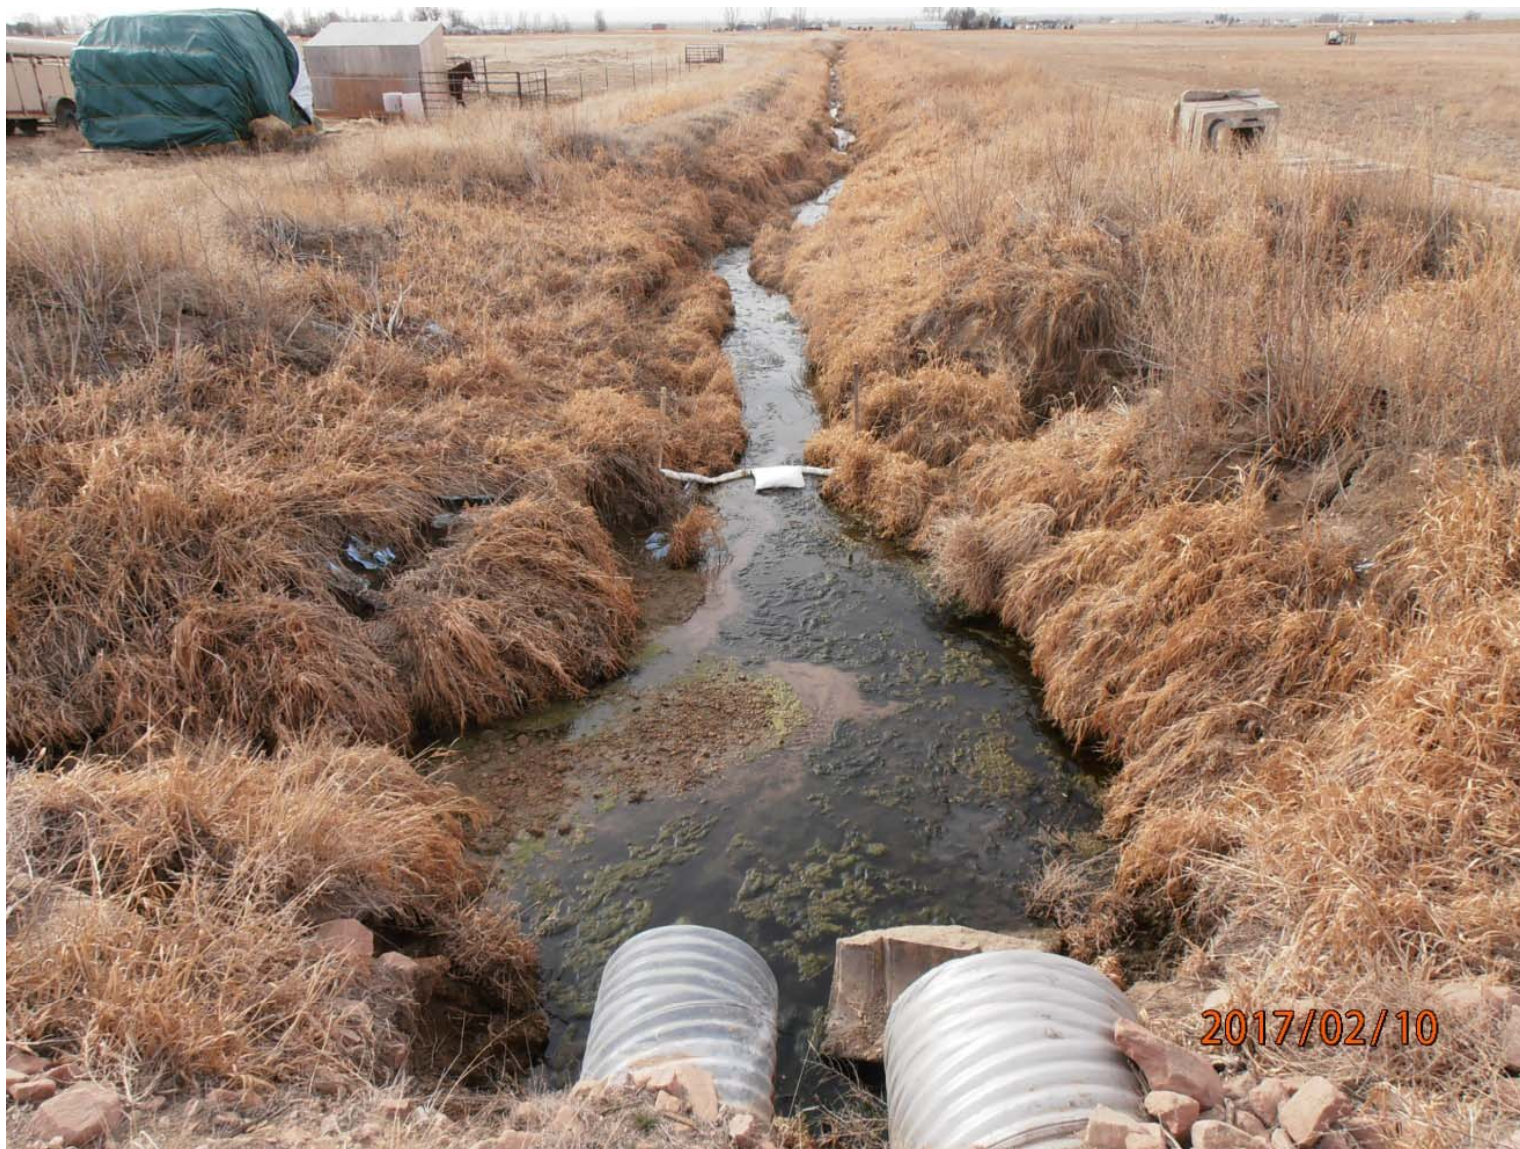
Photo of Owl Creek looking south from County Road 64. Absorbent material placed in creek. No visible hydrocarbons were observed.
