February 2, 2017

Inspection Photos: Encana PAs Schaeffer API#045-07398 -045-07388

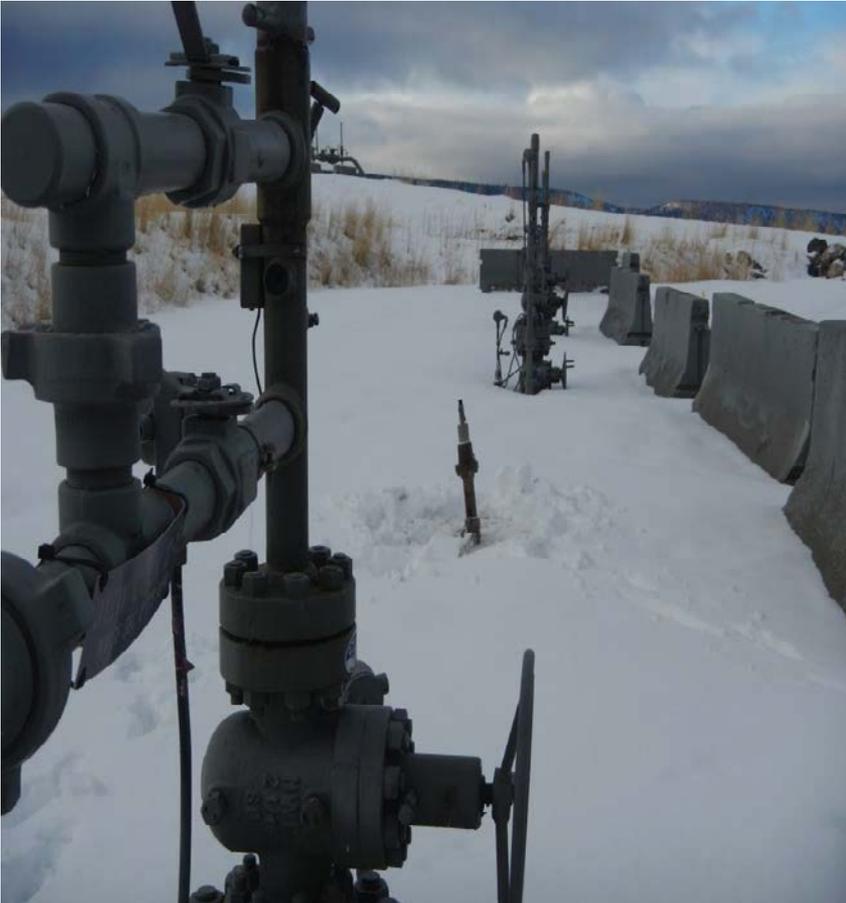
Photo#1:

View from East end of Well Row to West ; showing that Risers/Associated Facilities have been removed

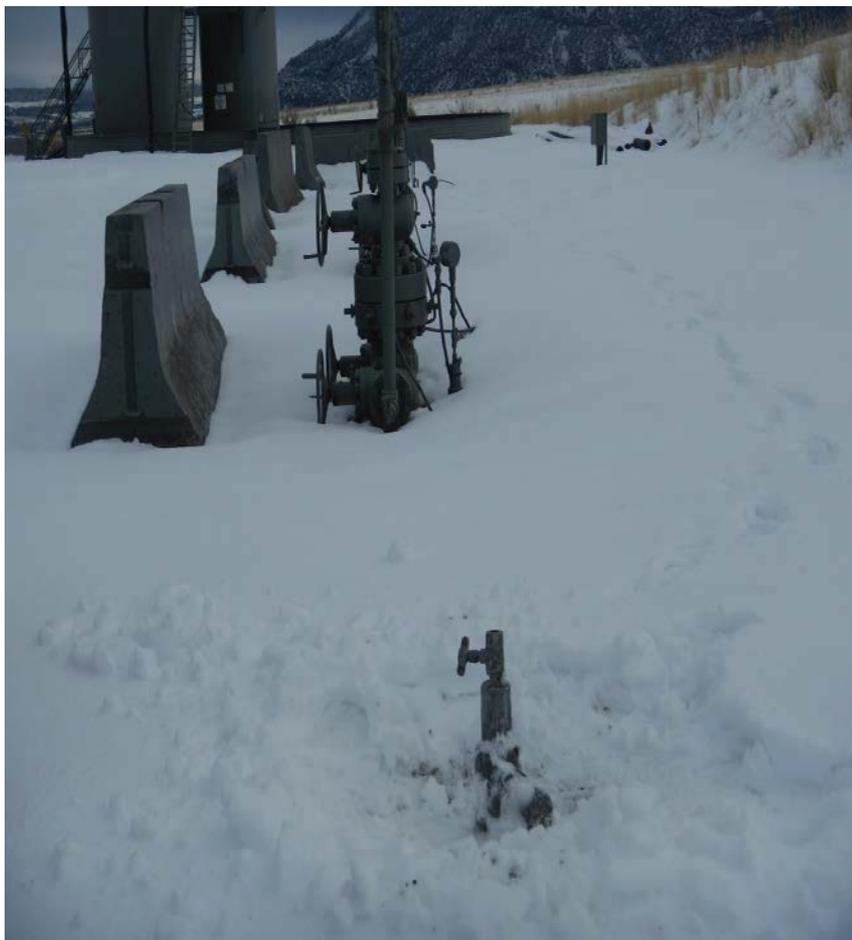
Photo#3:

View from West end of Well Line to East showing that Risers/Associated Facilities have been removed.

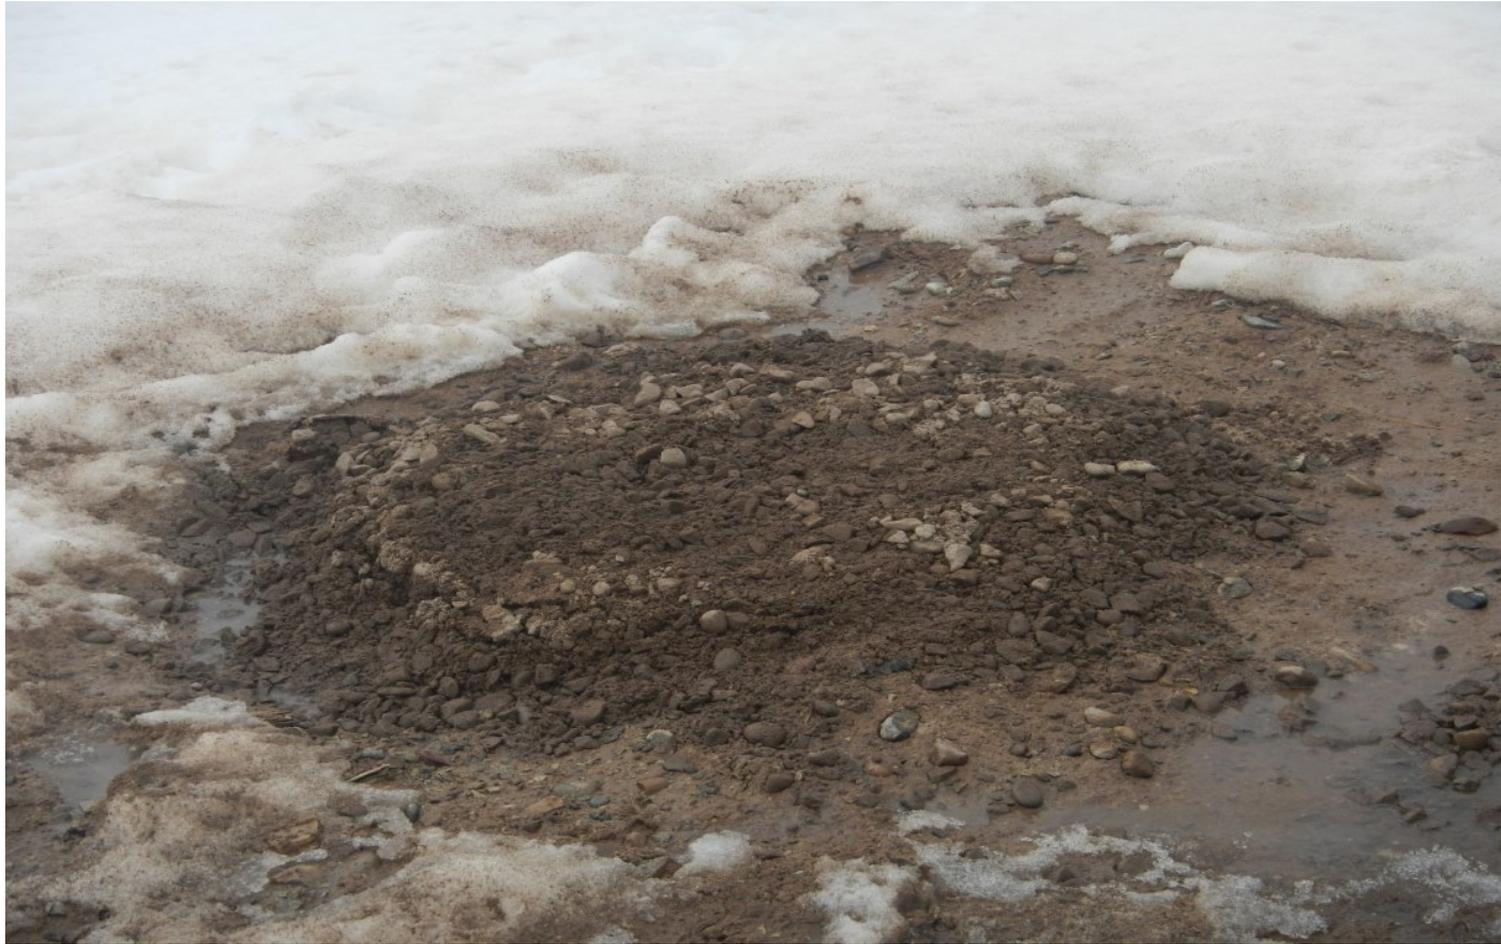
Photo#5:

Close up of area where Risers/Associated Facilities have been removed.
