**Inspection Photos**  
**Location Name: Rollie J Vincent A 1**  
**API: 05-123-12556**

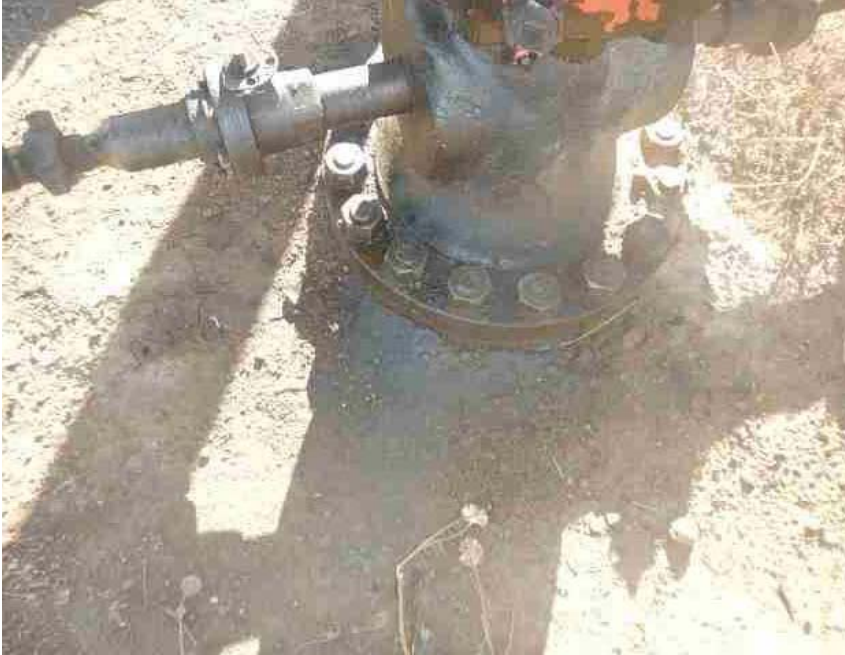
**Photo 1: Stained soil at wellhead.**

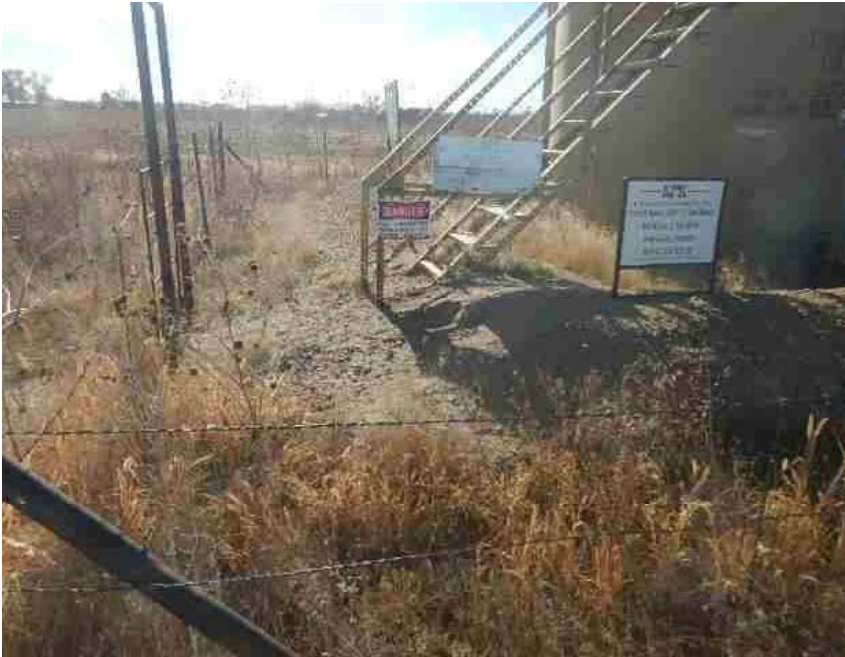
**Photo 2: Weeds controlled at tank battery, looking S**

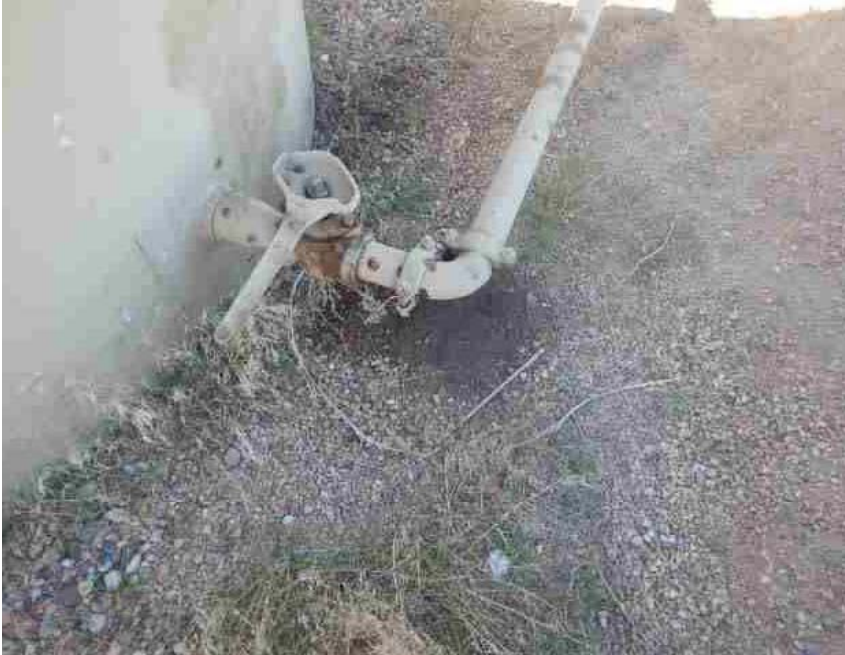
**Photo 3: Stained soil at loadout, E tank**

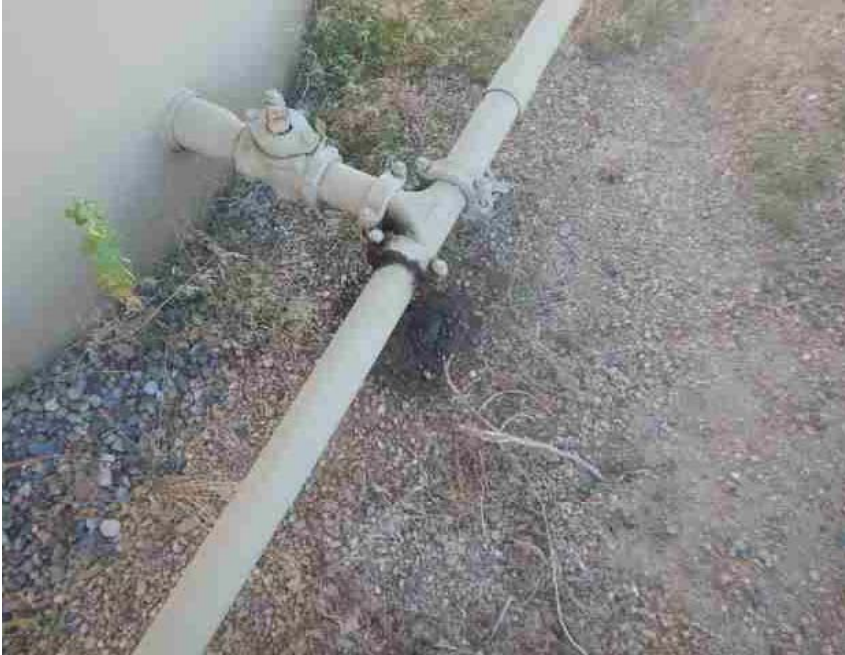
**Photo 4: Stained soil at loadout, W tank**

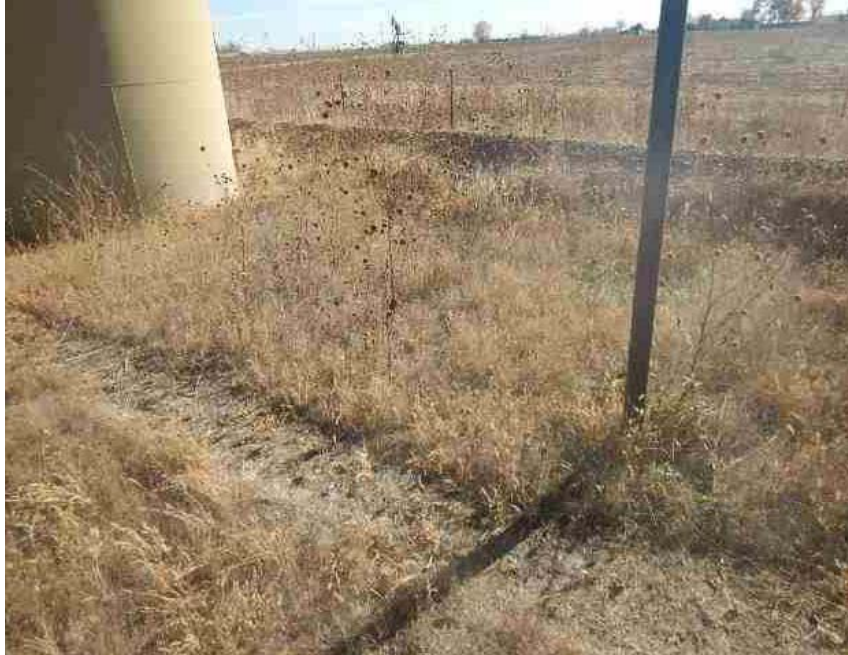
**Photo 5: Weeds controlled at tank battery, looking S**

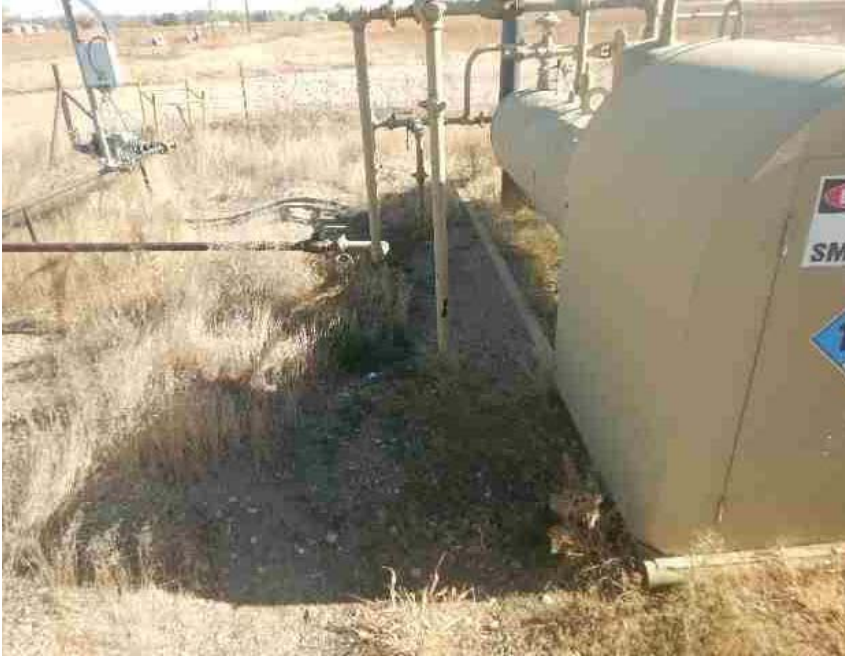
**Photo 6: Weeds controlled at separator**

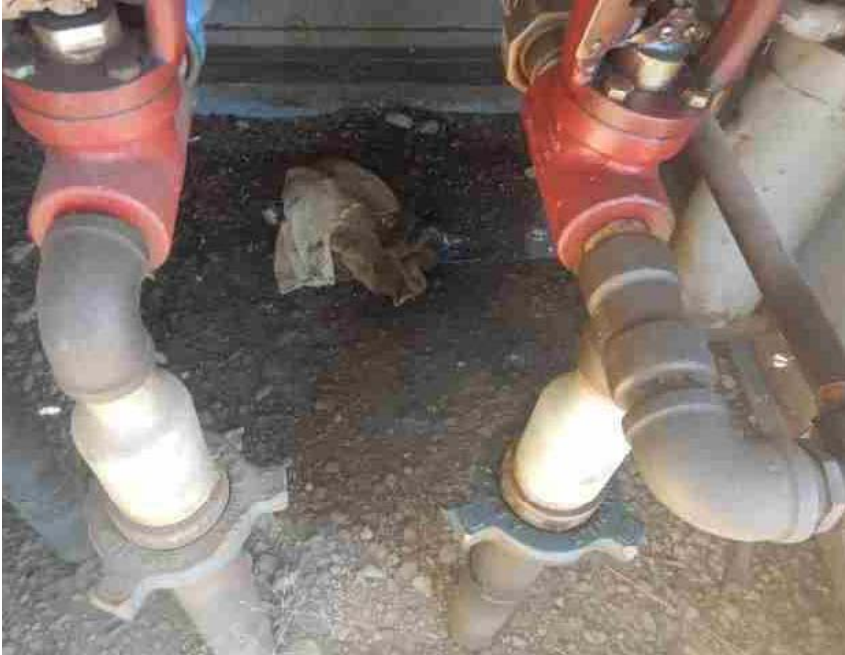
**Photo 7: Stained soil in separator house**

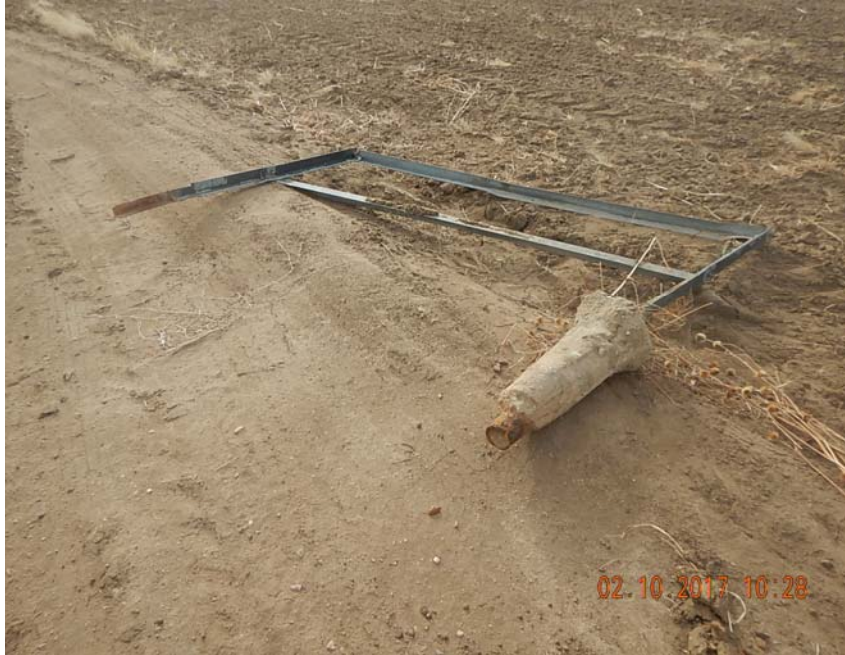
**Photo 8: Unused angle iron fencing**

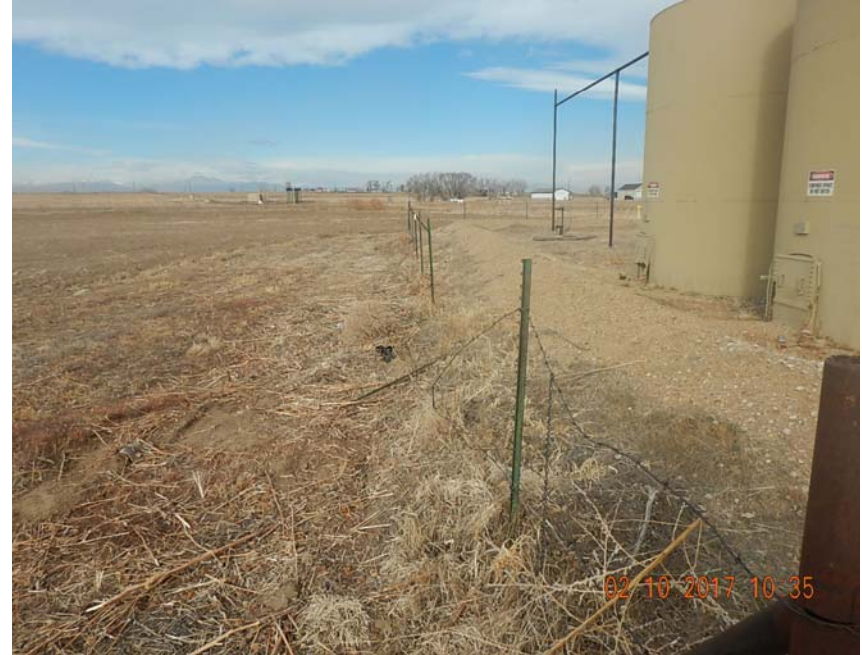
**Photo 9: Tank battery fence in disrepair**
