Inspection Photos
Location Name: Elkhorn Company B-6
API: 05-123-09488

COLORADO
Oil & Gas Conservation
Commission
Department of Natural Resources

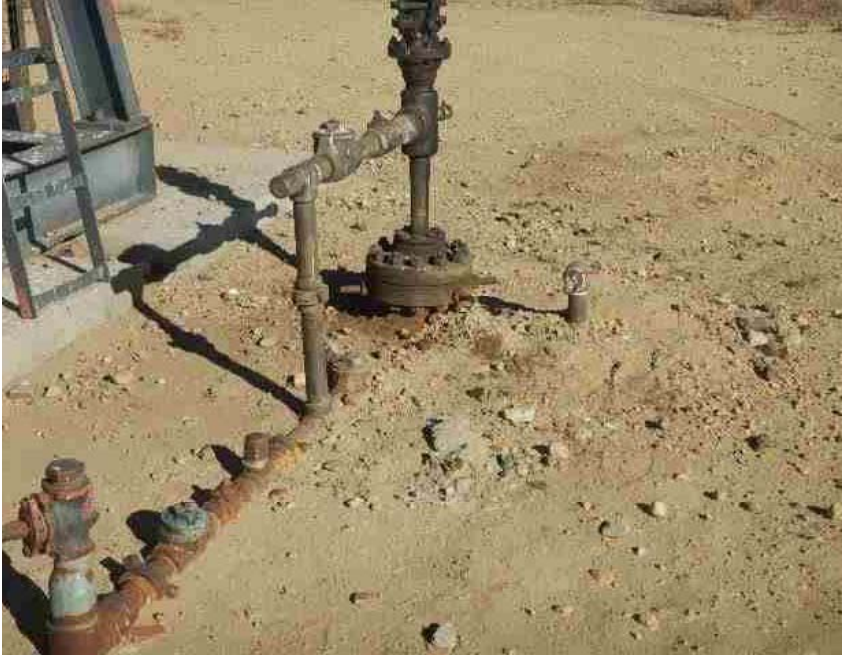
Photo from prior inspection for comparison purposes

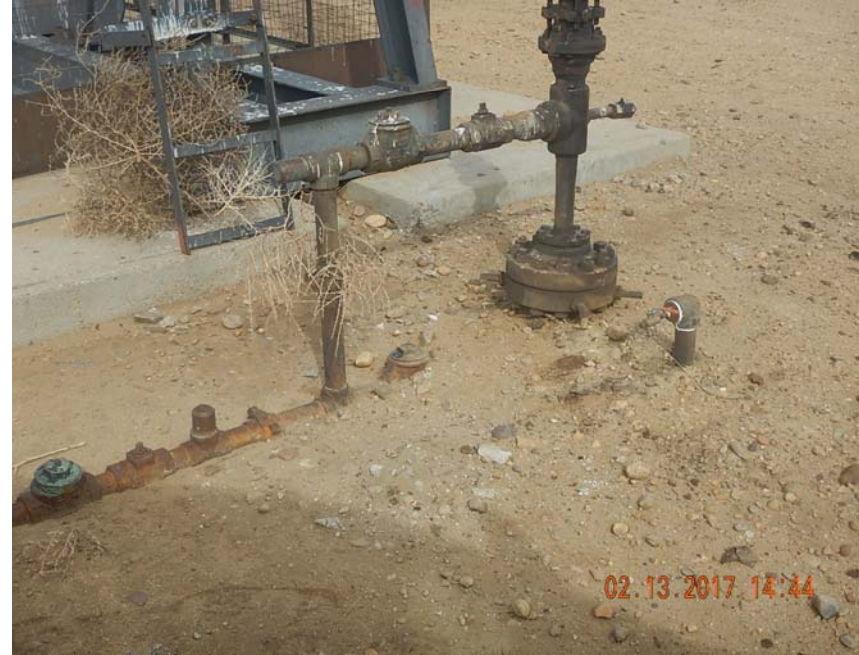
Photo 1: Stained soil removed at wellhead

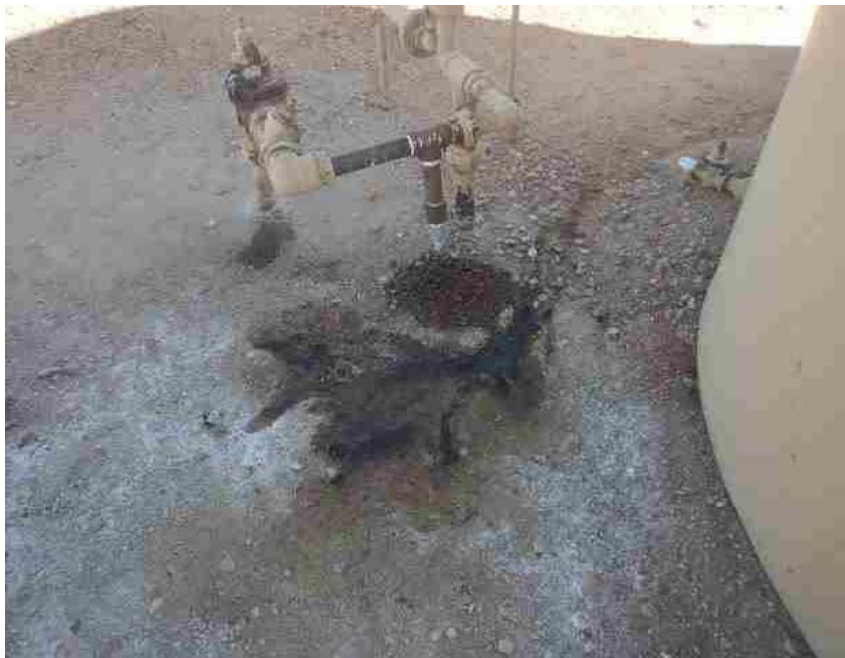
Photo from prior inspection for comparison purposes

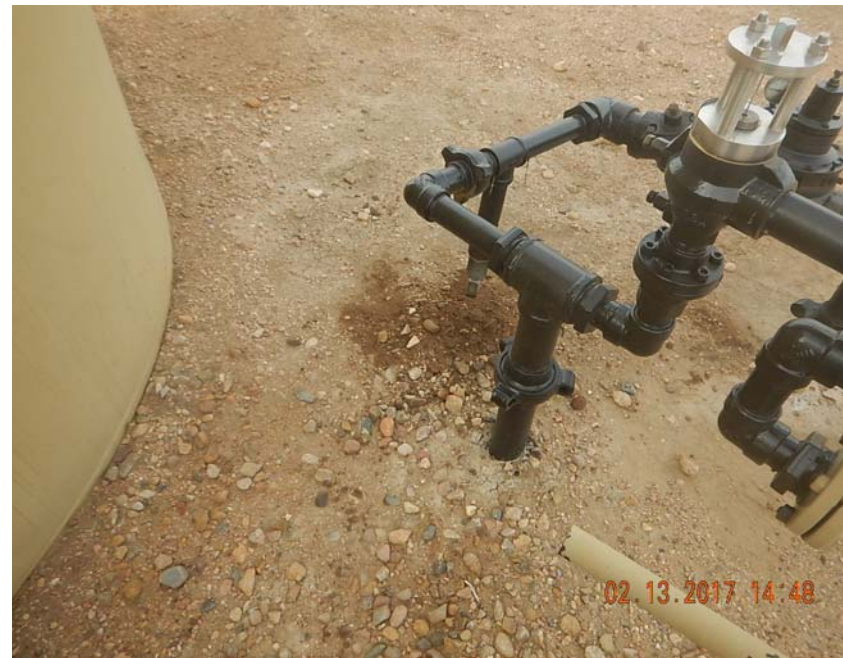
Photo 2: Stained soil around tank

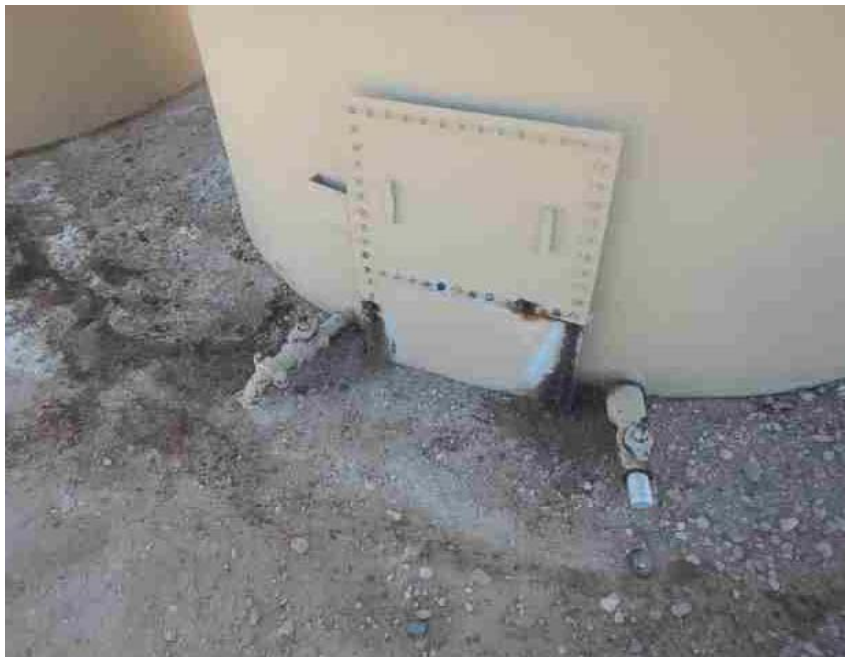
Photo from prior inspection for comparison purposes

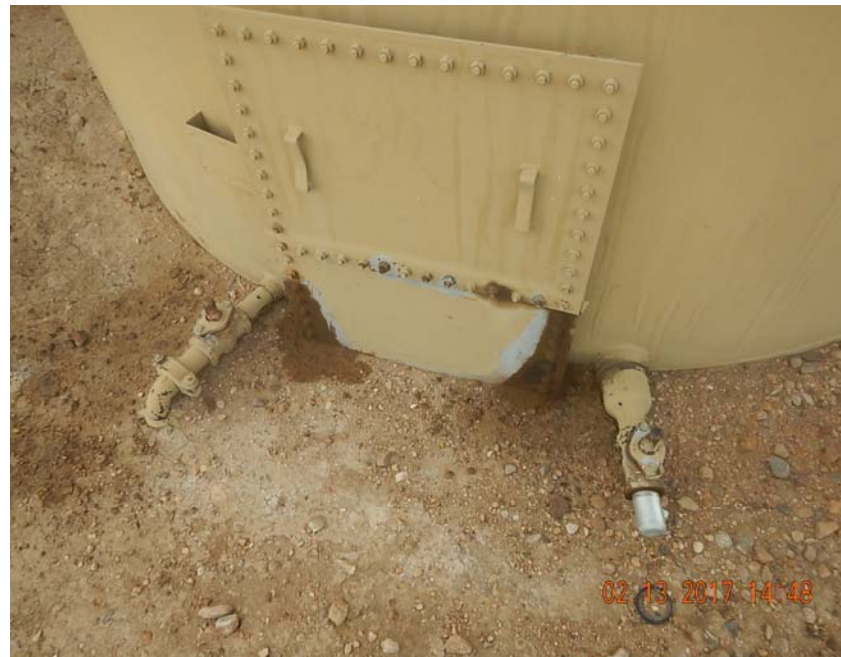
Photo 3: Stained soil at hatch

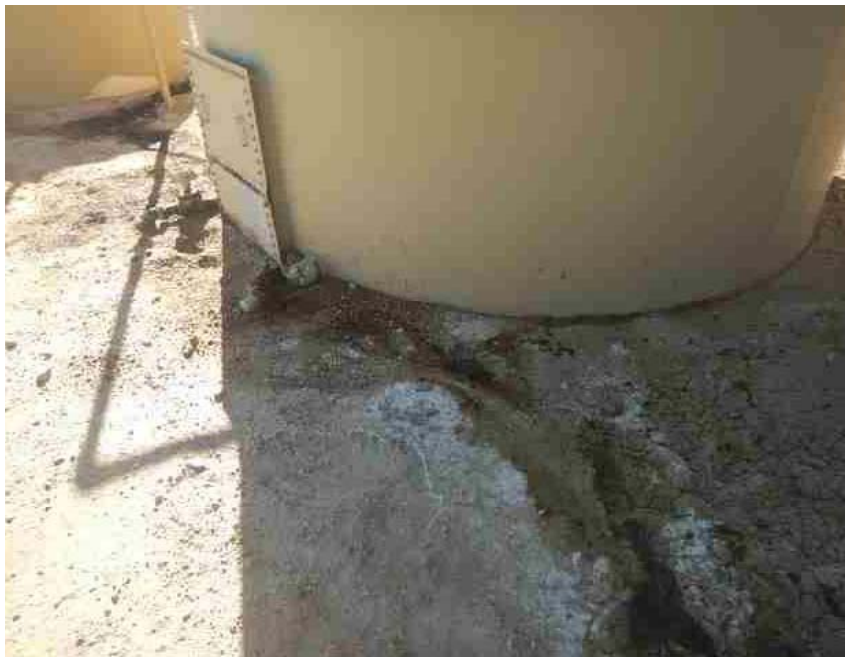
Photo from prior inspection for comparison purposes

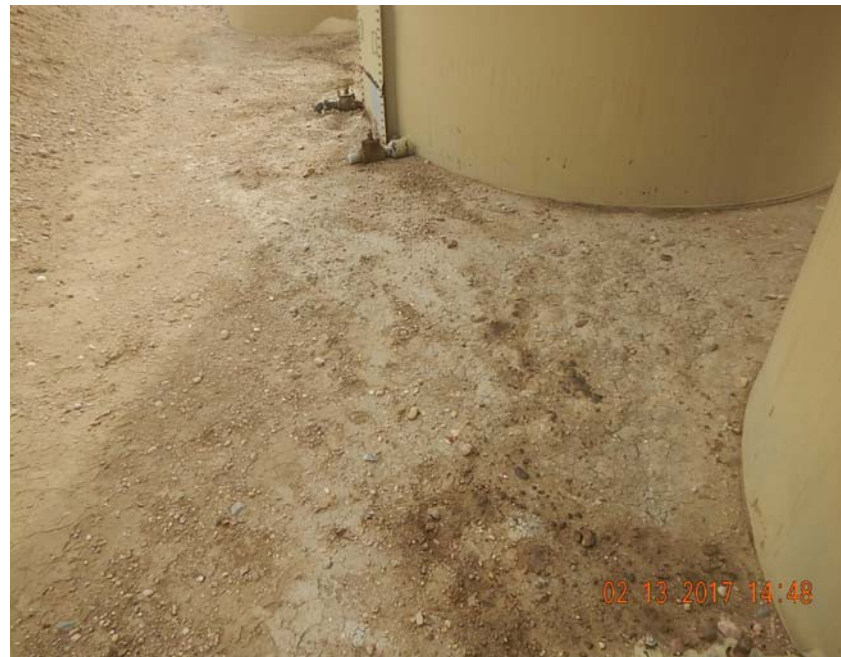
Photo 4: stained soil between tanks

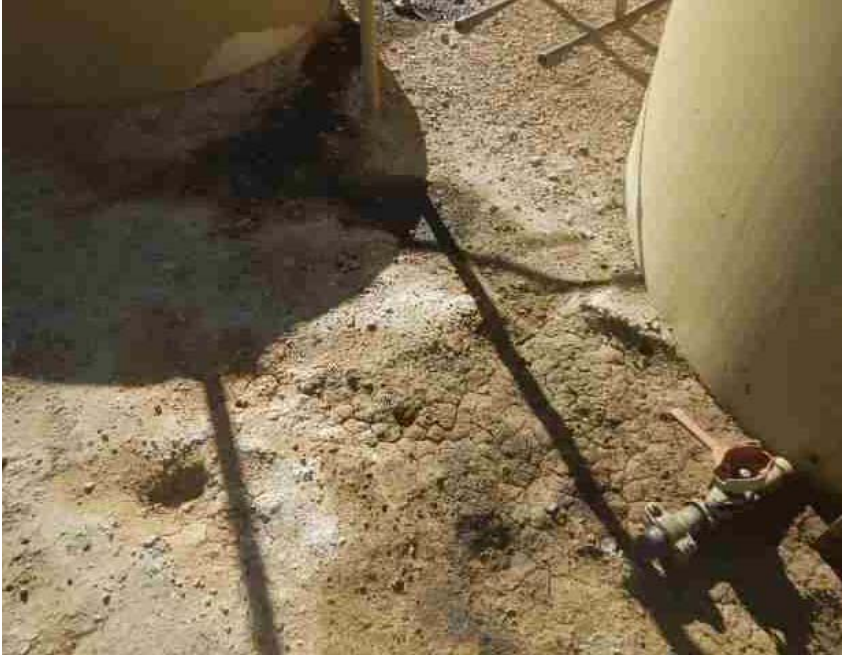
Photo from prior inspection for comparison purposes

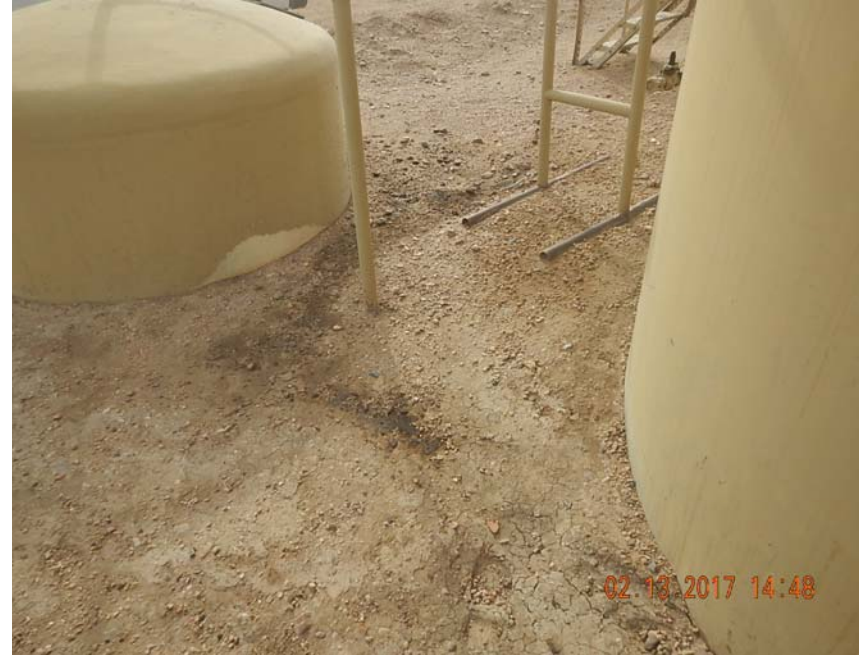
Photo 5: Stained soil at produced water tank

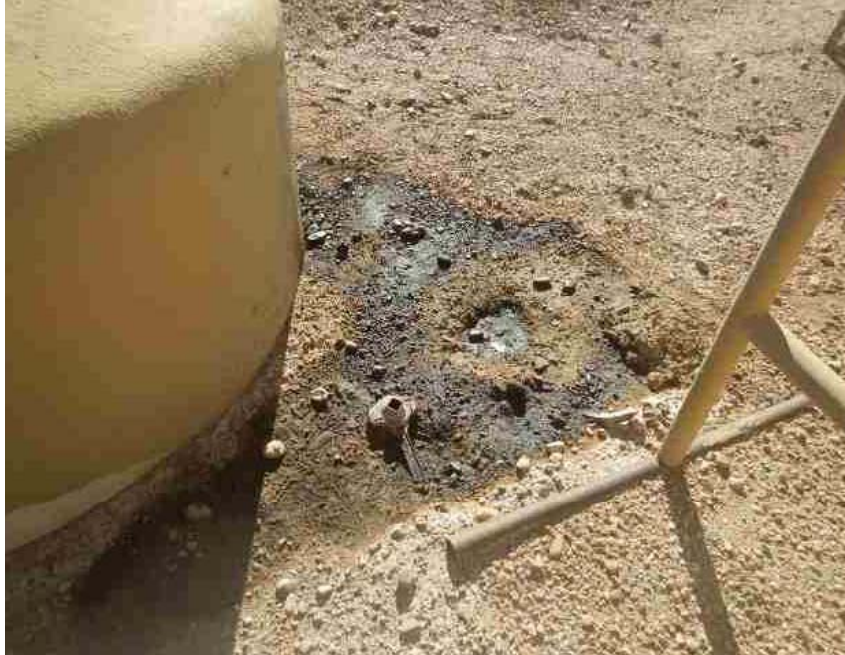
Photo from prior inspection for comparison purposes

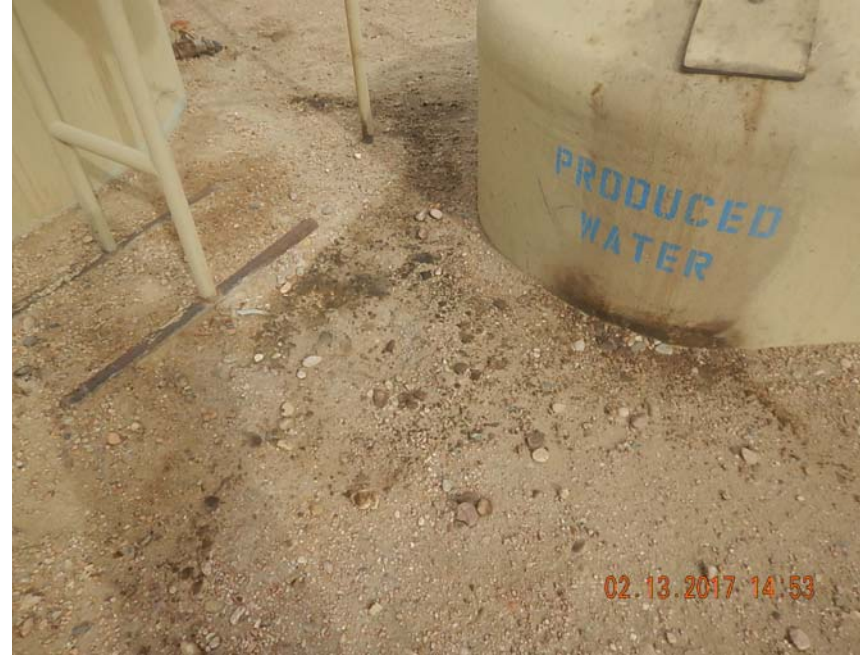
Photo 6: Stained soil at produced water tank

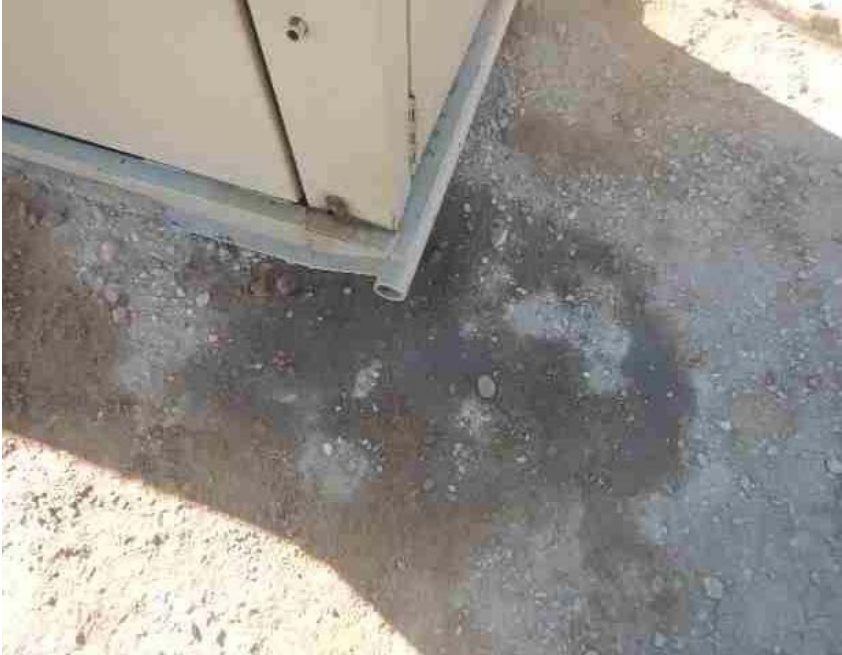
Photo from prior inspection for comparison purposes

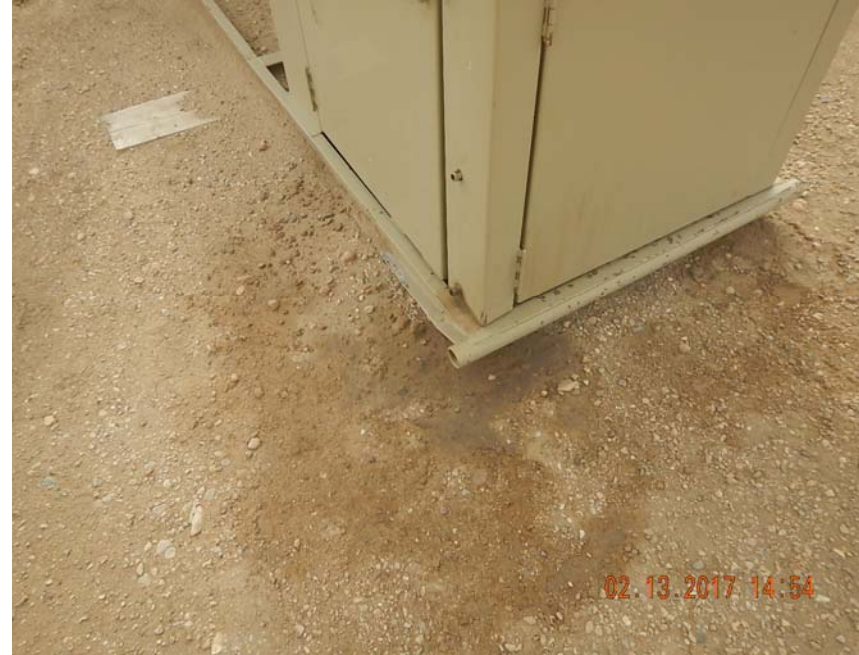
Photo 7: Stained soil at NW corner of separator

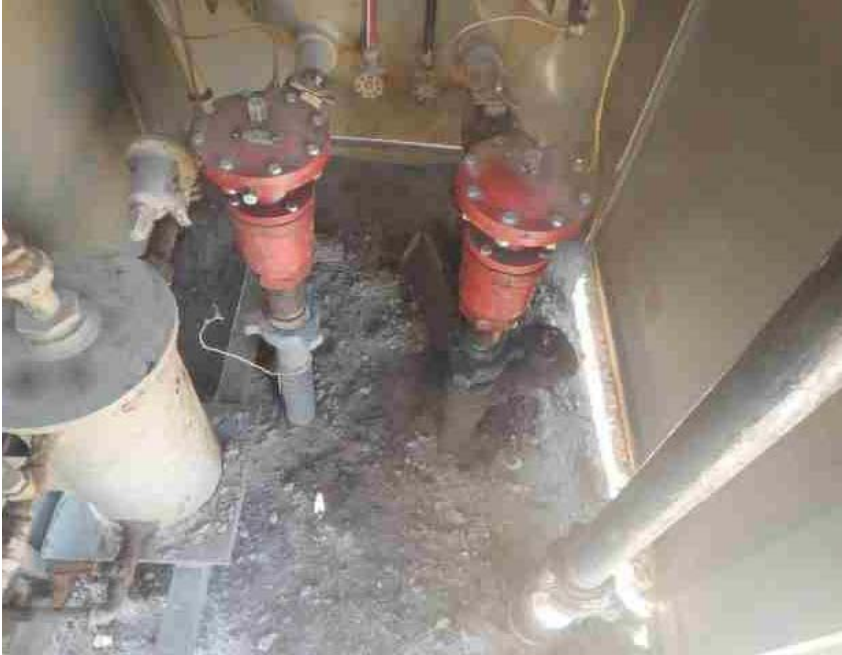
Photo from prior inspection for comparison purposes

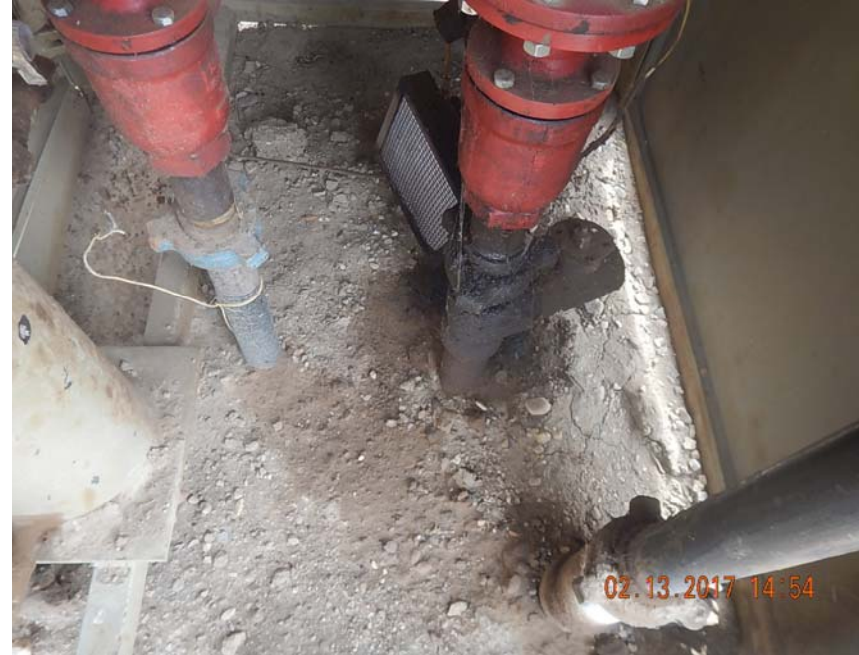
Photo 8: Stained soil in separator house

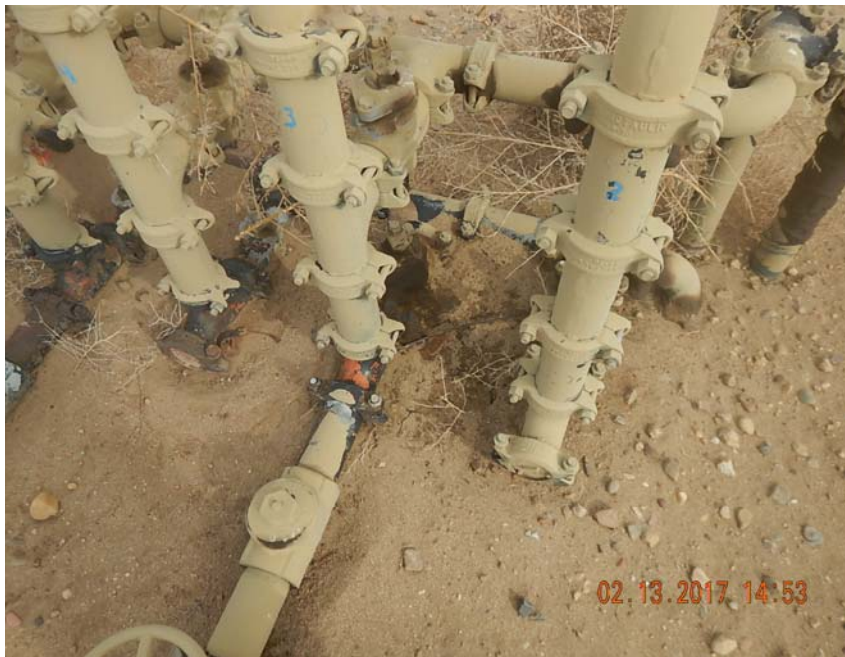
Photo 9: Stained soil at manifold
