# Reclamation Inspection

Operator: Davis, LLC\* Edwards Mike #22755

Location ID: 419744

Inspection Doc. Number: 682501649

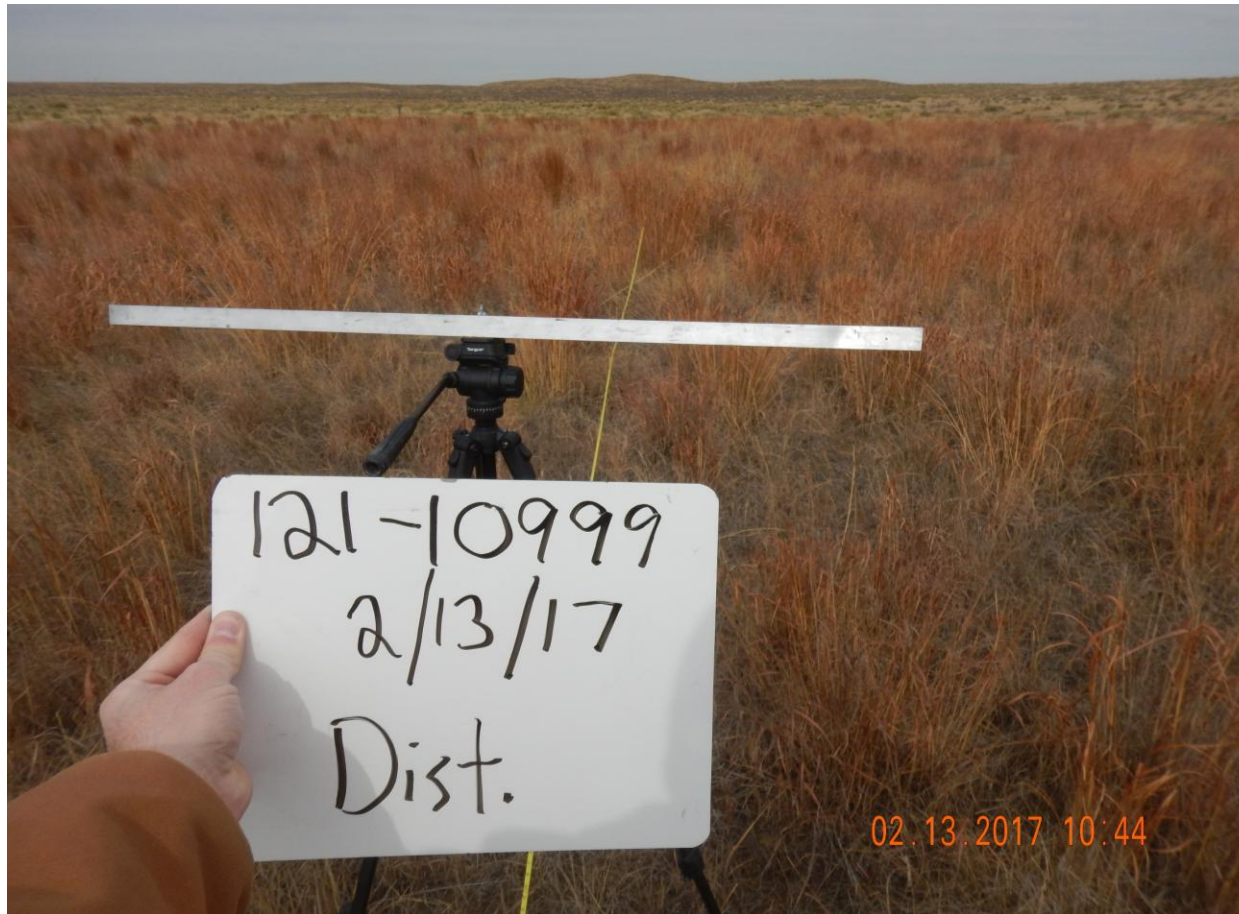
**Figure 1:** Photo taken from location. Photo shows starting point for the disturbance area transect, facing northwest. Photo shows vegetation over the reclamation area.

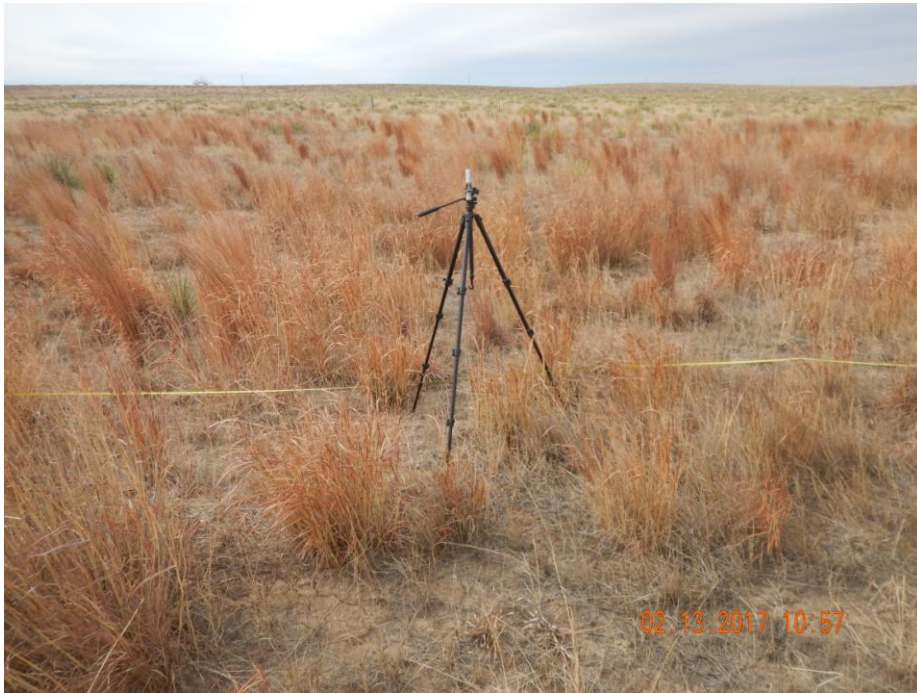
**Figure 2:** Photo taken from the 50<sup>th</sup> point of the disturbance area transect, facing southwest.

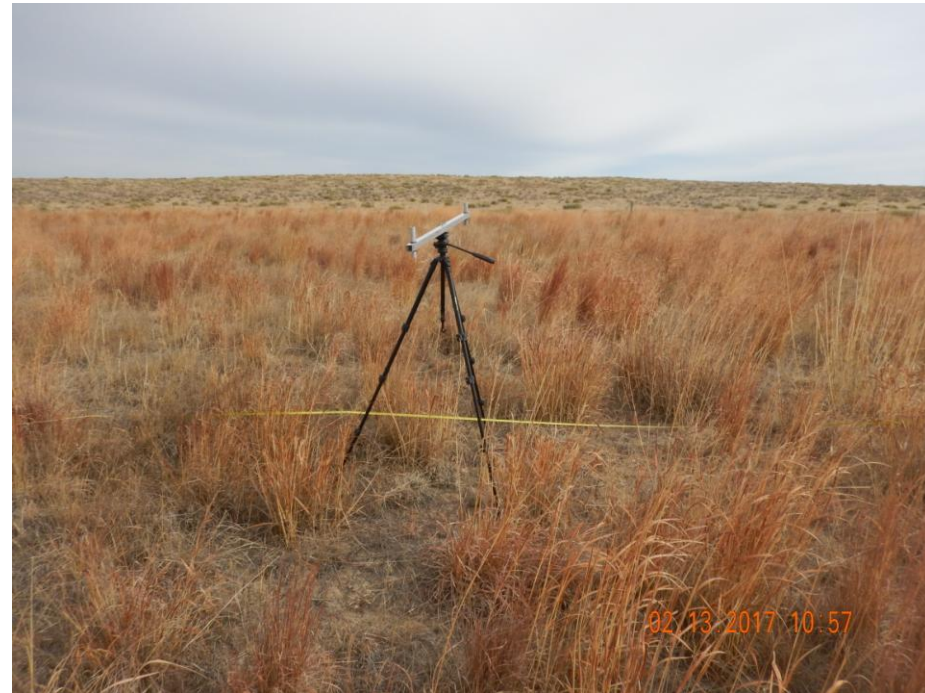
**Figure 3:** Photo taken from the 50<sup>th</sup> point of the disturbance area transect, facing southwest.

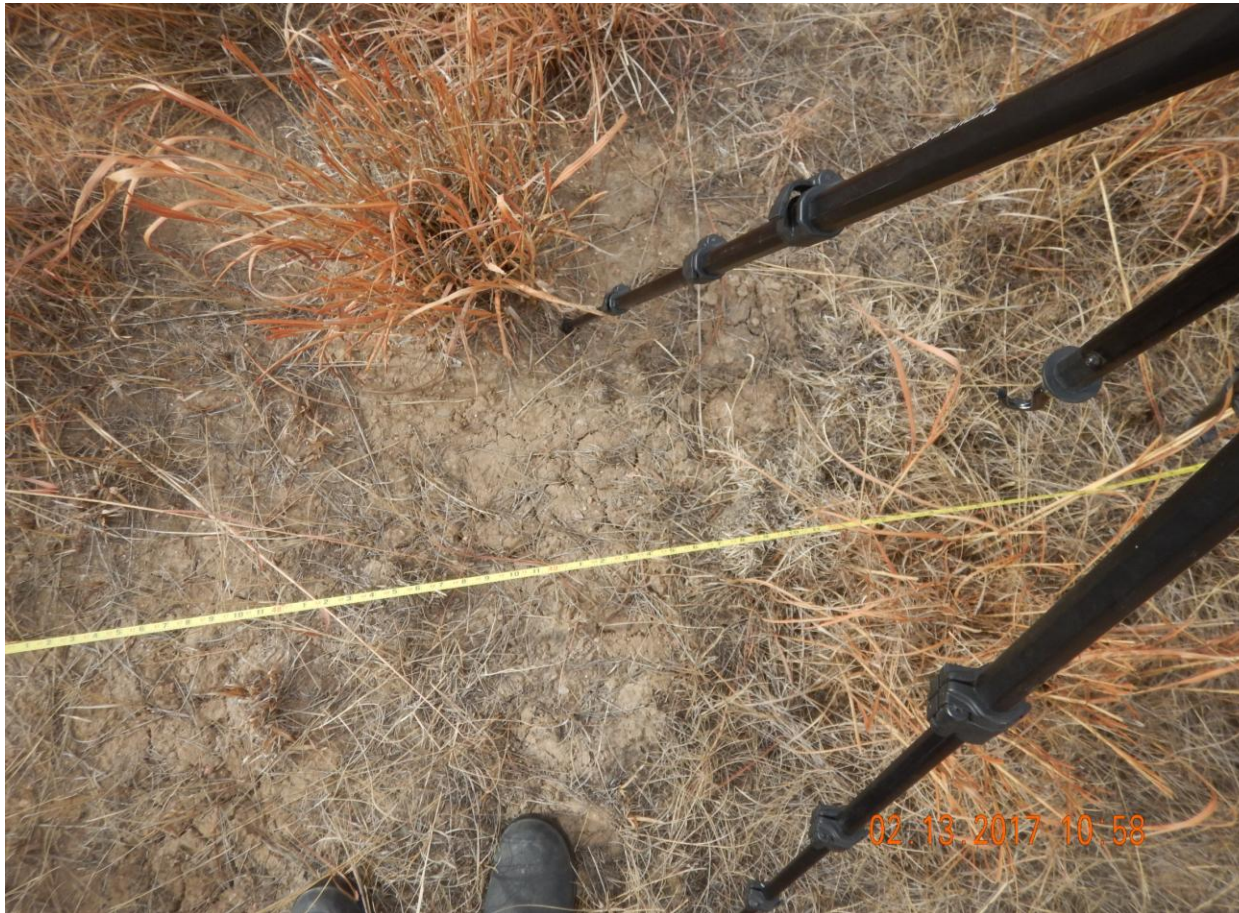
**Figure 4:** Photo taken from the 50<sup>th</sup> point of the disturbance transect. Photo shows vegetative cover at the 50<sup>th</sup> point.

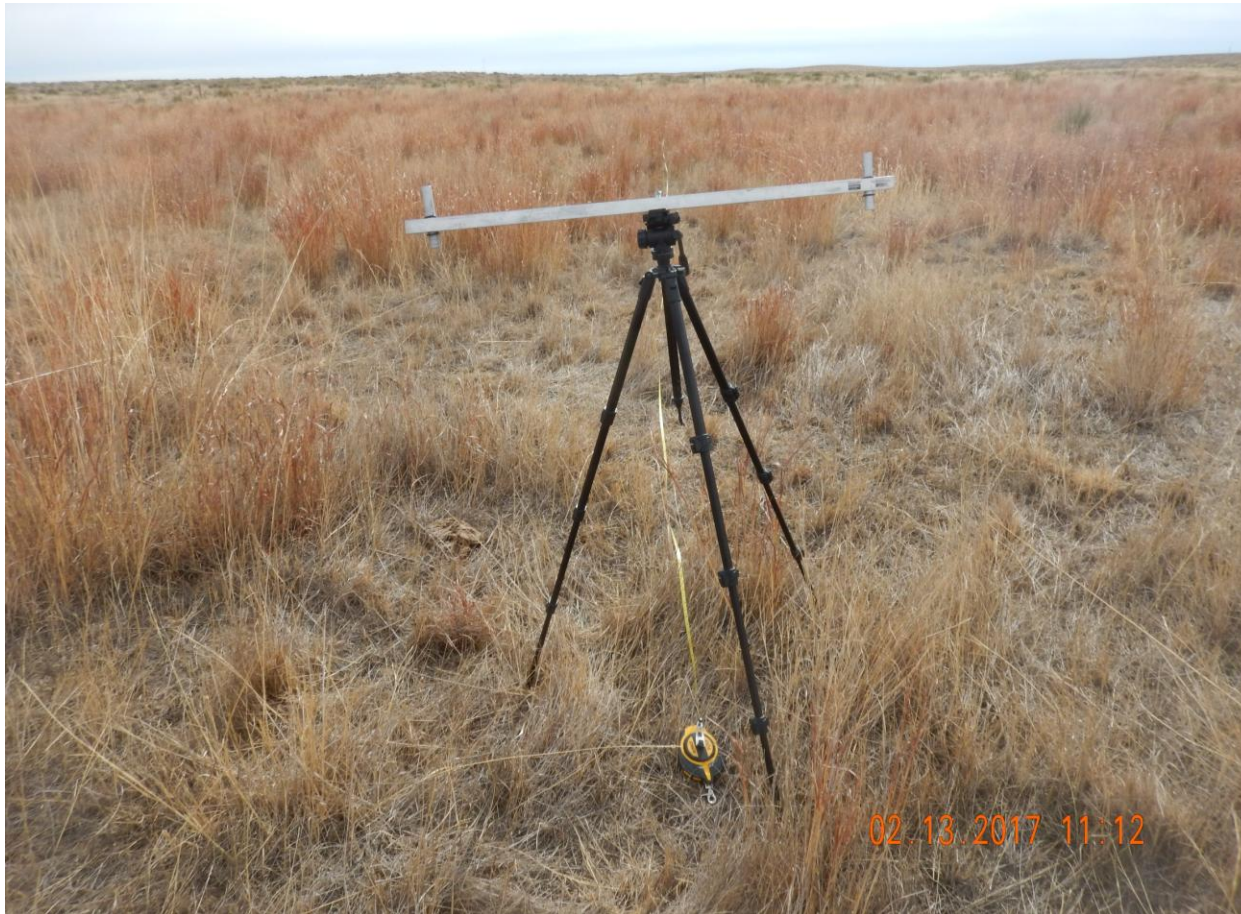
**Figure 5:** Photo taken from the end point of the disturbance transect, facing southeast. Photo shows vegetative cover at the 50<sup>th</sup> point. Photo shows vegetation over the reclamation area.

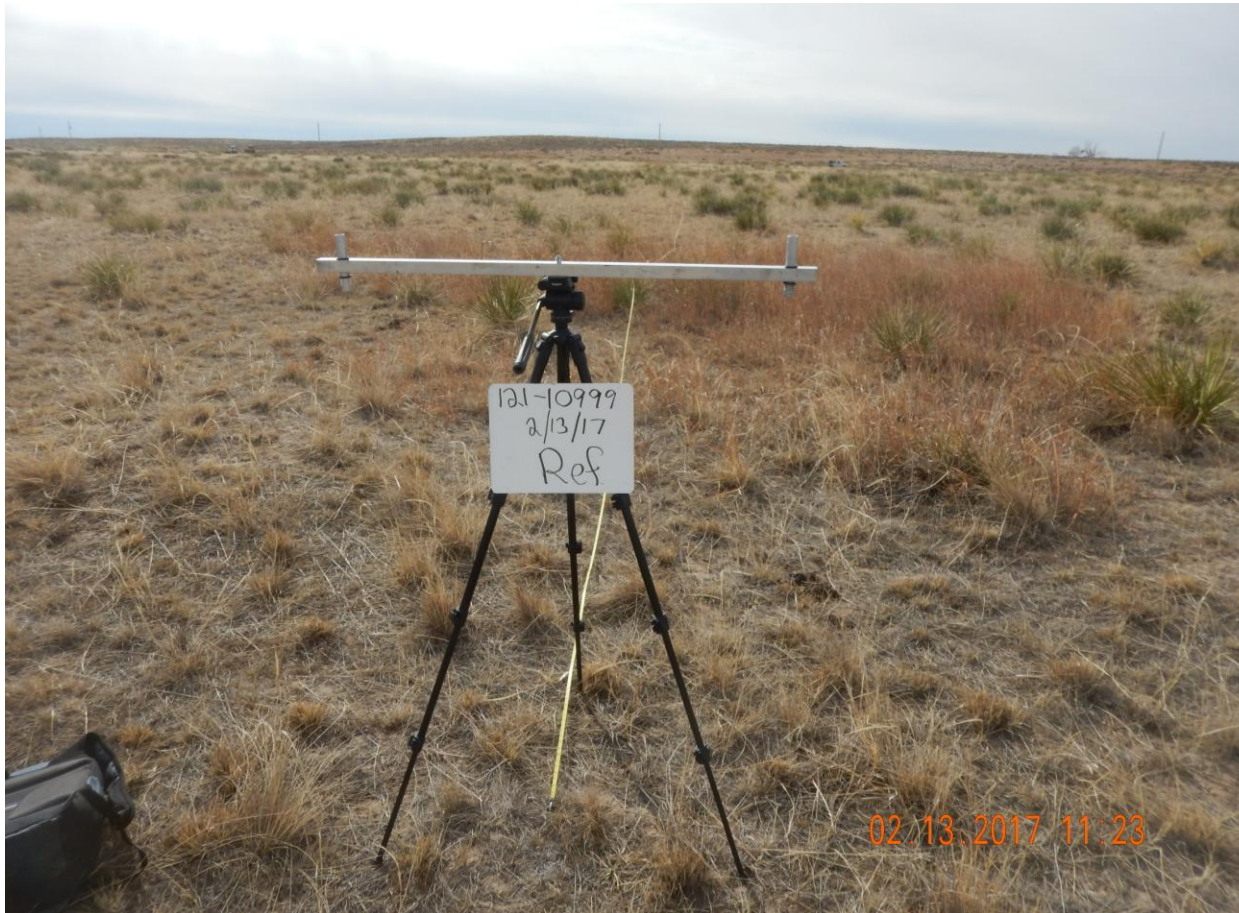
**Figure 6:** Photo of the starting point of the reference transect, facing south. Photo shows vegetation over the reference area.

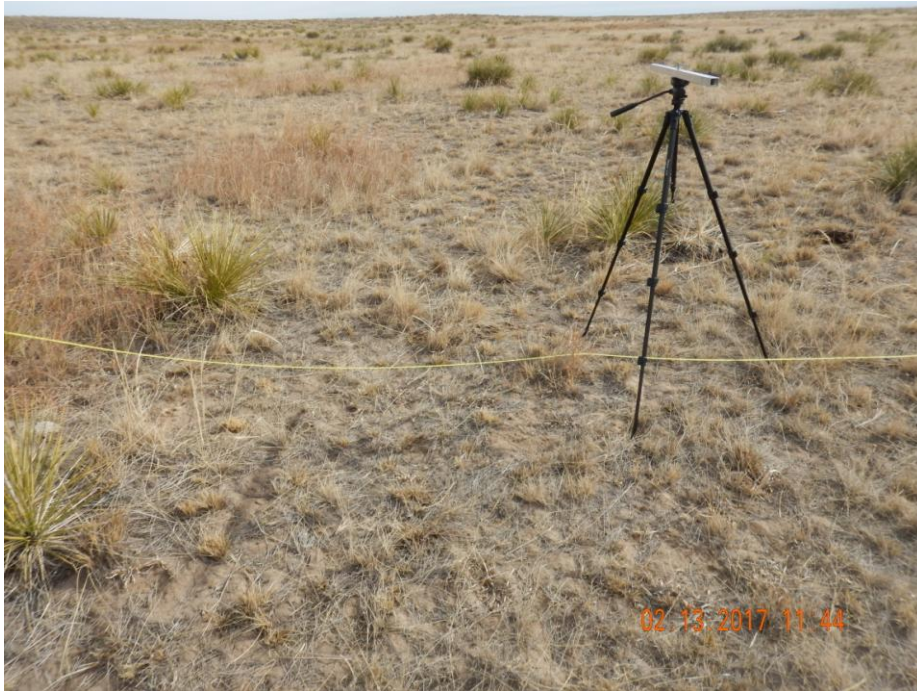
**Figure 7:** Photo taken from the 50<sup>th</sup> point of the reference area transect, facing east.

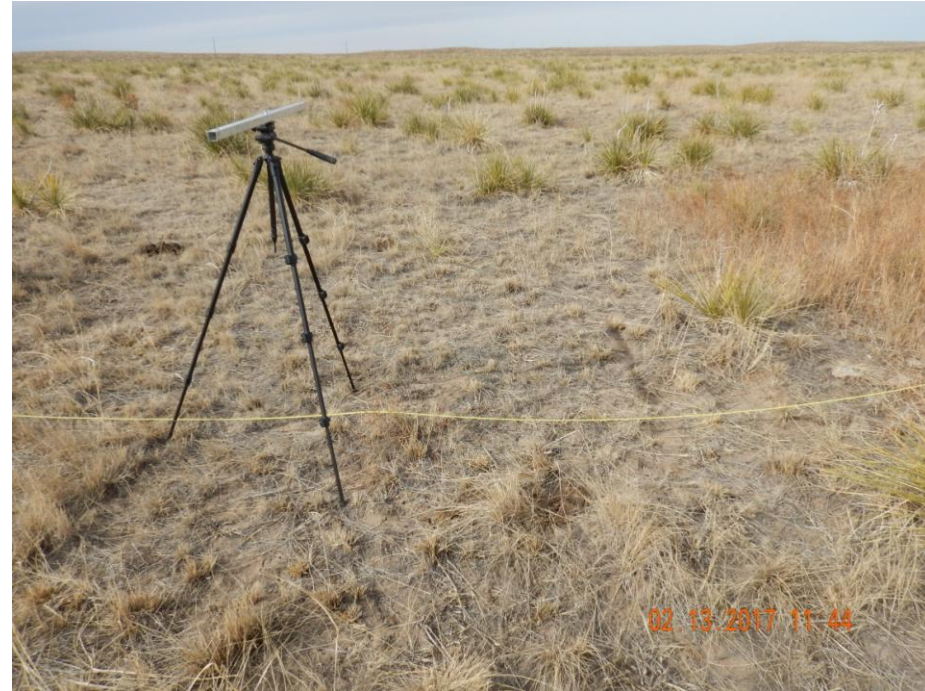
**Figure 8** Photo taken from the 50<sup>th</sup> point of the reference area transect, facing west.

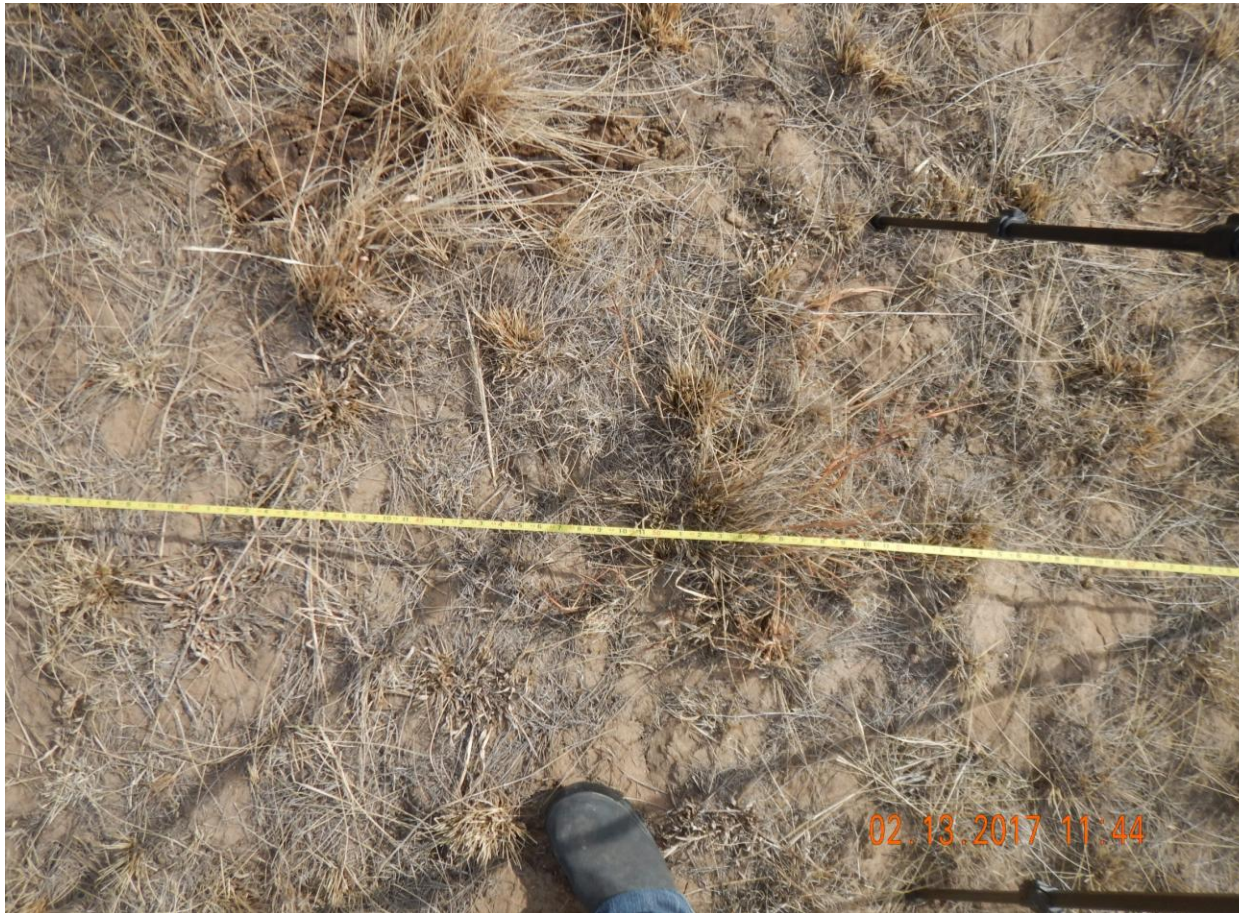
**Figure 9:** Photo taken from the 50<sup>th</sup> point of the reference transect. Photo shows vegetative cover at the 50<sup>th</sup> point.

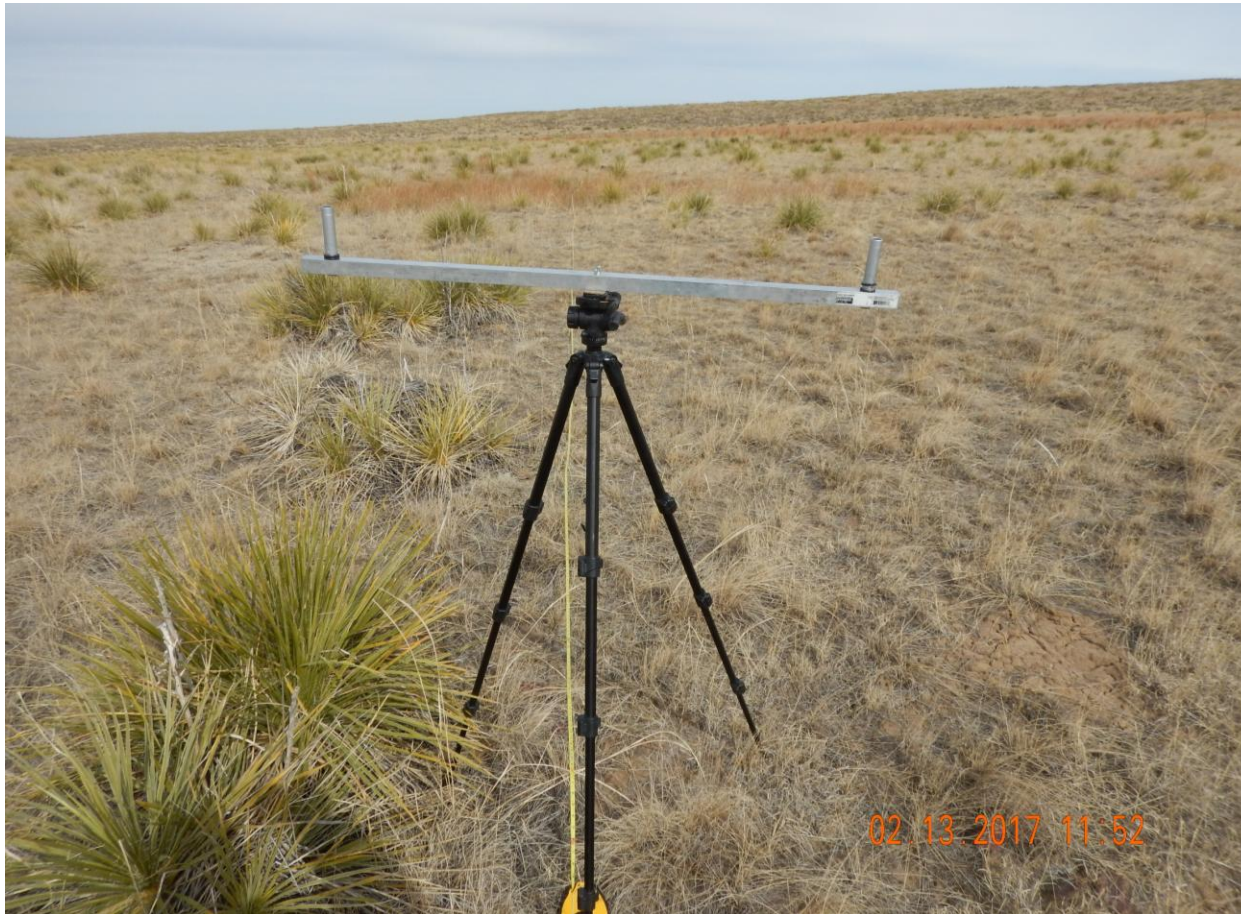
**Figure 10:** Photo taken from the end point of the reference transect, facing north. Photo shows vegetative cover at the 50<sup>th</sup> point. Photo shows vegetation over the reclamation area.
