Inspection Photos
Location Name: Andrews 16-7
API: 05-123-14881

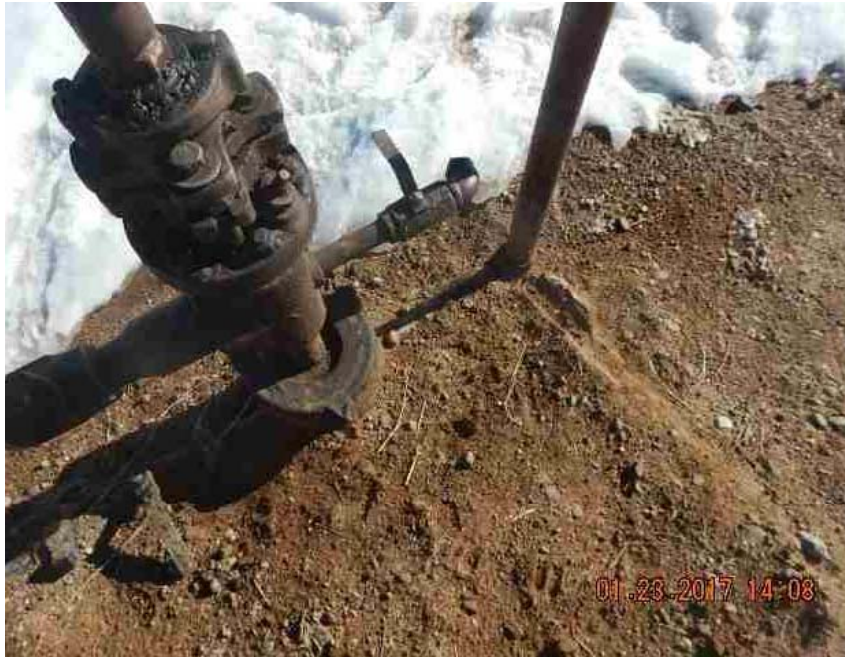
Photo from prior inspection for comparison purposes

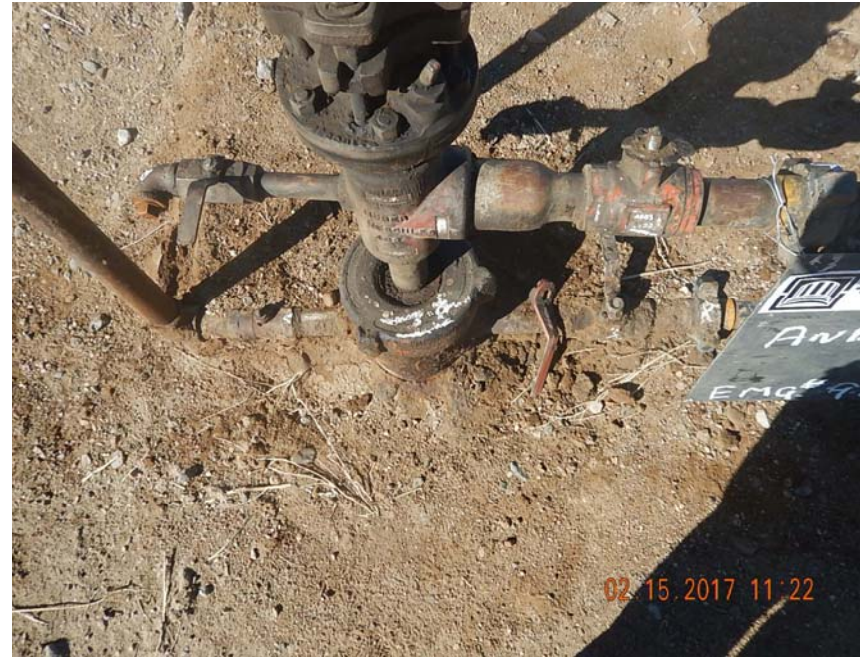
Photo 1: Stained soil at wellhead

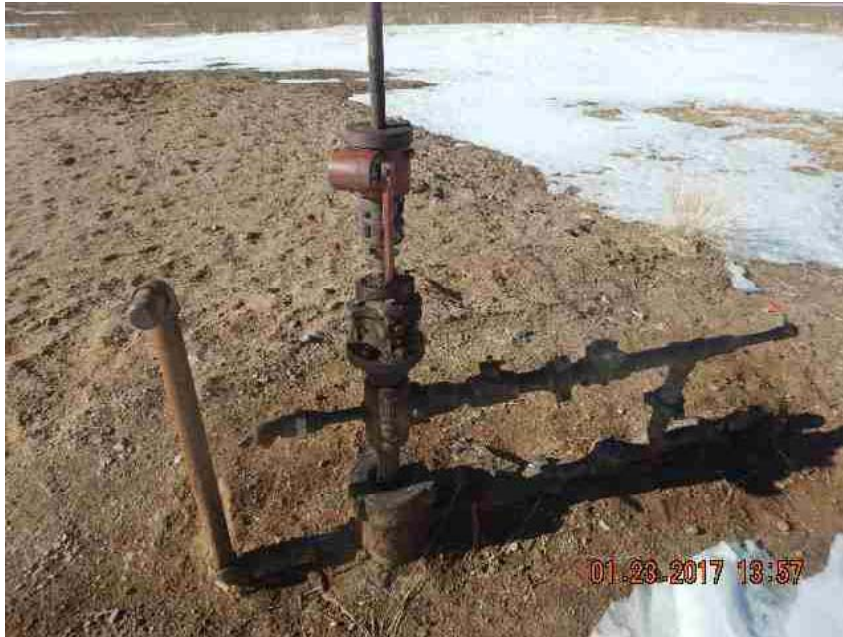
Photo from prior inspection for comparison purposes

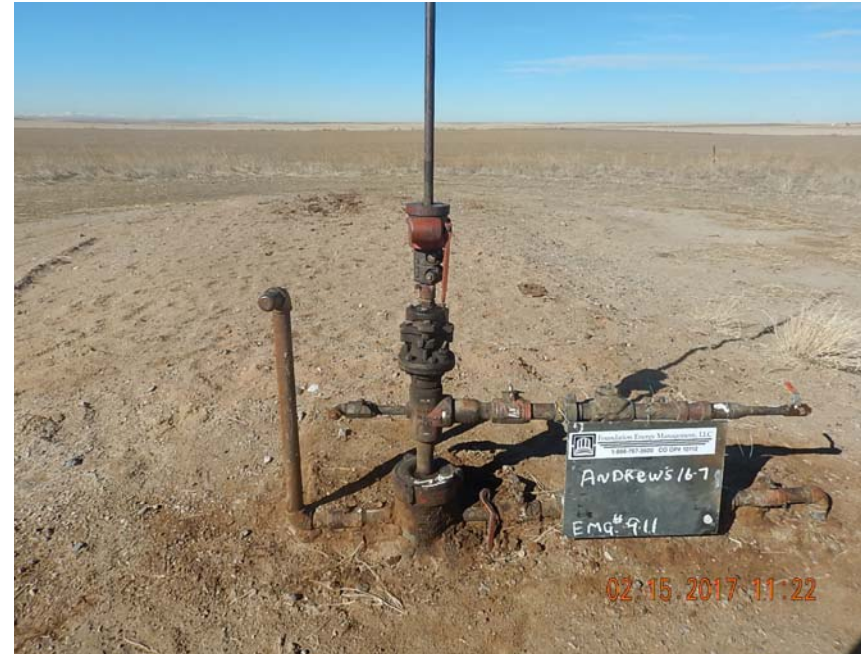
Photo 2: Sign put in at wellhead. Stained soil where pump jack used to be. Looking W.
