Inspection Photos
Location Name: Peters 1
API: 05-123-07170

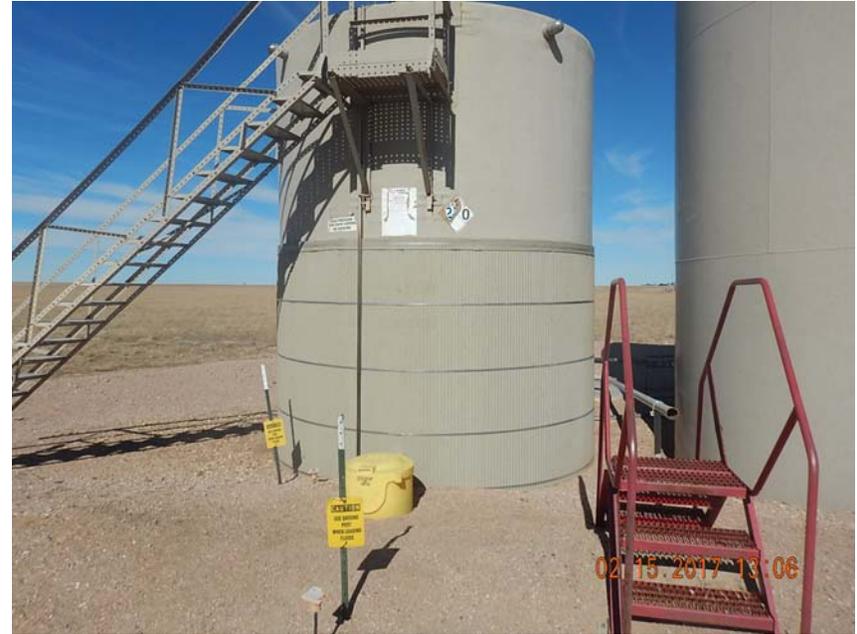
Photo 1: No contents, capacity on fiberglass tank

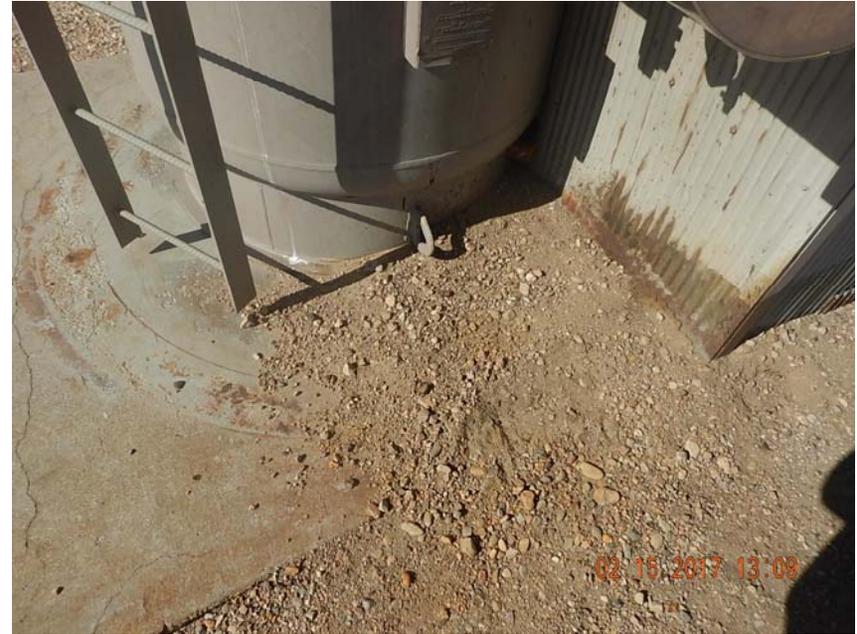
Photo 2: Stained soil from prior CA has been addressed.

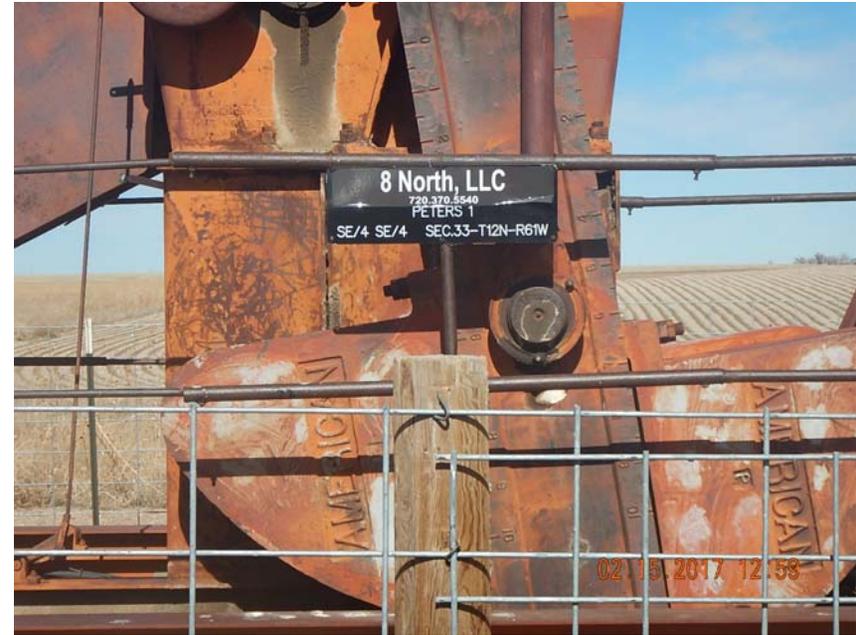
Photo 3: Operator signage has been updated per CA.

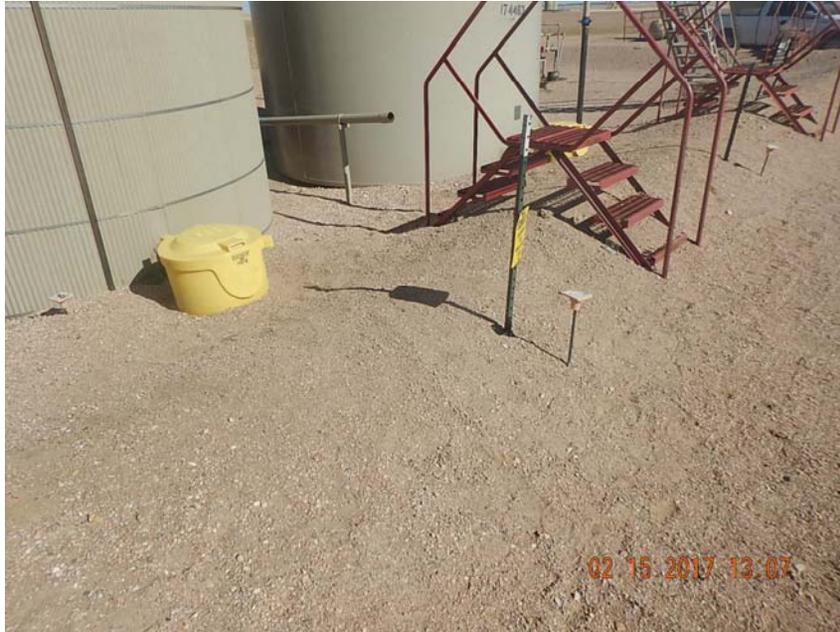
Photo 4: Low berms at loadout valve
