Construction and Stormwater Inspection

February 13 & 15, 2017

Operator: EXTRACTION OIL & GAS LLC - #10459

Location ID: 444315

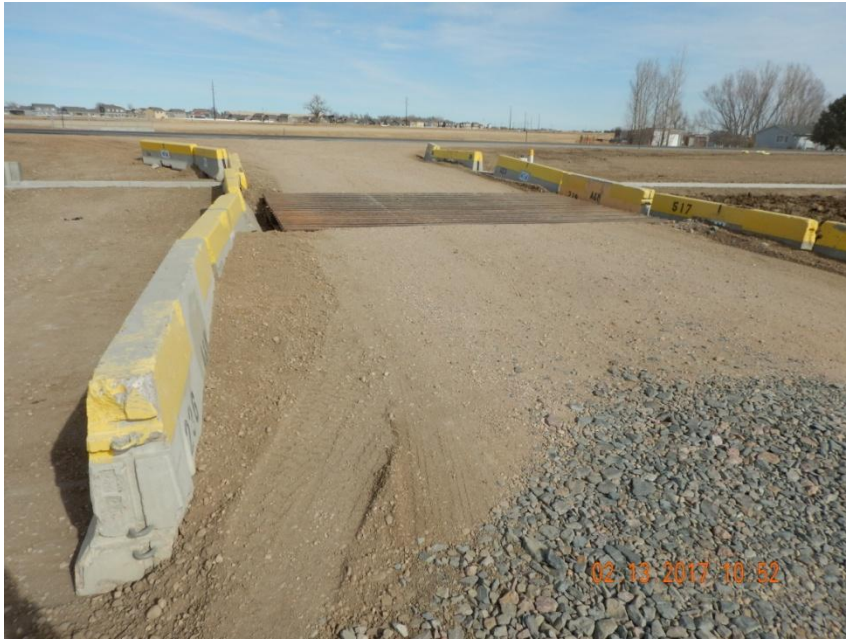
Photo 1. Photo taken from the entrance of location, facing North. Vehicle tracking pad installed and properly functioning. In addition, two (2) cattle guards have been installed.

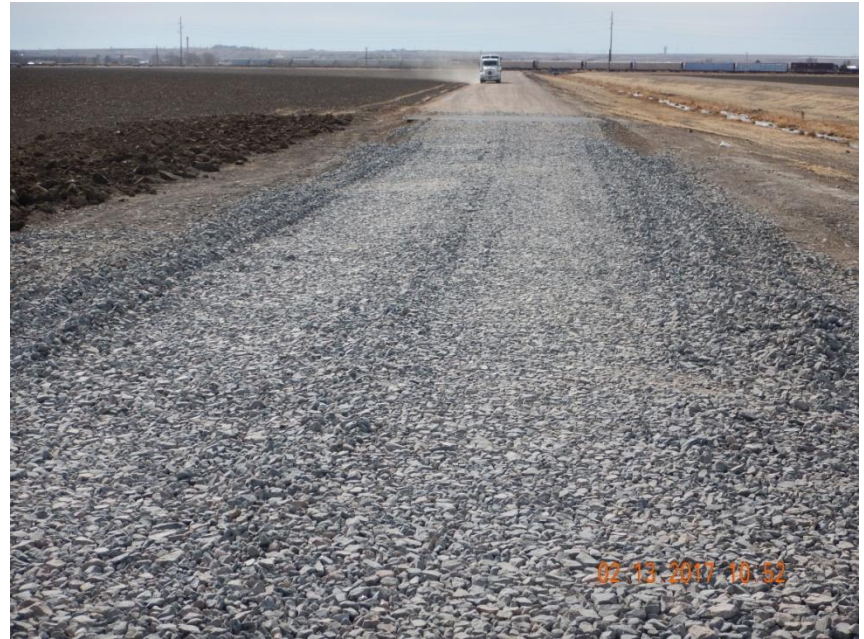
Photo 2. Photo taken from the entrance of location, facing South. Vehicle tracking pad installed and properly functioning. In addition, two (2) cattle guards have been installed.

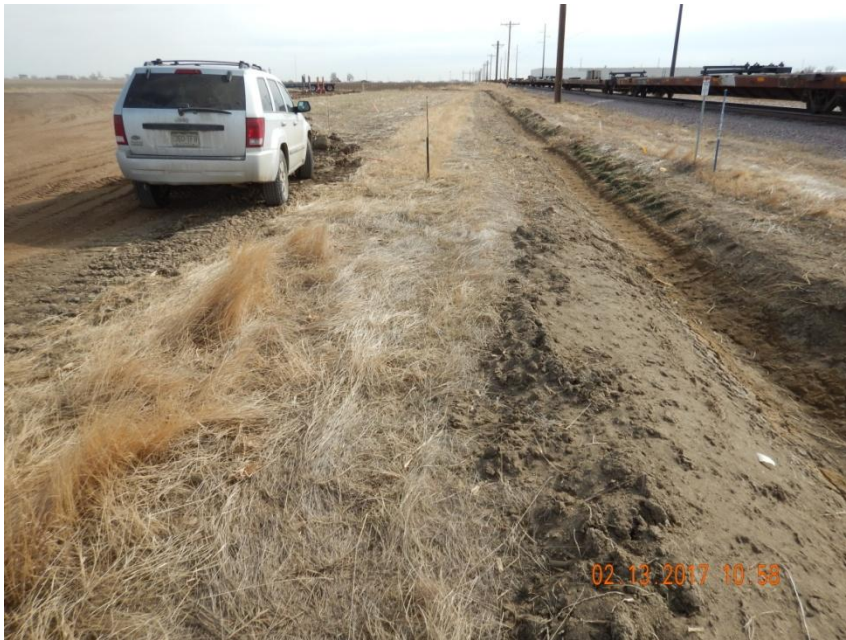
Photo 3. Photo taken from the southwest location, facing East. Vegetative buffer between disturbance area and pre-existing ditch used by the landowner.

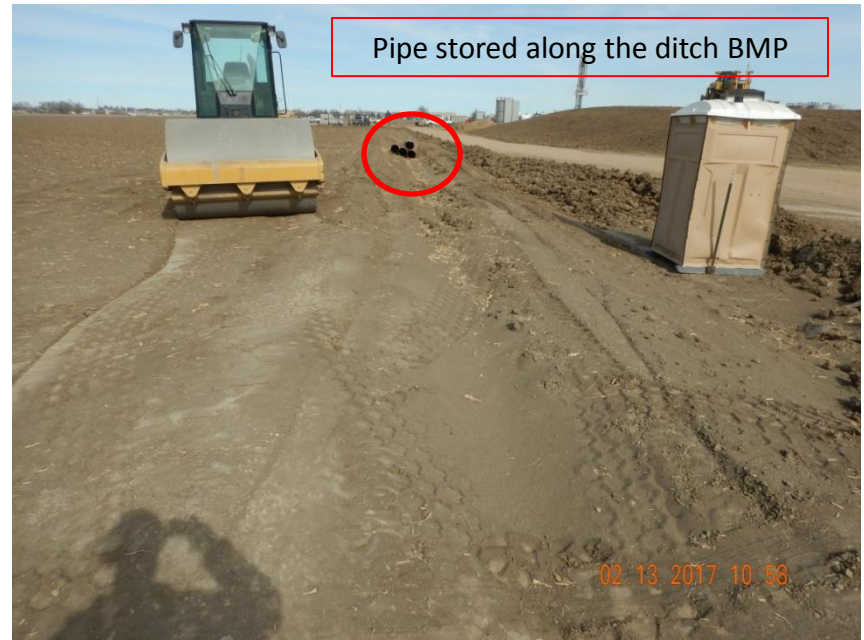
Photo 4. Photo taken from the southwest location, facing North. Ditch and berm BMP installed around the perimeter of location. Berm may need to be built to a sufficient height as the height appears minimal along portions of the BMP. Also, keep equipment and debris free of the BMP.

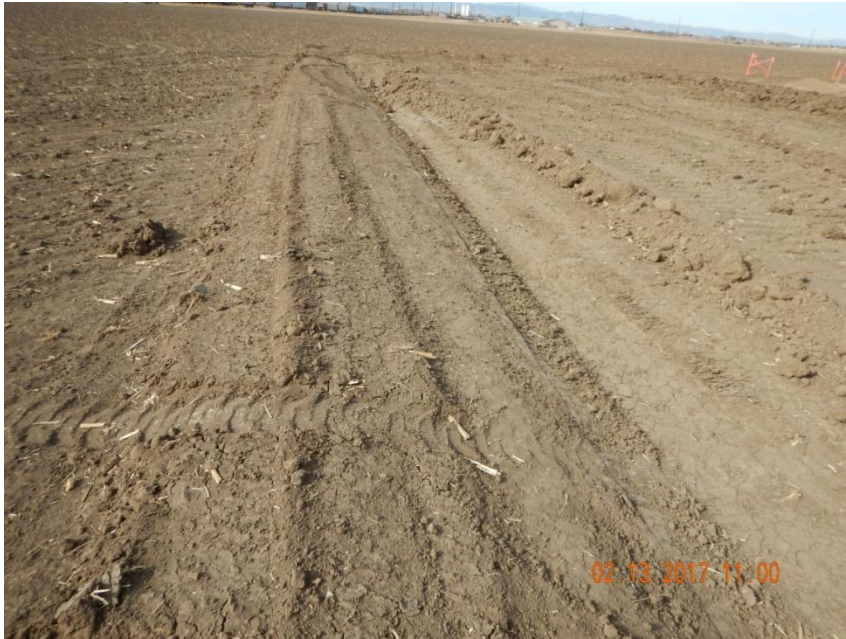
Photo 5. Photo taken from the western location, facing West. Ditch and berm BMP installed around the perimeter of location. Equipment traffic should stay off BMPs to ensure BMP is not damaged so BMP properly functions.

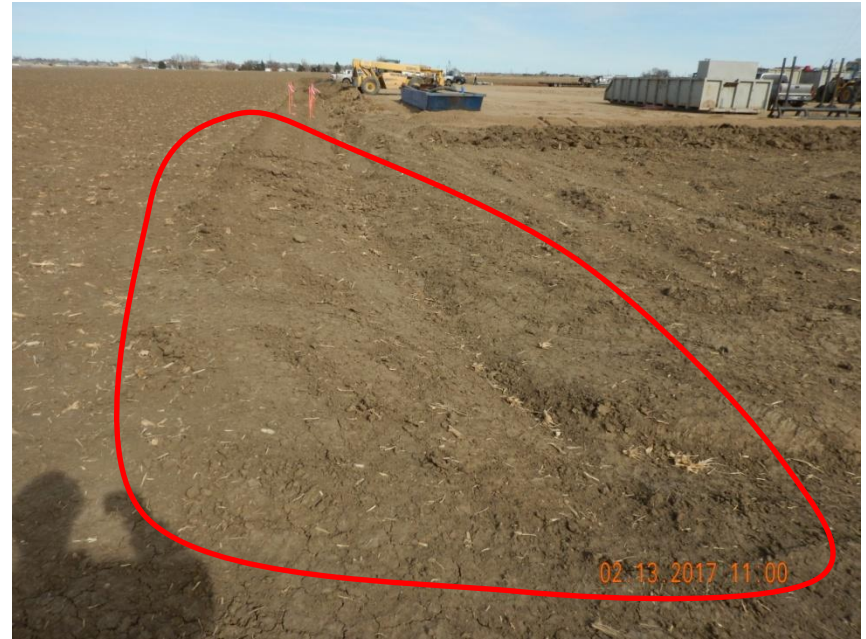
Photo 6. Photo taken from the western location, facing North. BMP may need to be re-installed because equipment traffic has damaged the BMP. Equipment traffic should stay off BMPs to ensure BMP is not damaged so BMP properly functions.

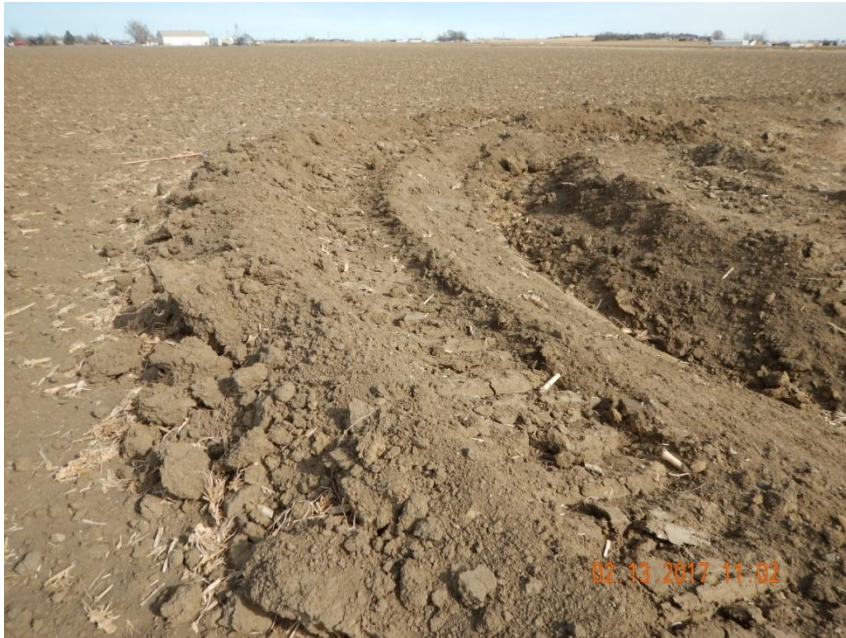
Photo 7. Photo taken from the northwest location, facing Northeast. Berm has not been compacted leaving excessive soil material unconsolidated.

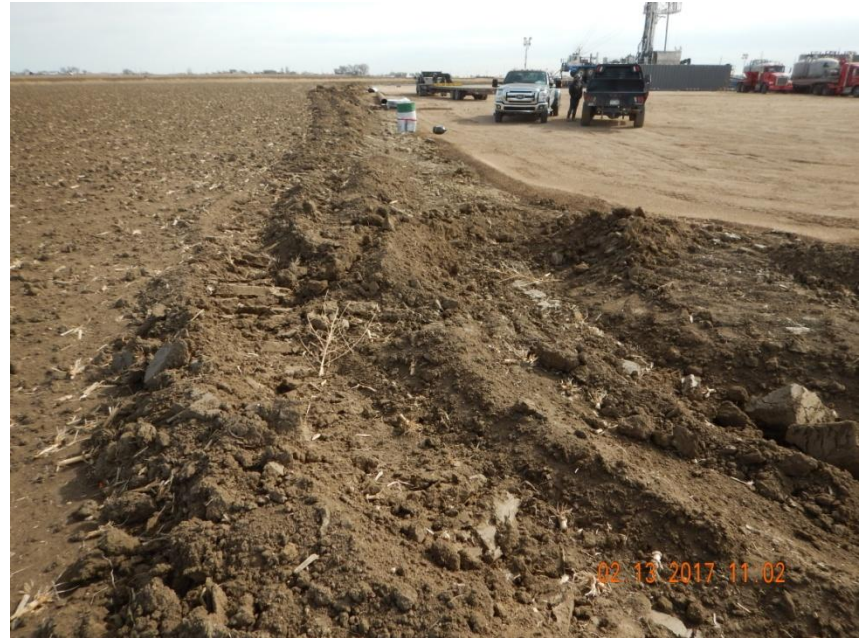
Photo 8. Photo taken from the northwest location, facing East. Berm has not been compacted leaving excessive soil material unconsolidated.

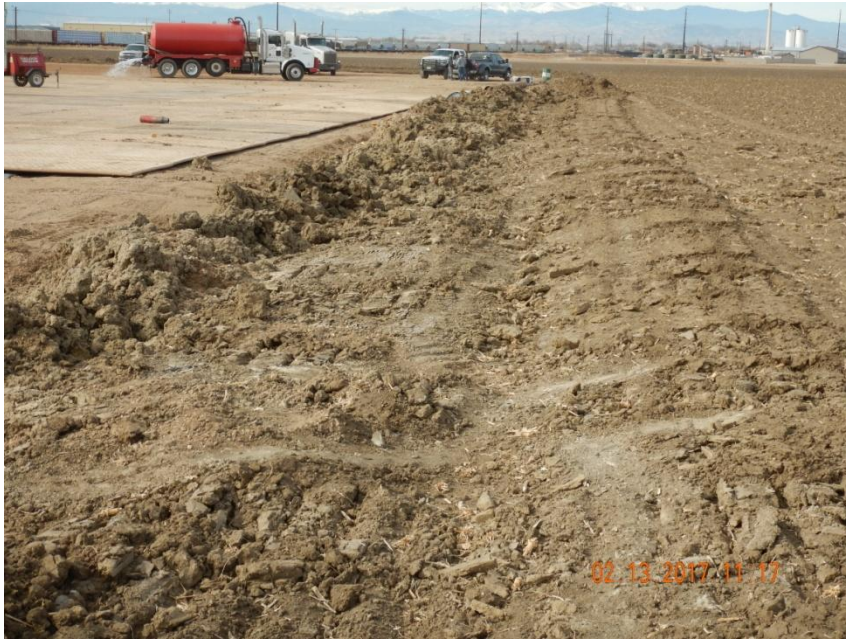
Photo 9. Photo taken from the northeast location, facing West. Excessive, unconsolidated soil material along the ditch BMP.

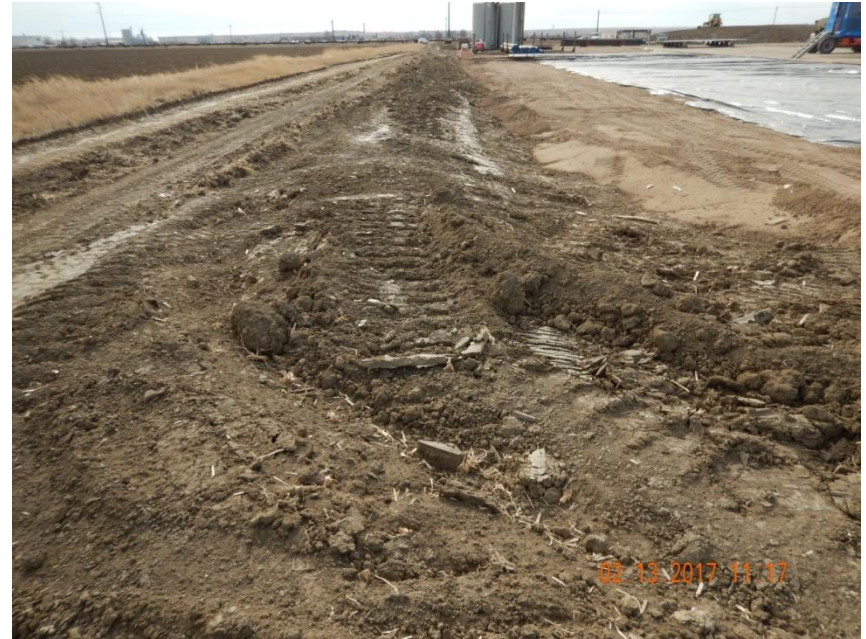
Photo 10. Photo taken from the northeast location, facing South. Ditch and berm BMP installed around the perimeter of location. Unconsolidated soil material along the ditch BMP shall be compacted.

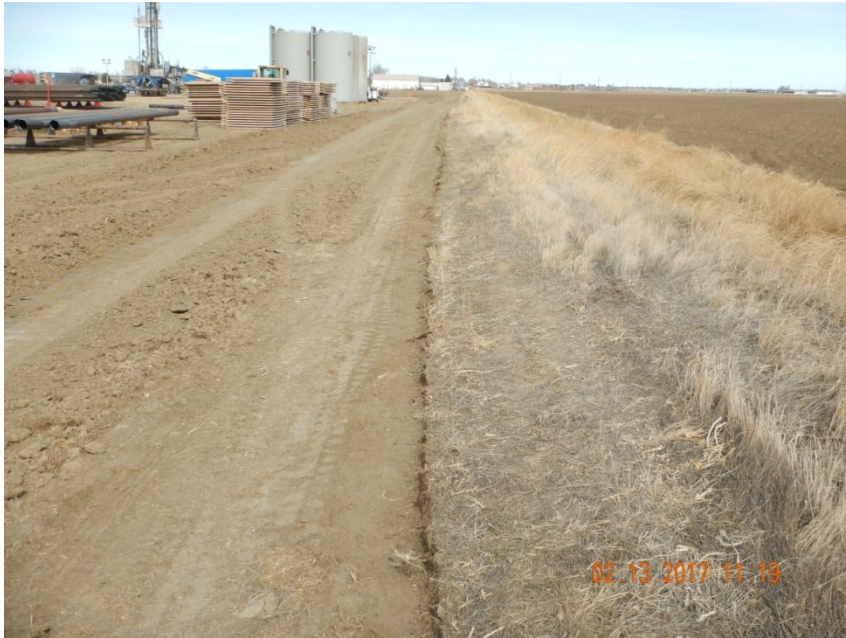
Photo 11. Photo taken from the eastern location, facing North. Pre-existing vegetated berm in-place just outside of the disturbance area.

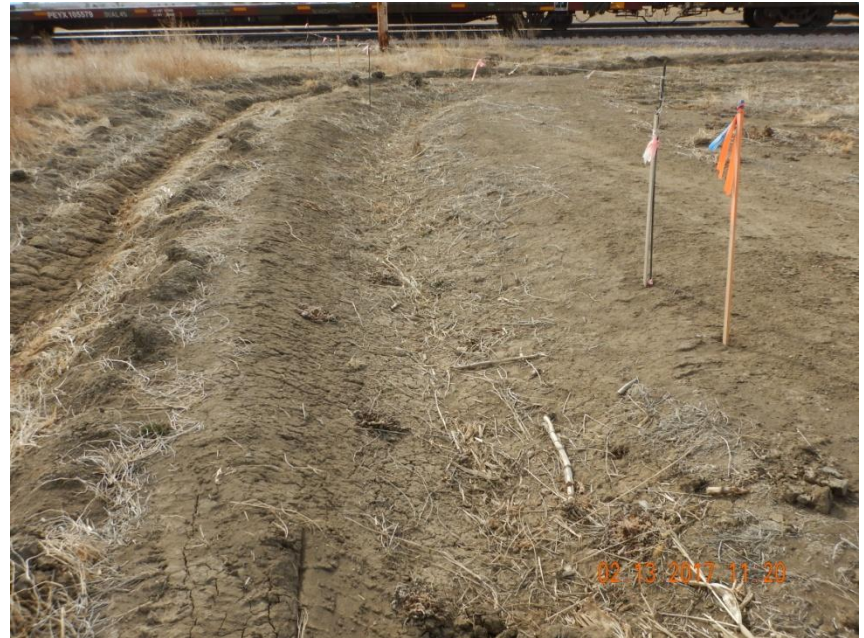
Photo 12. Photo taken from the southeast location, facing South. Pre-existing ditch and berm in-place just outside of the disturbance area.

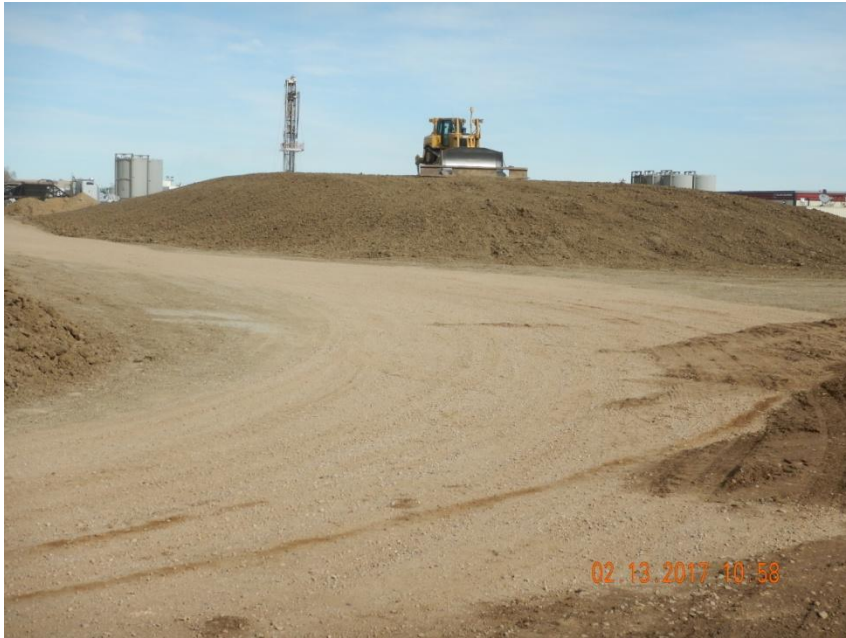
Photo 13. Photo taken from the southwest location, facing Northeast. Stockpile is excessive material from the construction build.

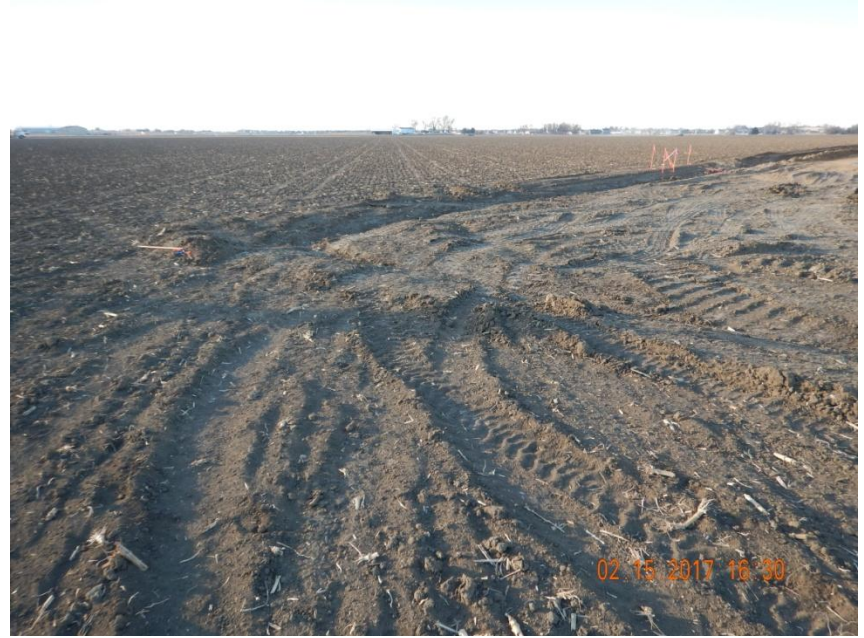
Photo 14. Photo taken on 2/15/17 from the western location, facing Northwest. BMP may need to be re-installed because equipment traffic has damaged the BMP. Equipment traffic should stay off BMPs to ensure BMP is not damaged so BMP properly functions.

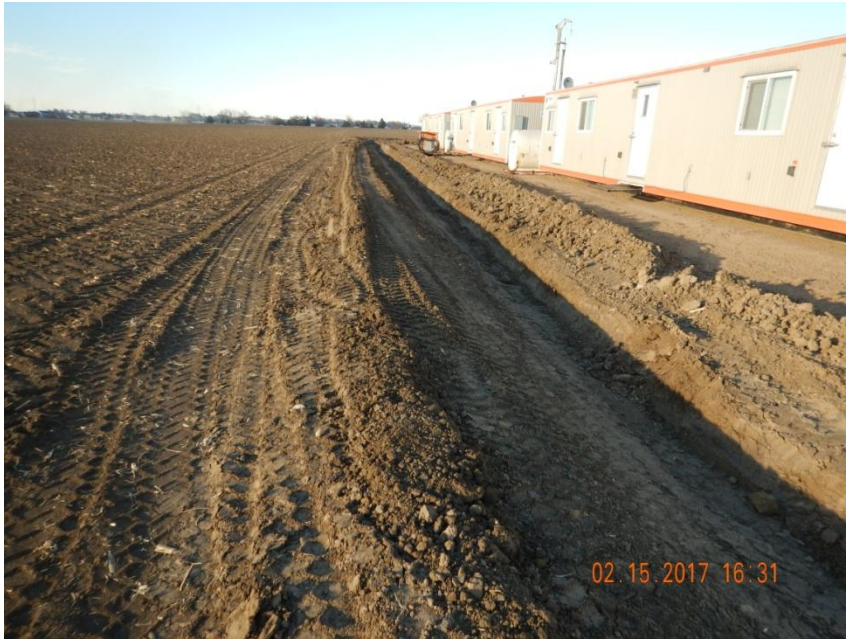
Photo 15. Photo taken on 2/15/17 from the western location, facing North. Appears the BMP has been re-installed along the western perimeter since 2/13/17.

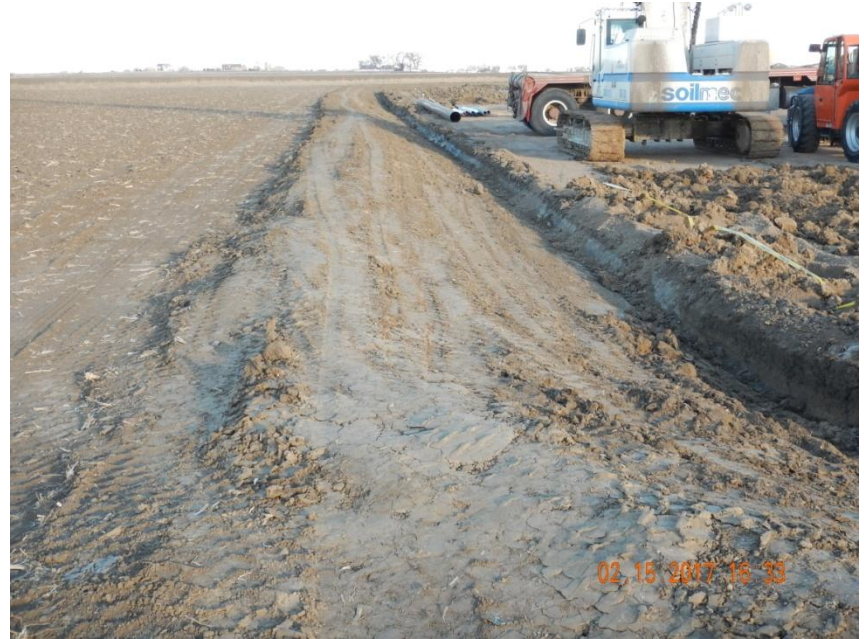
Photo 16. Photo taken from the northwest location, facing East. Appears the BMP has been re-installed along the northern perimeter since 2/13/17.
