Inspection Photos
Location Name: West Animas-University 9-3
API: 05-067-08741

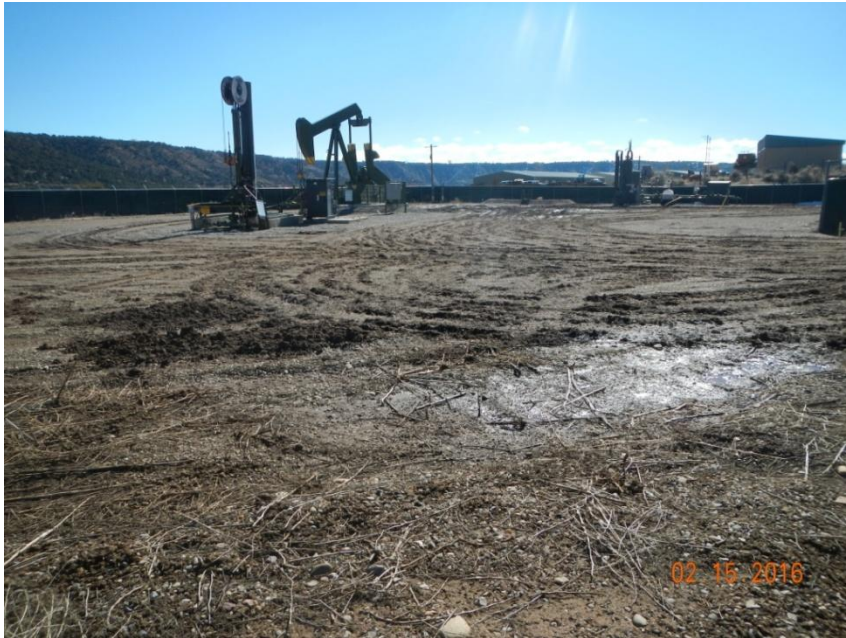
Photo 1. View of the project area from the northwestern corner facing center.

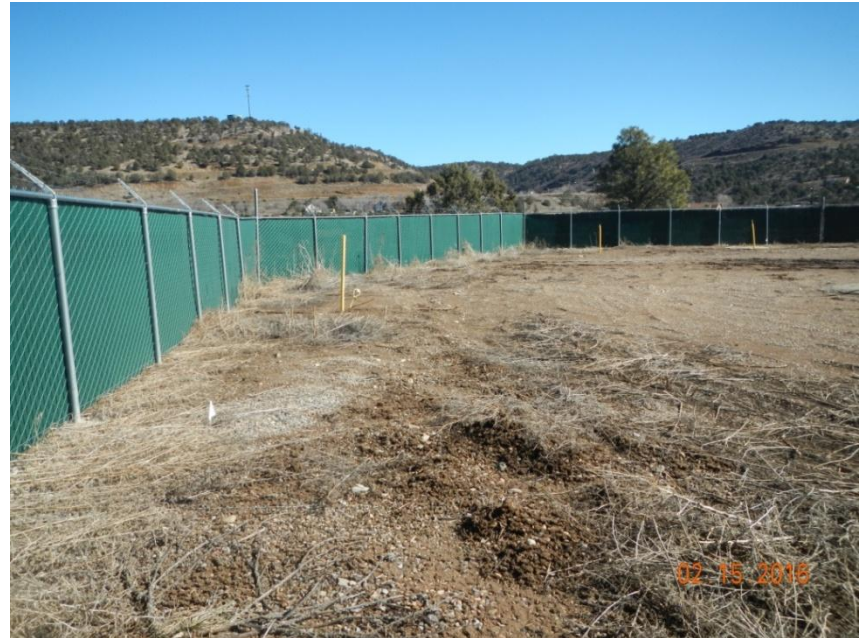
Photo 2. View of the northern portion of the working area from the northwestern corner facing eastward.

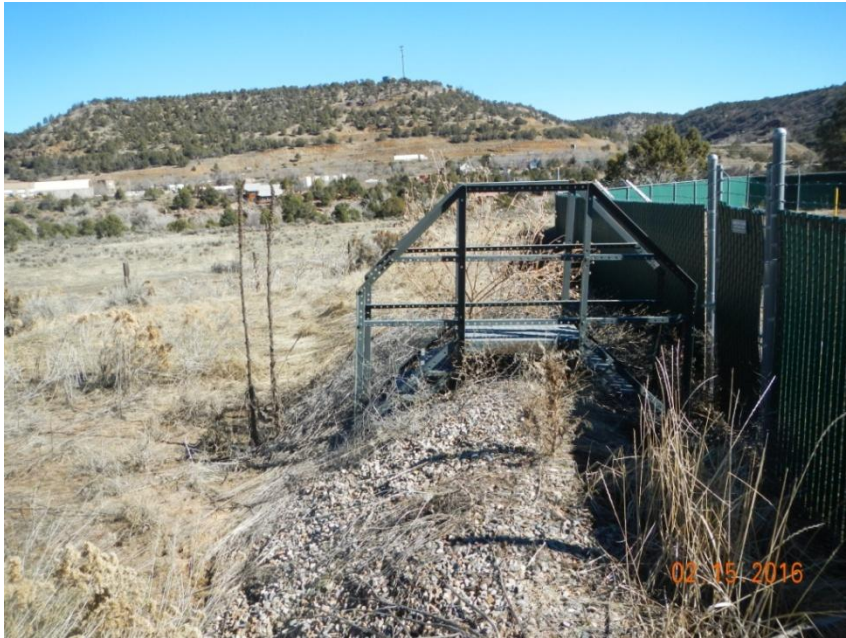
Photo 3. View of the northern portion of the interim reclamation area from the northwestern corner facing eastward. Revegetation is progressing with western wheatgrass (*Pascopyrum smithii*), intermediate wheatgrass (*Thinopyron intermedium*), and rubber rabbitbrush (*Chrysothamnus nauseosus*).

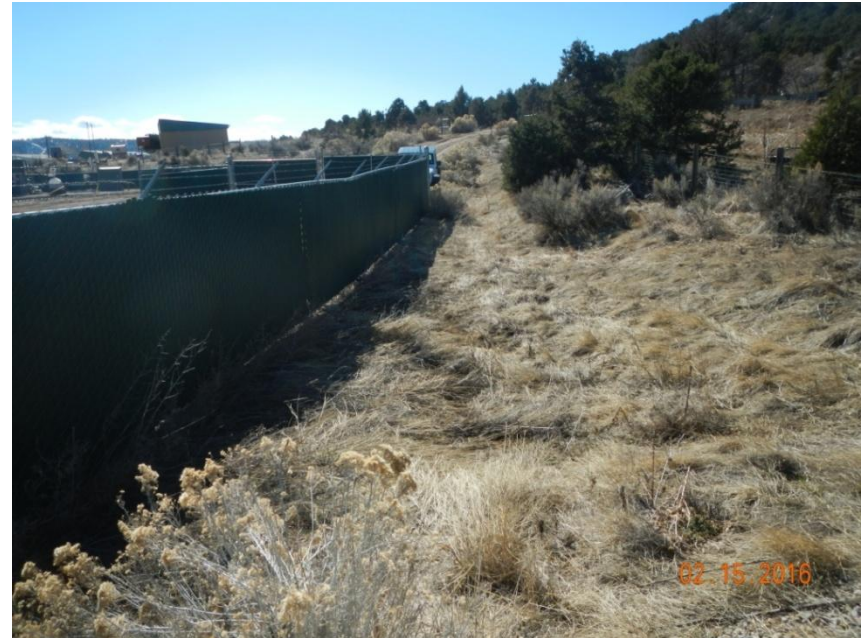
Photo 4. View of the western portion of the interim reclamation area. A vegetated silt trap is in good condition.

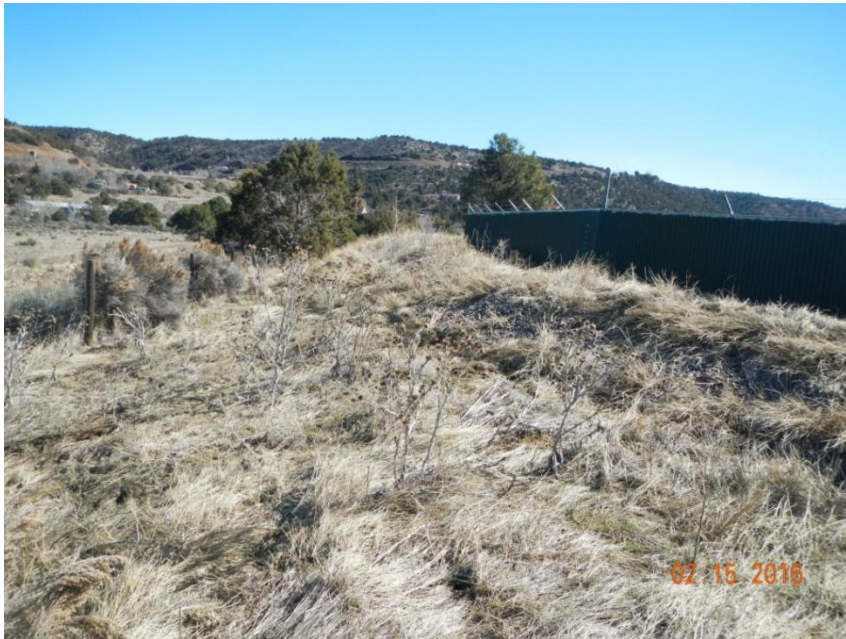
Photo 5. View of Scotch thistles (*Onopordum acanthium*) from the previous growing season in the northern portion of the interim reclamation area.

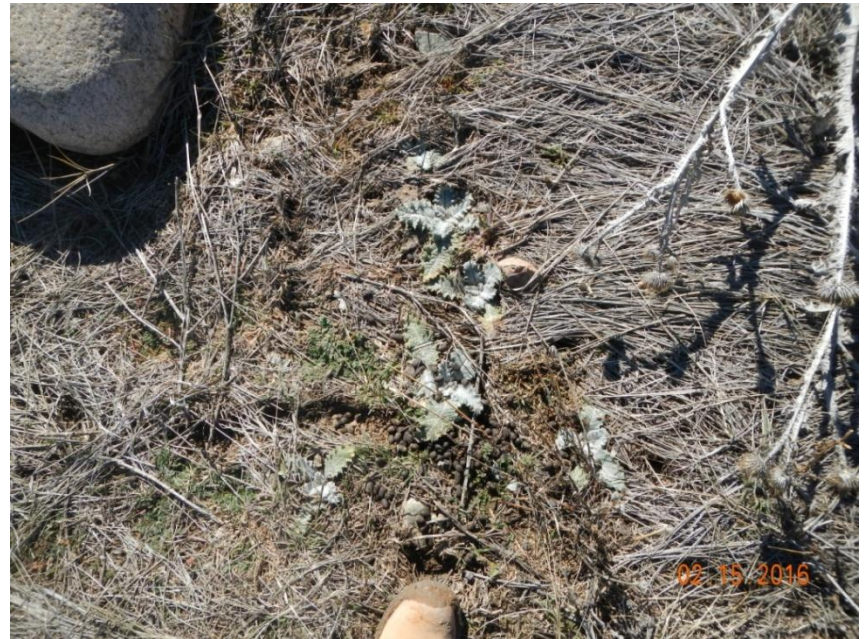
Photo 6. View of Scotch thistle rosettes in the eastern portion of the interim reclamation area.
