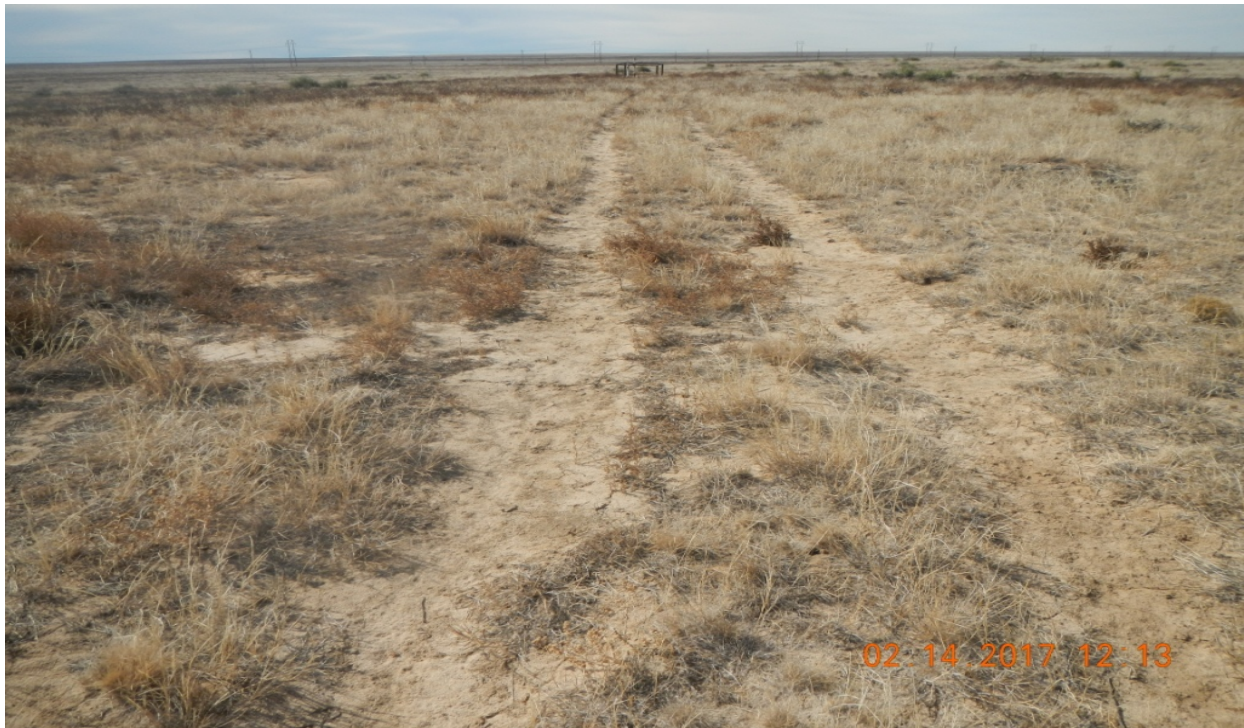
**photo 1:** Facing southwest along the access road. There are areas where the two track road is still visible.

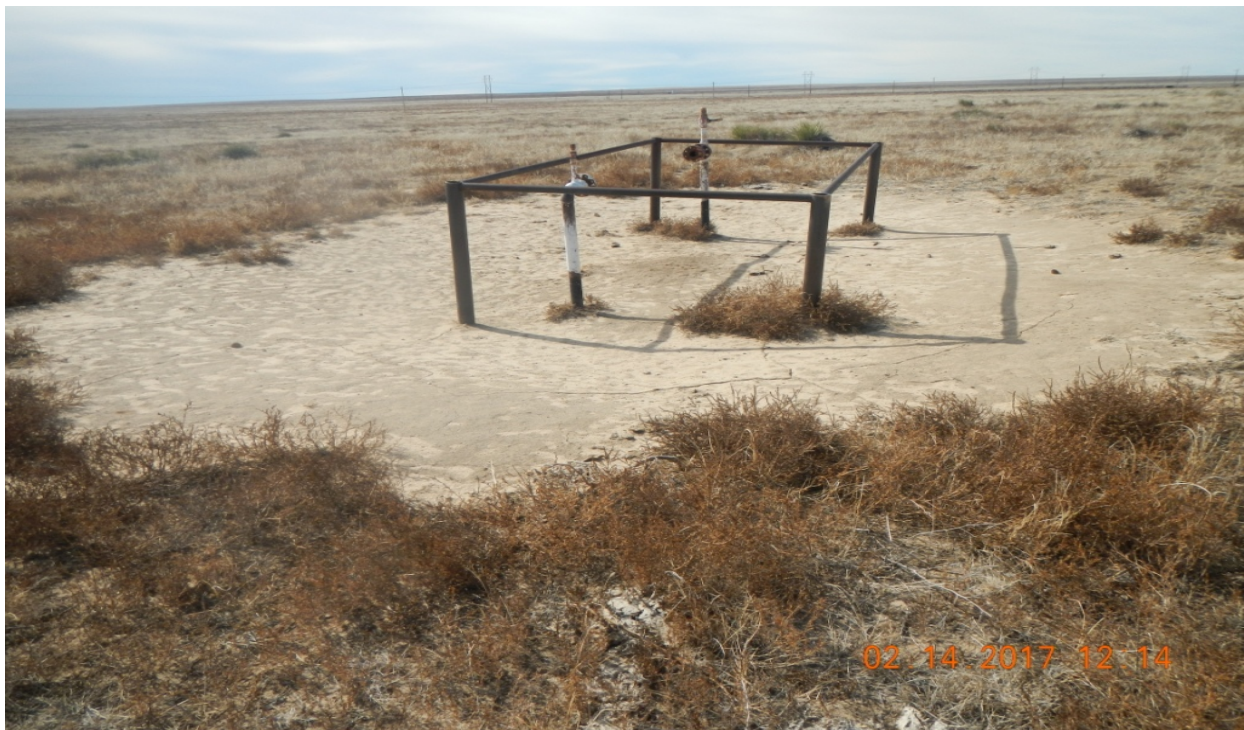
**photo 2:** Pipe risers remain at the location.

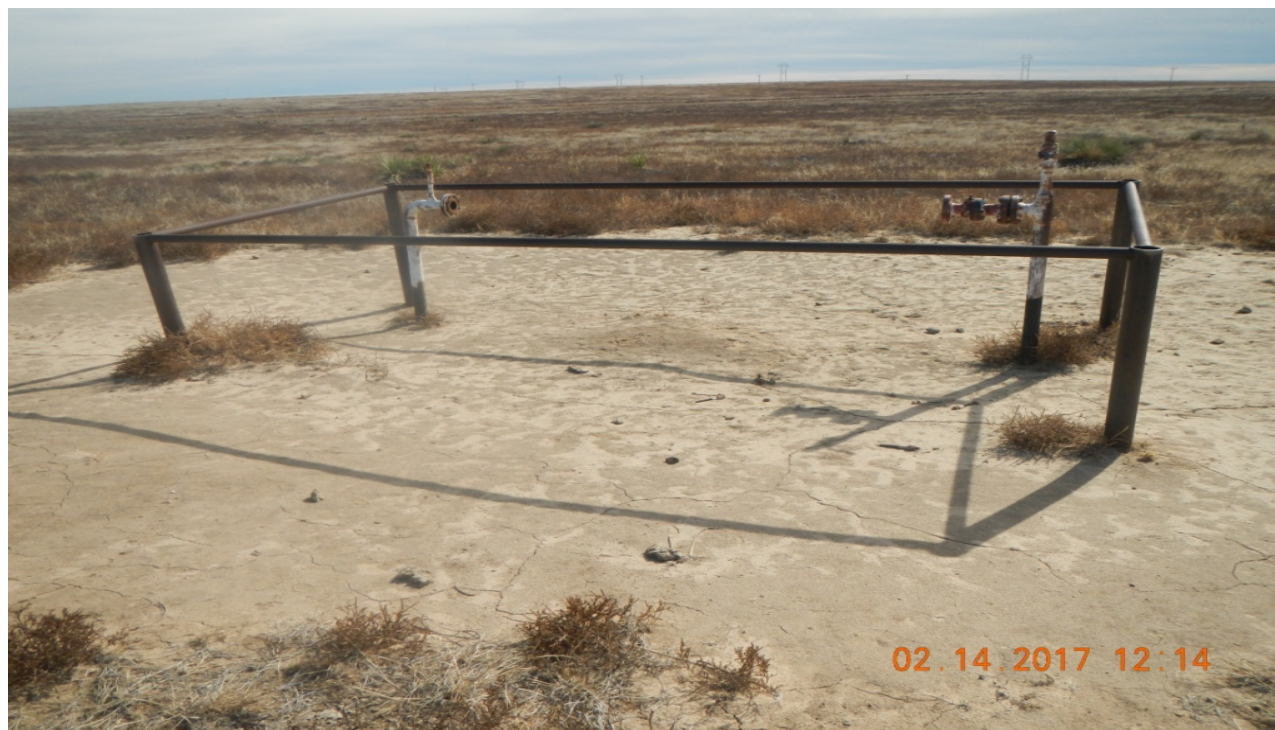
**photo 3:** The area around the pipe risers is devoid of vegetation.

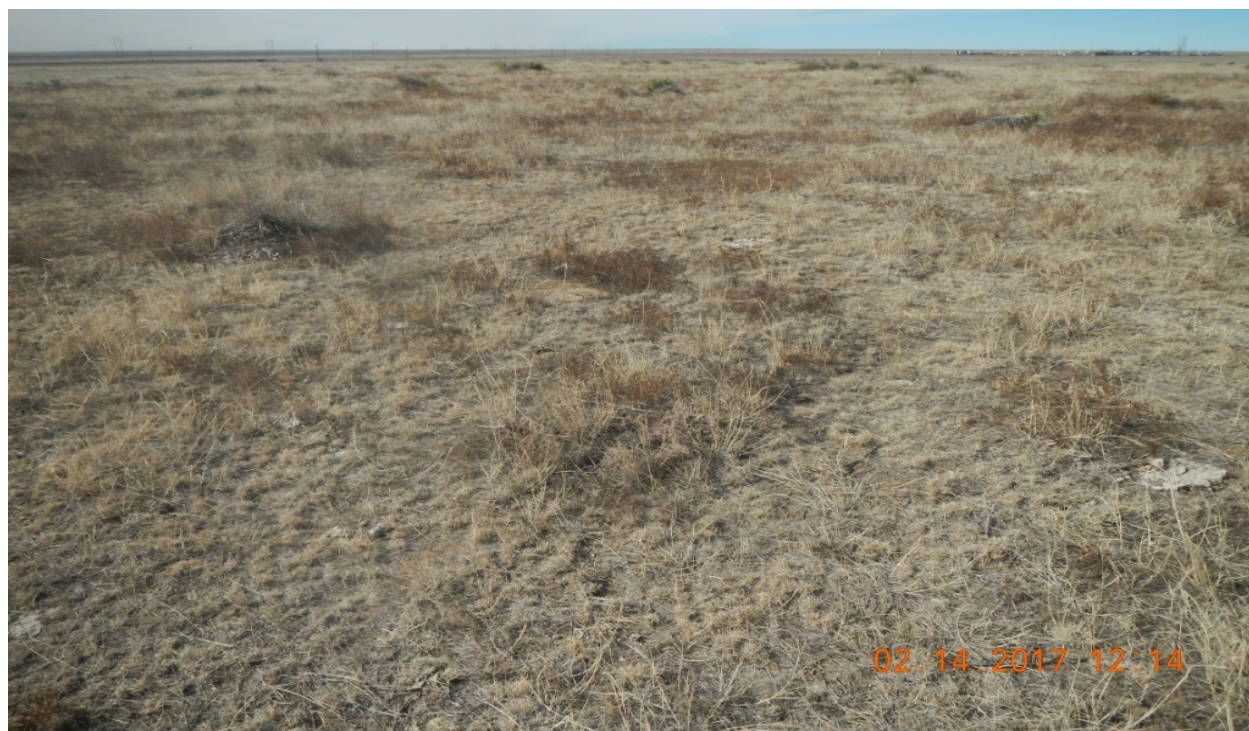
**photo 4:** Facing west toward the surrounding undisturbed vegetation.
