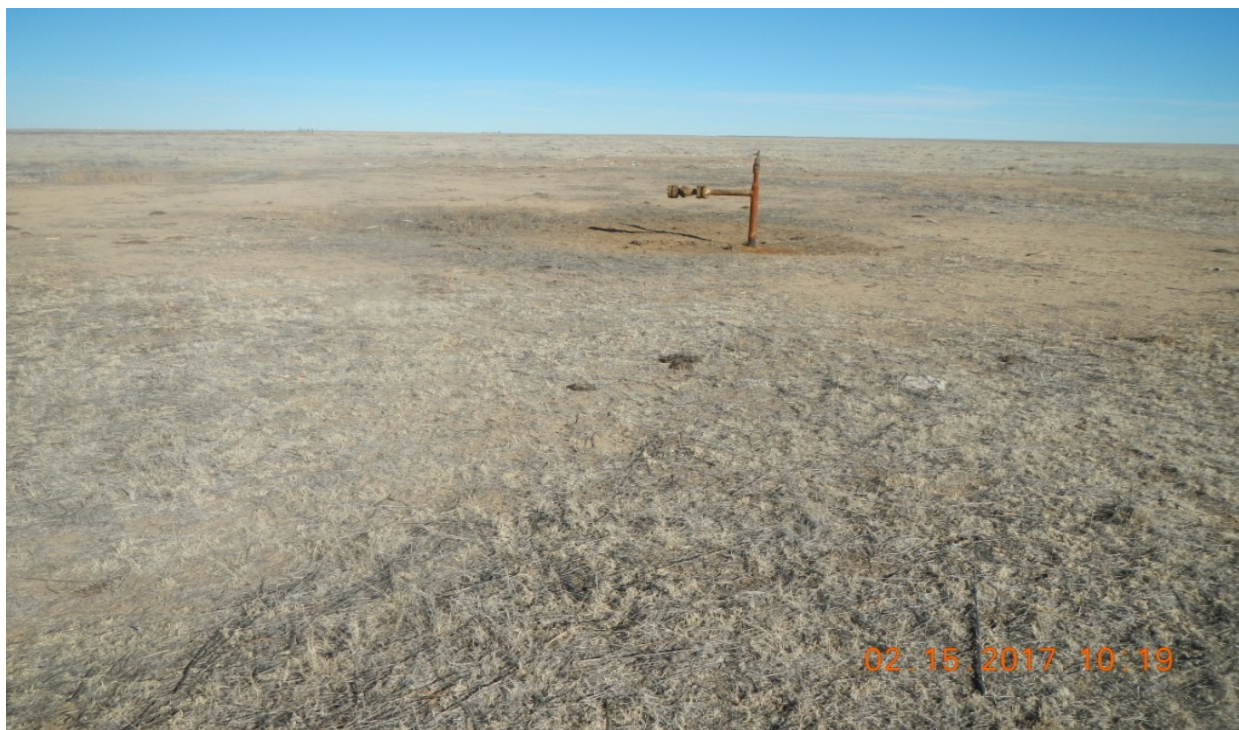
photo 1: Facing north toward the location.

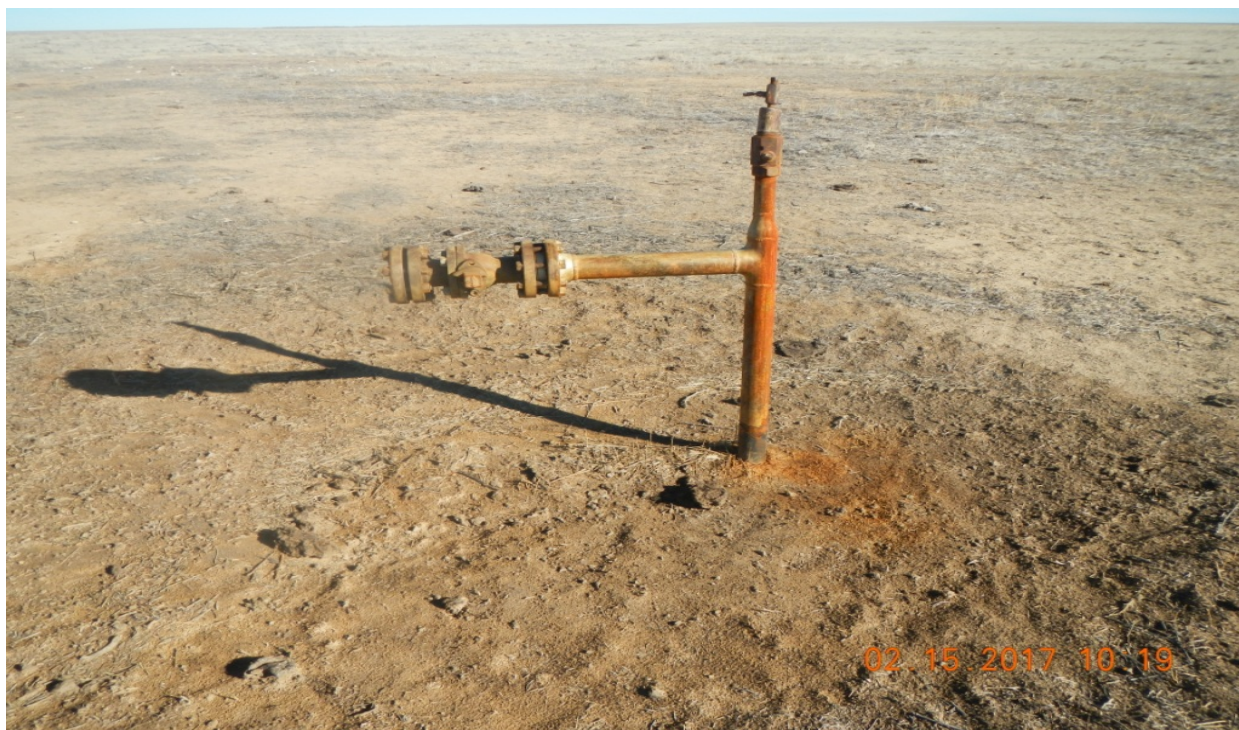
photo 2: Pipe riser remains at the location.

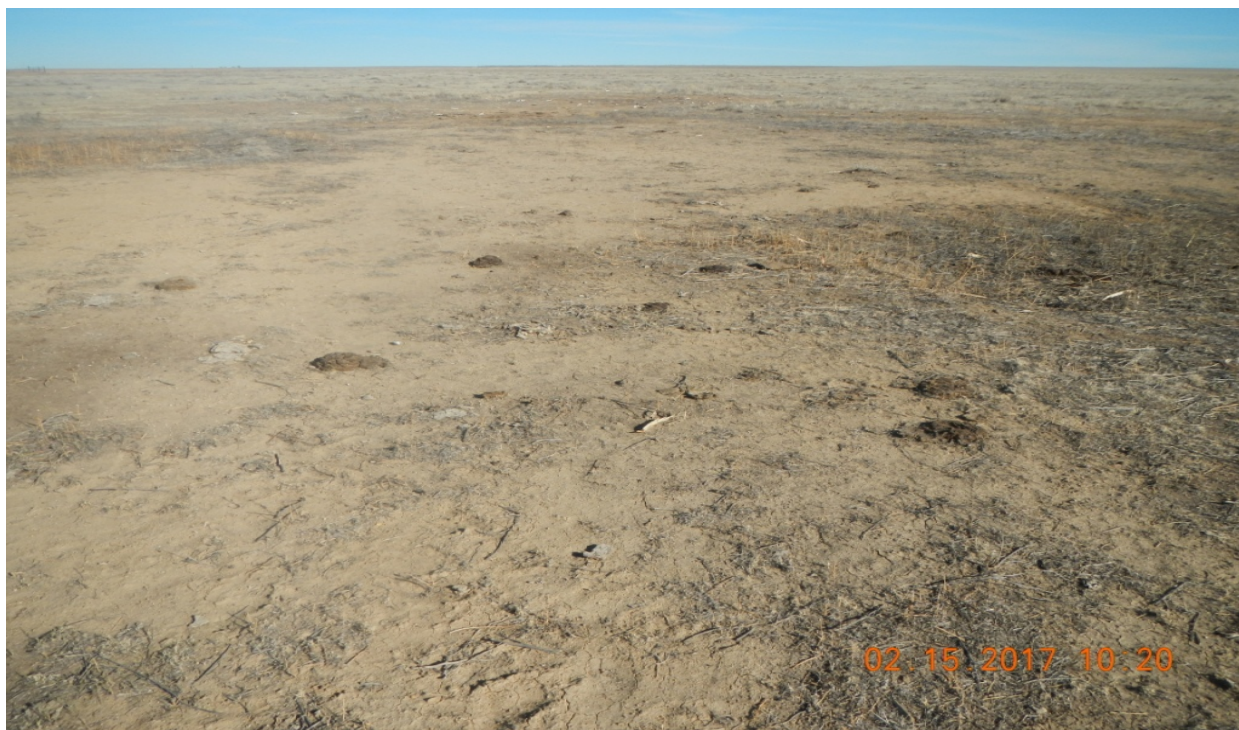
**photo 3:** Facing north at the location. The vegetation has not established.

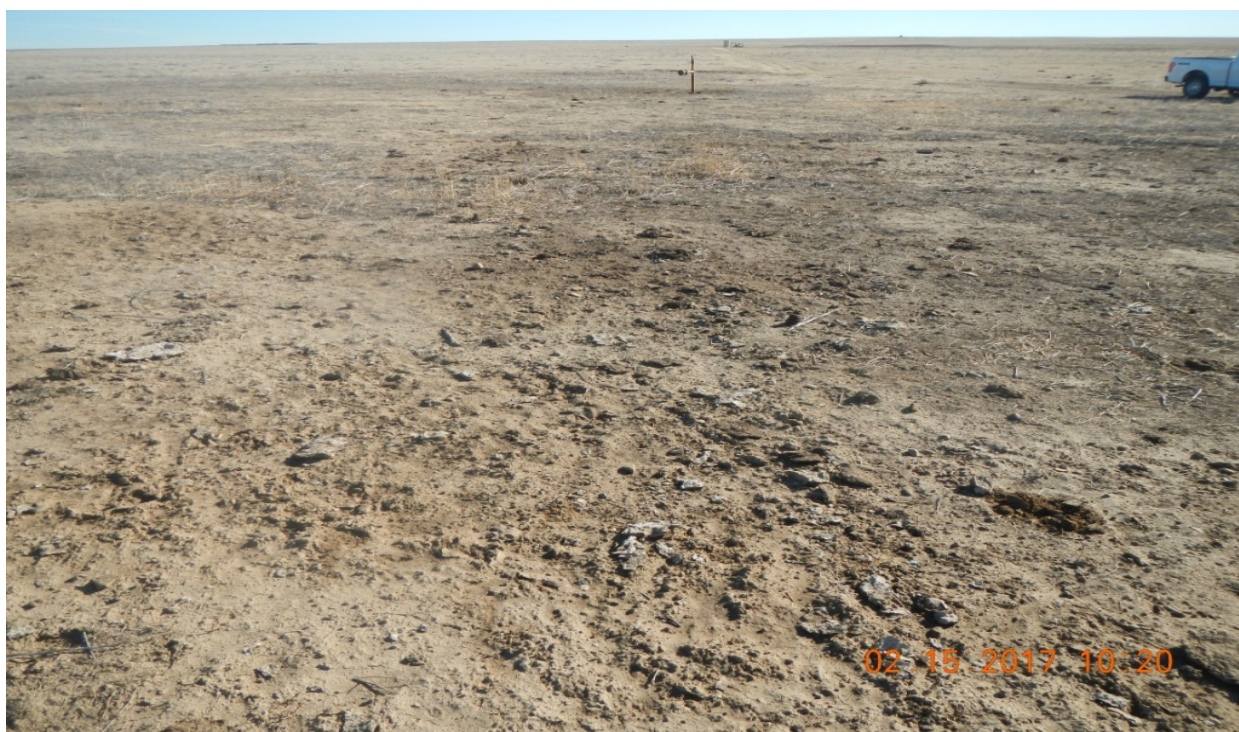
**photo 4:** Facing east toward the location. The vegetation has not established.
