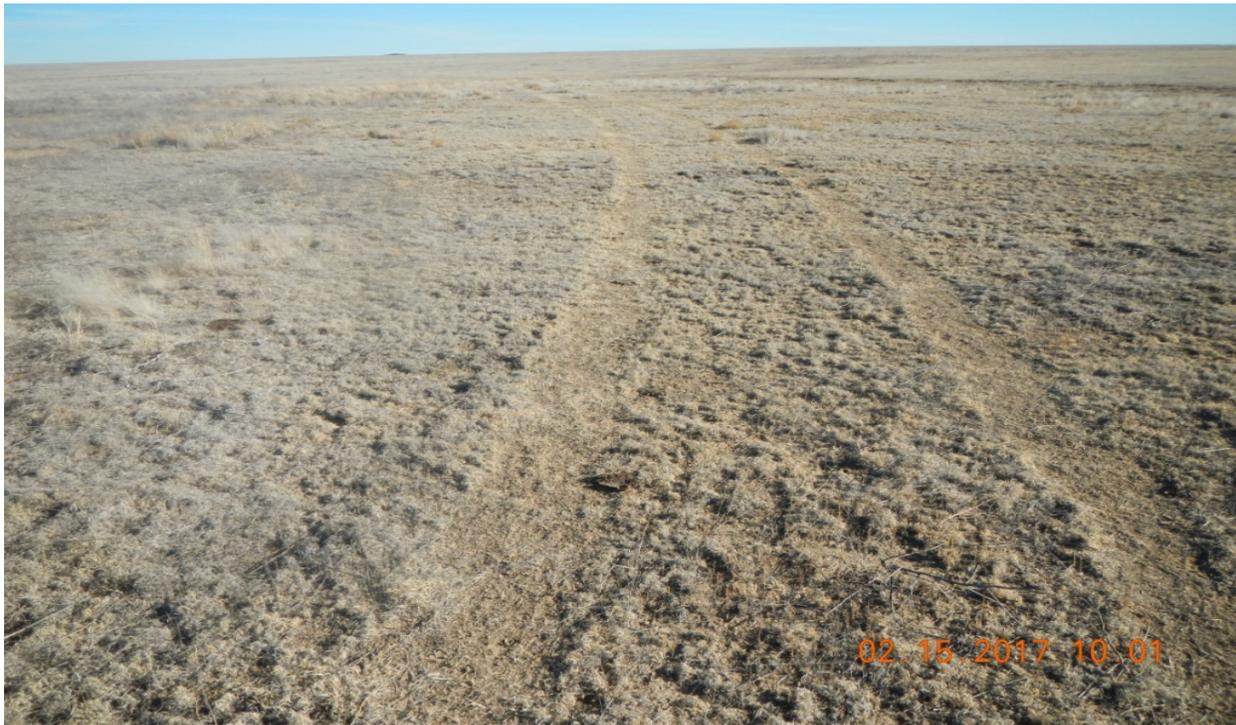
photo 1: A two track ranch road runs thru the location.

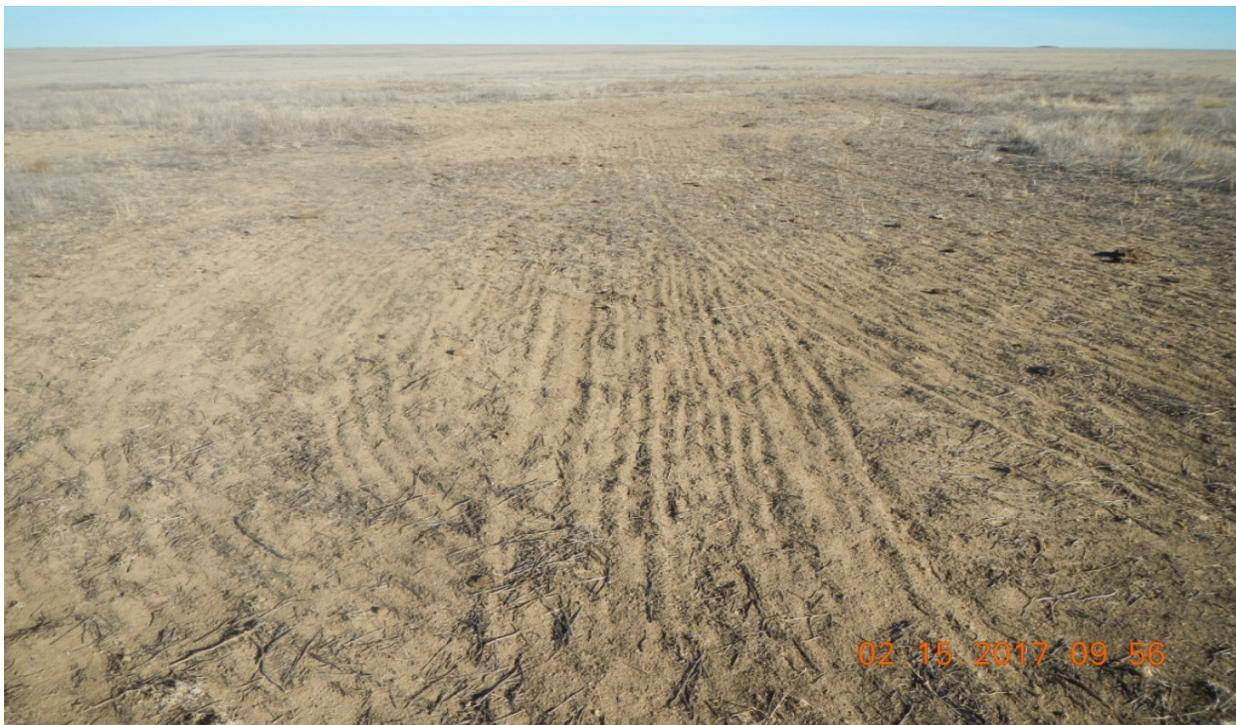
photo 2: South side of the location facing northwest. The vegetation has not established along the west side of the location. It appears this area was recently drill seeded.

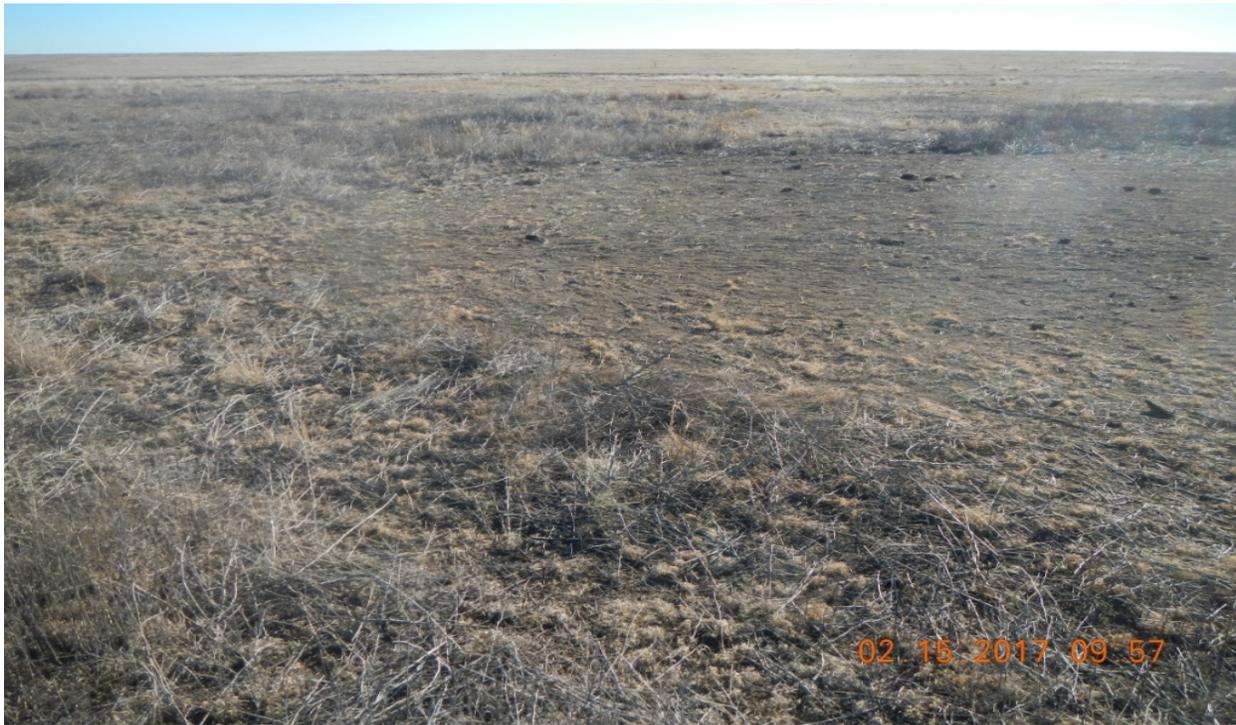
photo 3: West side of the location facing east.

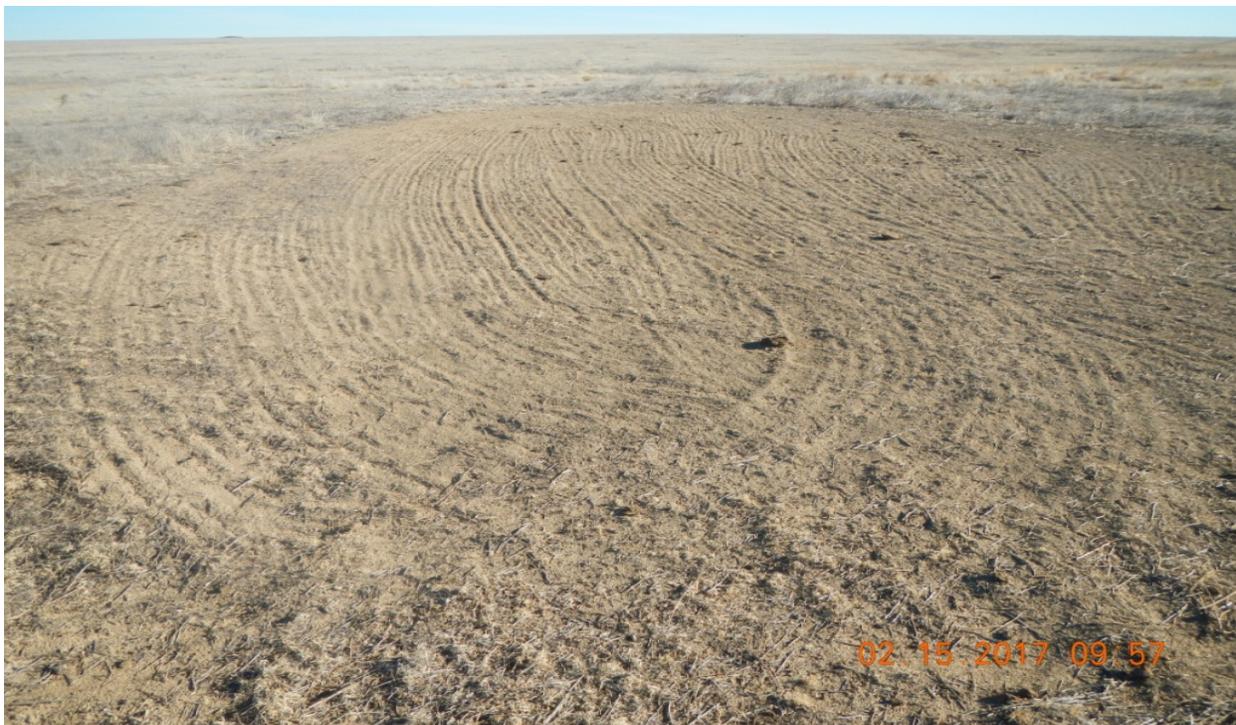
photo 4: Facing north at the northwest side of the location. This area appears to have recently been drill seeded.

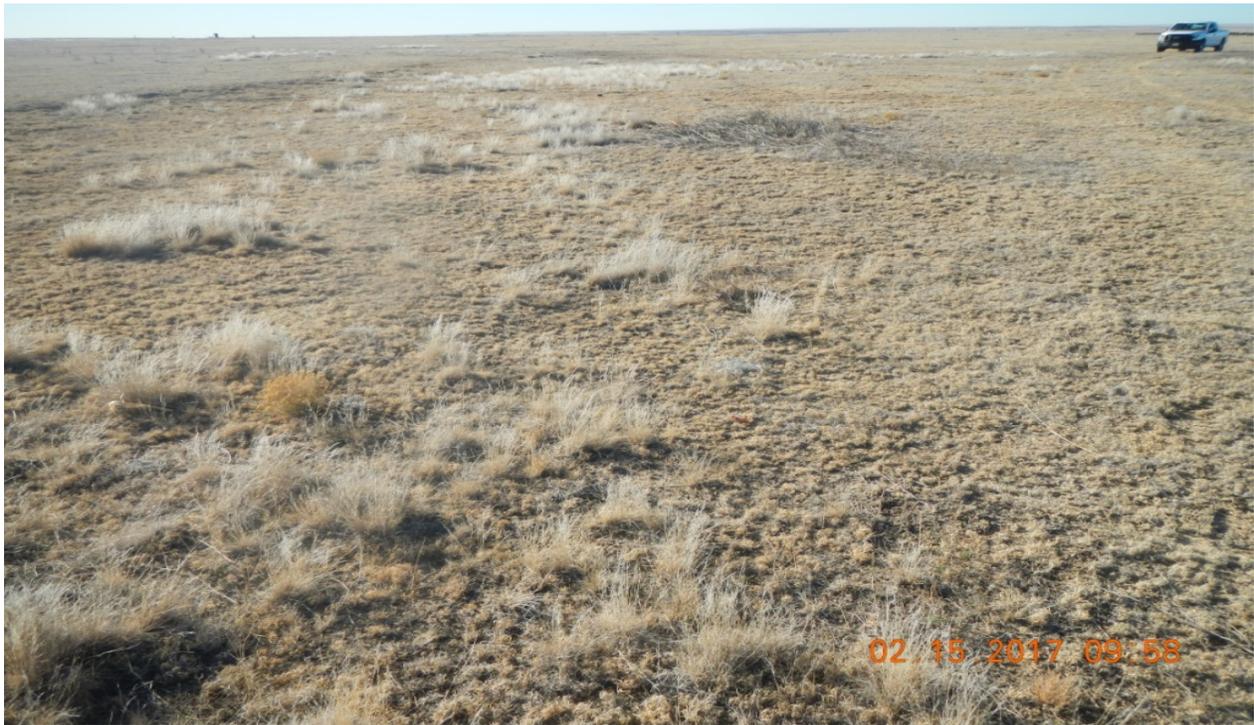
photo 5: Facing south along the east side of the location. Vegetation is well established in this area.

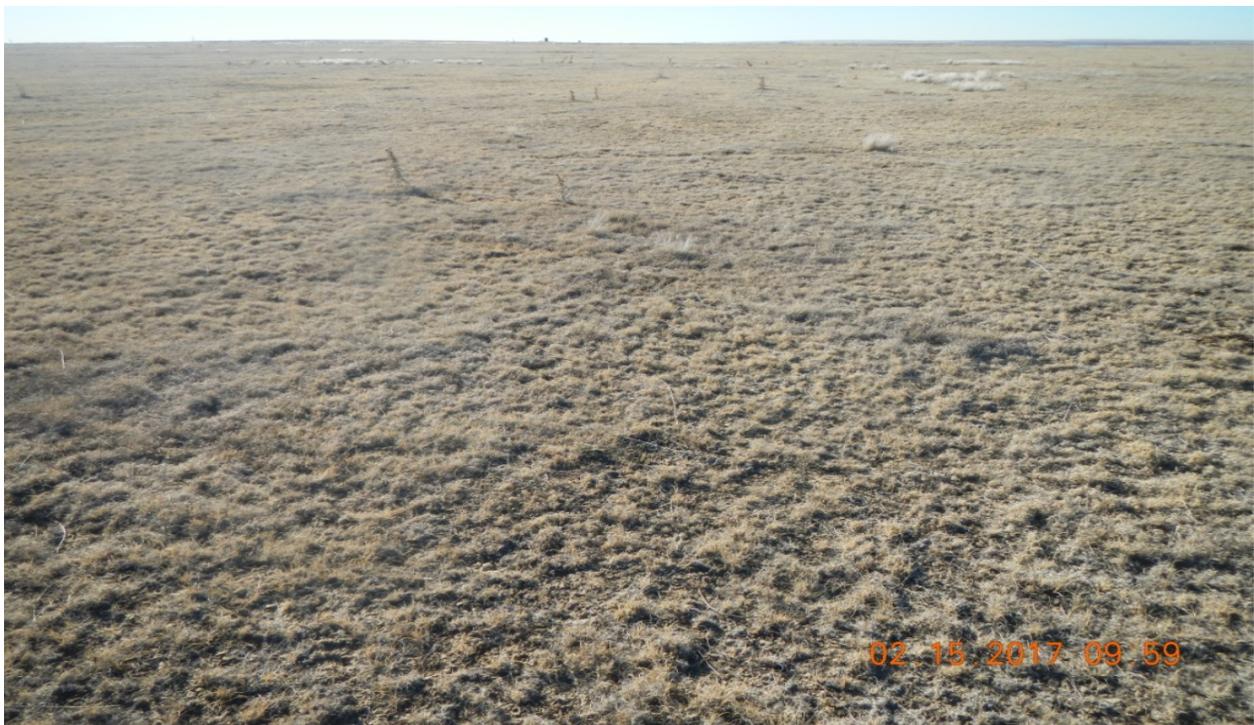
photo 6: Facing east toward the surrounding undisturbed vegetation.
