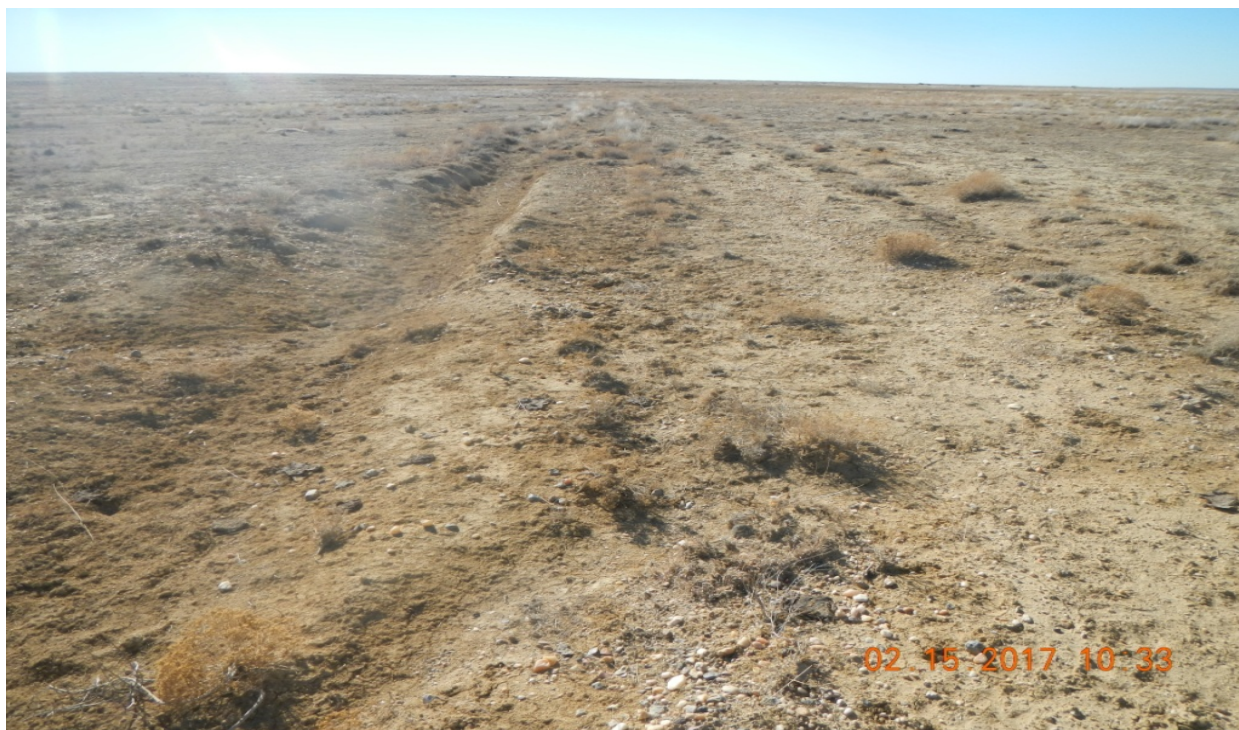
photo 1: Facing south along the access road. There are signs of erosion along the road.

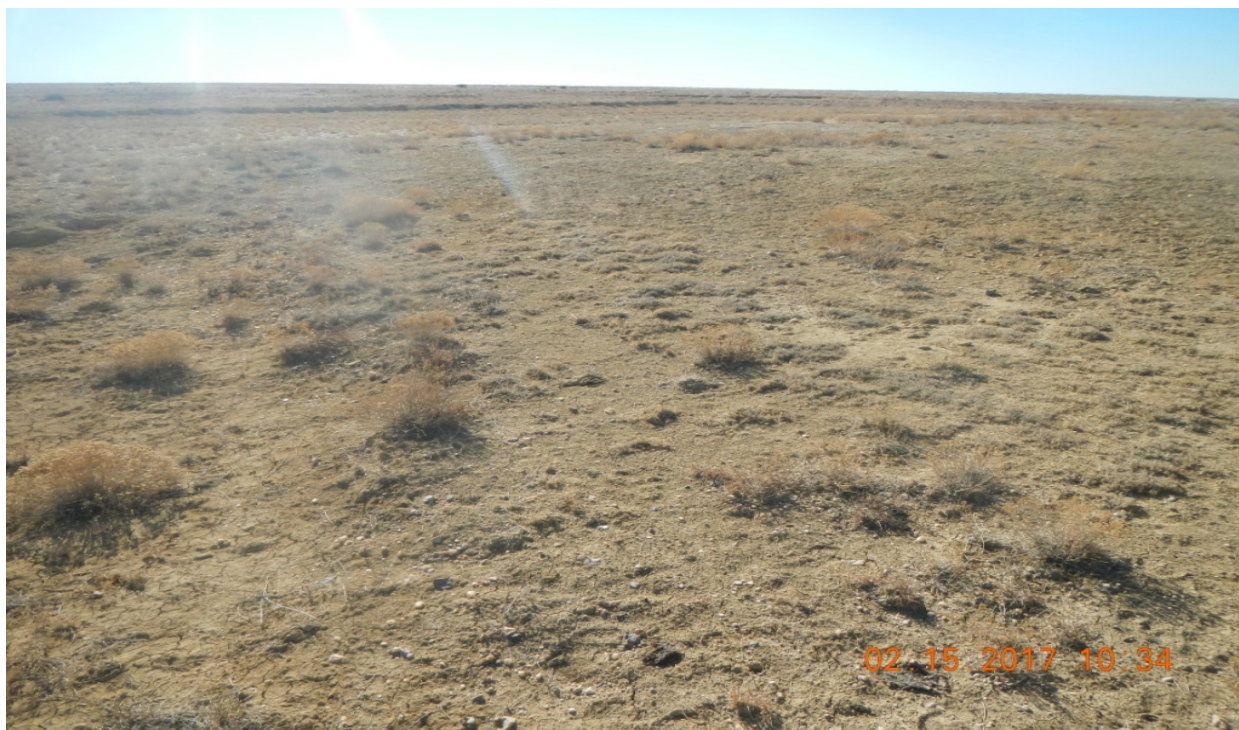
photo 2: Facing south toward the location.

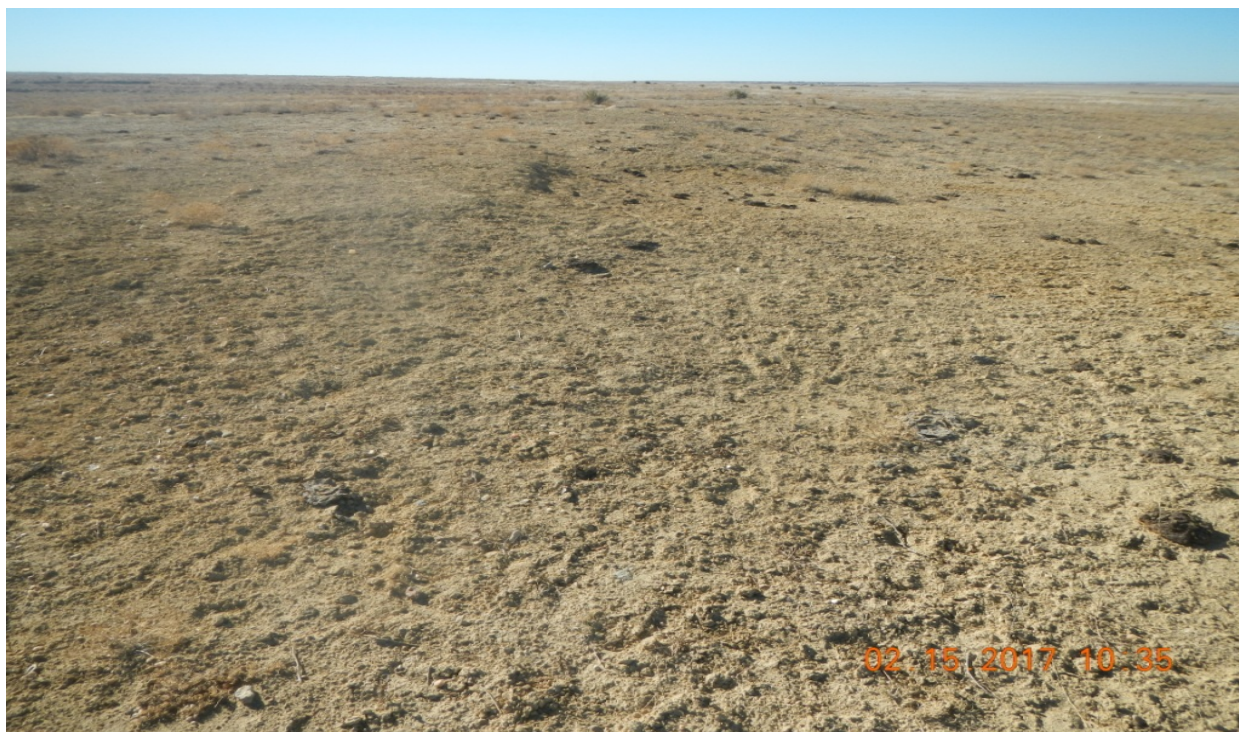
photo 3: Facing west along the north fill slope.

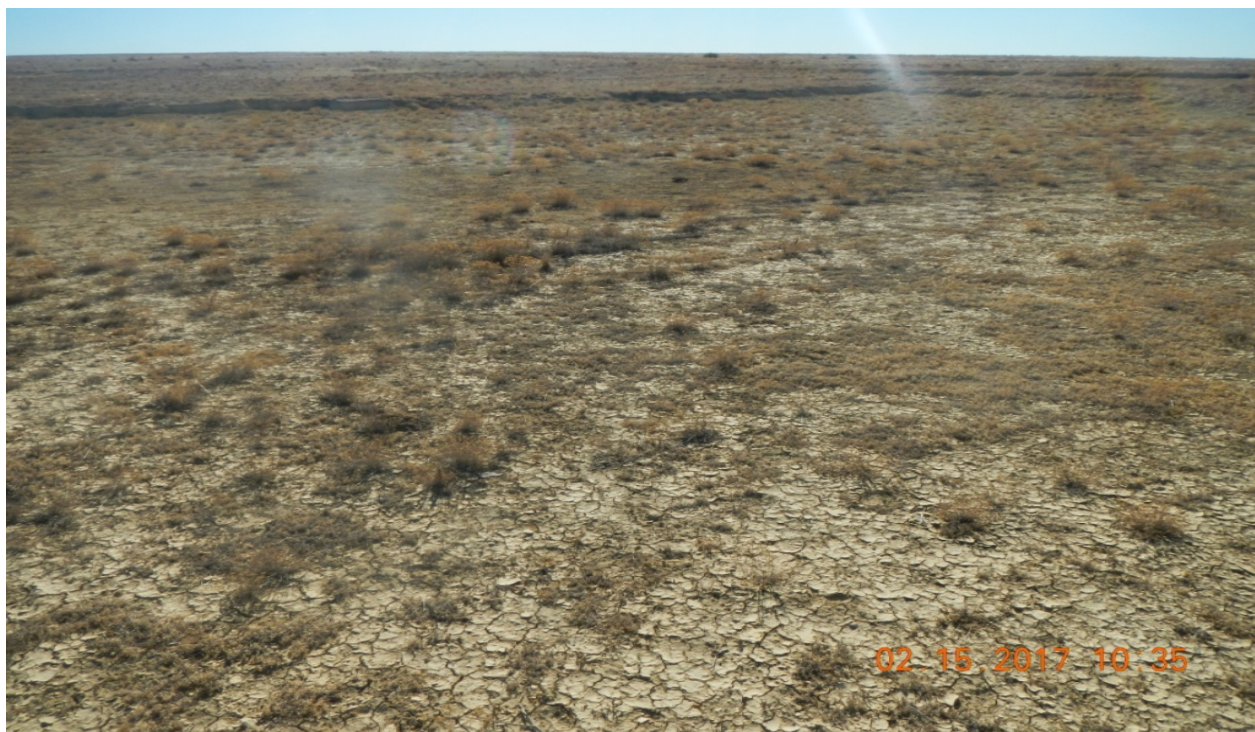
photo 4: Center of the location facing south.

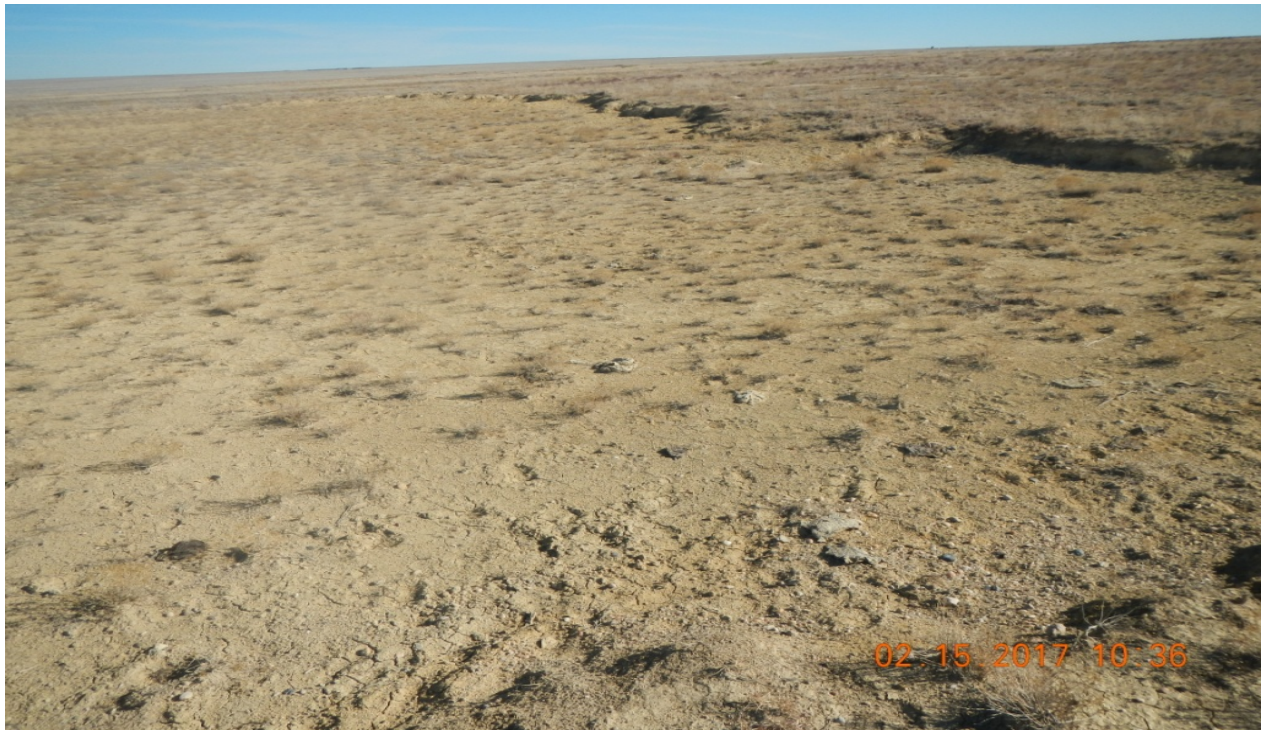
photo 5: Facing east along the south cut slope.

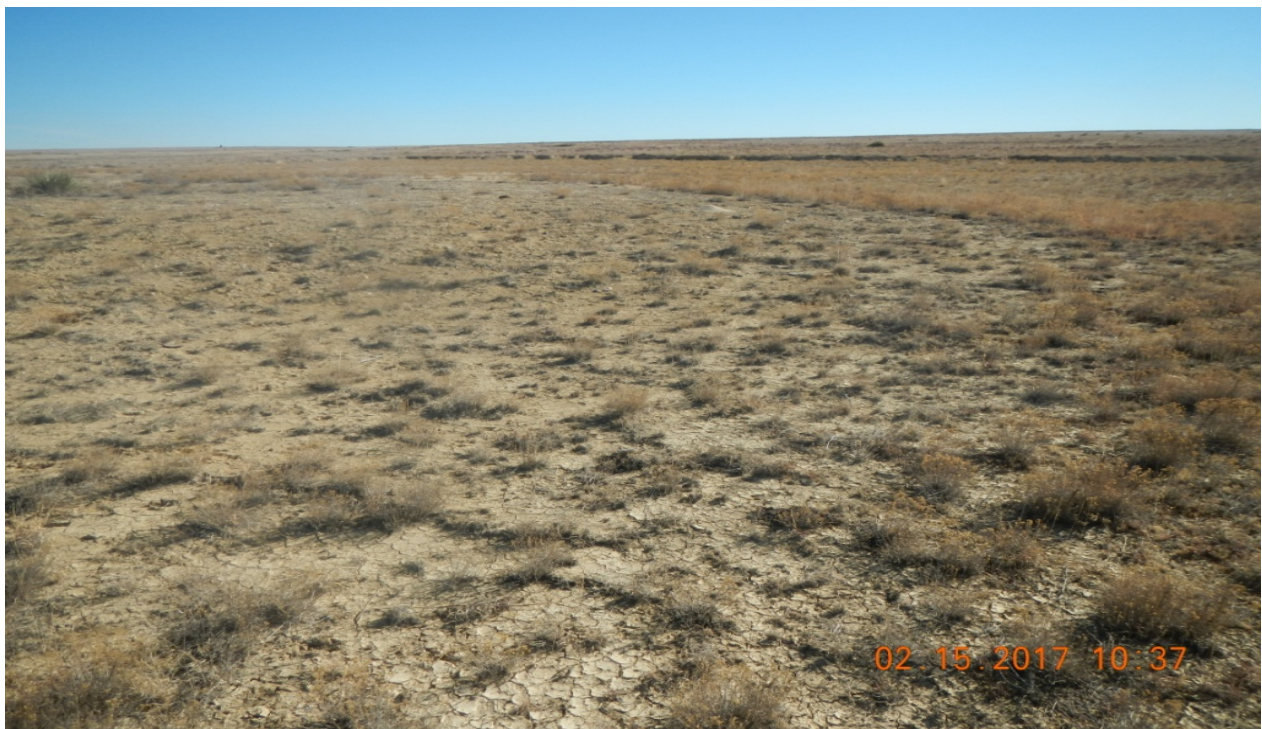
photo 6: Facing southwest toward the location.

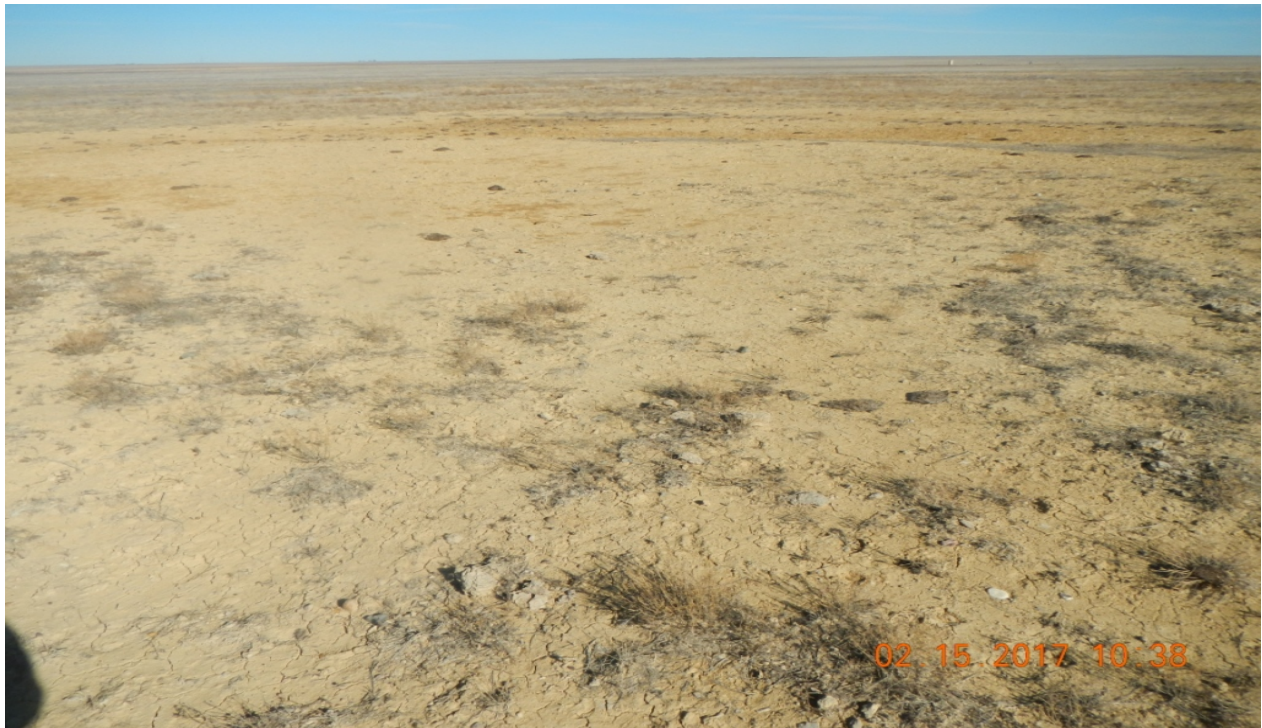
photo 7: Facing north at the north side of the location. There is little to no vegetation establishment in this area.

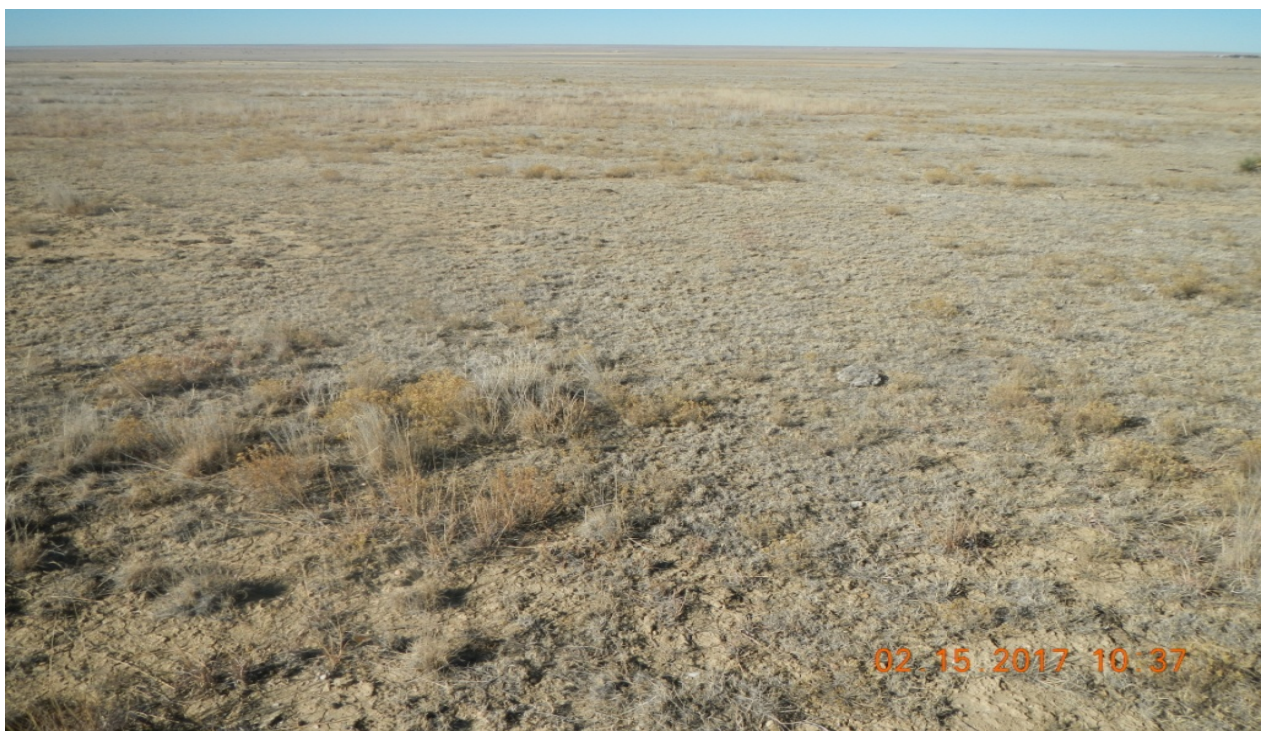
photo 6: Facing west toward the surrounding undisturbed vegetation.

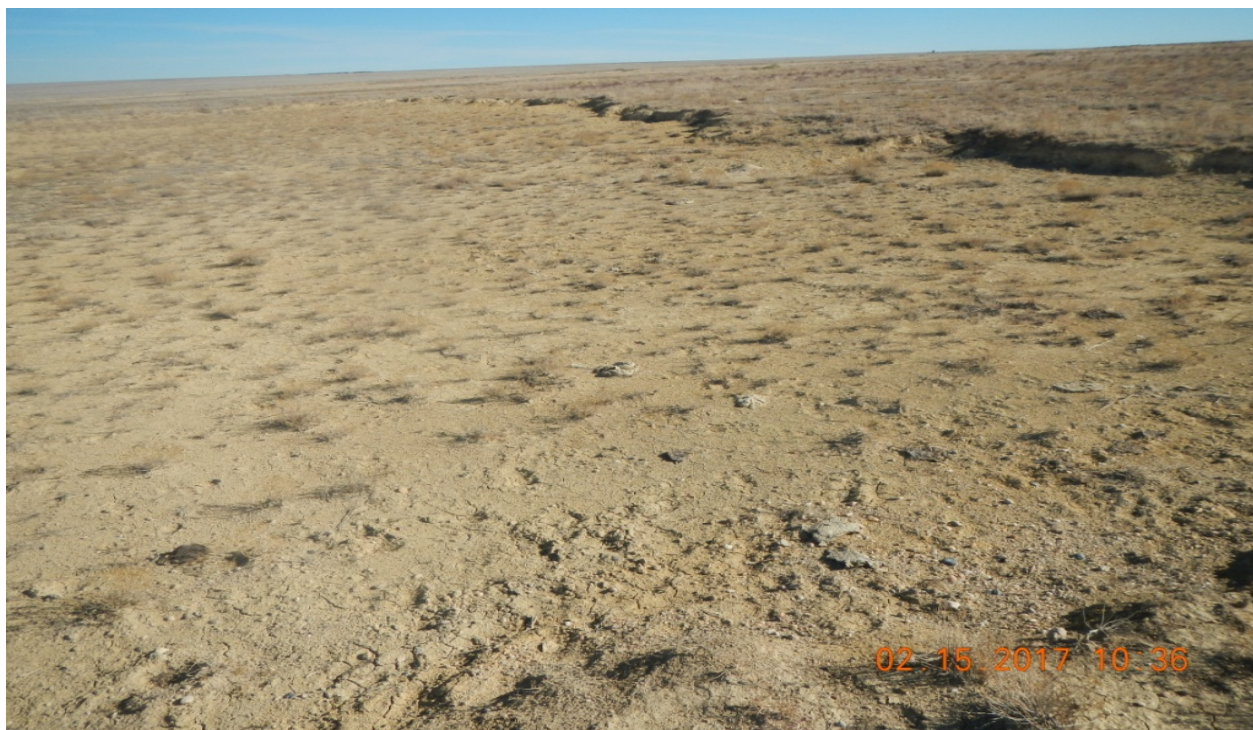
photo 6: Facing east toward the surrounding undisturbed vegetation.
