# Construction and Stormwater Inspection

February 22, 2017

Operator: EXTRACTION OIL & GAS LLC - #10459

Inspection Photos  
Location Name: Kennedy /18-D Pad  
Location ID: 439079

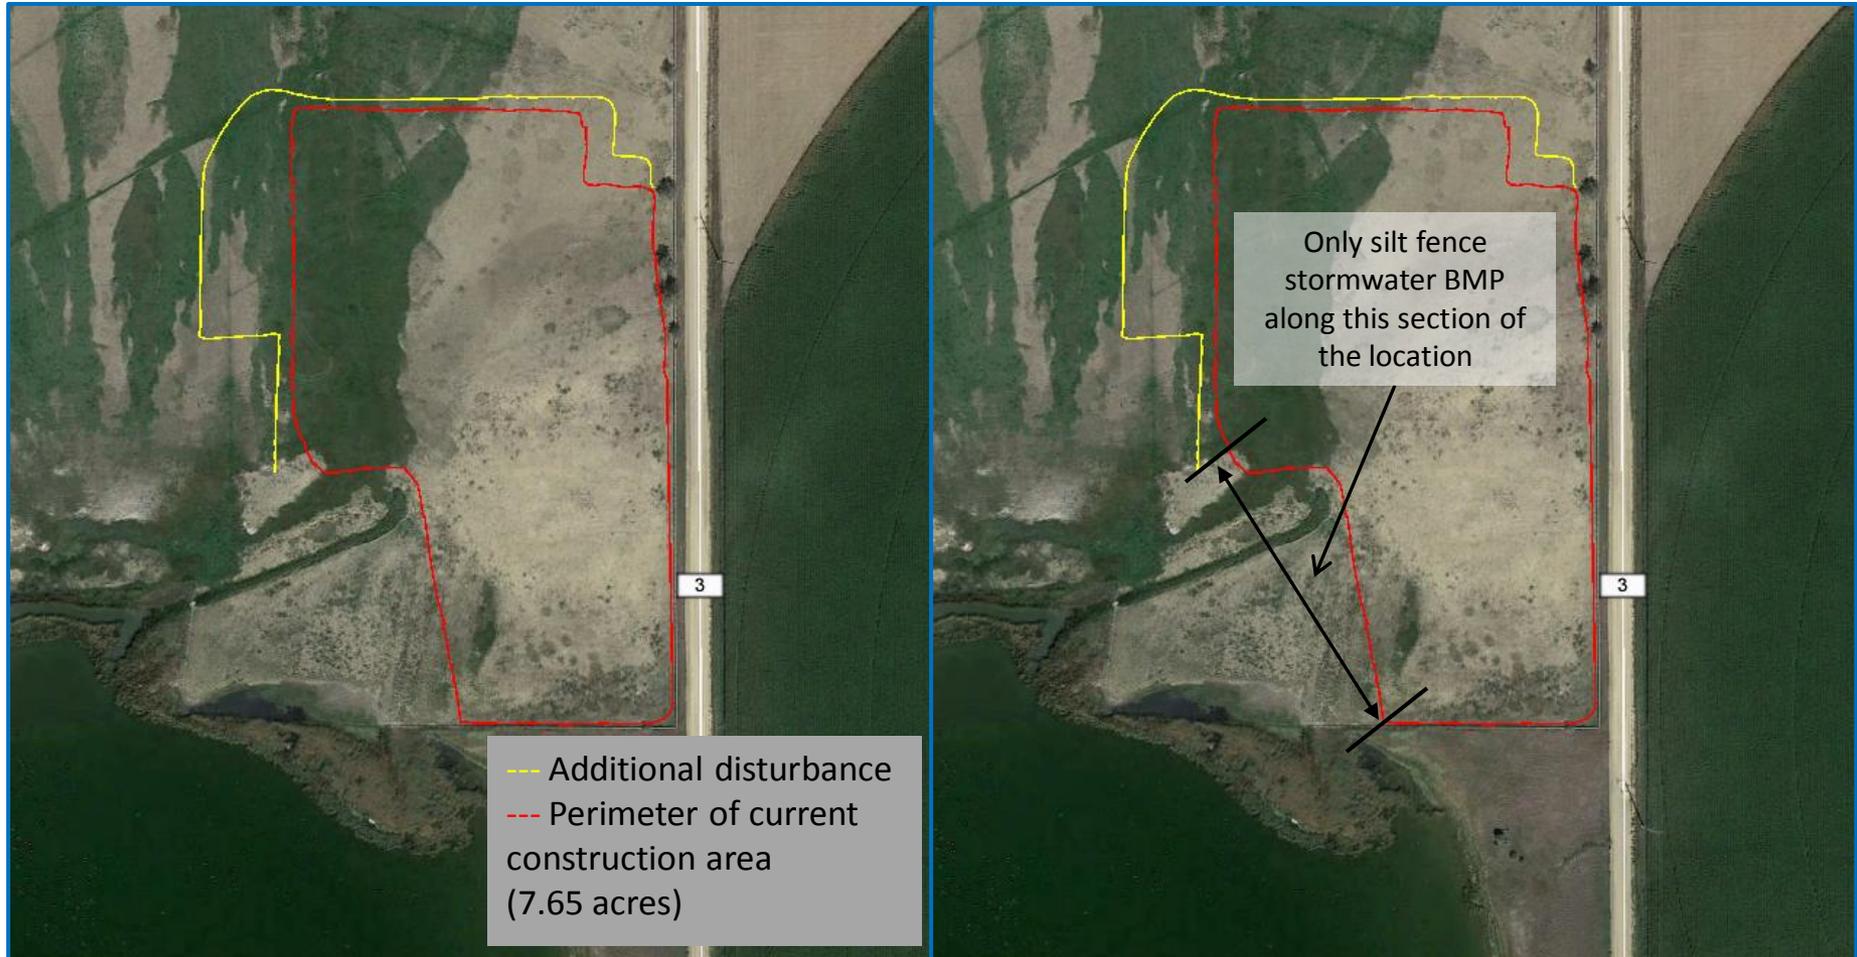
Google Earth aerial photo taken 9/7/2016 illustrating the Kennedy location in relation to Newell Lake to the southwest. Refer to photos 1-15 regarding perimeter stormwater BMPs. Ditch and berm BMP installed around the perimeter of location minus the southwest as indicated in the upper right figure. Silt fence BMP is the only stormwater BMP along the southwestern location which is not in proper functioning condition. Refer to photos 16-21 regarding additional disturbance highlighted above in yellow. Appears the Operator started to construct stormwater BMPs but then reduced the size of the location. Operator will be responsible for reclaiming disturbances along portions highlighted in yellow.

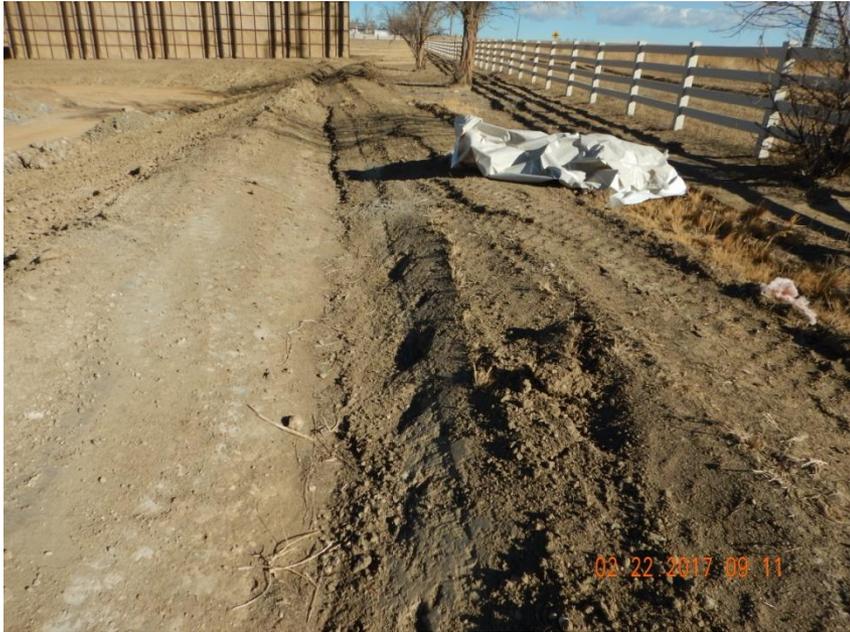
**Photo 1.** Photo taken from the eastern location, facing North. Ditch and berm BMP installed. Need to remove trash from perimeter of location.

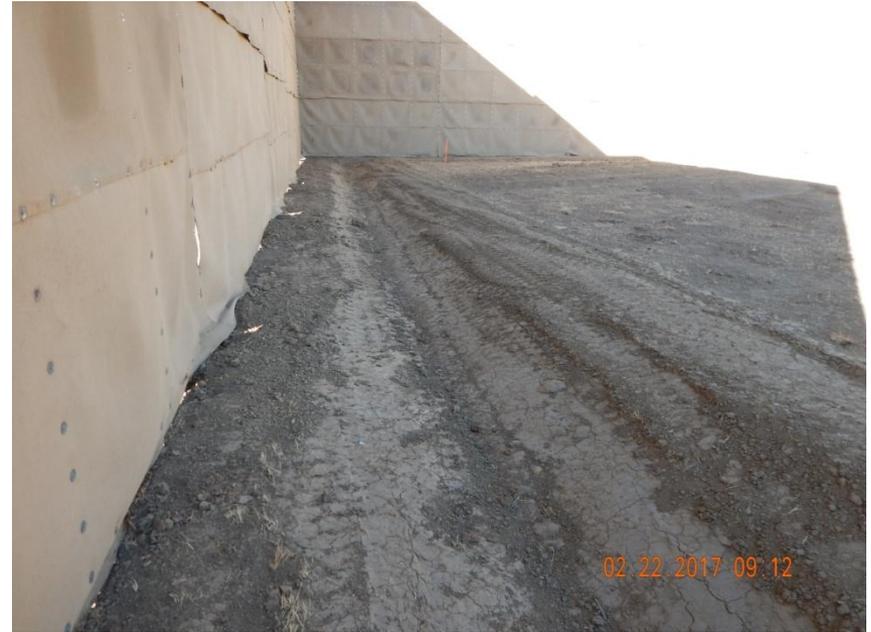
**Photo 2.** Photo taken from the northeast location, facing West. Ditch and berm BMP installed.

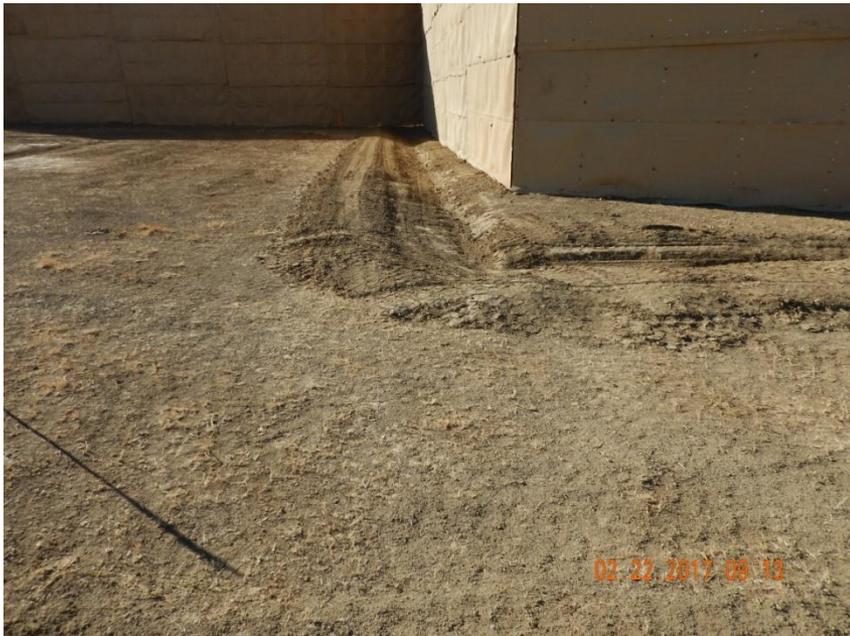
**Photo 3.** Photo taken from the northeast location, facing South. Ditch and berm BMP installed.

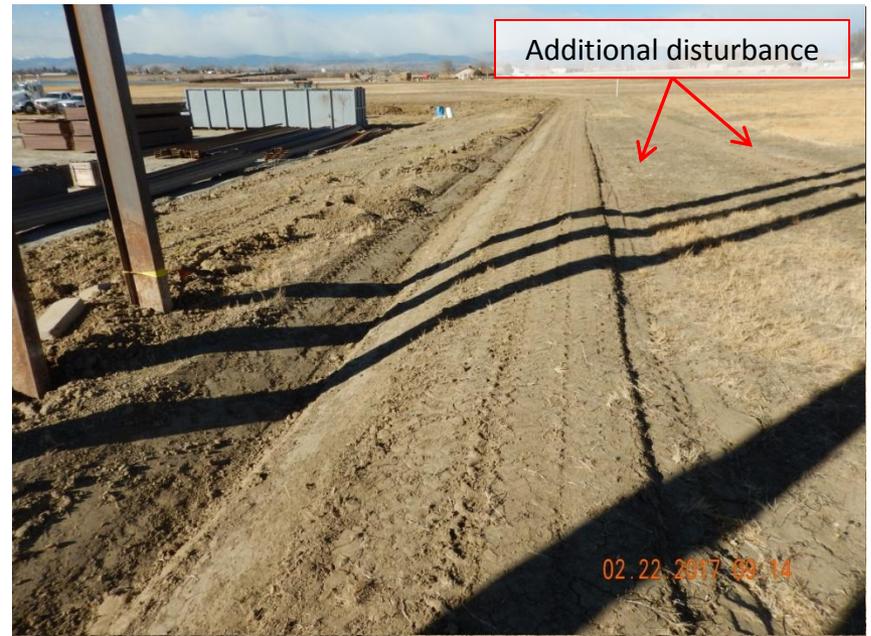
**Photo 4.** Photo taken from the northern location, facing Southwest. Ditch and berm BMP installed.

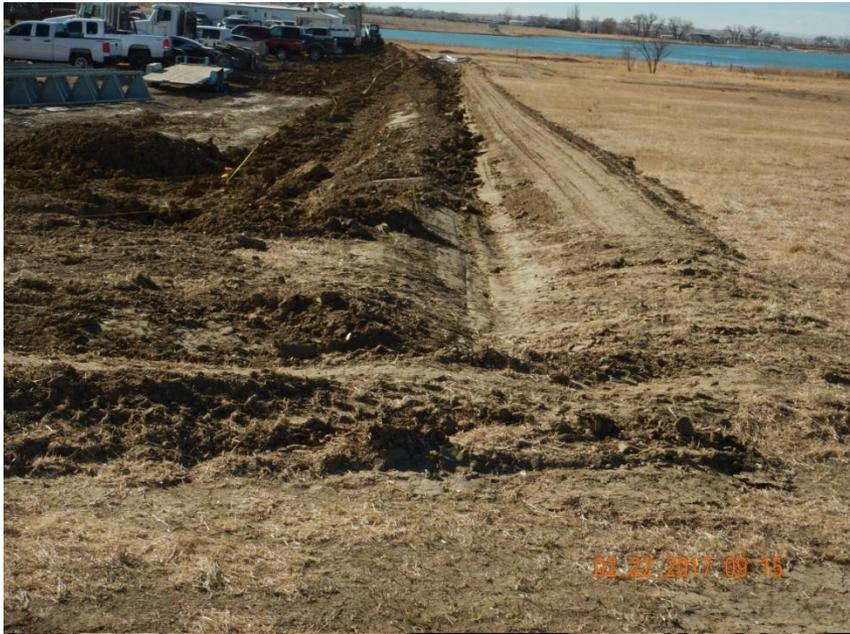
**Photo 5.** Photo taken from the northwest location, facing South. Ditch and berm BMP installed.

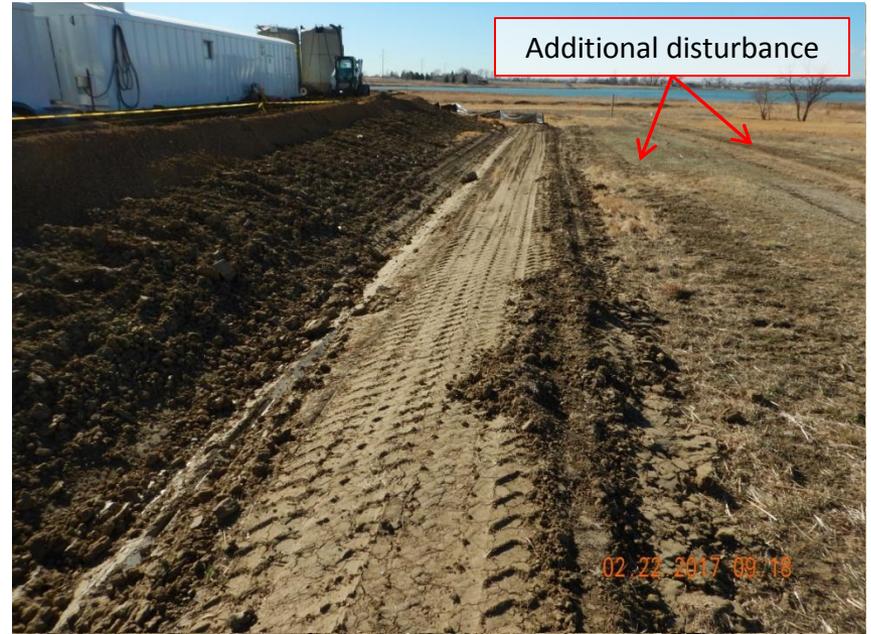
**Photo 6.** Photo taken from the western location, facing South. Ditch and berm BMP installed.

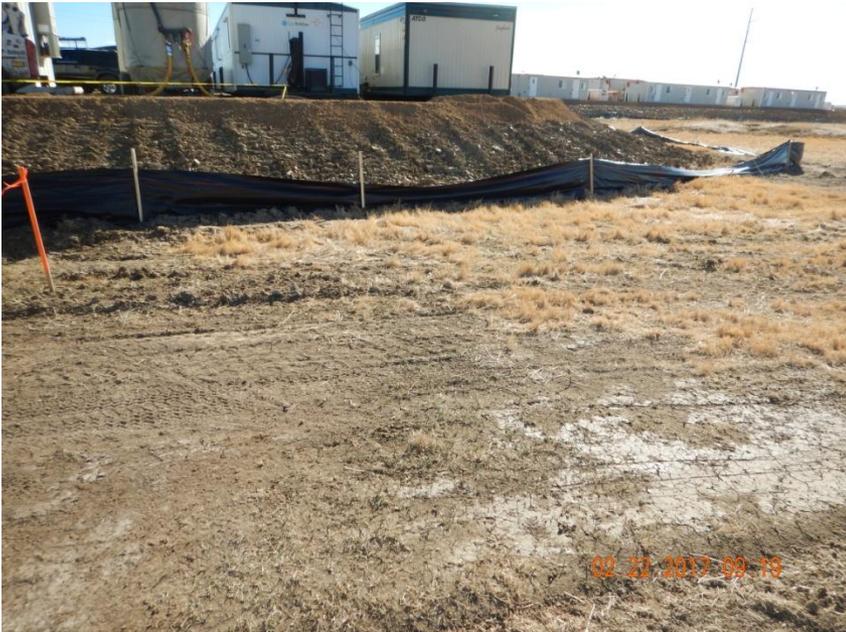
**Photo 7.** Photo taken from the southwestern location, facing East. Silt fence BMP installed but needs maintenance and repairs. BMP not in proper functioning condition. Stakes appear to be installed too far apart (i.e., 15' or more apart).

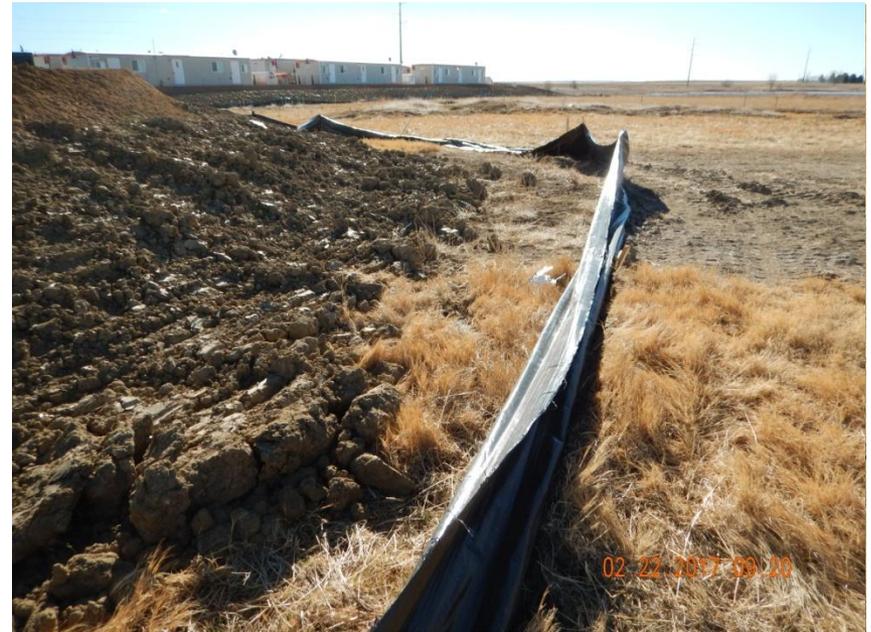
**Photo 8.** Photo taken from the southwestern location, facing South. Silt fence BMP installed but needs maintenance and repairs. BMP not in proper functioning condition. Stakes appear to be installed too far apart (i.e., 15' or more apart).

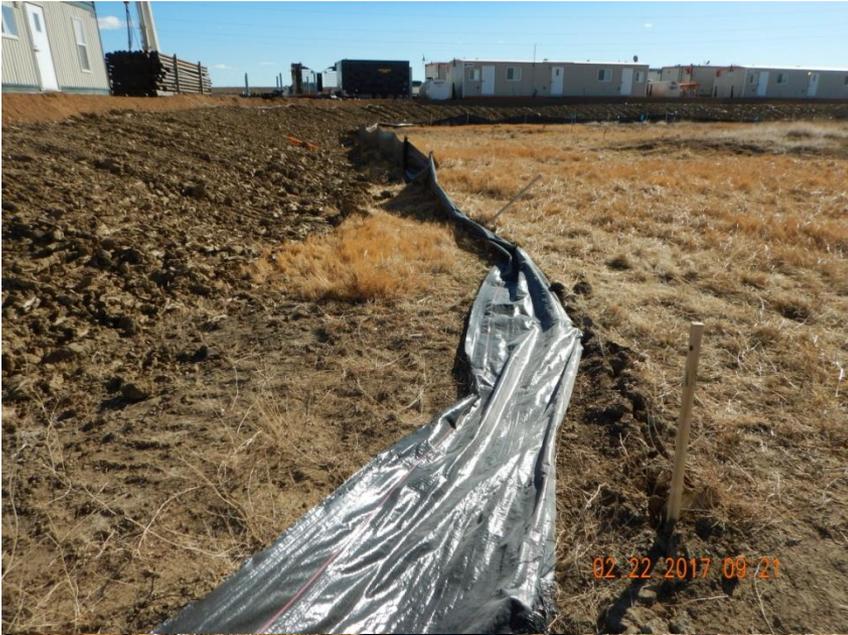
**Photo 9.** Photo taken from the southwestern location, facing East. Silt fence BMP installed but needs maintenance and repairs. BMP not in proper functioning condition. Stakes appear to be installed too far apart (i.e., 15' or more apart).

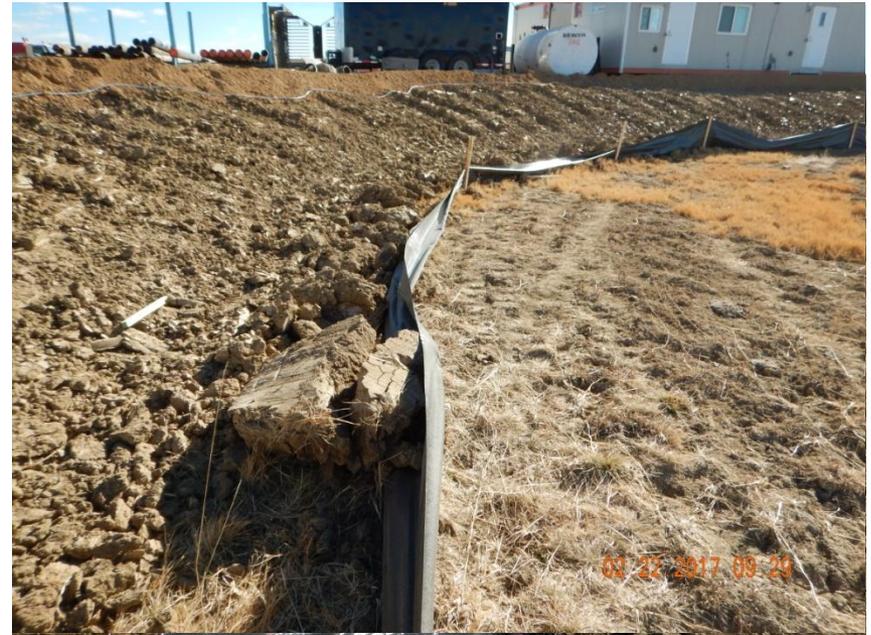
**Photo 10.** Photo taken from the southwestern location, facing East. Silt fence BMP installed but needs maintenance and repairs. BMP not in proper functioning condition. Stakes appear to be installed too far apart (i.e., 15' or more apart) and excessive soil material against BMP.

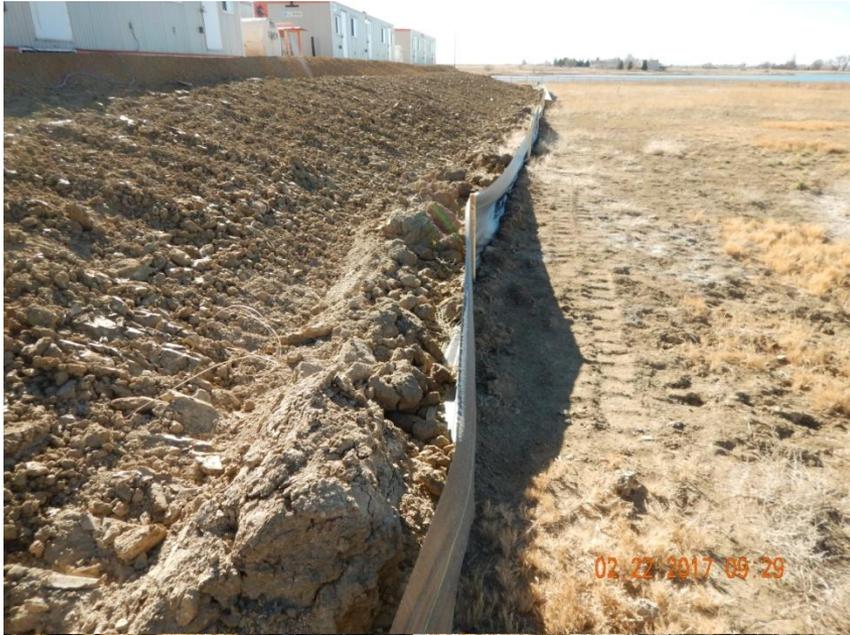
**Photo 11.** Photo taken from the southwestern location, facing South. Silt fence BMP installed but needs maintenance and repairs. BMP not in proper functioning condition. Stakes appear to be installed too far apart (i.e., 15' or more apart) and excessive soil material against BMP.

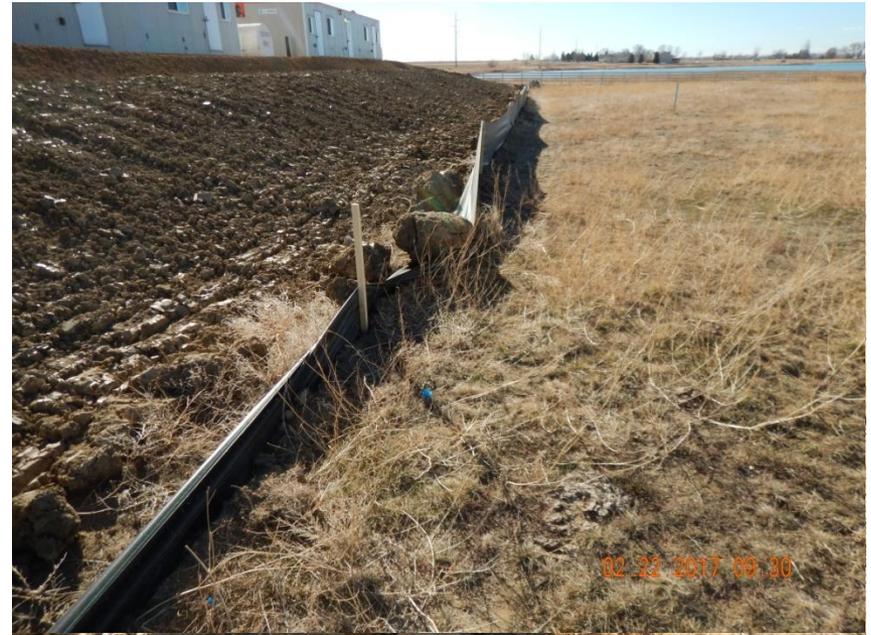
**Photo 12.** Photo taken from the southwestern location, facing South. Silt fence BMP installed but needs maintenance and repairs. BMP not in proper functioning condition. Stakes appear to be installed too far apart (i.e., 15' or more apart) and excessive soil material against BMP.

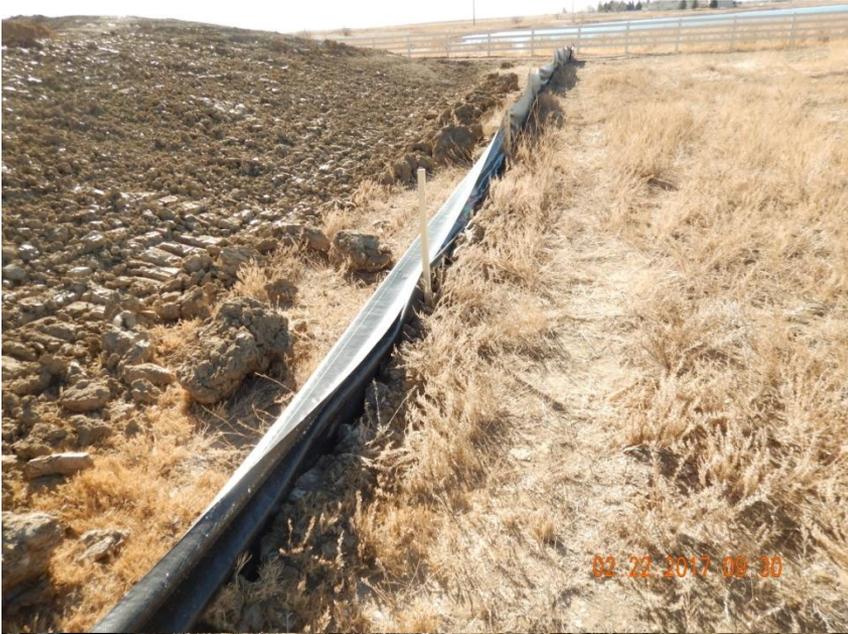
**Photo 13.** Photo taken from the southwestern location, facing South. Silt fence BMP installed but needs maintenance and repairs. BMP not in proper functioning condition. Stakes appear to be installed too far apart (i.e., 15' or more apart).

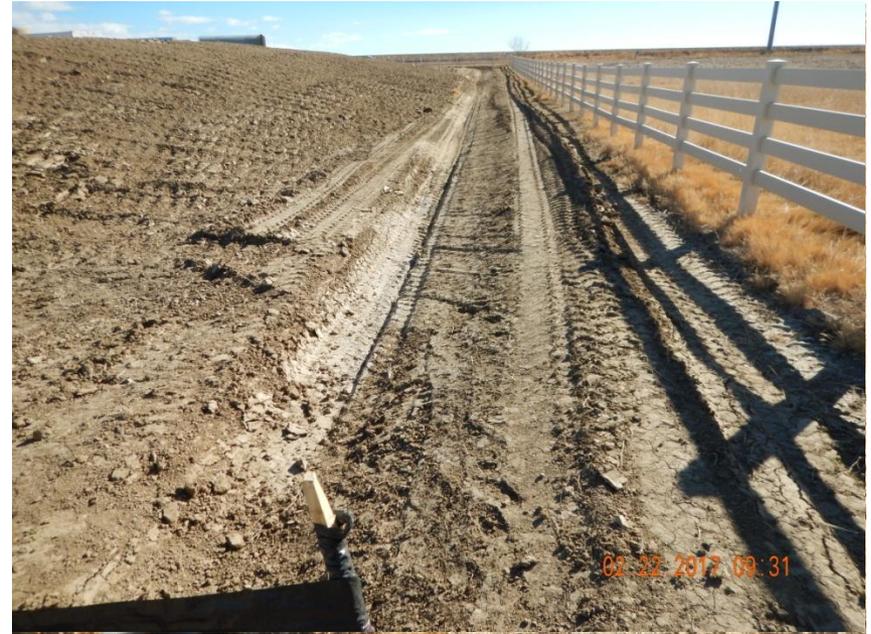
**Photo 14.** Photo taken from the southwest location, facing East. Ditch and berm BMP installed outside of the topsoil stockpile.

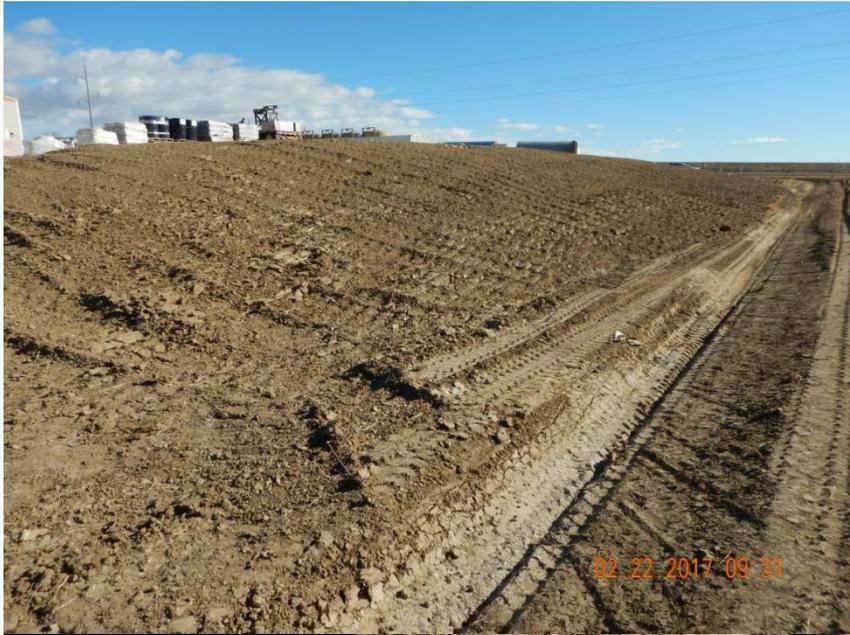
**Photo 15.** Photo taken from the southern location, facing Northeast, towards the topsoil stockpile.

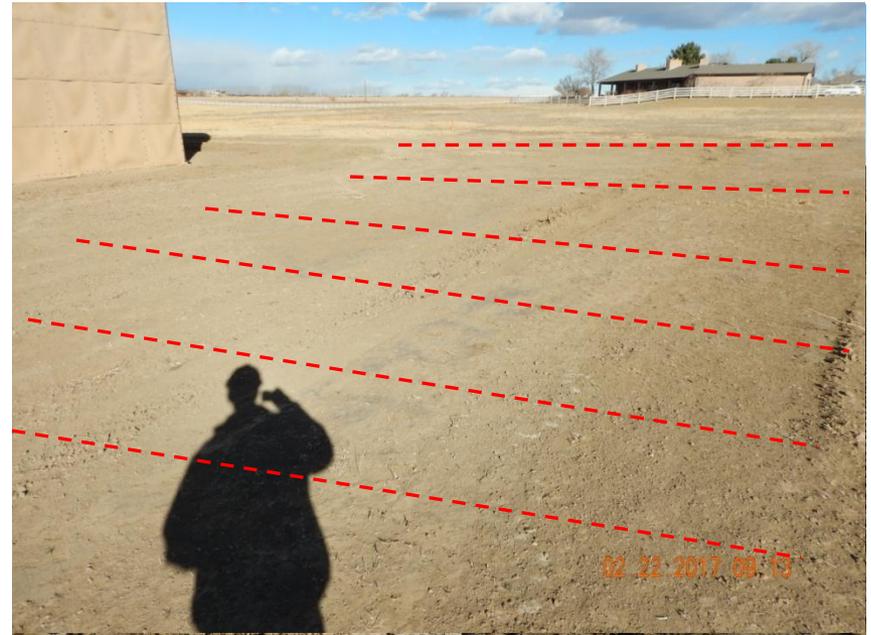
**Photo 16.** Photo taken from the northeast location, facing Northwest. Operator created additional disturbance from initial construction build which is outside of the current construction area (red-dashed line).

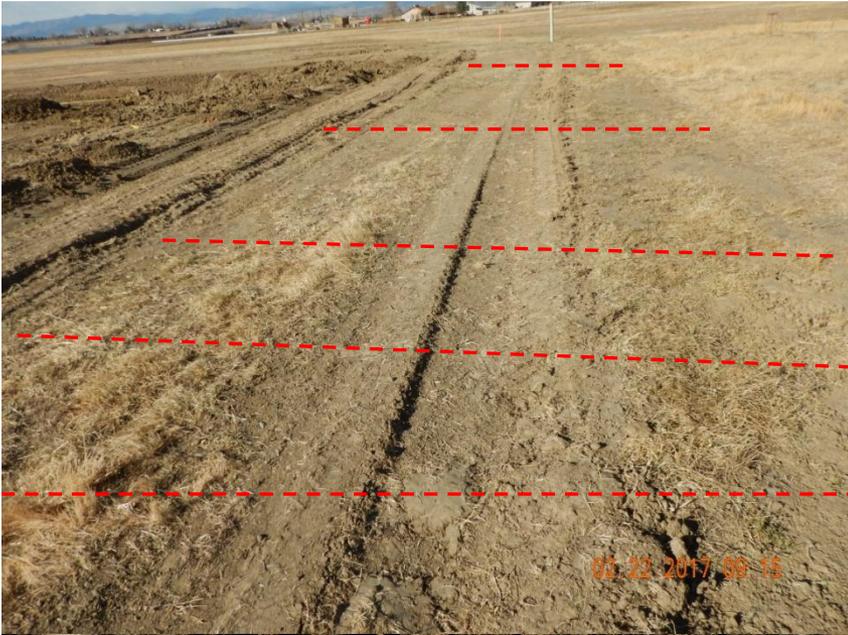
**Photo 17.** Photo taken from the northern location, facing West. Operator created additional disturbance from initial construction build which is outside of the current construction area (red-dashed line).

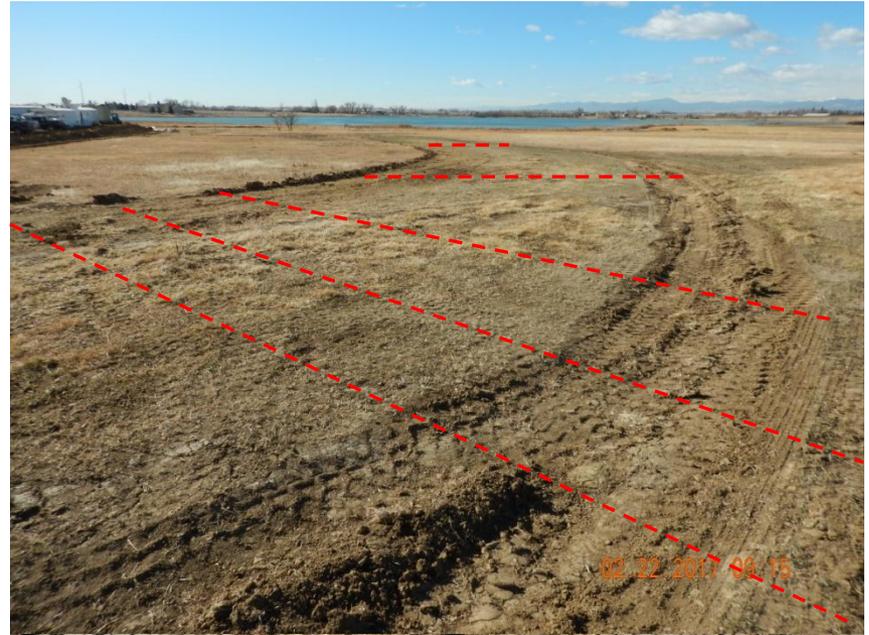
**Photo 18.** Photo taken from the northwest location, facing Southwest. Operator created additional disturbance from initial construction build which is outside of the current construction area (red-dashed line).

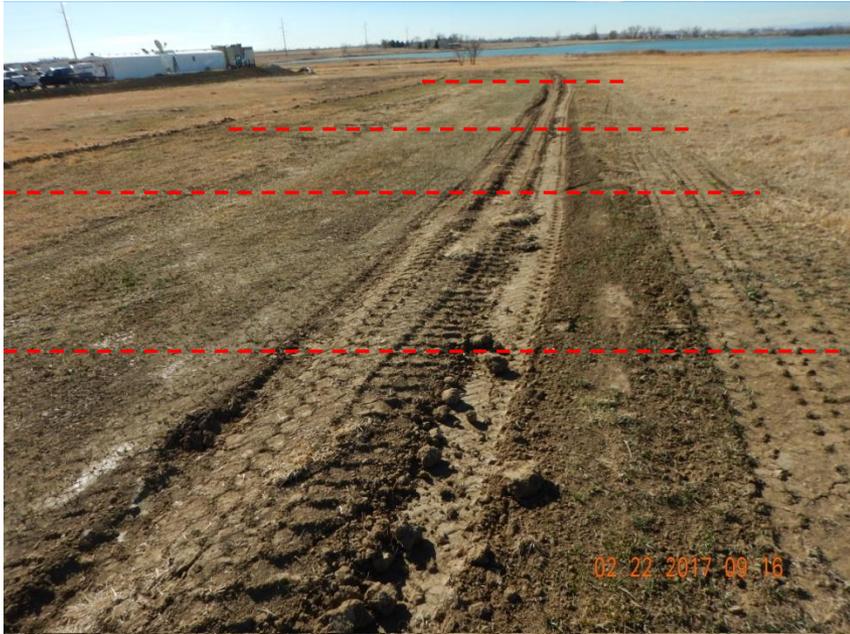
**Photo 19.** Photo taken from the western location, facing South. Operator created additional disturbance from initial construction build which is outside of the current construction area (red-dashed line).

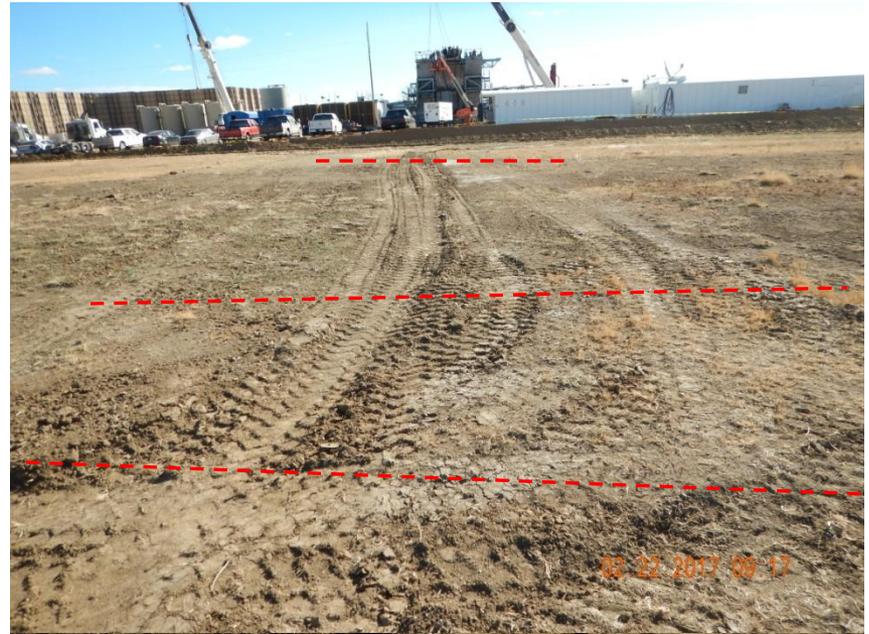
**Photo 20.** Photo taken from the western location, facing East. Operator created additional disturbance from initial construction build which is outside of the current construction area (red-dashed line).

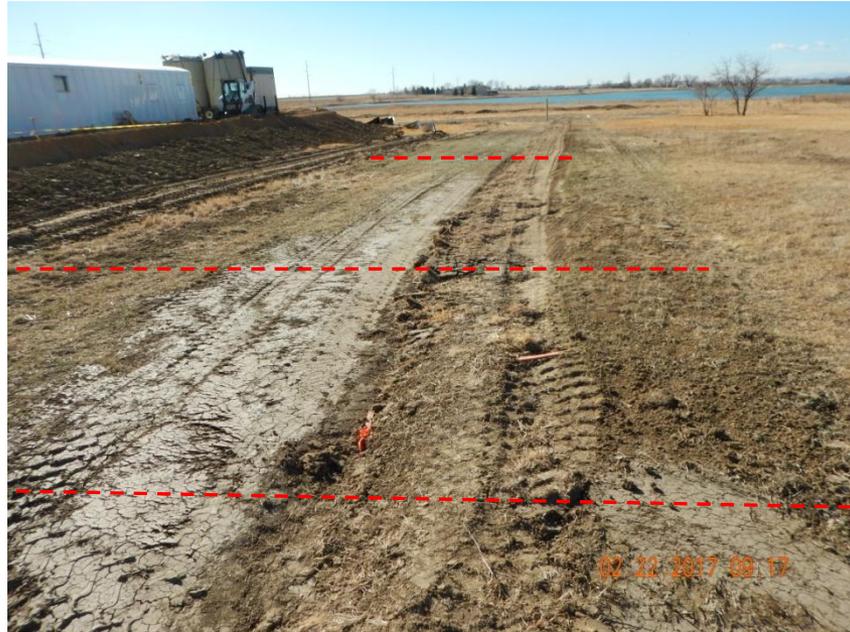
**Photo 21.** Photo taken from the southwestern location, facing South. Operator created additional disturbance from initial construction build which is outside of the current construction area (red-dashed line).
