Reclamation Inspection

Operator: Whiting Oil and Gas #96155

Location ID: 444471

Inspection Doc. Number: 682501694

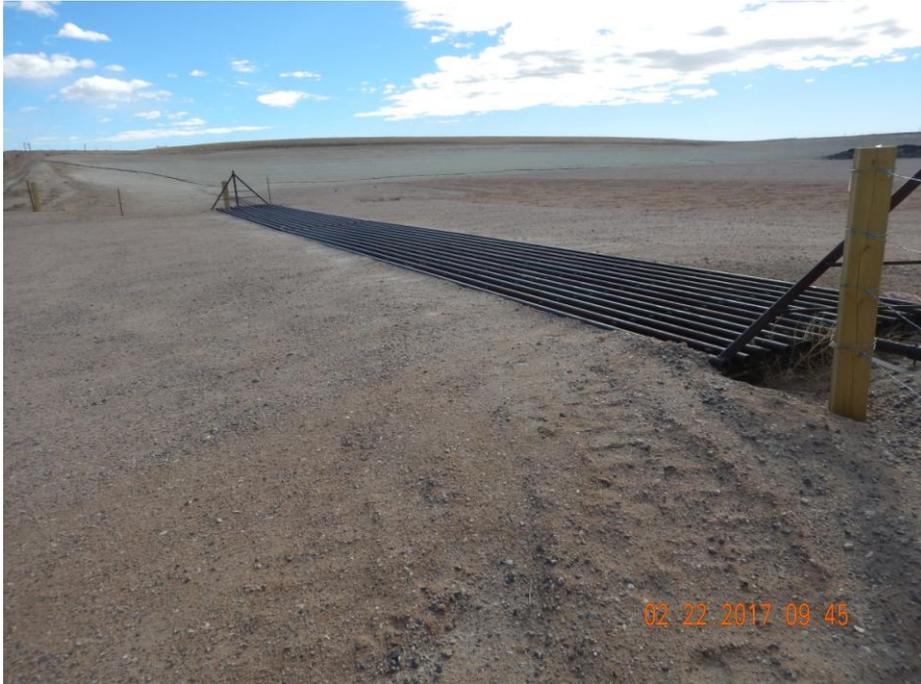
Photo 1: Photo taken from the north end of the location, facing southeast. Photo shows vehicle tracking BMP as entrance to location.

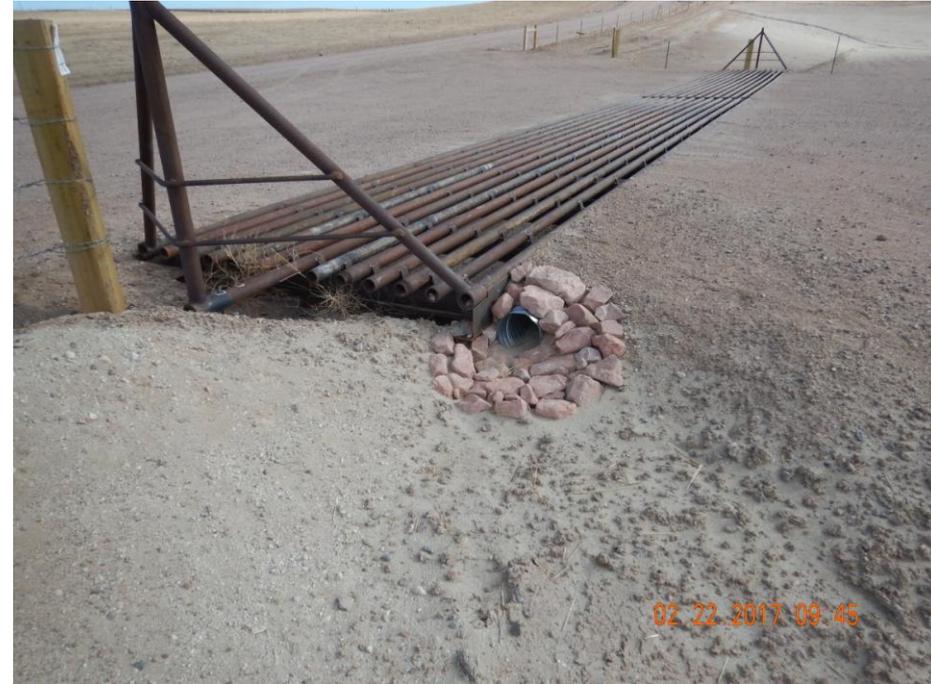
Photo 2: Photo taken from the north end of the location, facing east. Photo shows vehicle tracking BMP at entrance to location and culvert with rock armoring.

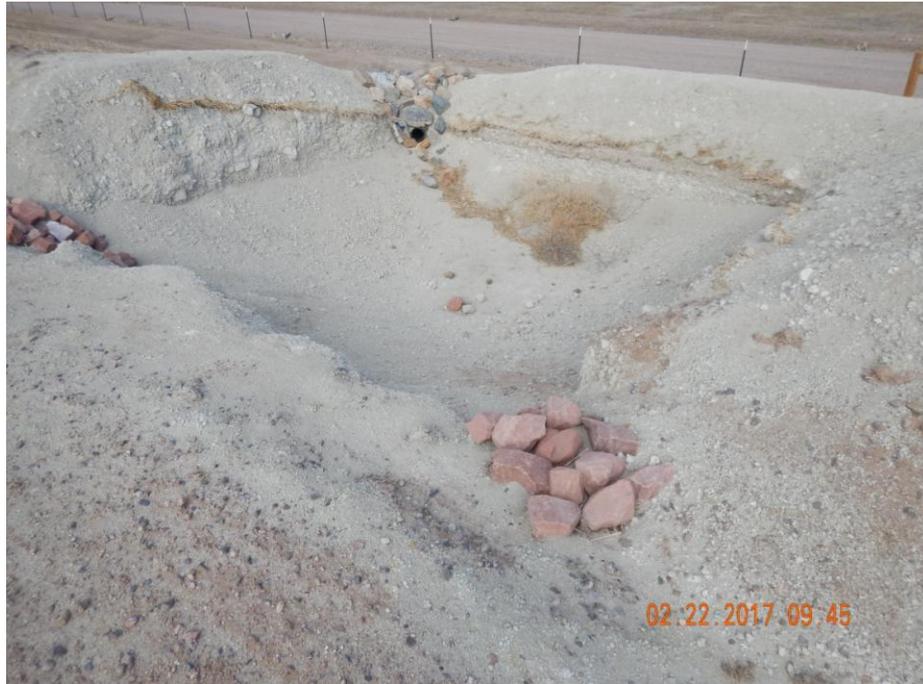
Photo 3: Photo taken from the north end of the location. Photo shows sediment trap used as a stormwater and sediment control BMP. Inlets and outlet contain armoring. Drain incorporated in outlet.

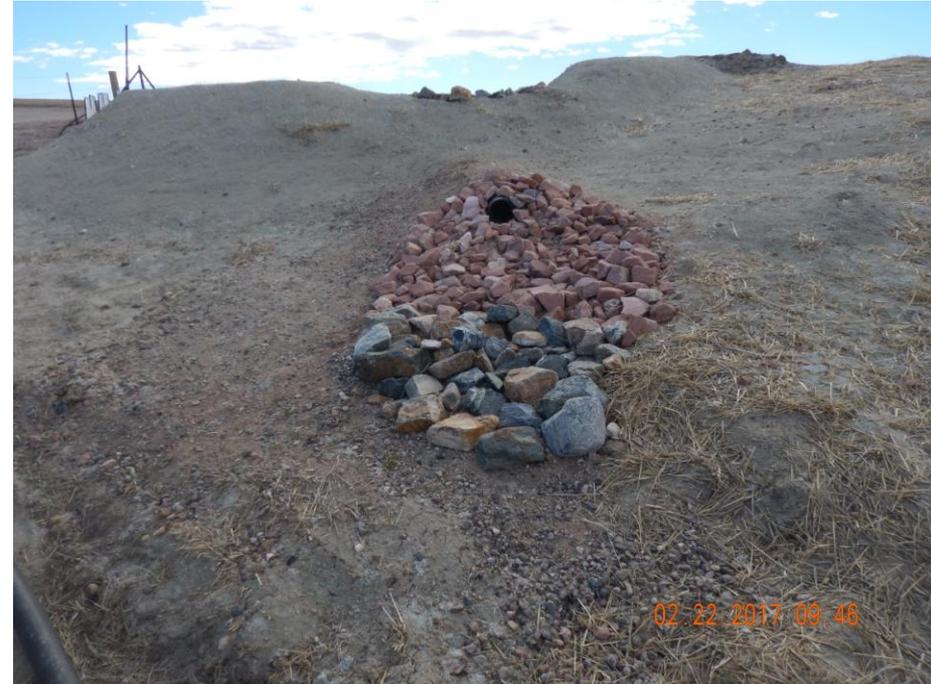
Photo 4: Photo taken from the north end of the location. Photo shows sediment trap used as a stormwater and sediment control BMP. Photo shows armoring around outlet drain, that leads into a stormwater ditch on the north perimeter.

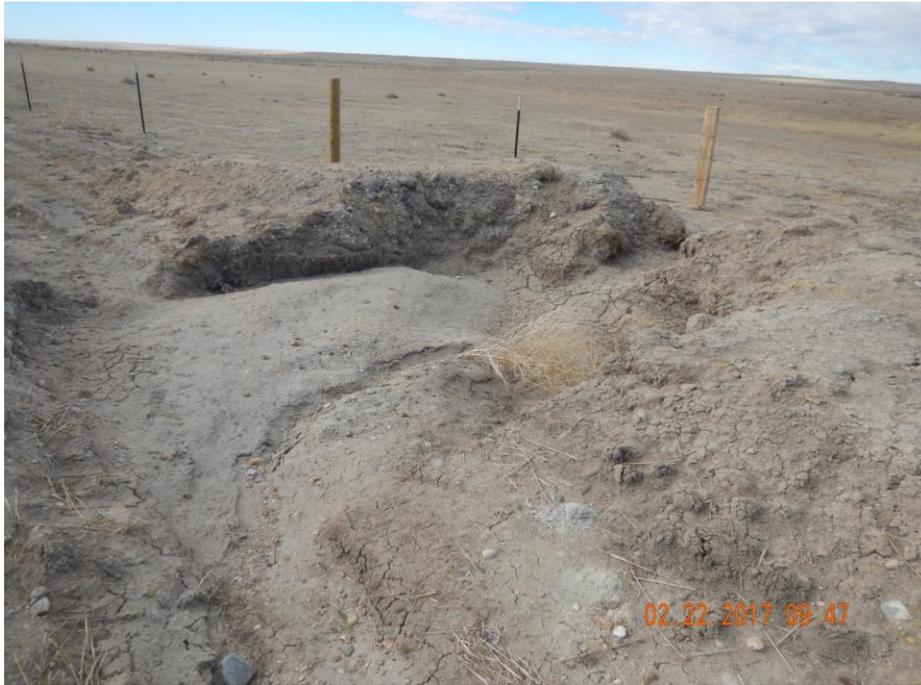
Photo 5: Photo taken from the northwest end of the location. Photo shows sediment trap used as a stormwater and sediment control BMP. Sediment trap appears inadequate and improperly constructed. Sediment trap has insufficient inlet and outlet protection. Photo shows trap has filled with sediment and will require maintenance.

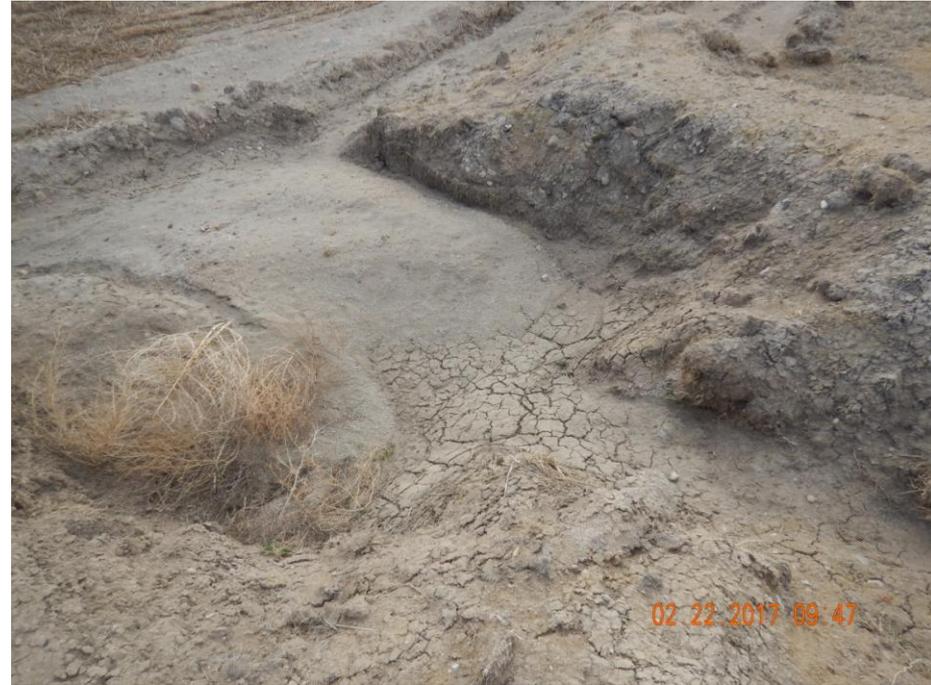
Photo 6: Photo taken from the northwest end of the location. Photo shows sediment trap used as a stormwater and sediment control BMP. Sediment trap appears inadequate and improperly constructed. Sediment trap has insufficient inlet and outlet protection. Photo shows trap has filled with sediment and will require maintenance.

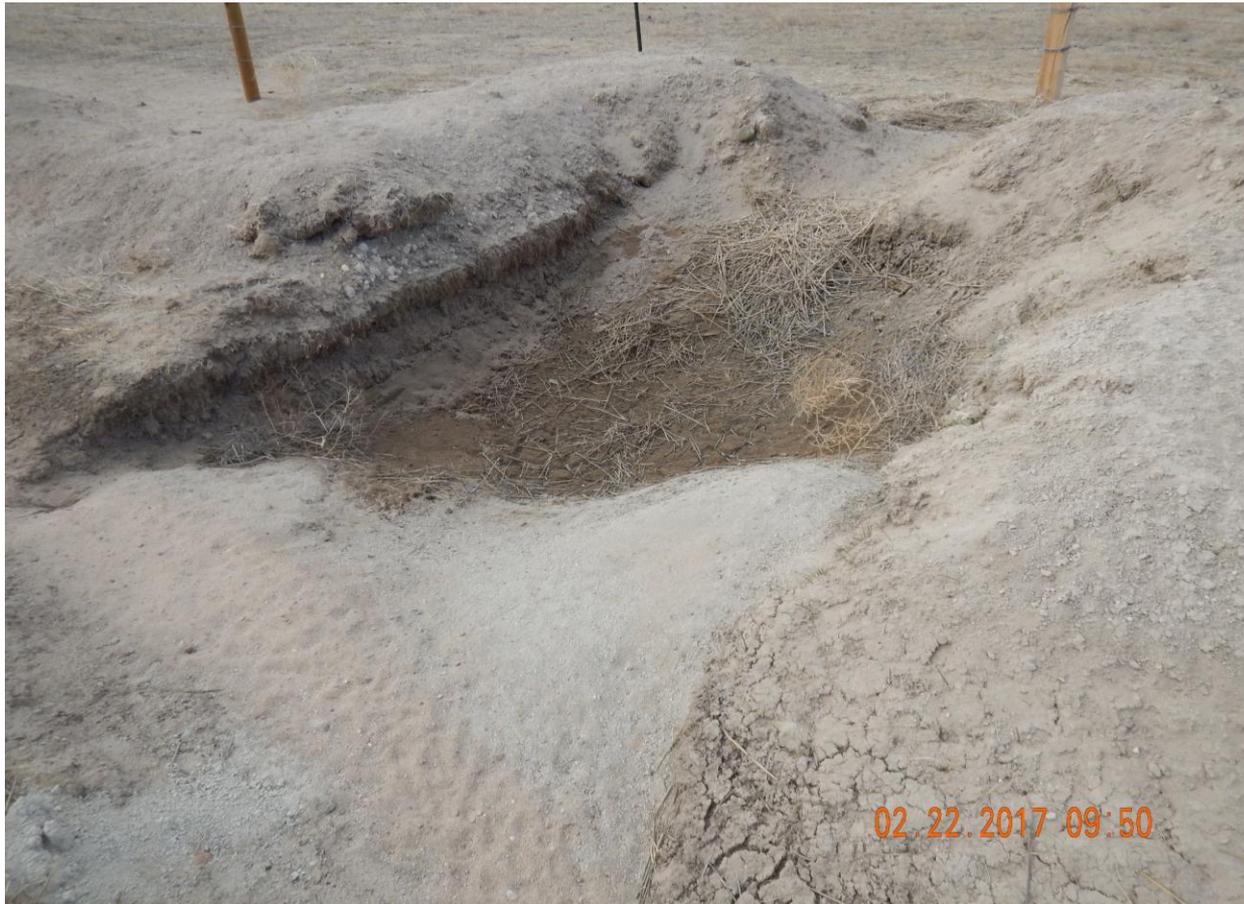
Photo 7: Photo taken from the west end of the location. Photo shows sediment trap used as a stormwater and sediment control BMP. Sediment trap appears inadequate and improperly constructed. Sediment trap has insufficient inlet and outlet protection. Photo shows trap has filled with sediment and will require maintenance.

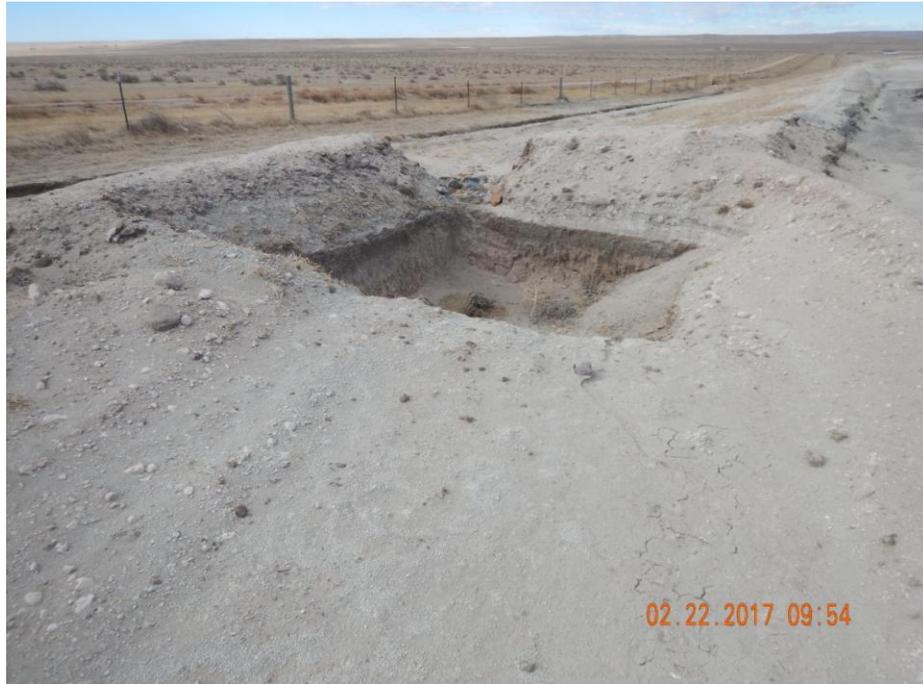
Photo 8: Photo taken from the south end of the location. Photo shows sediment trap used as a stormwater and sediment control BMP. Sediment trap has insufficient inlet protection. Sediment has begun to fill with sediment and will require maintenance.

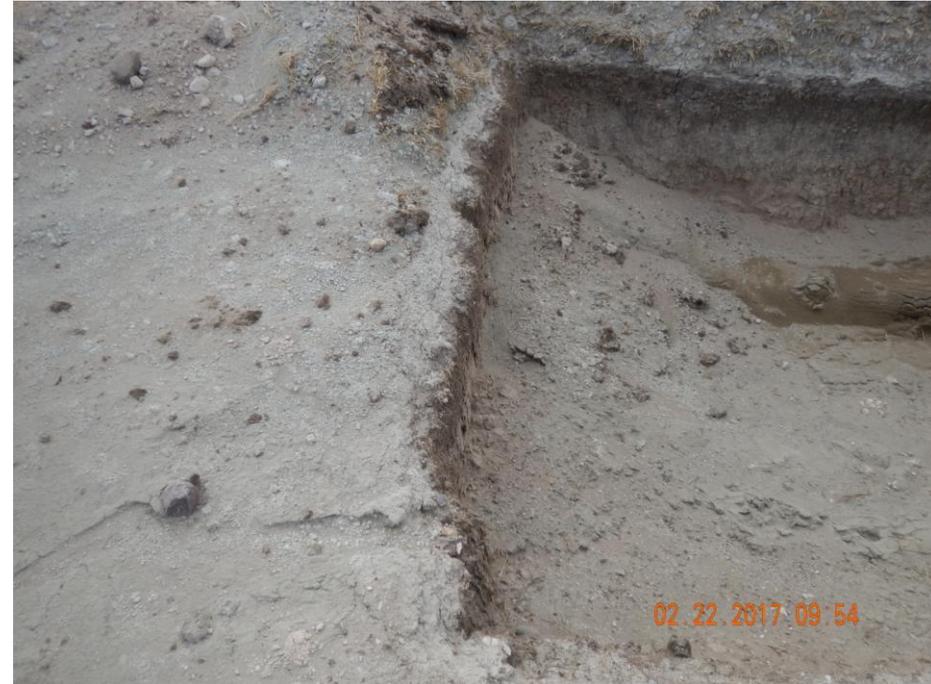
Photo 9: Photo taken from the south end of the location. Photo shows sediment trap used as a stormwater and sediment control BMP. Sediment trap has insufficient inlet protection. Photo shows inlet as been inadequately constructed; it is advised that inlets are constructed with a 2:1 slope, or flatter.

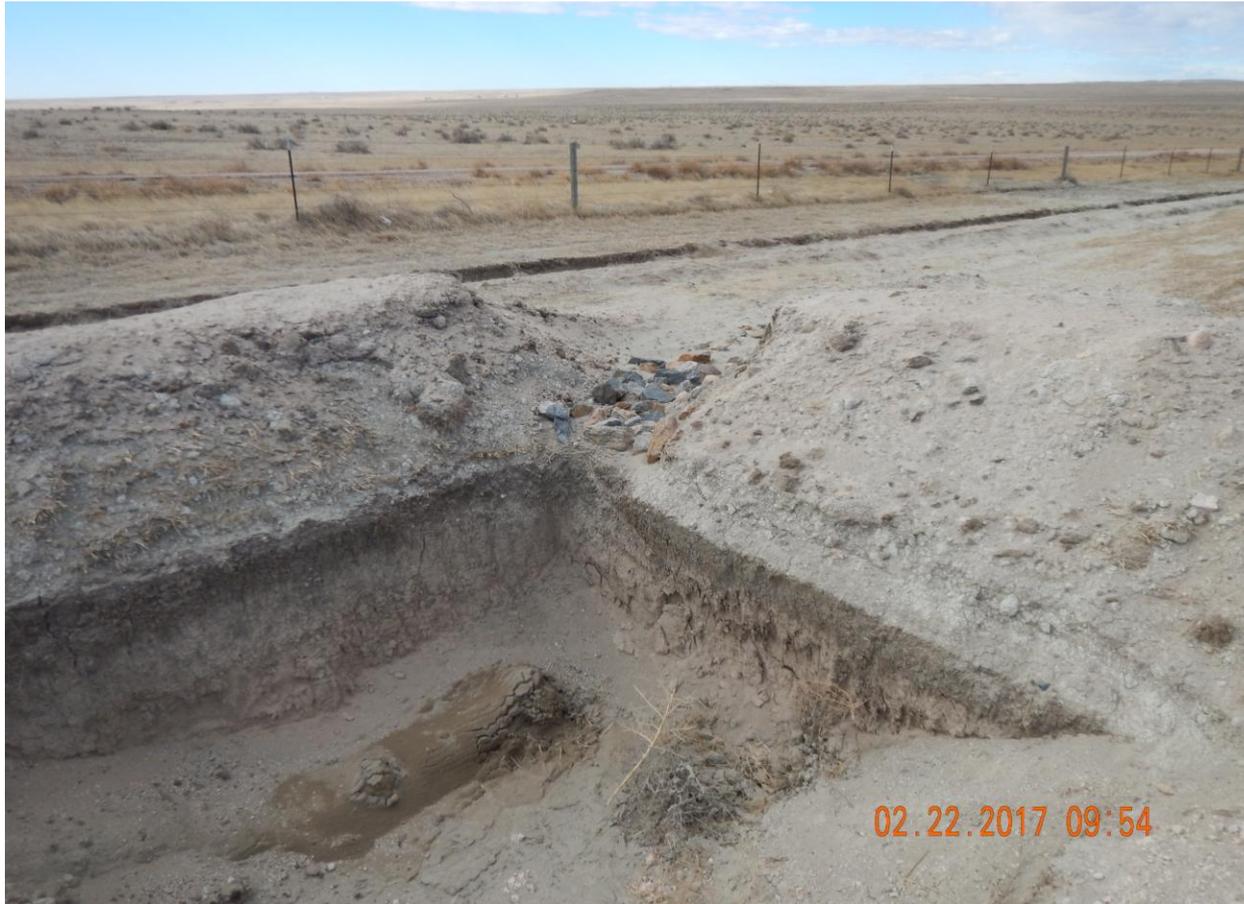
Photo 10: Photo taken from the south end of the location, facing south. Photo shows sediment trap used as a stormwater and sediment control BMP. Photo shows armoring around outlet. Current rock armoring may be insufficient and appears to have filled with sediment.

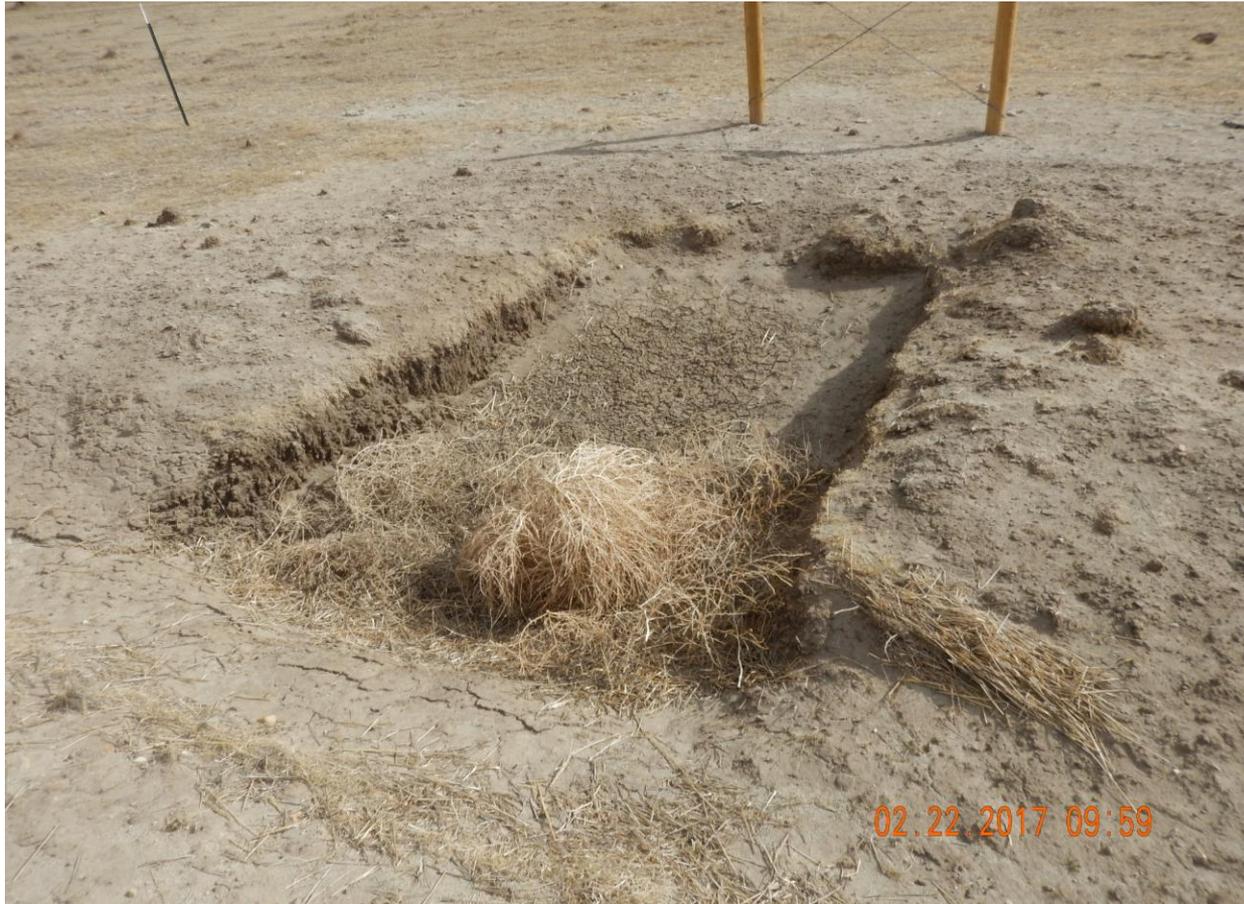
Photo 11: Photo taken from the east end of the location. Photo shows sediment trap used as a stormwater and sediment control BMP. Sediment trap appears inadequate and improperly constructed. Sediment trap has insufficient inlet and outlet protection. Sediment trap appears inadequate and improperly constructed.

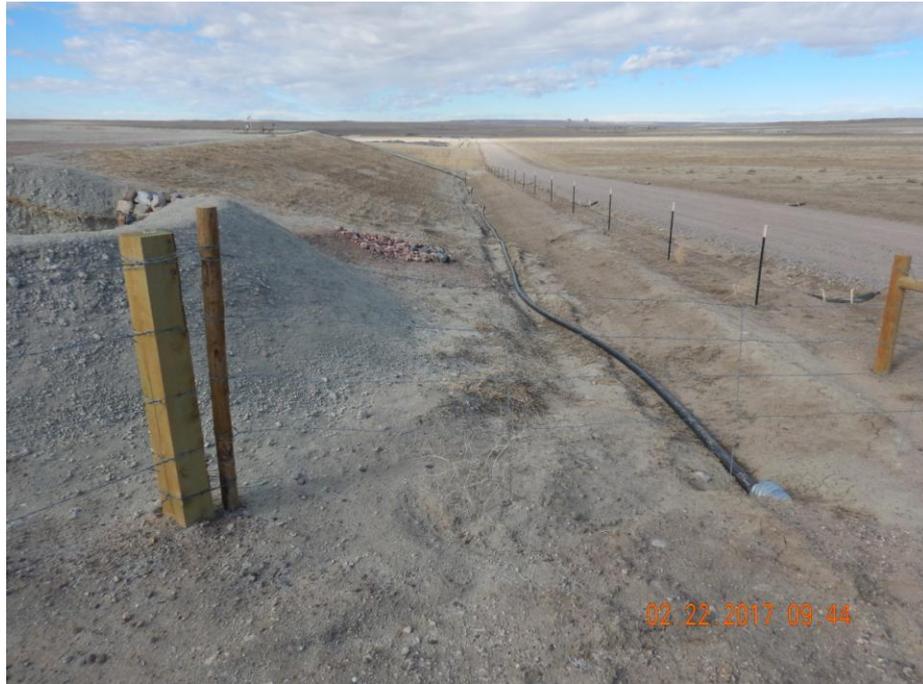
Photo 12: Photo taken from the location entrance on the north end of the location, facing west. Photo shows stormwater control ditch along perimeter.

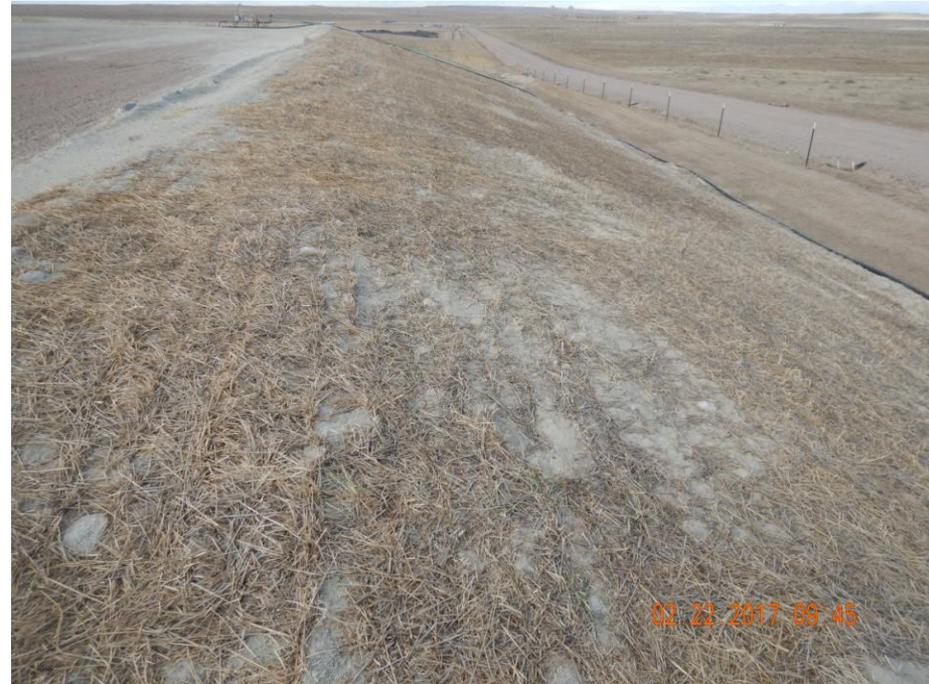
Photo 13: Photo taken from the north end of the location, facing west. Photo shows slopes on the north end of the location appear to be seeded, and crimped with straw to stabilize the soil.

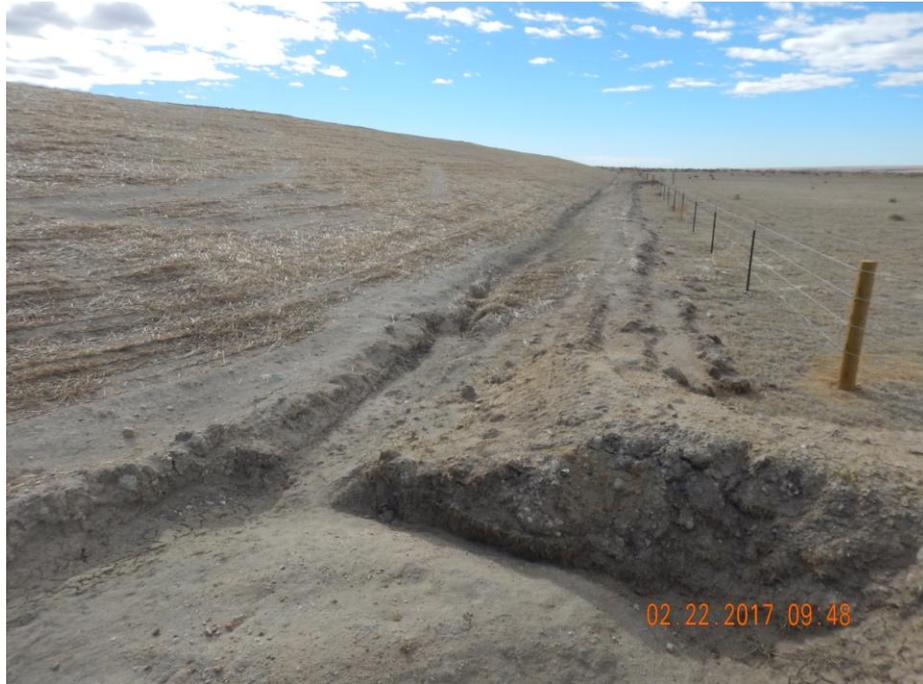
Photo 14: Photo taken from the northwest corner of the location, facing south. Photo shows stormwater control ditch along perimeter of the location. Photo also shows slopes on the west end of the location appear to be seeded, and crimped with straw to stabilize the soil.

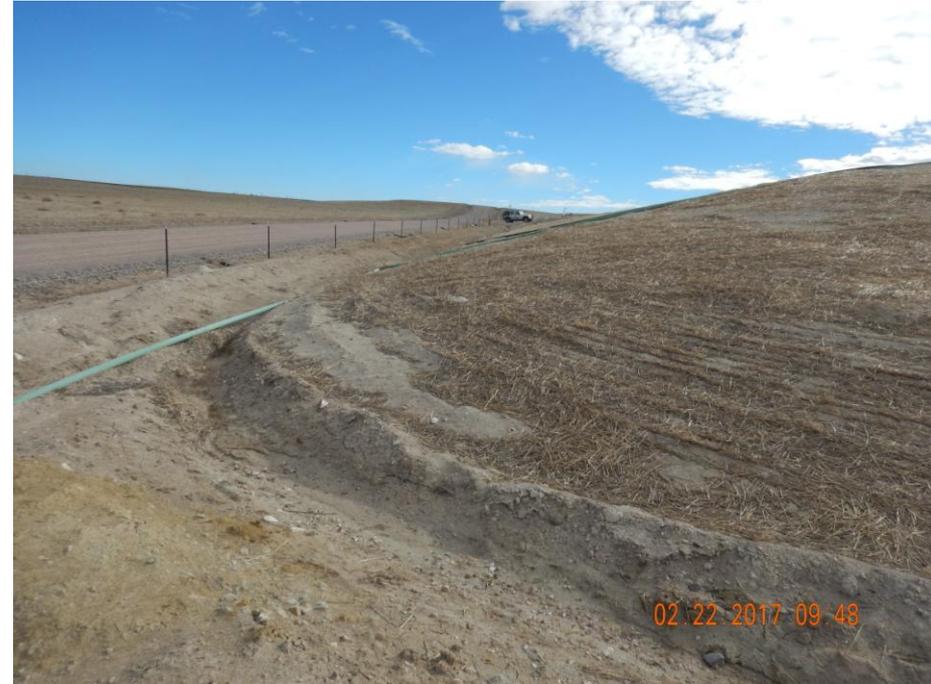
Photo 15: Photo taken from the northwest corner of the location, facing east. Photo shows stormwater control ditch along perimeter of the location.

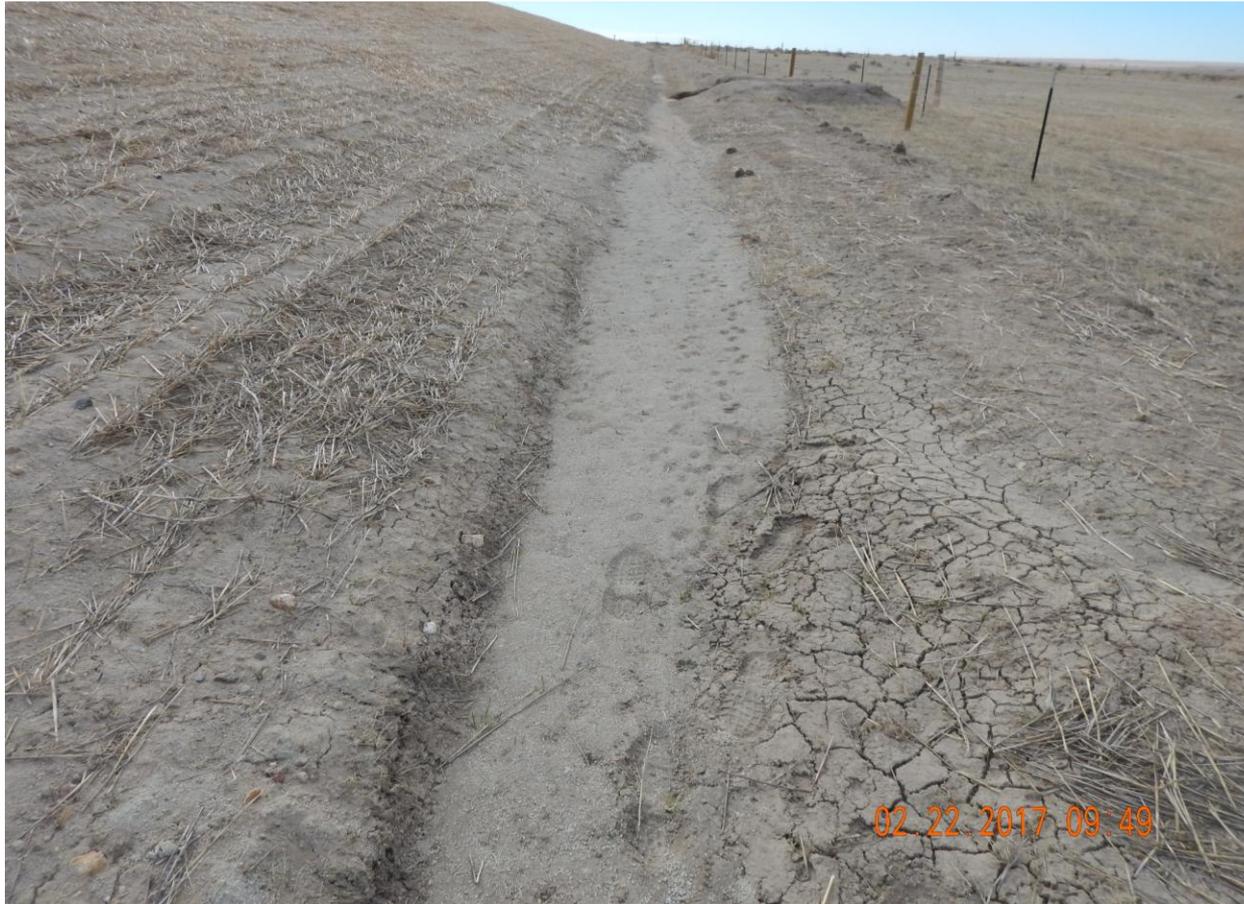
Photo 16: Photo taken from the west end of the location, facing south. Photo shows stormwater ditch has filled with sediment and no longer in proper functioning condition. Ditch will require maintenance.

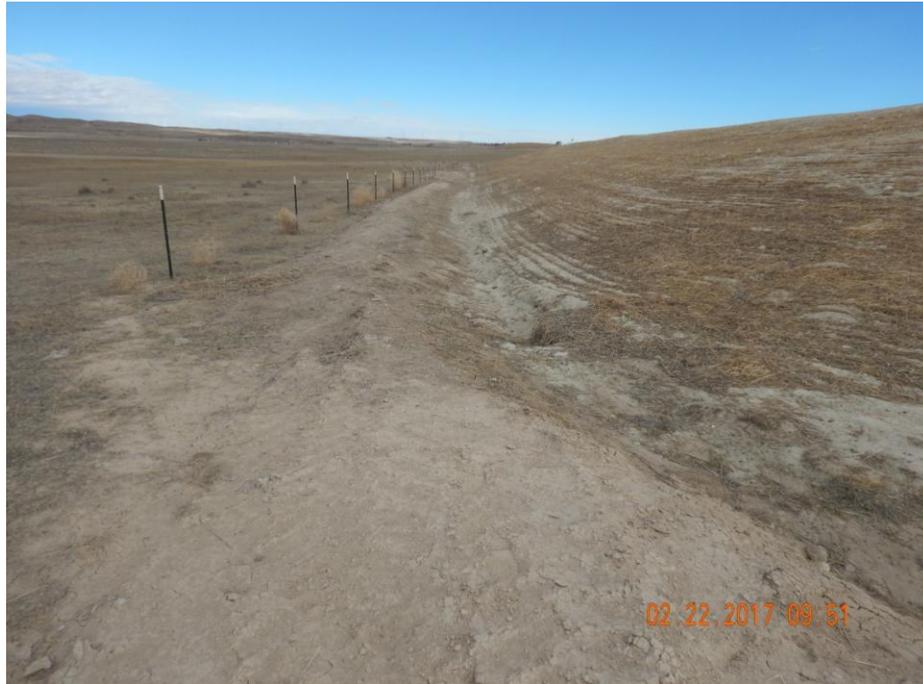
Photo 17: Photo taken from the southwest corner of the location, facing north. Photo shows stormwater control ditch along perimeter of the location.

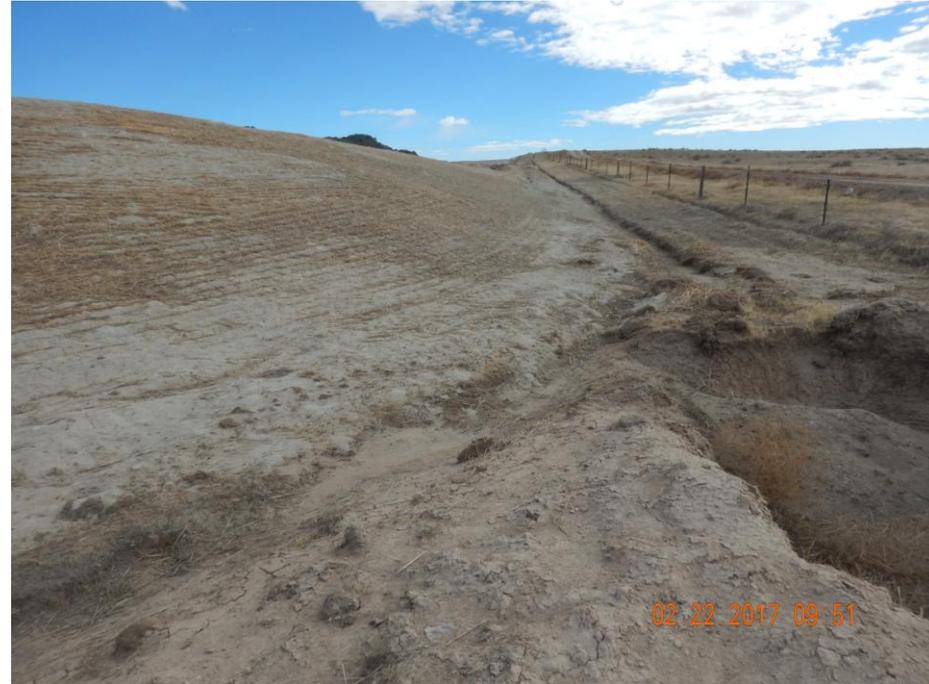
Photo 18: Photo taken from the northwest corner of the location, facing east. Photo shows stormwater control ditch along perimeter of the location. Photo also shows slopes on the south end of the location appear to have been seeded, and crimped with straw to stabilize the soil.

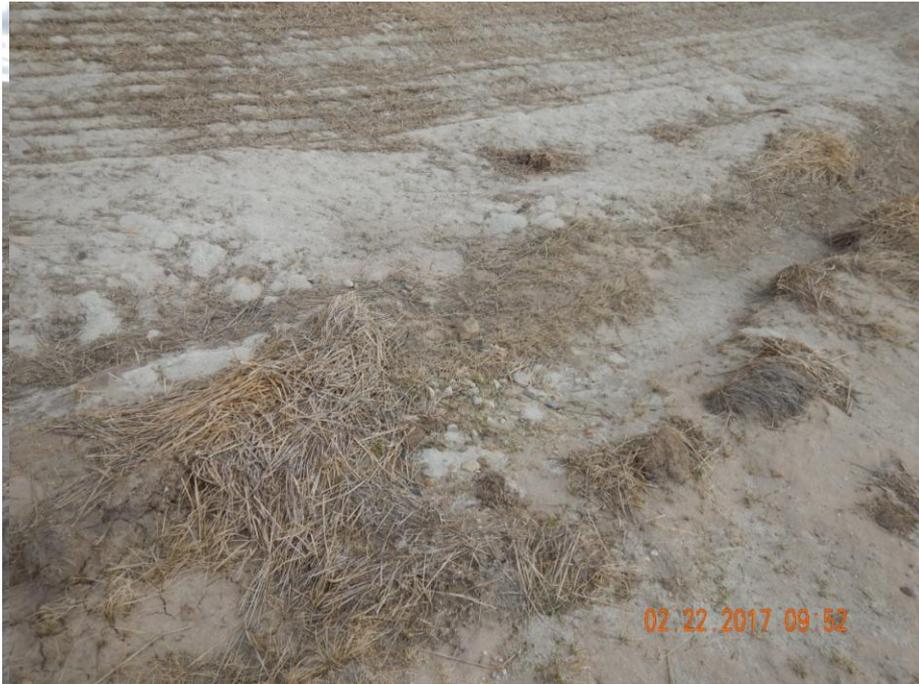
Photo 19: Photo taken from the south end of the location. Photo shows stormwater ditch has filled with sediment and no longer in proper functioning condition. Ditch will require maintenance.

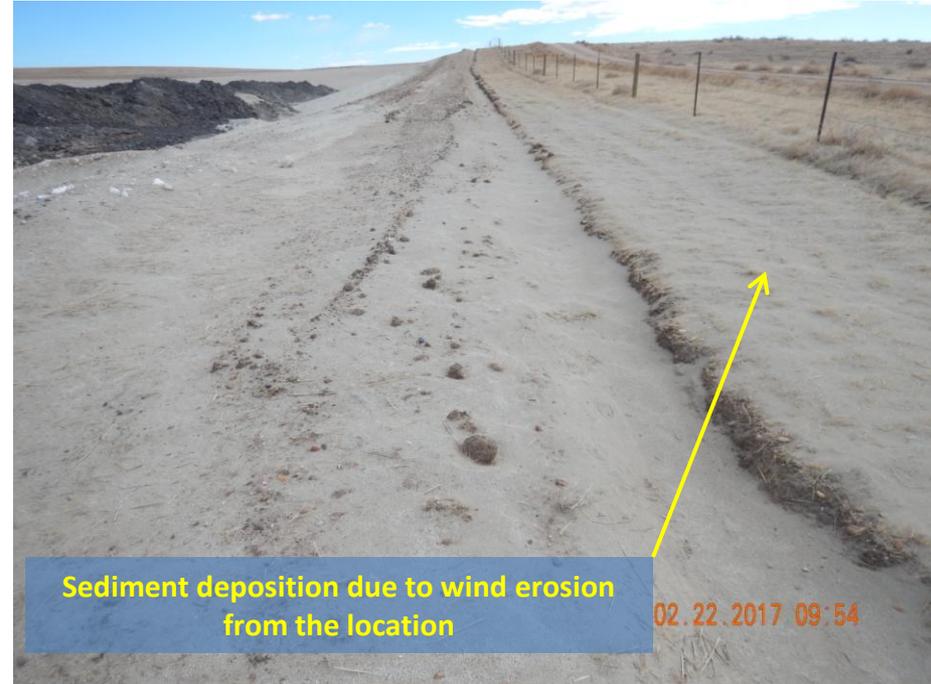
Photo 20: Photo taken from the south end of the location, facing east. Photo shows stormwater ditch has filled with sediment and no longer in proper functioning condition. Ditch will require maintenance. Photo also shows areas outside of the location where wind erosion has deposited sediment from the location.

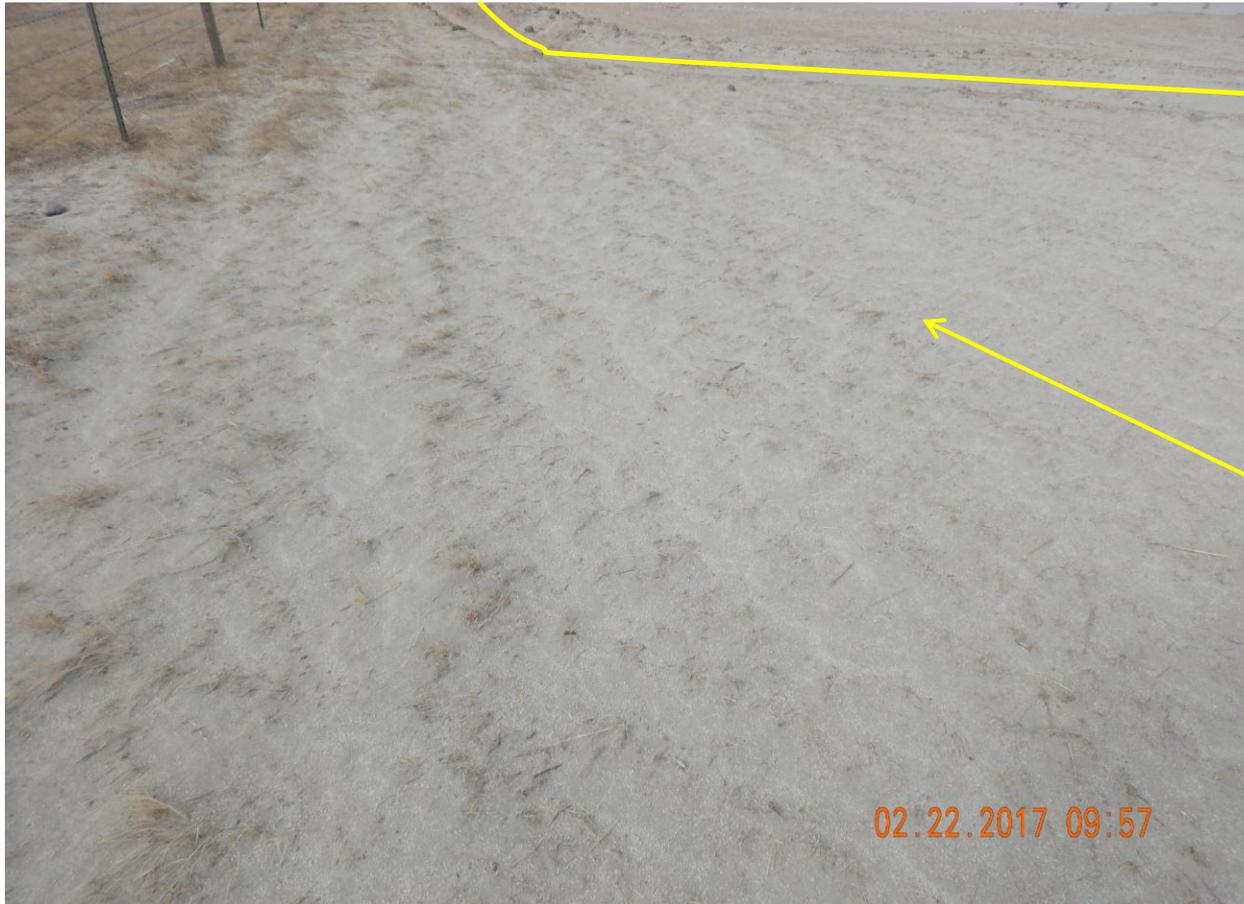
Sediment deposition
due to wind erosion
from the location

Photo 21: Photo taken from the southeast corner of the location. Photo shows areas outside of the location where wind erosion has deposited sediment from the location. Yellow line represents stormwater control ditch that exists along the perimeter of the location. Areas below line seen in photo is rangeland that was not disturbed during the construction activities of the location.

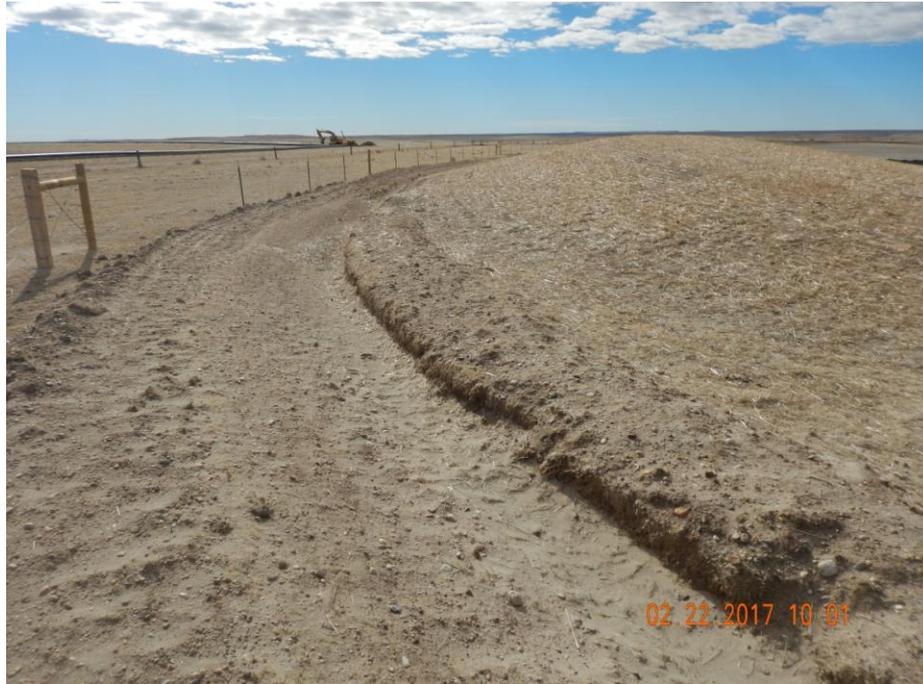
Photo 22: Photo taken from the northeast corner of the location, facing south. Photo shows stormwater control ditch along perimeter of the location. Photo also shows topsoil berm located on the east end of the location. Berm appears to have been seeded, and crimped with straw to stabilize the soil.

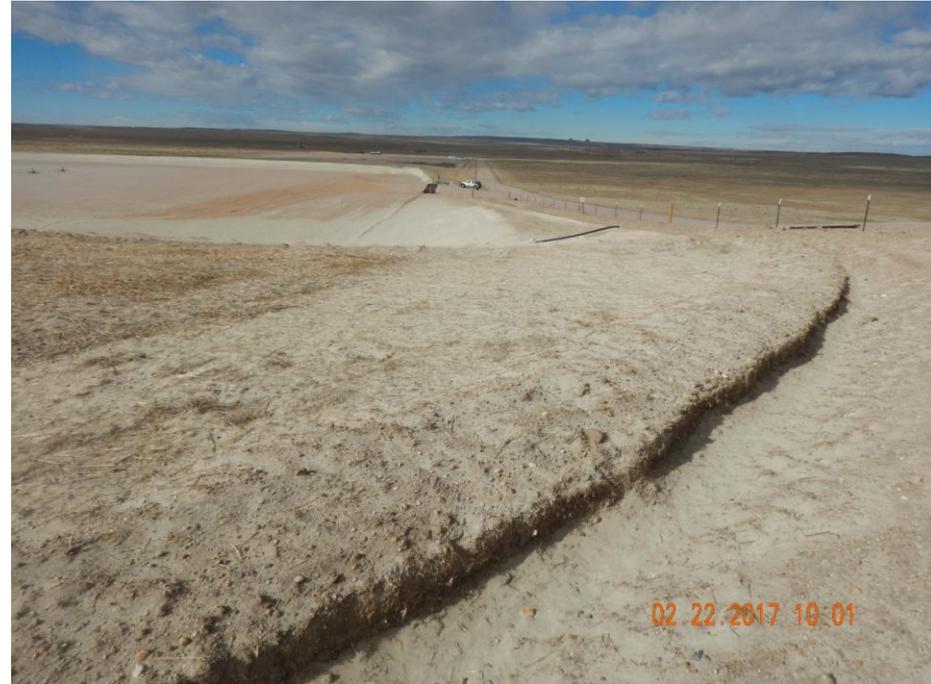
Photo 23: Photo taken from the northeast corner of the location, facing west. Photo shows stormwater control ditch along perimeter of the location.

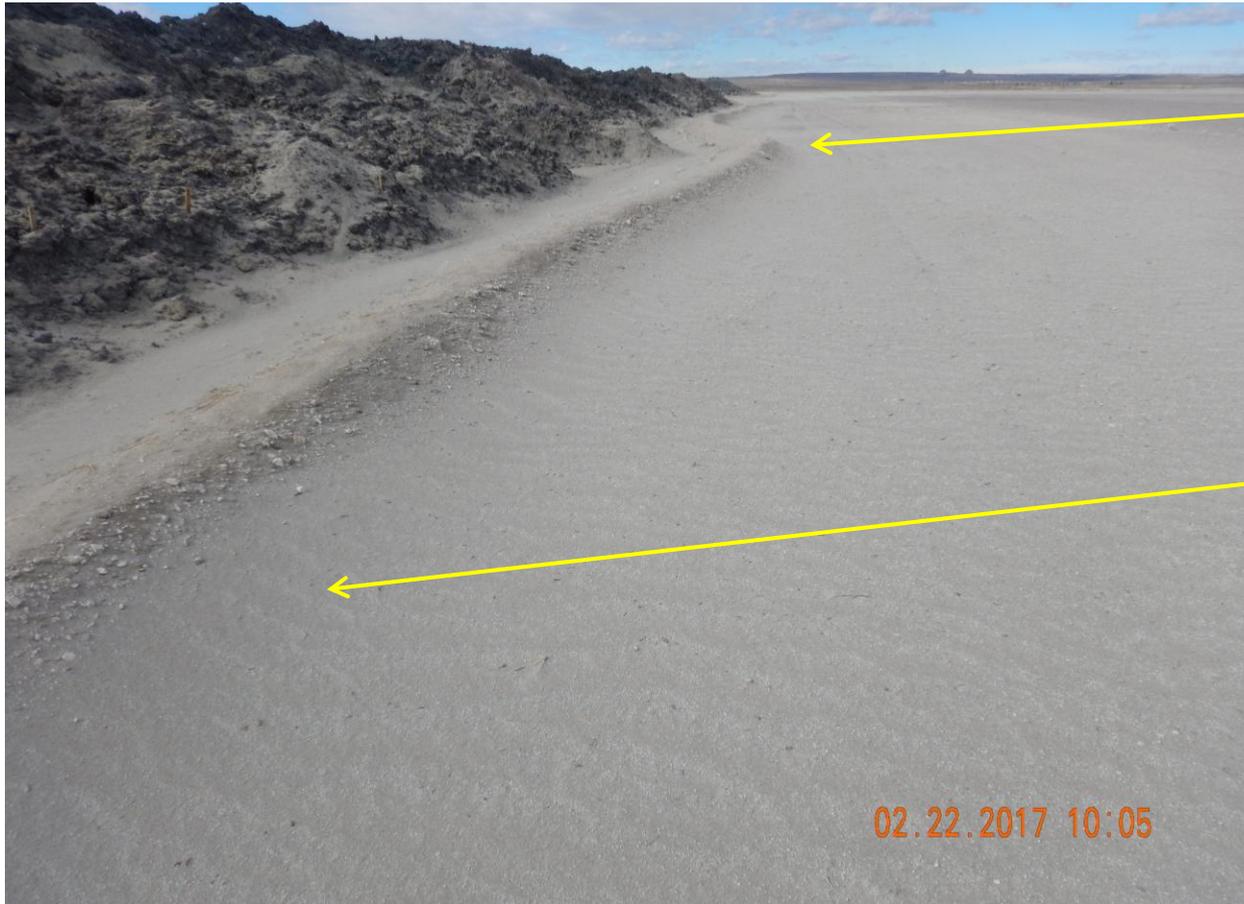
Berm around drill cuttings ~ 1ft in height

Sediment deposition due to wind erosion from the location

Photo 24: Photo taken from the south end of the location, facing west. Photo shows berm constructed around drill cuttings. Photo also shows sediment deposition due to wind erosion occurring on and from the location.

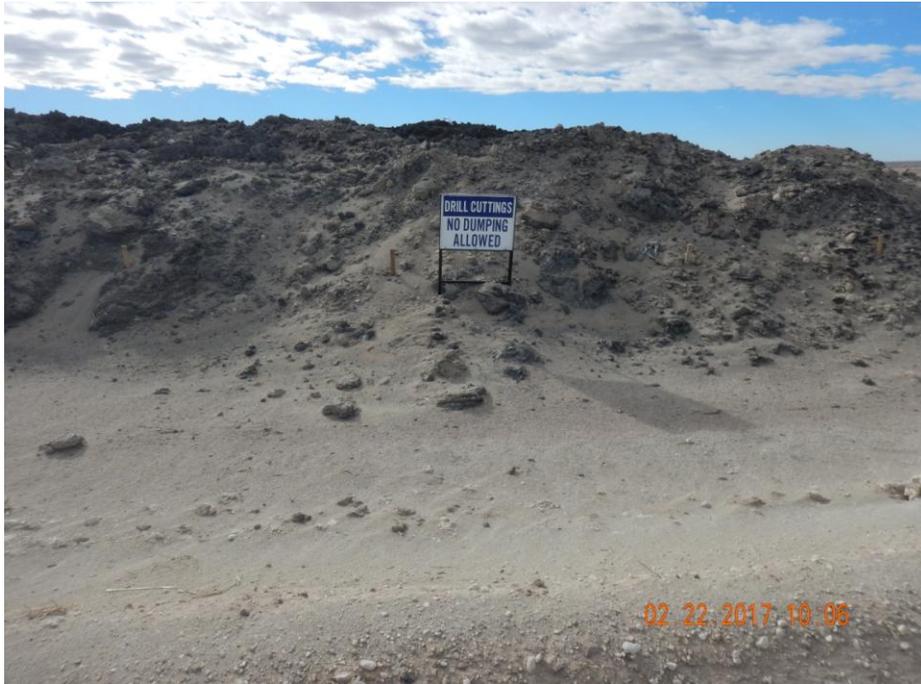
Photo 25: Photo taken from the south end of the location, facing south. Photo of drill cuttings. The lighter colored soils seen on the drill cuttings is sediment deposition from wind erosion occurring on location.

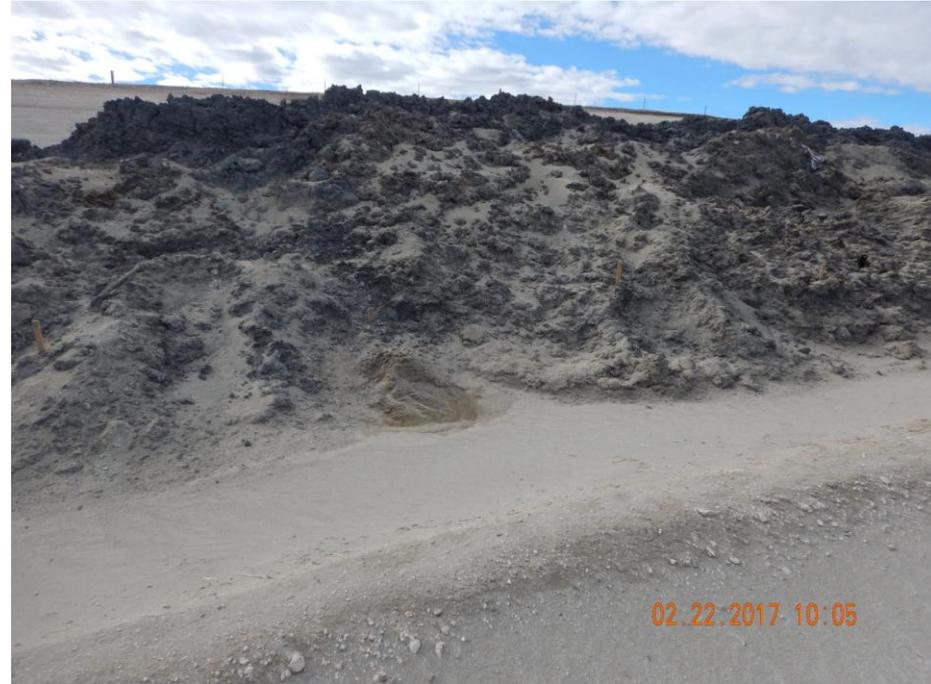
Photo 26: Photo taken from the south end of the location, facing south. Photo of drill cuttings. The lighter colored soils seen on the drill cuttings is sediment deposition from wind erosion occurring on location.
