Inspection Photos

Operator: Whiting Oil and Gas #96155

Location ID: 444465

Inspection Doc. Number: 682501695

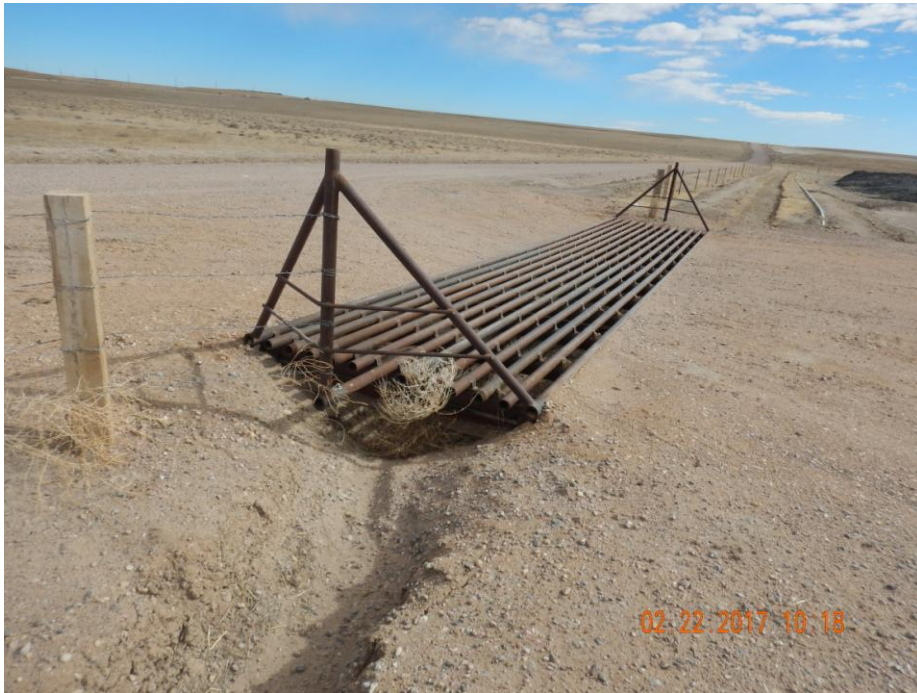
Photo 1: Photo taken from the north end of the location, facing southeast. Photo shows vehicle tracking BMP as entrance to location.

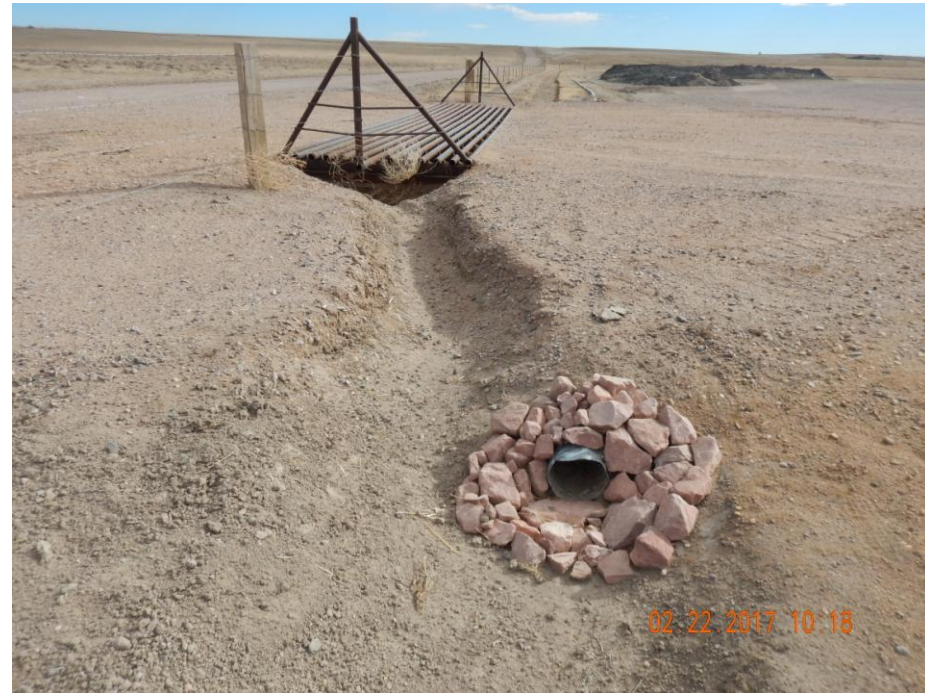
Photo 2: Photo taken from the north end of the location, facing east. Photo shows vehicle tracking BMP at entrance to location and culvert with rock armoring.

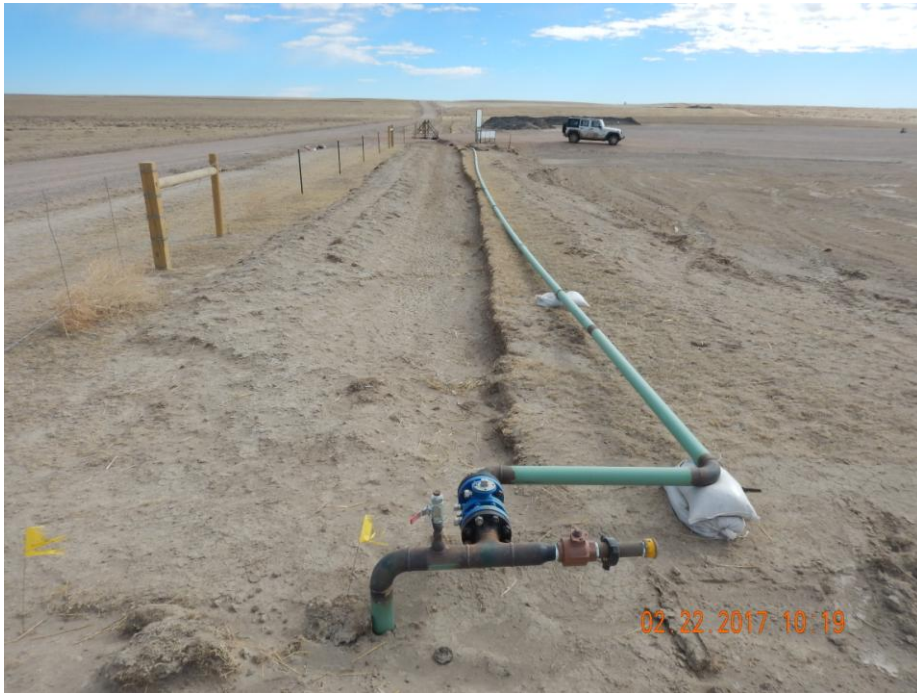
Photo 3: Photo taken from the northwest end of the location, facing east. Photo shows stormwater control ditch along perimeter of the location. Ditch does not appear to properly function.

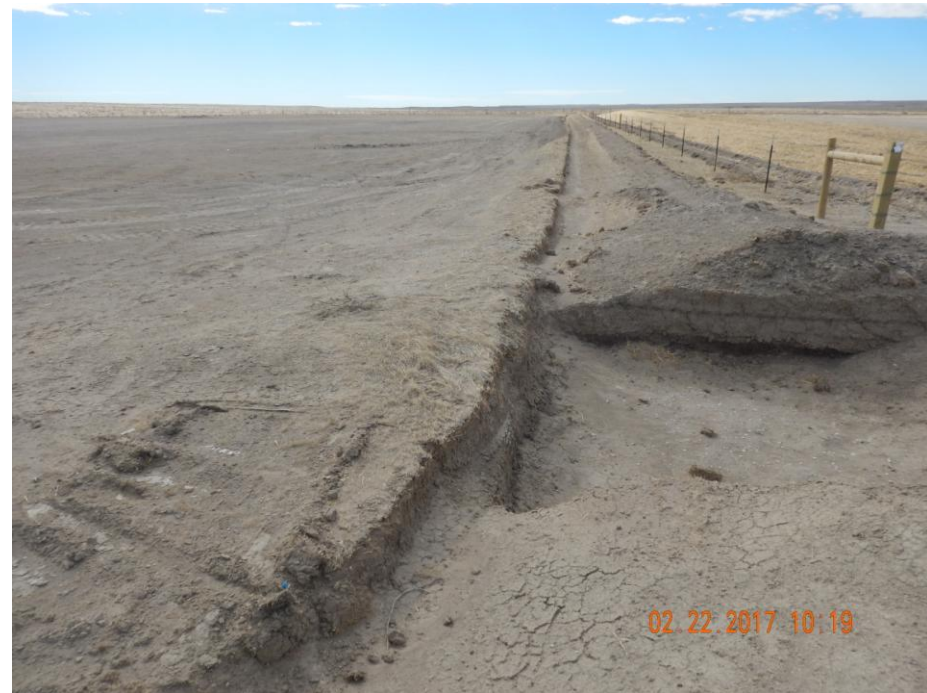
Photo 4: Photo taken from the northwest end of the location, facing south. Photo shows stormwater control ditch along the western perimeter of the location.

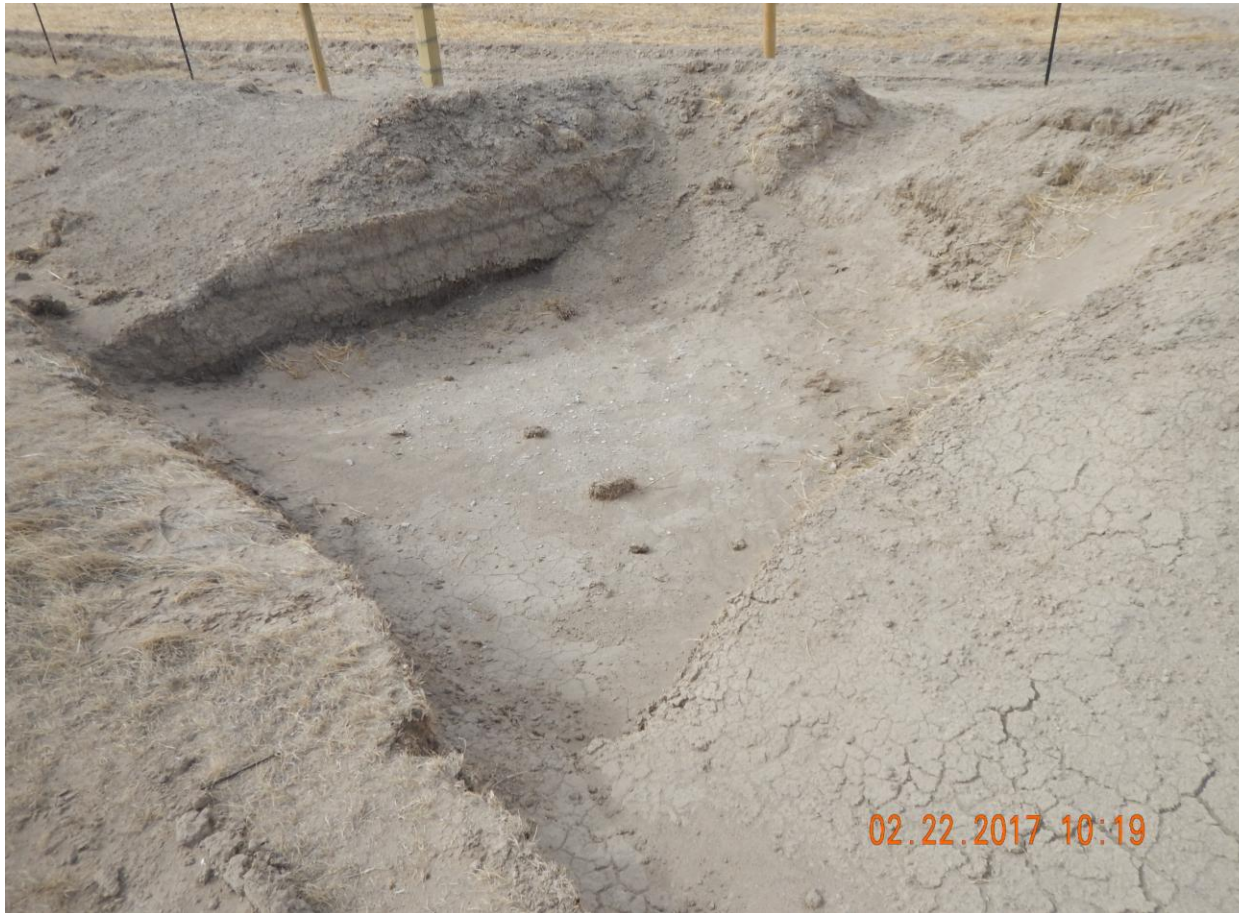
Photo 5: Photo taken from the northwest end of the location. Photo shows sediment trap used as a stormwater and sediment control BMP. Sediment trap appears inadequate and improperly constructed. Sediment trap has insufficient inlet and outlet protection.

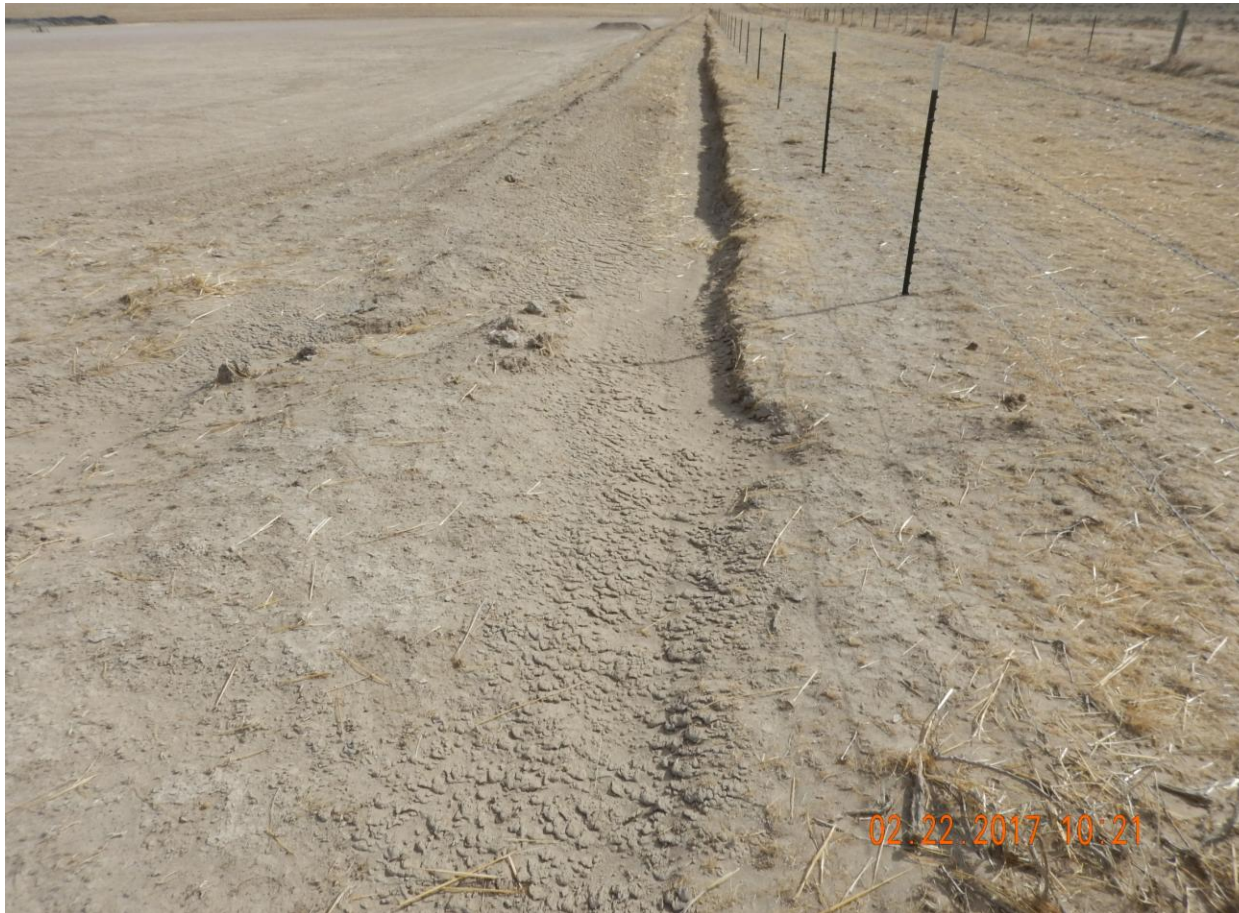
Photo 6: Photo taken from the southwest corner of the location, facing west. Photo shows area of the stormwater ditch along the southern perimeter of the location. Note that leads into the adjacent reference area to the west, and does not have any controls to prevent sediment transport off site, and

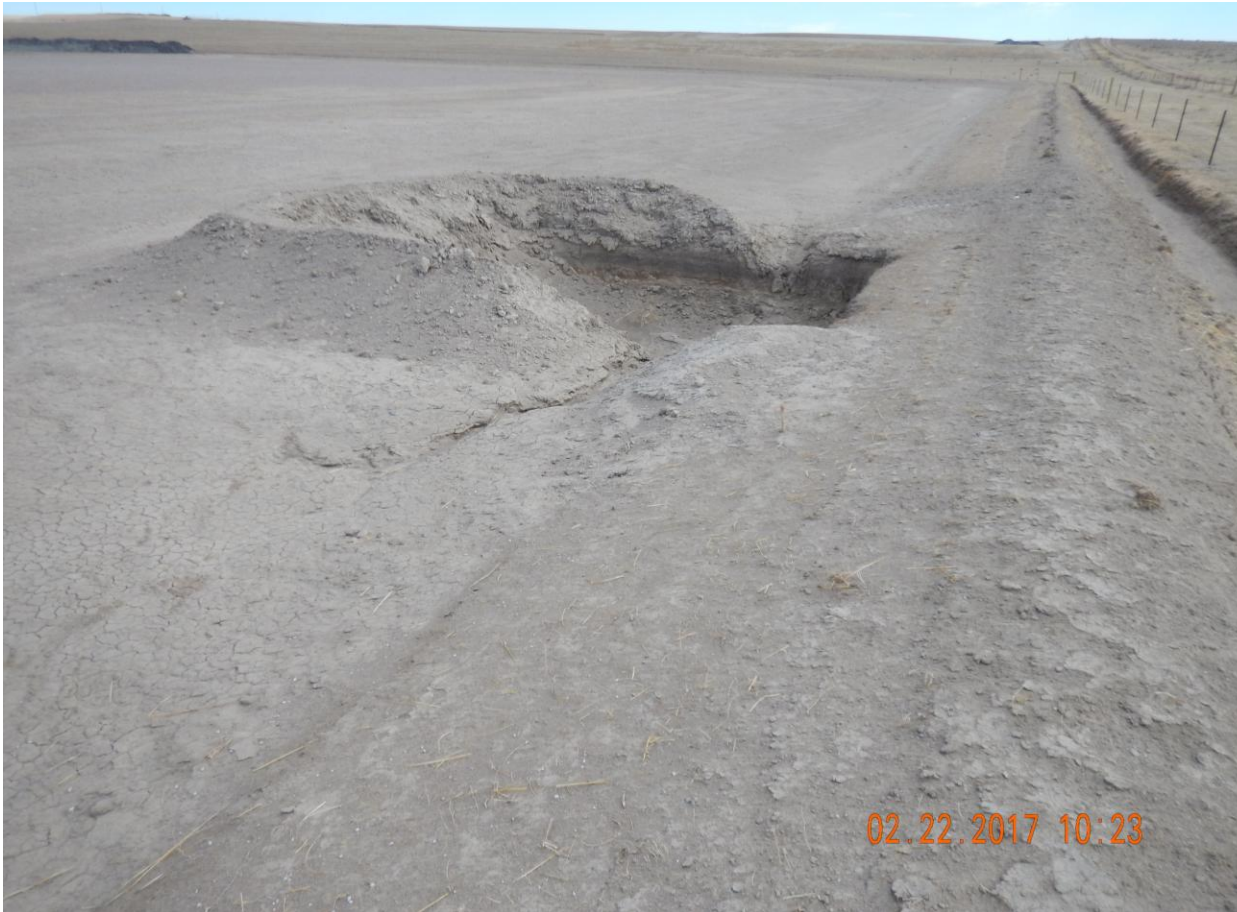
Photo 7: Photo taken from the south end of the location, facing east. Photo of sediment trap. Sediment trap appears inadequate and improperly constructed. Sediment trap has insufficient inlet protection and has gully erosion forming on the location. It is unclear as to why operator constructed BMP in such a manner, as the trap does not have an outlet that would allow water to flow out when it reaches capacity.

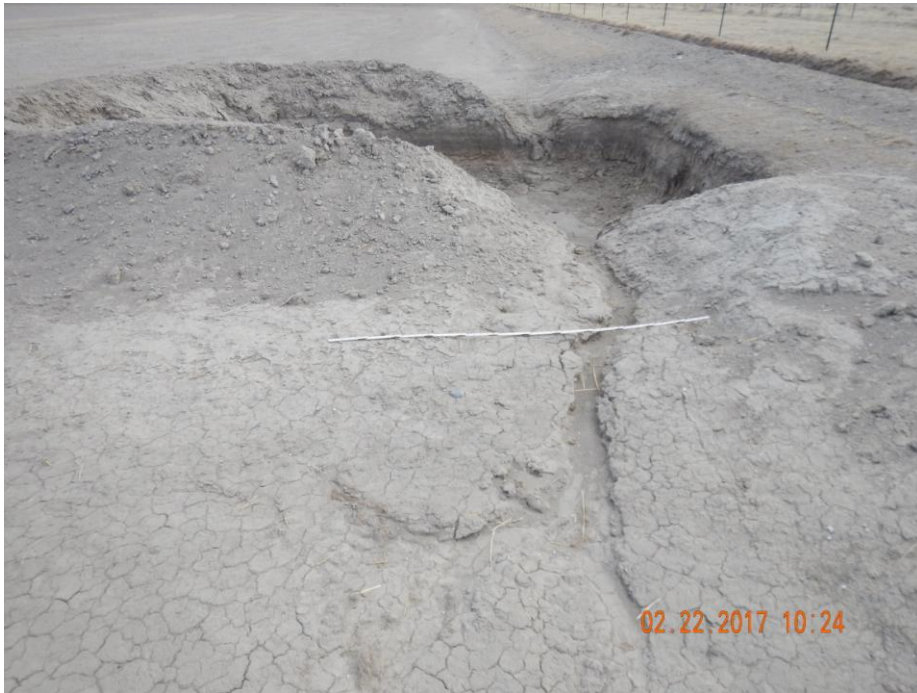
Photo 8: Photo taken from the east end of the location. Photo shows gulley erosion forming at sediment trap due to insufficient inlet protection. 6 foot measuring stick for reference.

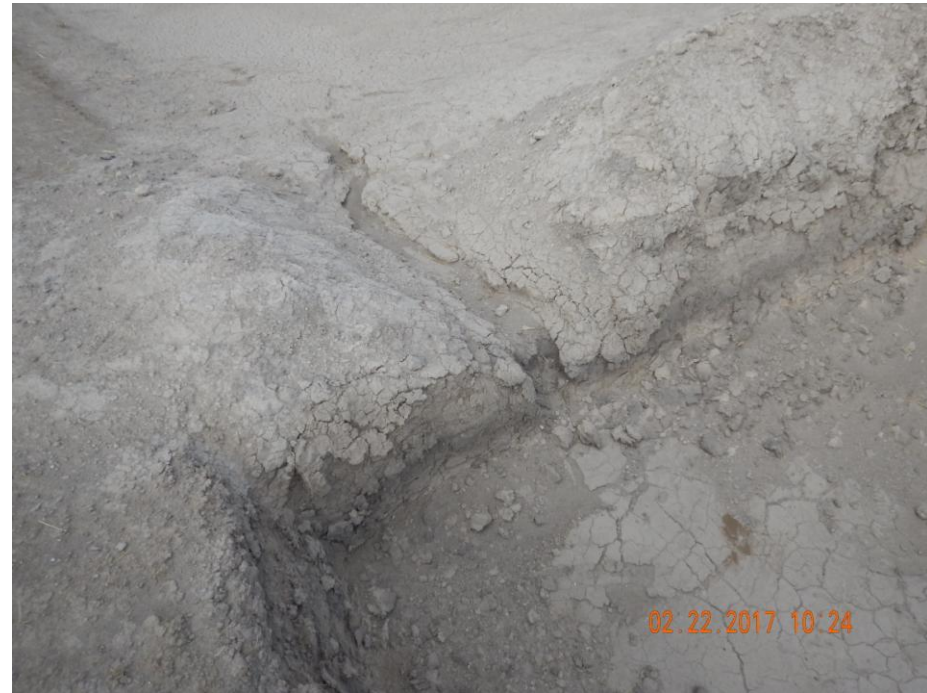
Photo 9: Photo taken from the east end of the location. Photo shows gulley erosion forming at sediment trap due to insufficient inlet protection.

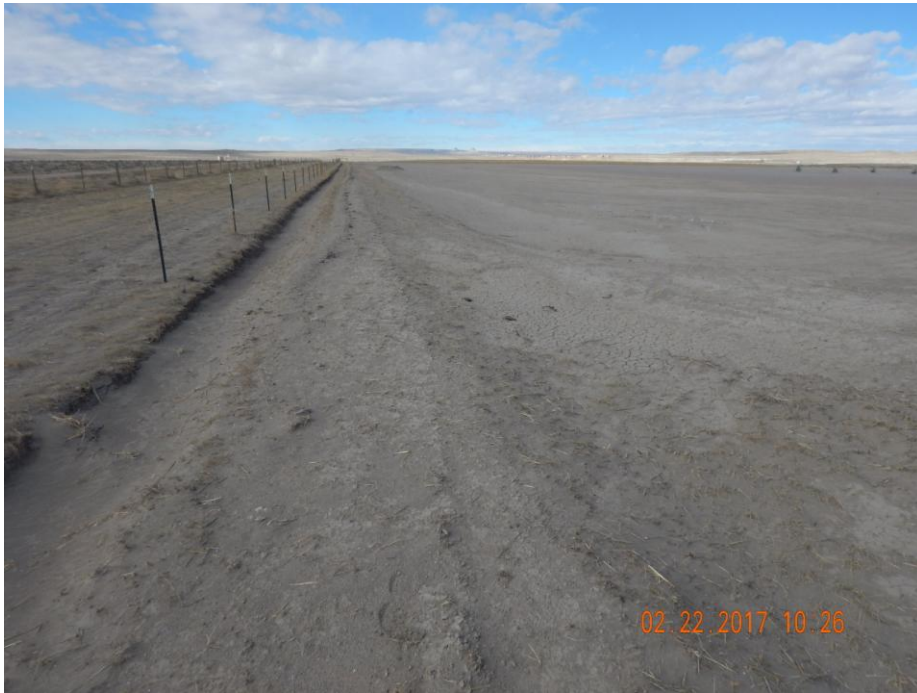
Photo 10: Photo taken from the southeast end of the location, facing west. Photo shows stormwater and sediment control ditch along the southern perimeter of the location.

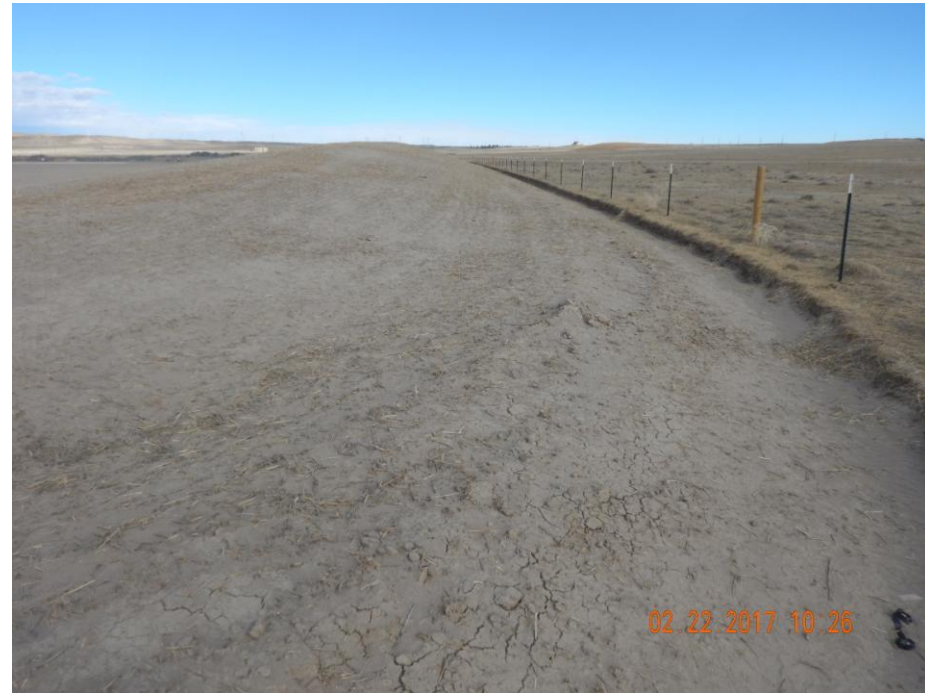
Photo 11: Photo taken from the southeast end of the location, facing north. Photo shows stormwater and sediment control ditch along the eastern perimeter of the location. Photo also shows location of topsoil berm. Topsoil berm appears to have been recently seeded, and crimped to stabilize soil.

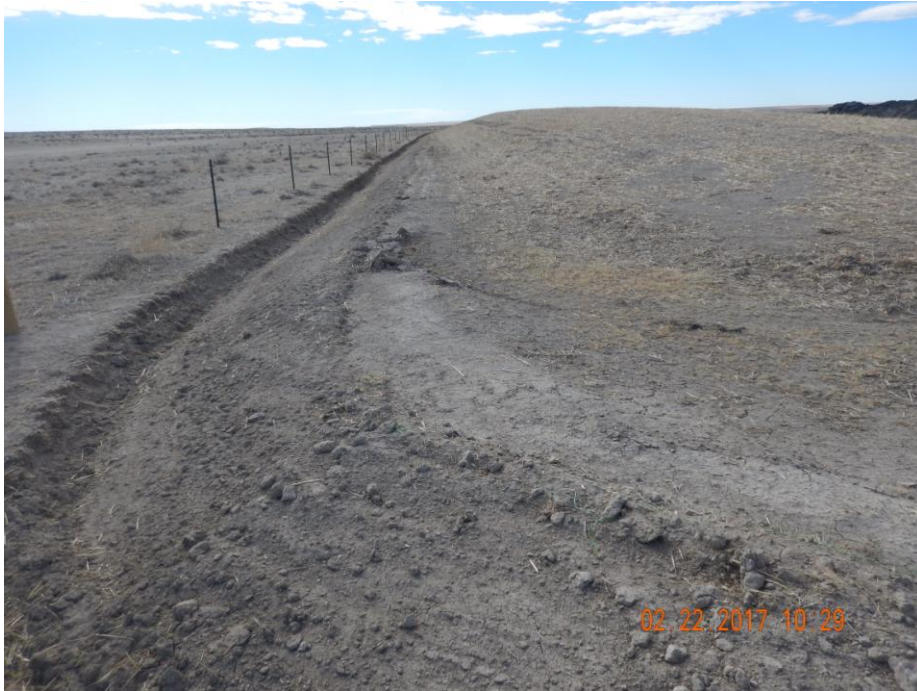
Photo 12: Photo taken from the northeast end of the location, facing south. Photo shows stormwater and sediment control ditch along the eastern perimeter of the location. Photo also shows location of topsoil berm. Topsoil berm appears to have been recently seeded, and crimped to stabilize soil.

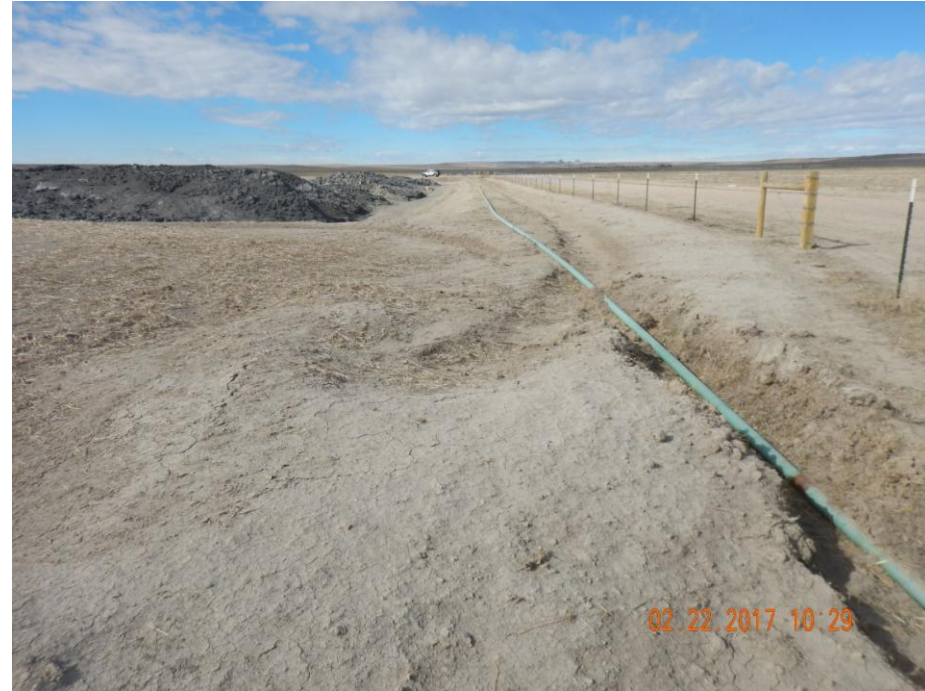
Photo 13: Photo taken from the northeast end of the location, facing south. Photo shows stormwater and sediment control ditch along the northern perimeter of the location.

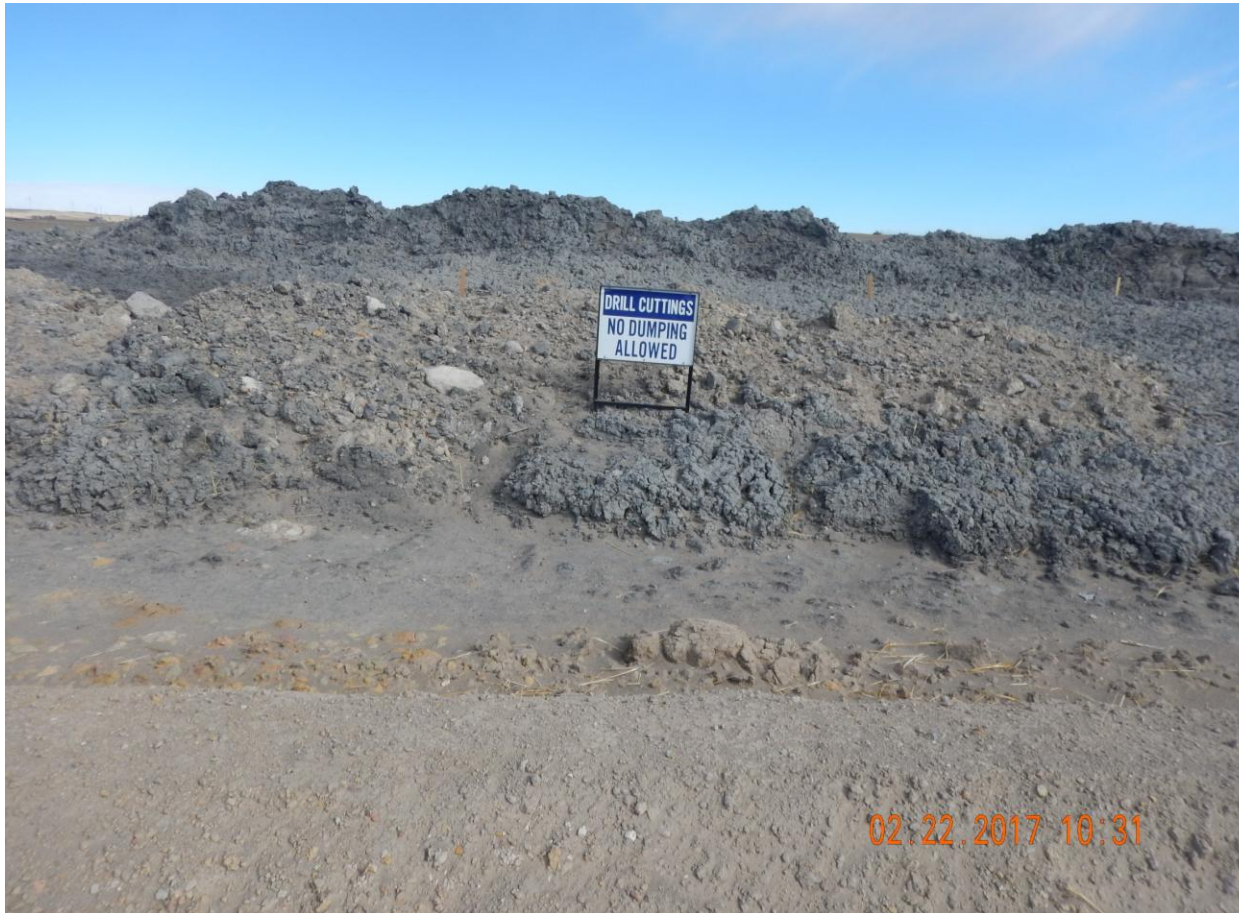
Photo 14: Photo taken from the north end of the location. Photo shows drill cuttings stored on the northeast. A berm has been constructed along the perimeter of the drill cuttings.

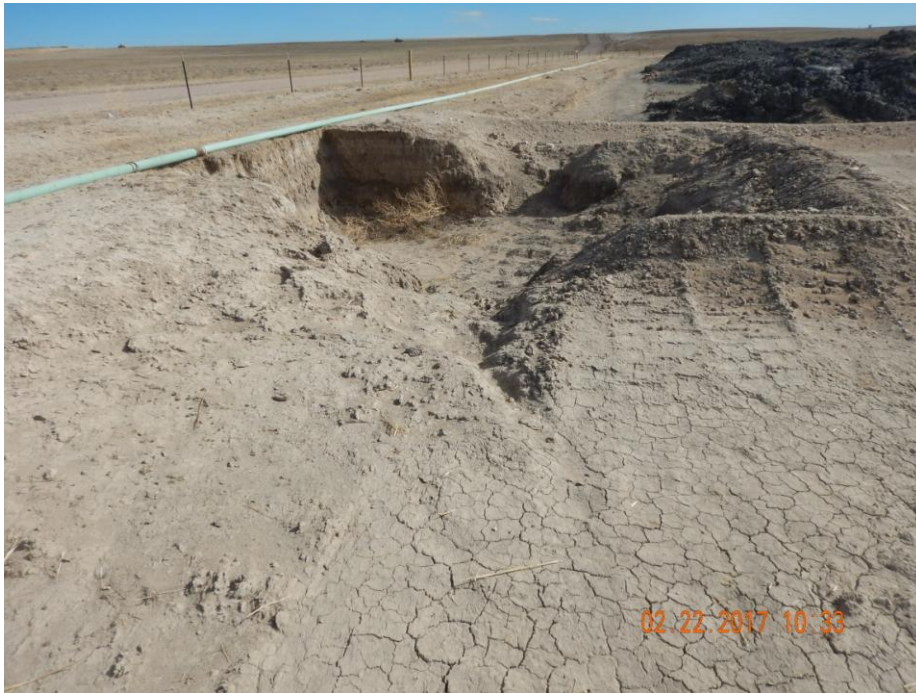
Photo 15: Photo taken from the north end of the location, facing east. Photo of sediment trap. Sediment trap appears inadequate and improperly constructed. Sediment trap has insufficient inlet protection. Due to the way the pad was constructed, it appears stormwater would pool on the north end of the pad as this area is lower in elevation than the adjacent stormwater ditch on the north end of the location.

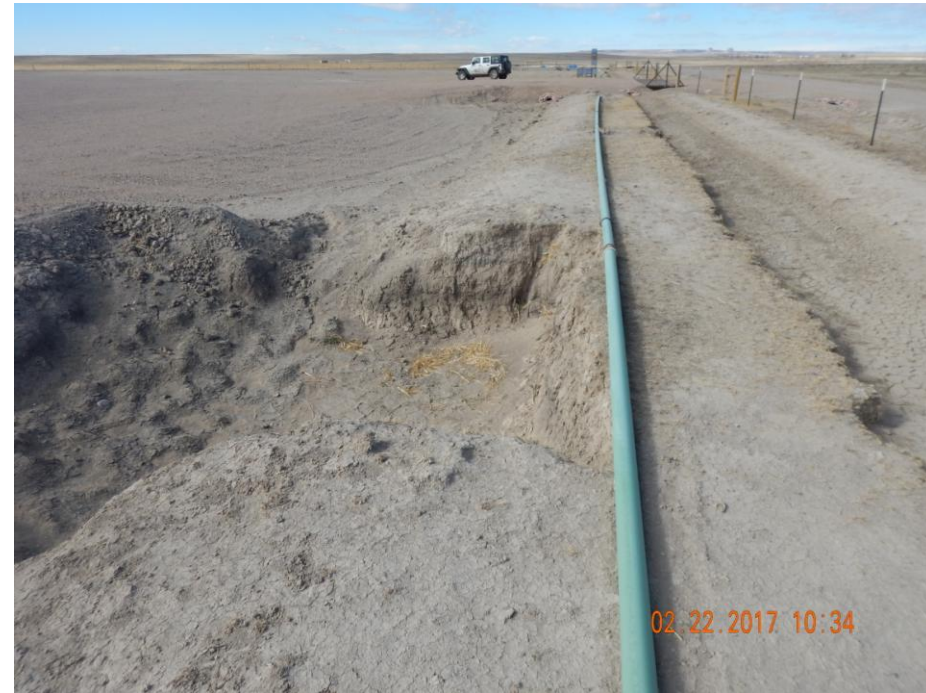
Photo 16: Photo taken from the north end of the location, facing west. Photo of sediment trap. Sediment trap appears inadequate and improperly constructed. Sediment trap has insufficient inlet protection. Due to the way the pad was constructed, it appears stormwater would pool on the north end of the pad, as this area is lower in elevation than the adjacent stormwater ditch on the north end of the location.
