Inspection Photos

Operator: Whiting O&G #96155

Location ID: 444459

Inspection Doc. Number: 682501698

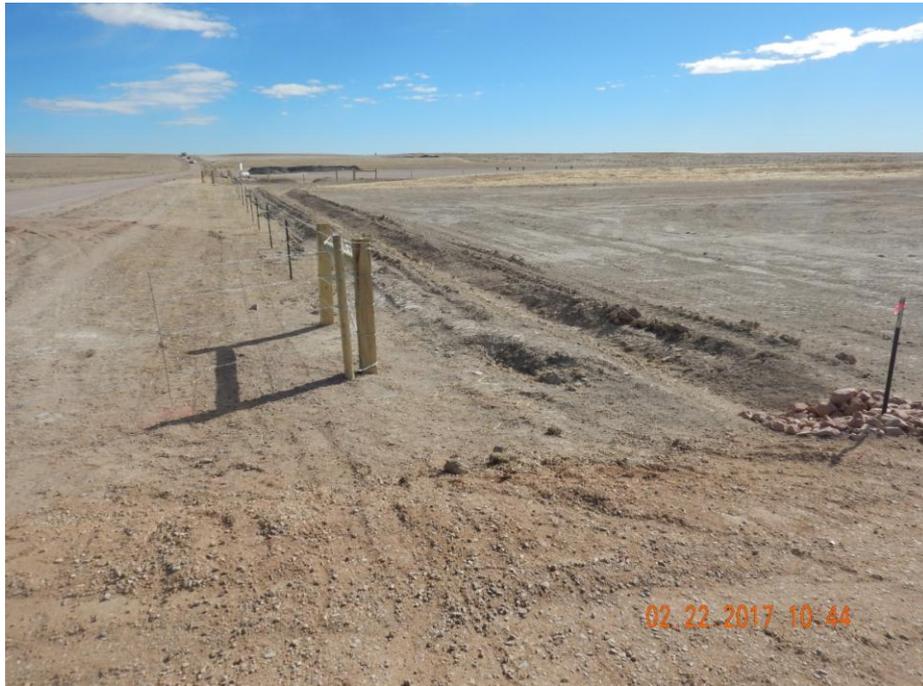
Photo 1: Photo taken from the location on the north end of the location, facing east. Photos 1-4 provide overview of location.

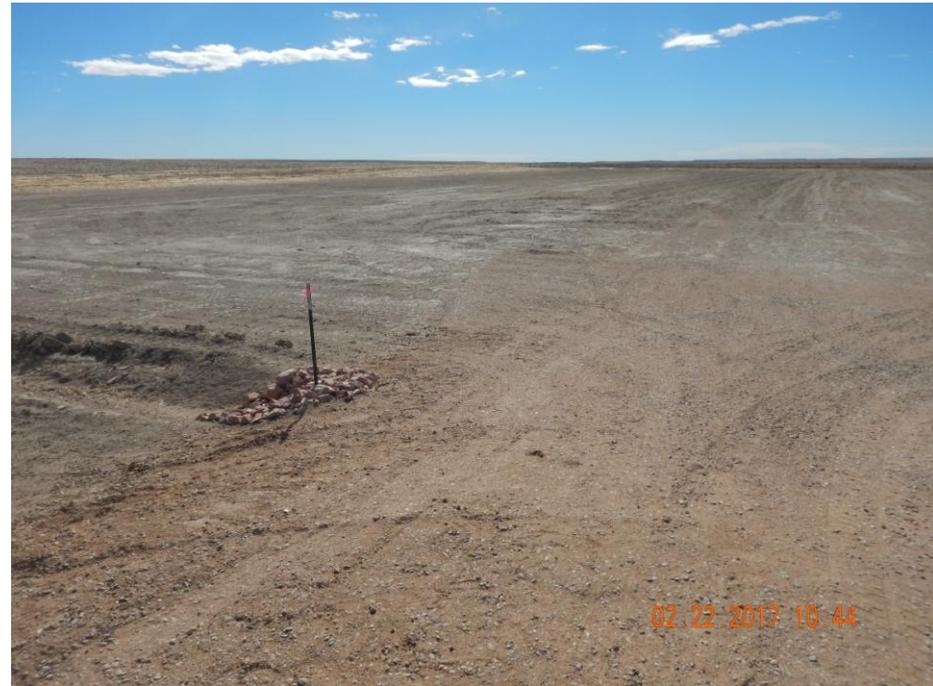
Photo 2: Photo taken from the location on the north end of the location, facing southeast. Photos 1-4 provide overview of location.

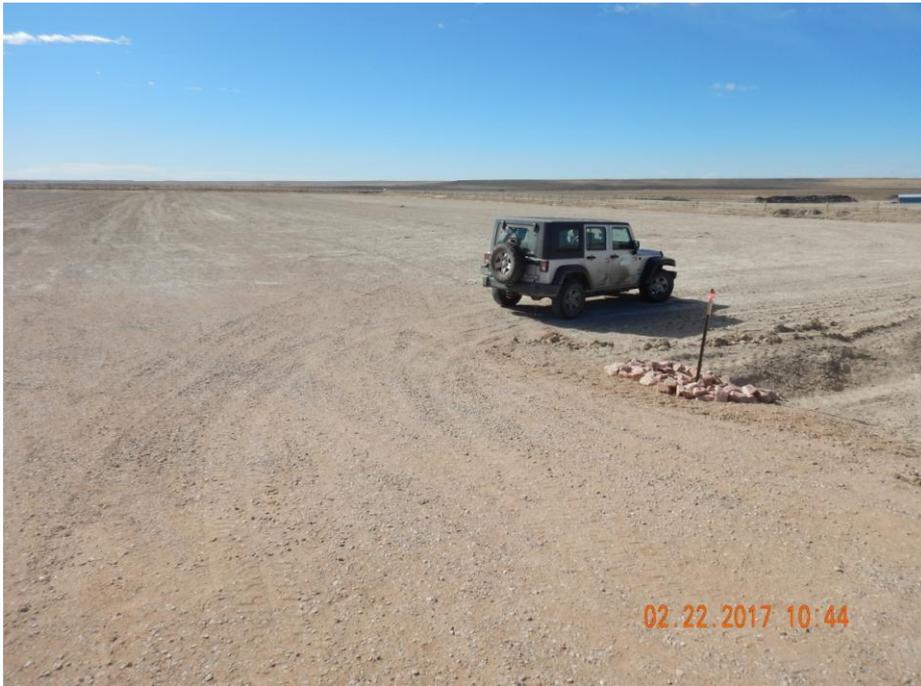
Photo 3: Photo taken from the location on the north end of the location, facing southwest. Photos 1-4 provide overview of location.

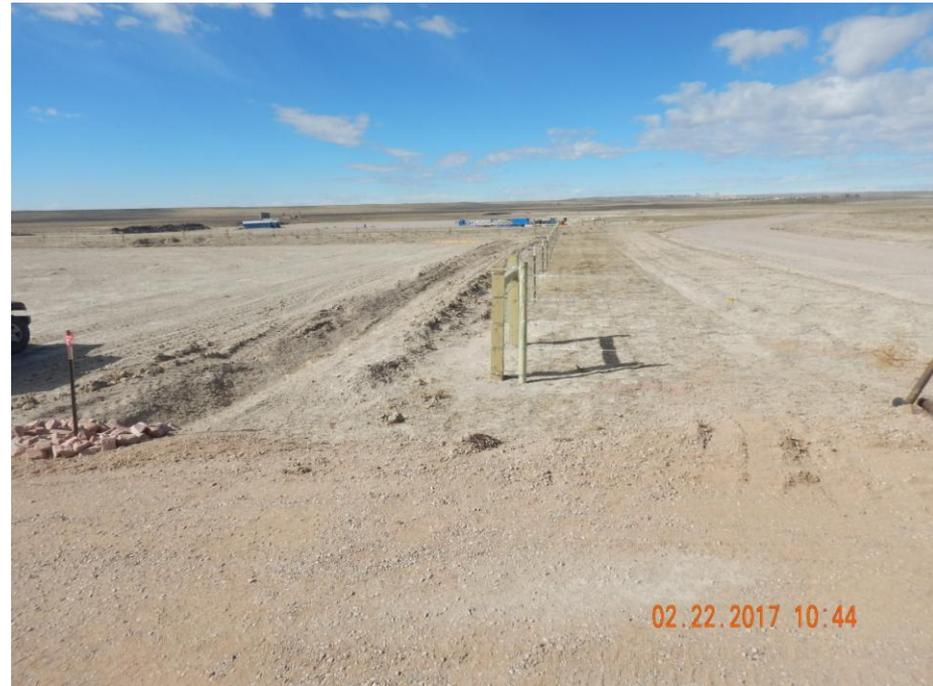
Photo 4: Photo taken from the location on the north end of the location, facing west. Photos 1-4 provide overview of location.

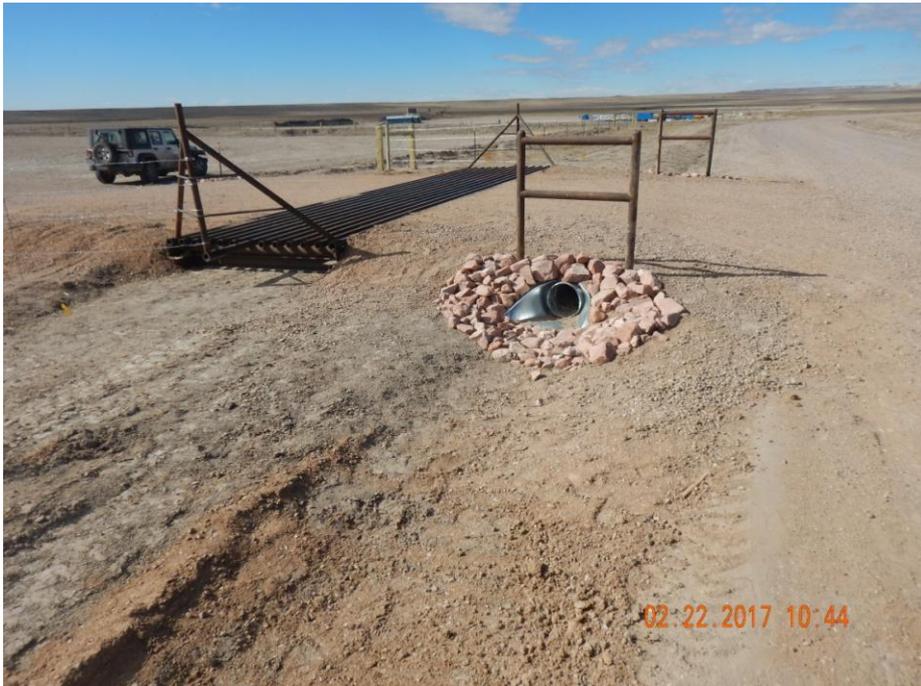
Photo 5: Photo taken from the location entrance on the north end of the location, facing west. Photo shows vehicle tracking BMP (cattle guard) and culvert with armor.

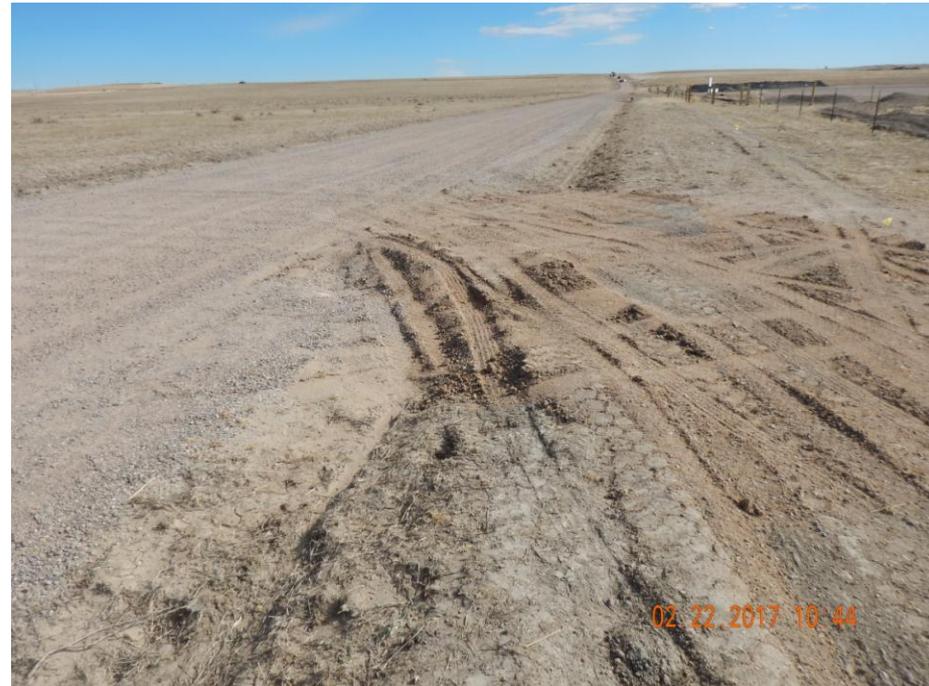
Photo 6: Photo taken from the access road adjacent to the location entrance on the north end of the location. Photo shows stormwater control ditch at access road has been filled with soil, and is no longer in proper functioning conduction.

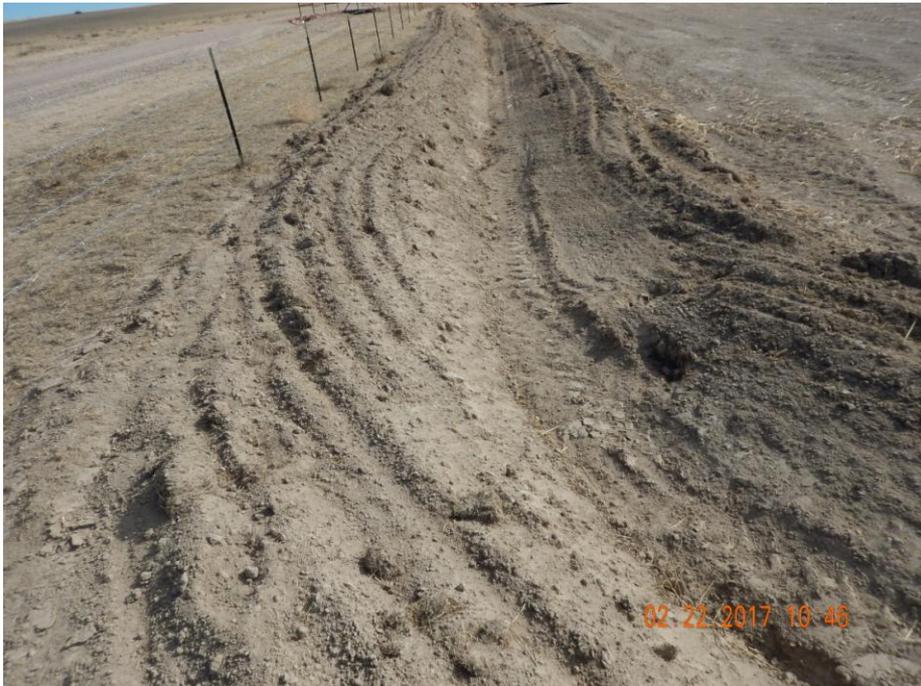
Photo 7: Photo taken from the northwest corner of the location, facing east. Photo shows stormwater and sediment control ditch along northern perimeter of location.

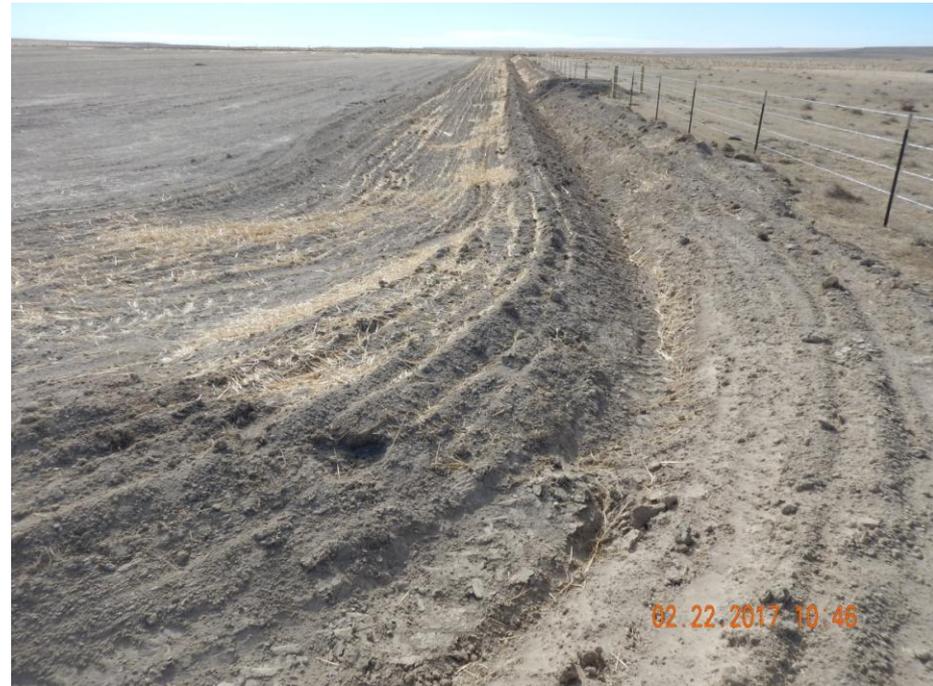
Photo 8: Photo taken from the northwest corner of the location, facing south. Photo shows stormwater and sediment control ditch along northern perimeter of location

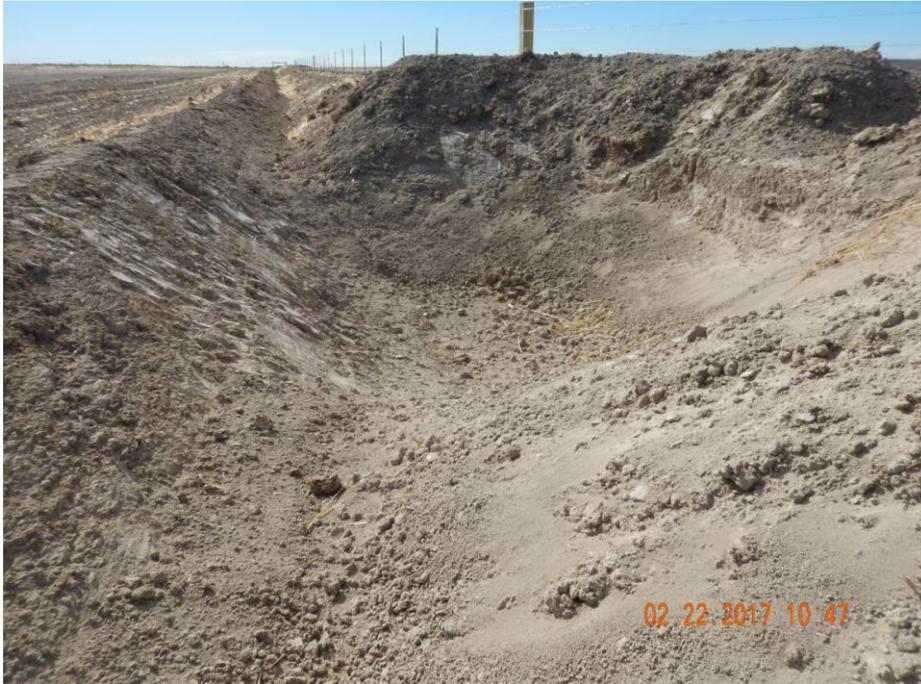
Photo 9: Photo taken from the west end of the location. Photo of sediment trap used as a stormwater and sediment control BMP. Sediment trap does not have sufficient inlet and outlet protection. Also appears that outlet of trap is higher in elevation than the stormwater ditch and the constructed location.

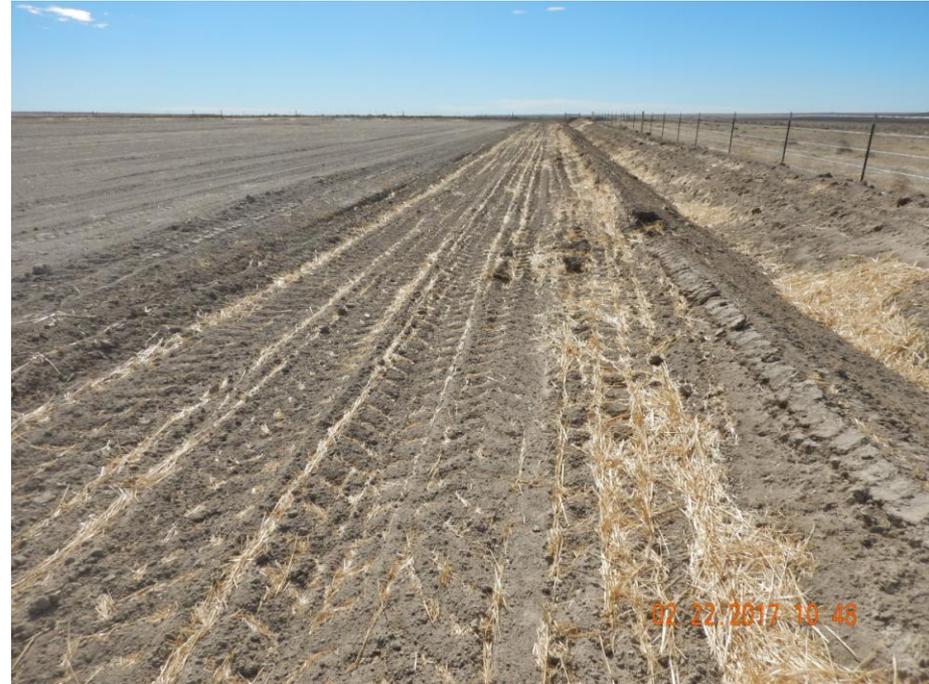
Photo 10: Photo taken from the west end of the location, facing south. Photo shows what appears to be a "spill way" constructed adjacent to the stormwater ditch. "Spill way" appears to have been seeded and stabilized with crimped straw.

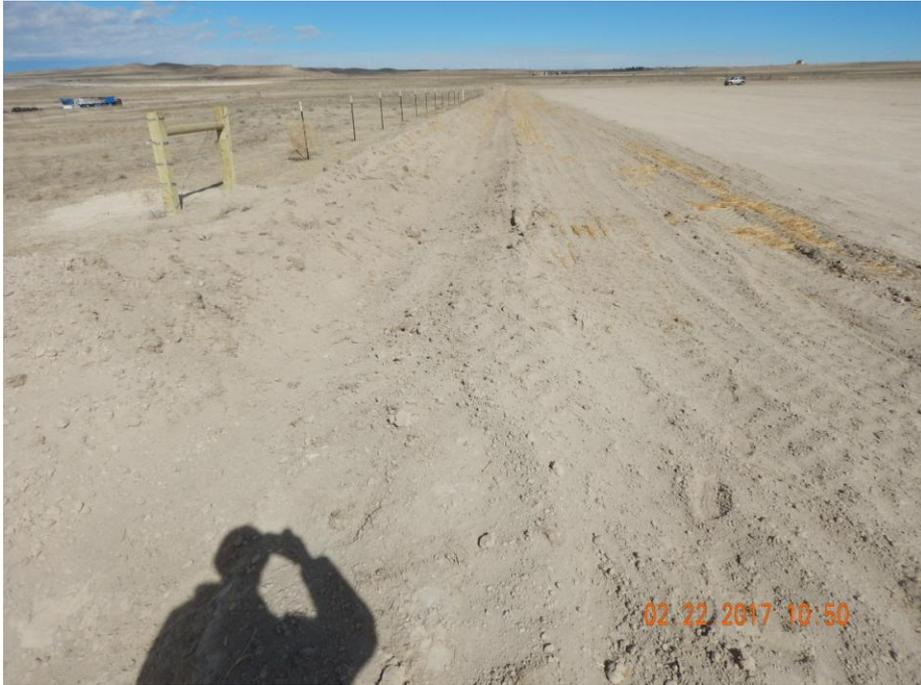
Photo 11: Photo taken from the southwest corner of the location, facing north. Photo shows ditch and “spill way” on west end of location used as stormwater and sediment control BMPs

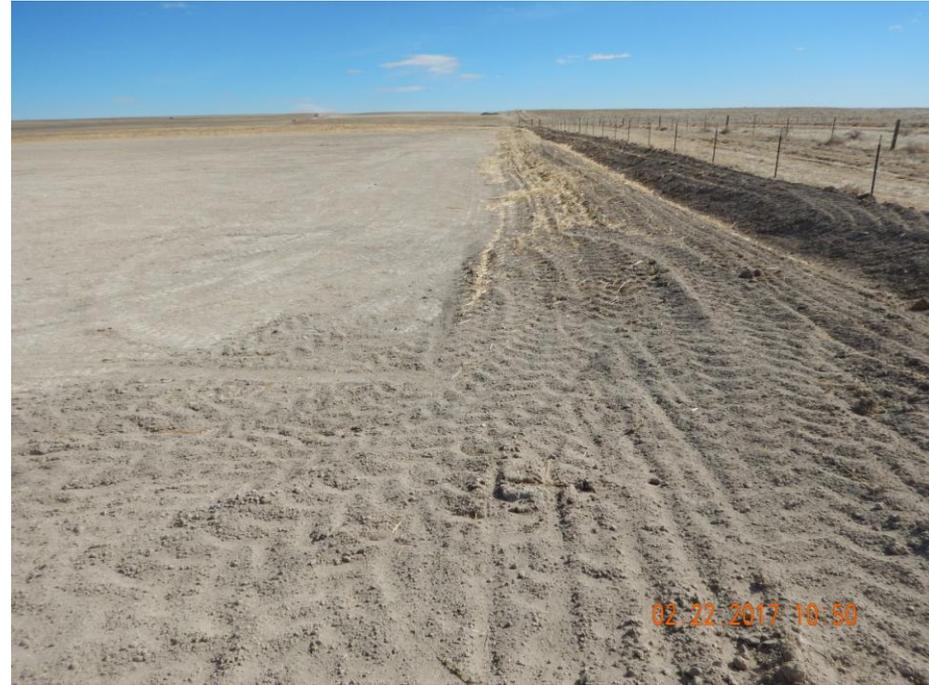
Photo 12: Photo taken from the southwest corner of the location, facing east. Photo shows stormwater control ditch along southern perimeter of the location.

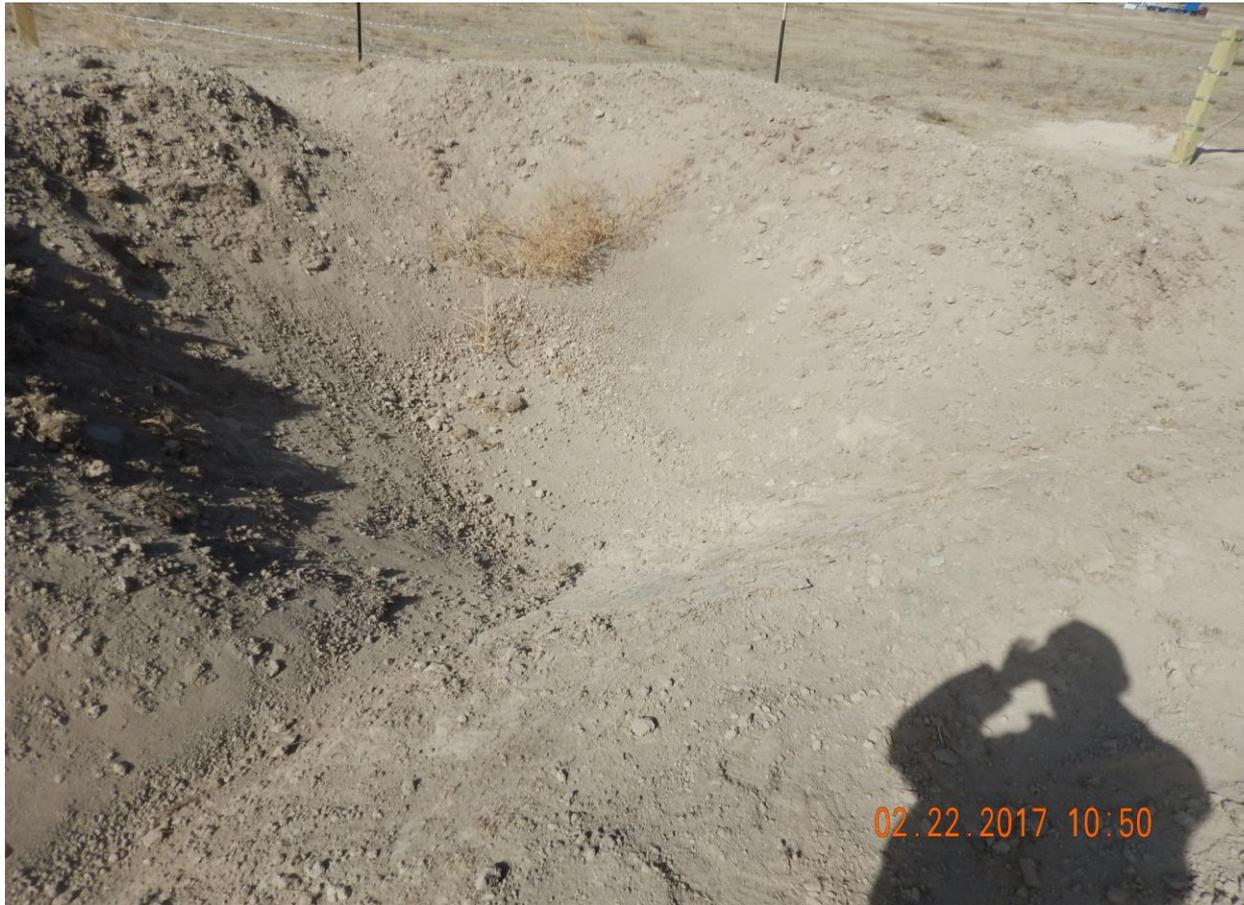
Photo 13: Photo taken from the southwest corner of the location. Photo shows stormwater and sediment control trap. Sediment trap does not have sufficient inlet and outlet protection.

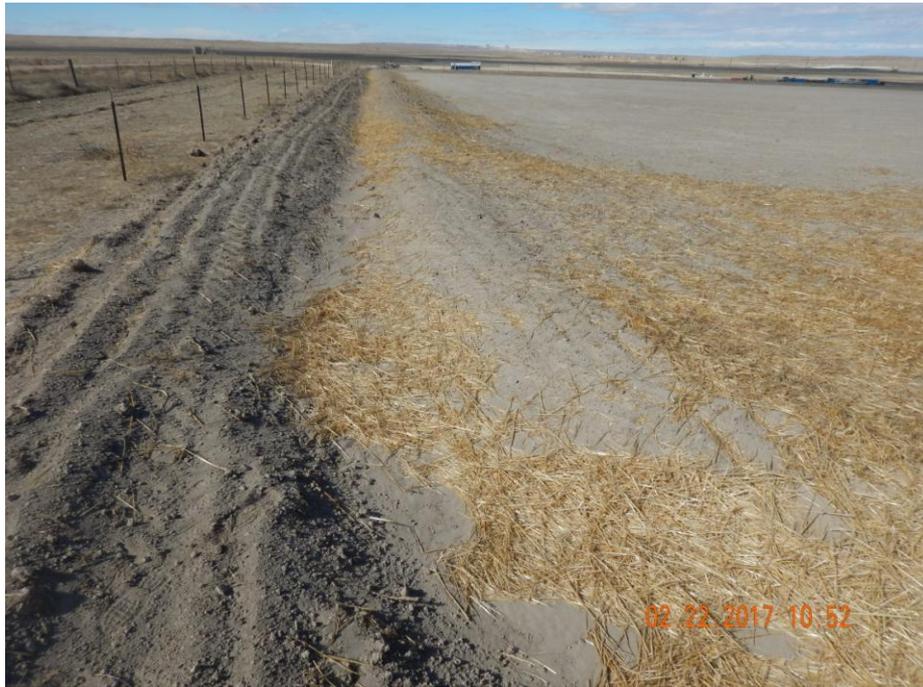
Photo 14: Photo taken from the southeast corner of the location, facing west. Photo shows stormwater control ditch along southern perimeter of the location.

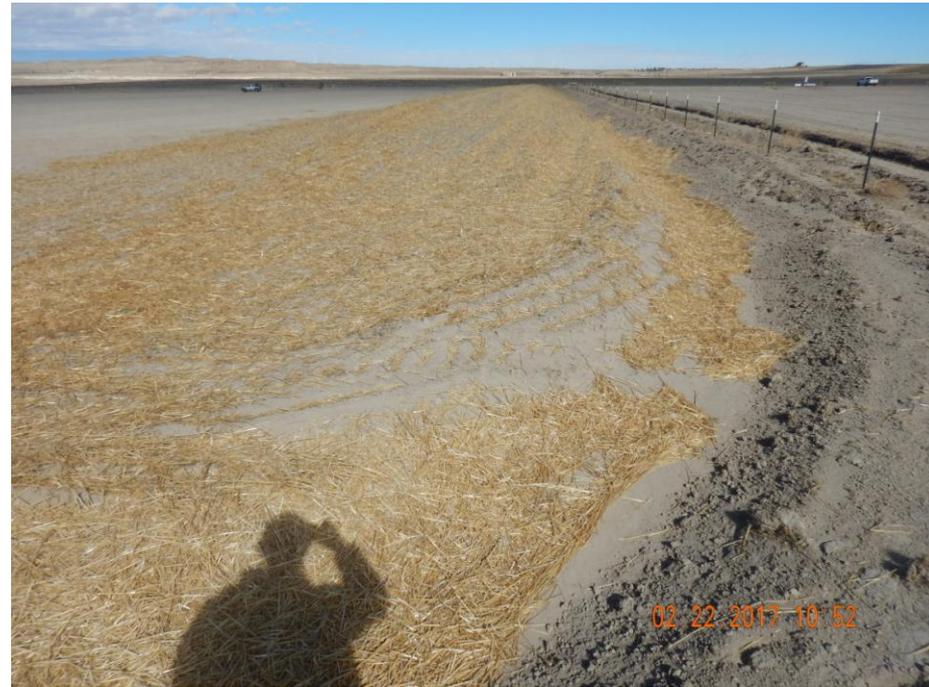
Photo 15: Photo taken from the southeast corner of the location, facing north. Photo shows stormwater control ditch along eastern perimeter of the location. Photo also shows topsoil berm. Topsoil appears to have been seeded and crimped to stabilize soil.

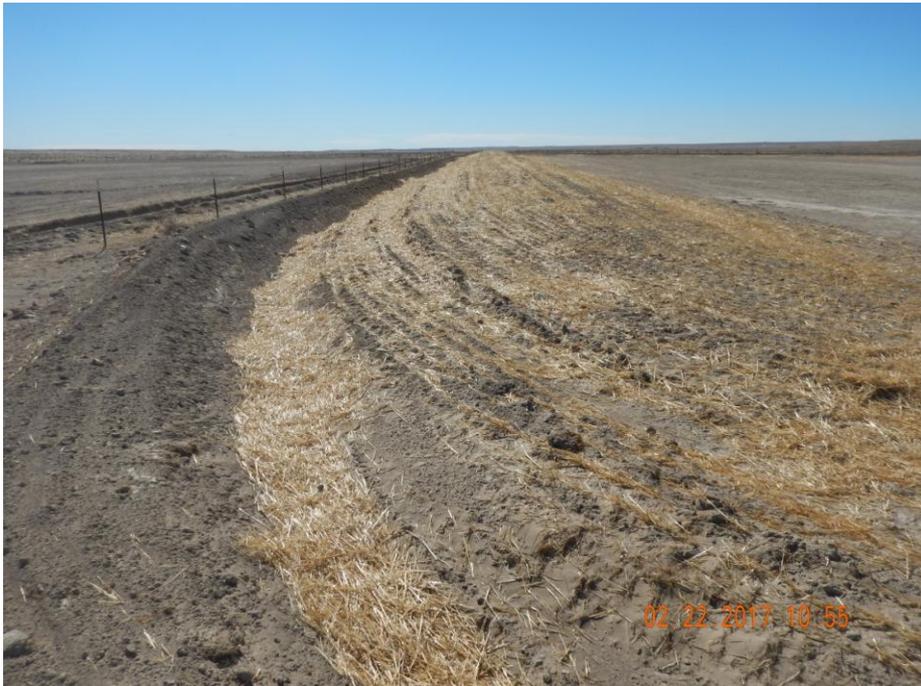
Photo 16: Photo taken from the northeast corner of the location, facing south. Photo shows stormwater control ditch along eastern perimeter of the location. Photo also shows topsoil berm. Topsoil appears to have been seeded and crimped to stabilize soil.

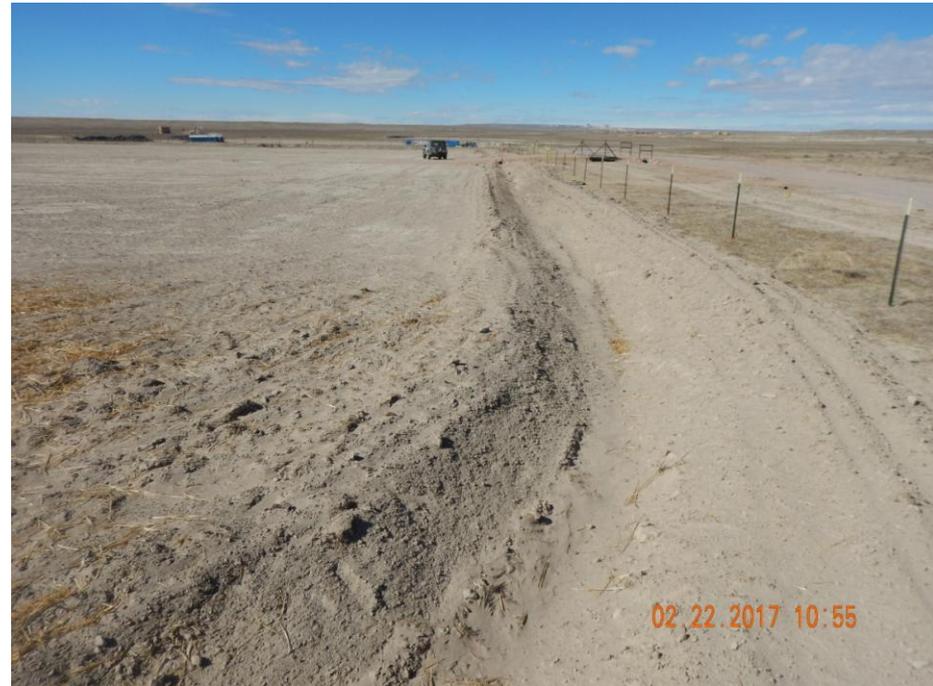
Photo 17: Photo taken from the northeast corner of the location, facing west. Photo shows stormwater control ditch along eastern perimeter of the location.
