Inspection Photos

02/22/2017

Operator: Whiting O&G #96155

Location ID: 444472

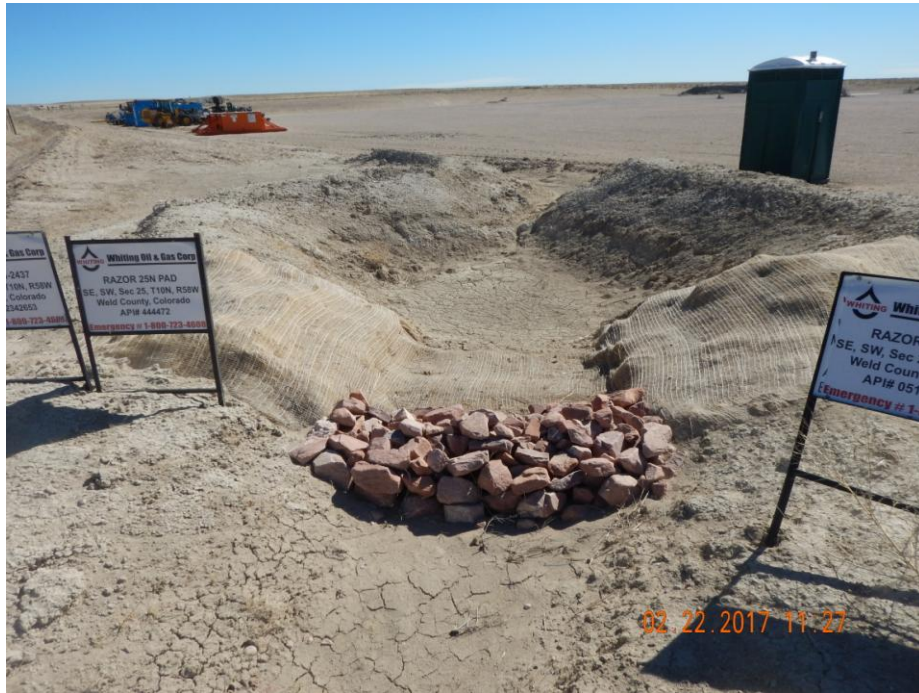
Photo 1: Photo taken from the north end of the location, facing east. Photos shows sediment trap, east of the location entrance, used as a stormwater and sediment control BMP. Photo shows sediment trap has insufficient inlet protection.

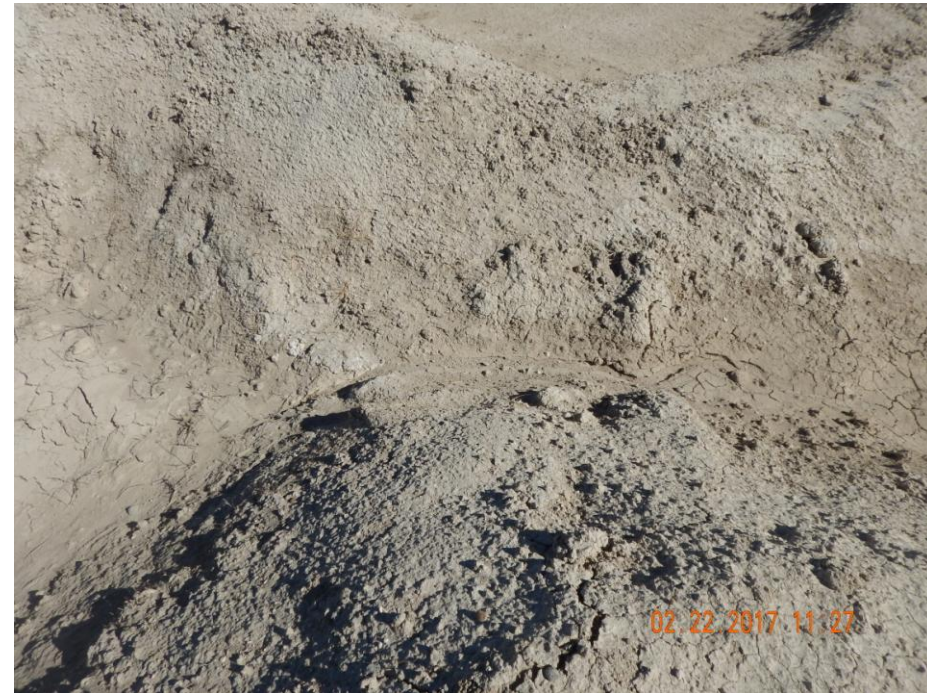
Photo 2: Photo taken from the sediment trap on the north end of the location, east of the location entrance. Photos shows sediment trap used as a stormwater and sediment control BMP. Photo shows sediment trap has insufficient inlet protection.

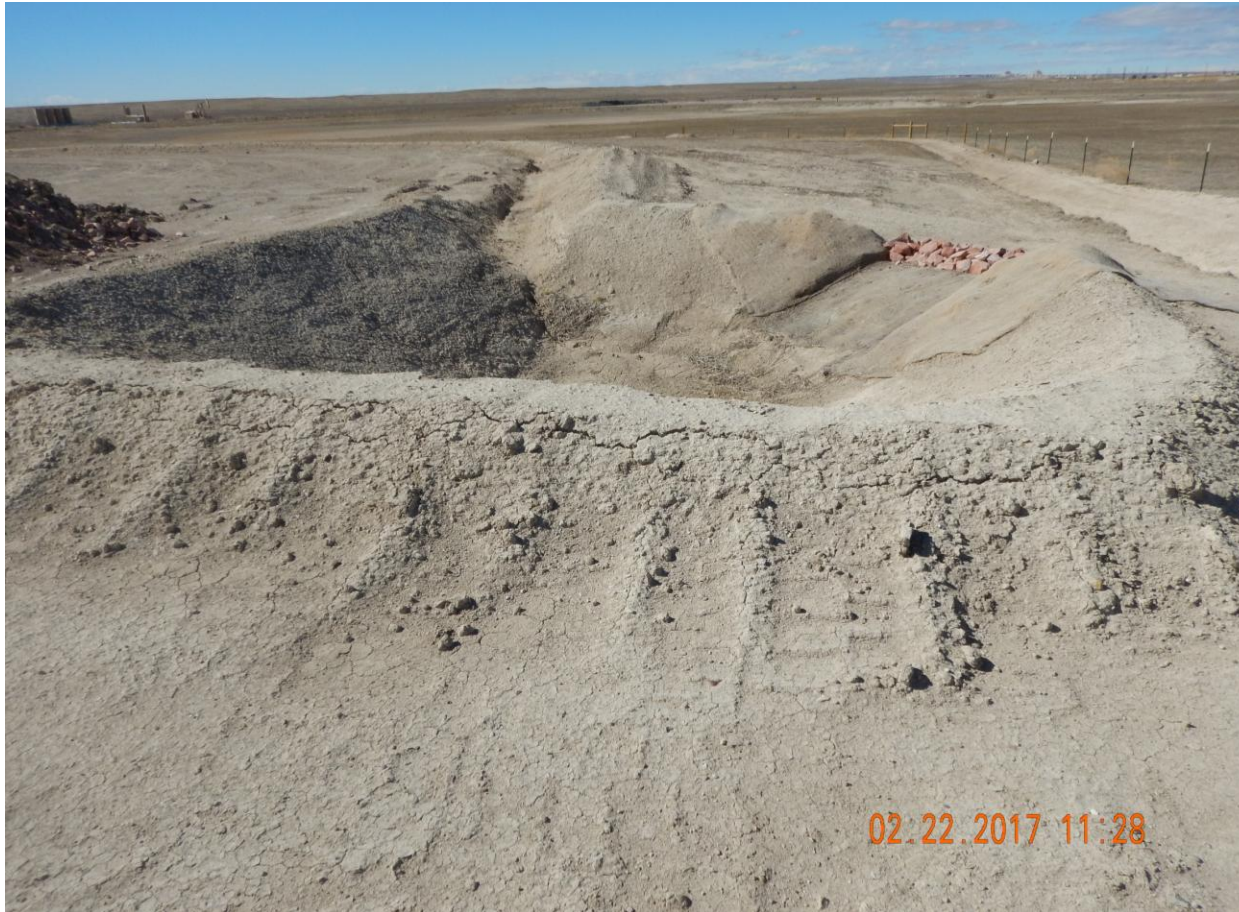
Photo 3: Photo taken from the north end of the location, facing east. Photo shows sediment trap, west of the location entrance, used as a stormwater and sediment control BMP. Photo shows sediment trap has insufficient inlet protection.

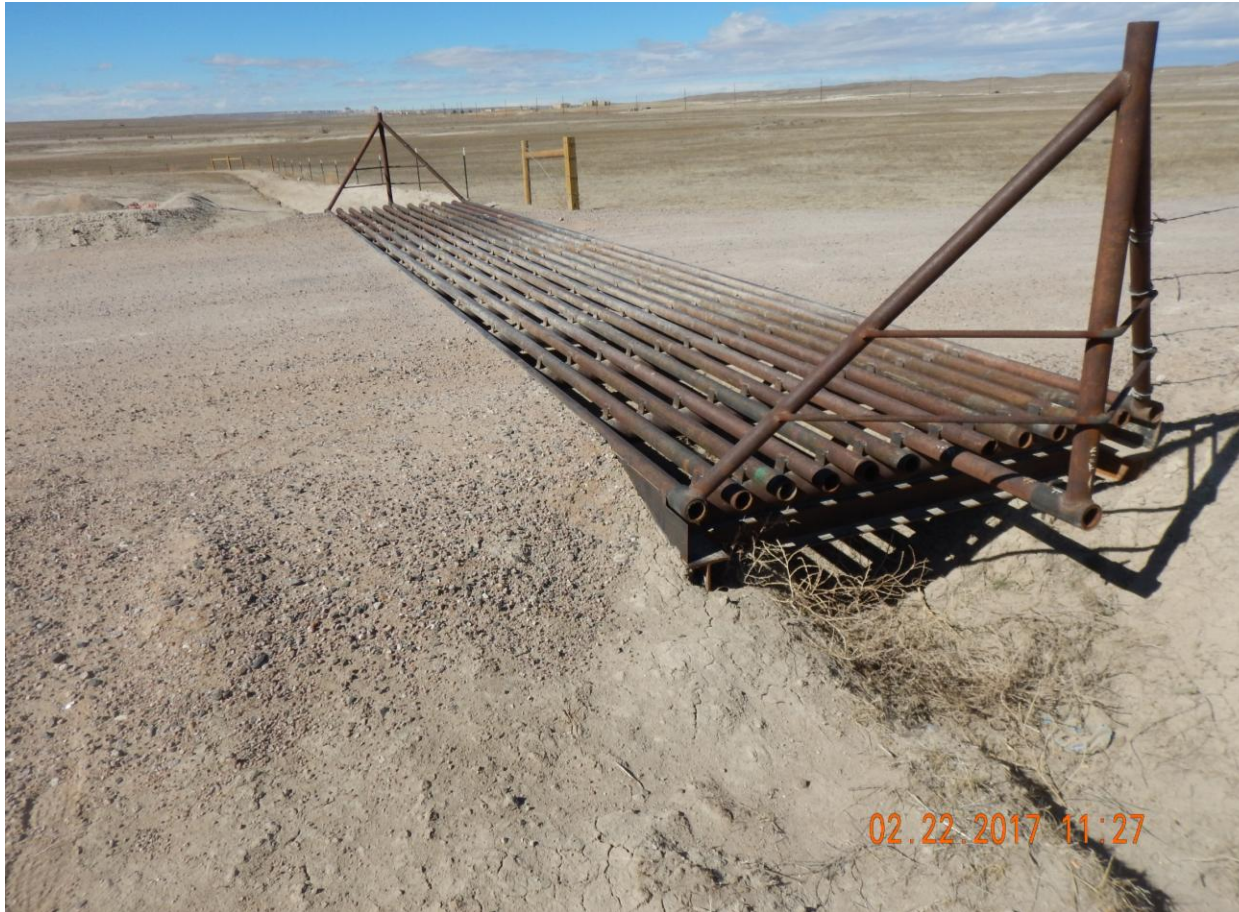
Photo 4: Photo taken from the north end of the location, facing west. Photo shows cattle guard used as vehicle tracking BMP

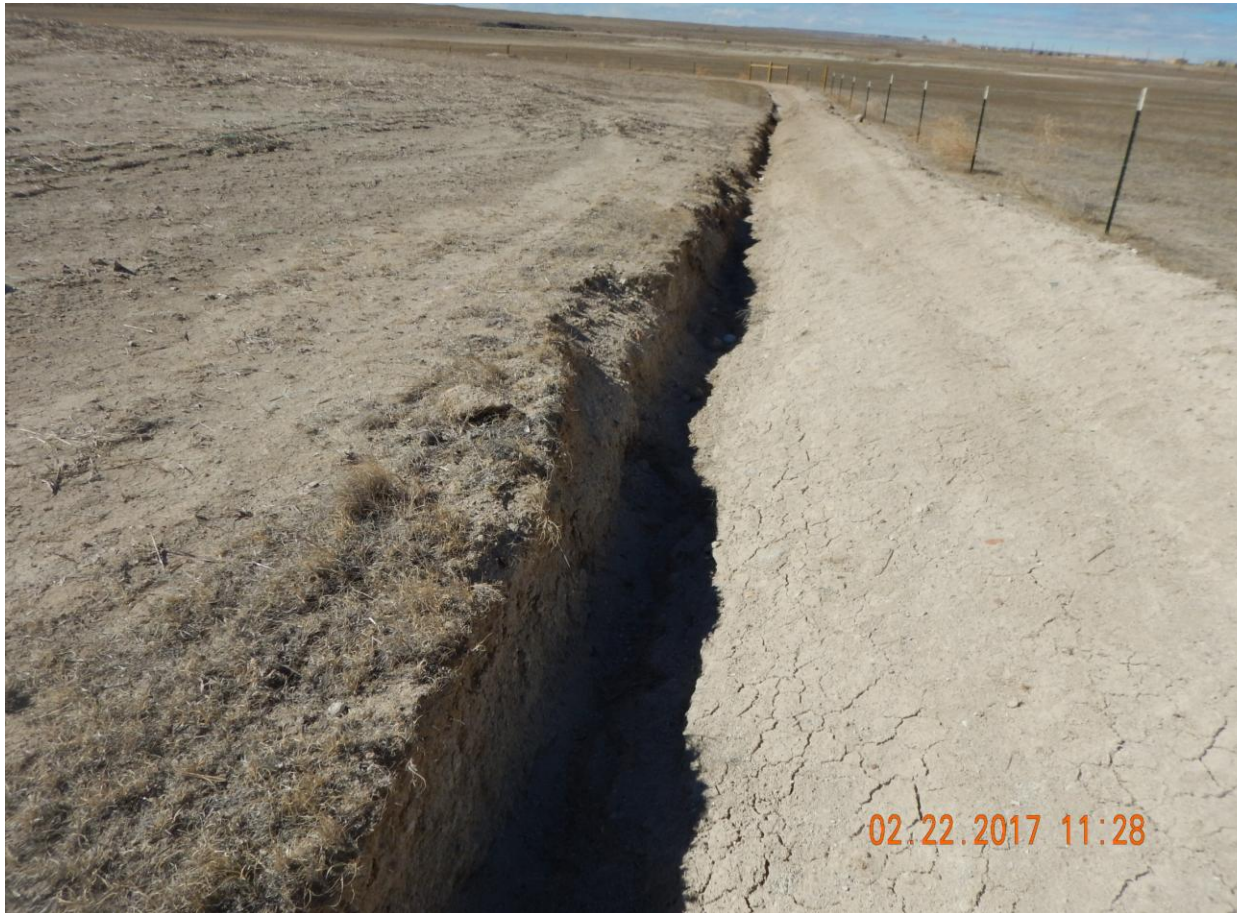
Photo 5: Photo taken from the north end of the location, facing west. Ditches constructed around the perimeter of the location have a "side wall" that was built vertically. It is advised that ditches built with the intent of being a more permanent stormwater and sediment control BMP be constructed with a more gradual slope and rounded or parabolic bottom. As an example, CDOT recommends a slope of 2:1 when constructing ditches.

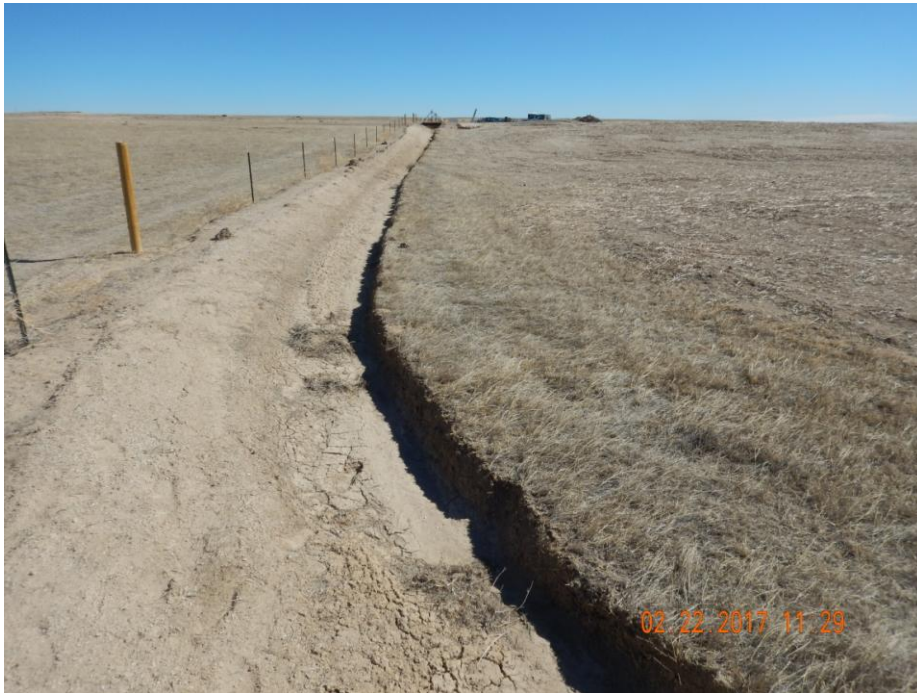
Photo 6: Photo taken from the northwest corner of the location, facing east. Photo shows stormwater and sediment control constructed on the northern perimeter of the location.

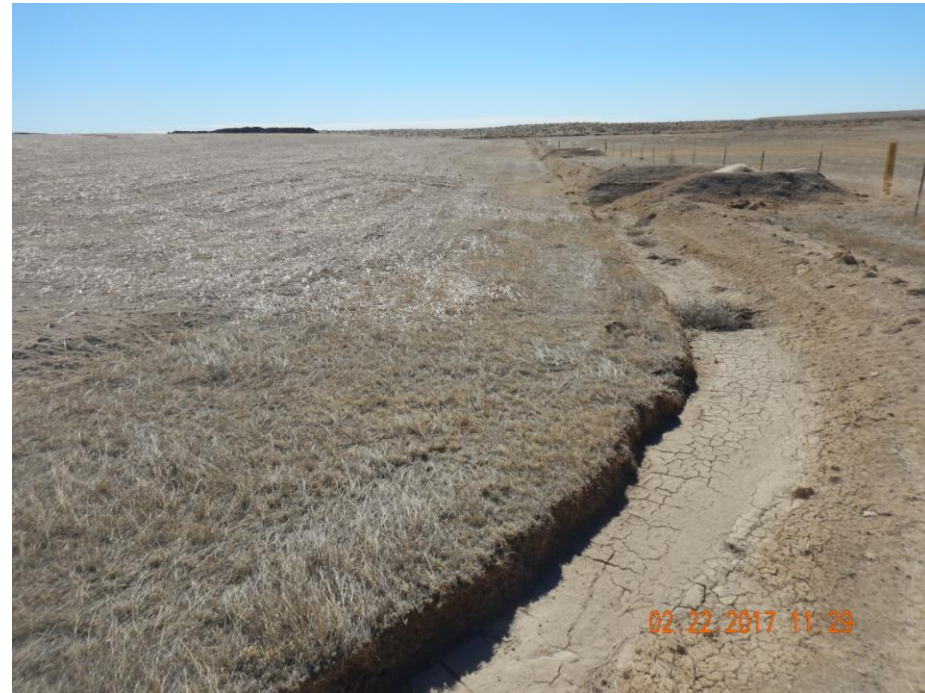
Photo 7: Photo taken from the northwest corner of the location, facing south. Photo shows stormwater and sediment control constructed on the northern perimeter of the location.

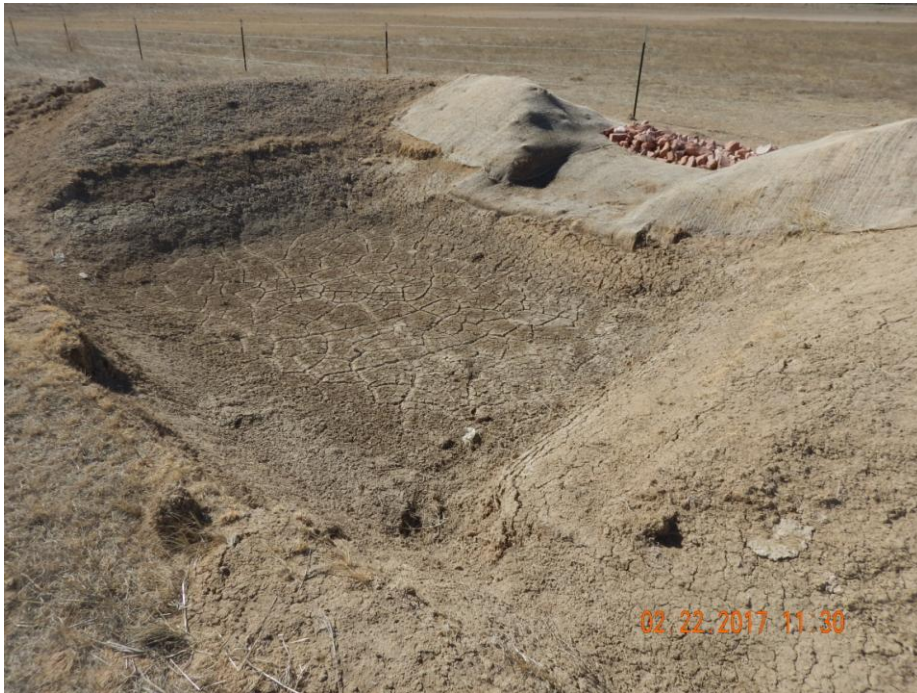
Photo 8: Photo taken from the west end of the location. Photo shows the northern sediment trap on the west end of the location. Photo shows inlet of the sediment trap does not have adequate inlet protection.

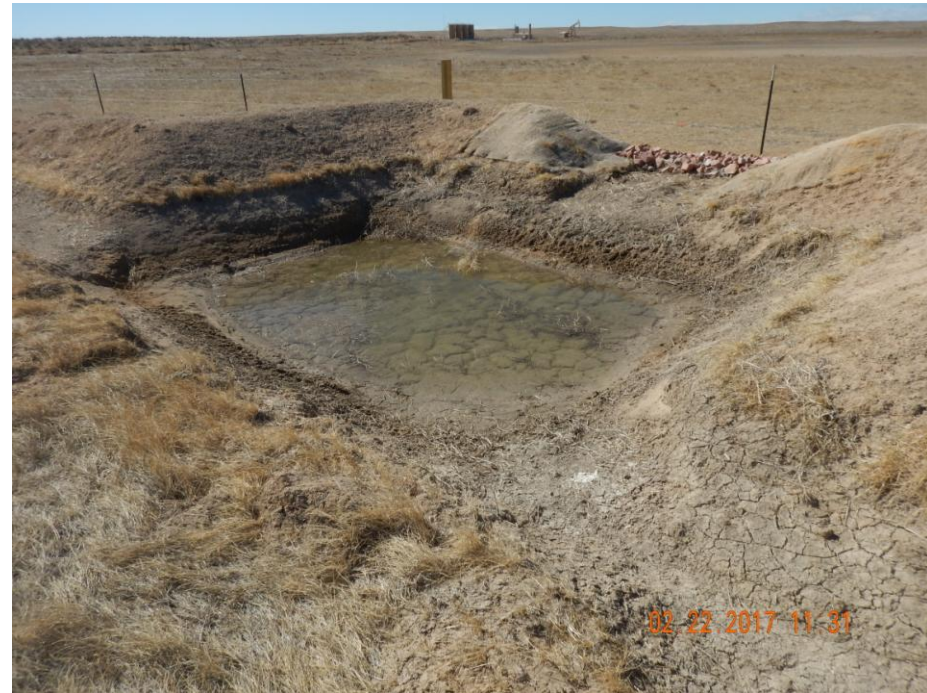
Photo 9: Photo taken from the west end of the location. Photo shows the southern sediment trap on the west end of the location. Photo shows inlet of the sediment trap does not have adequate inlet protection.

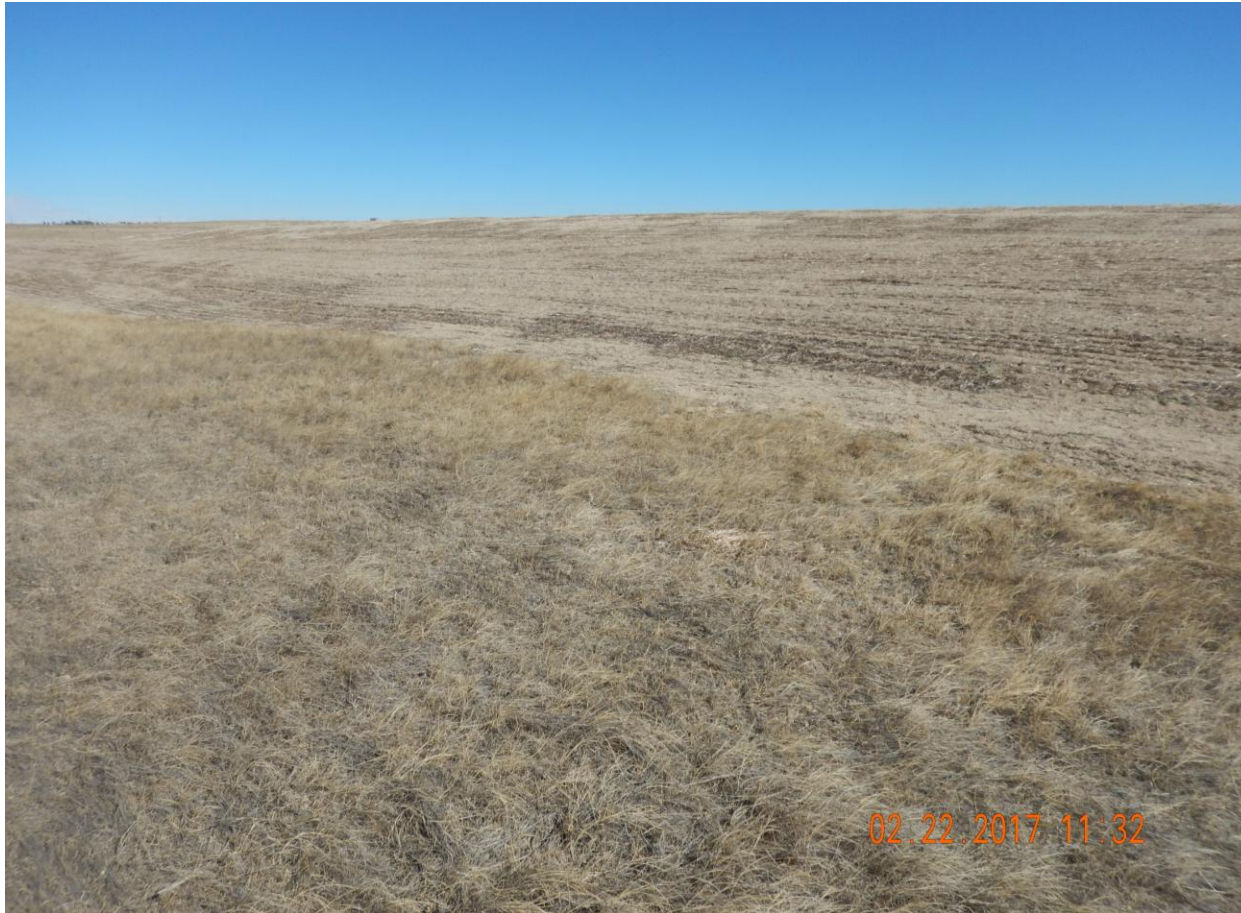
Photo 10: Photo taken from the west end of the location, facing east. Photo shows slopes appear to have been seeded and crimped to stabilize the soil.

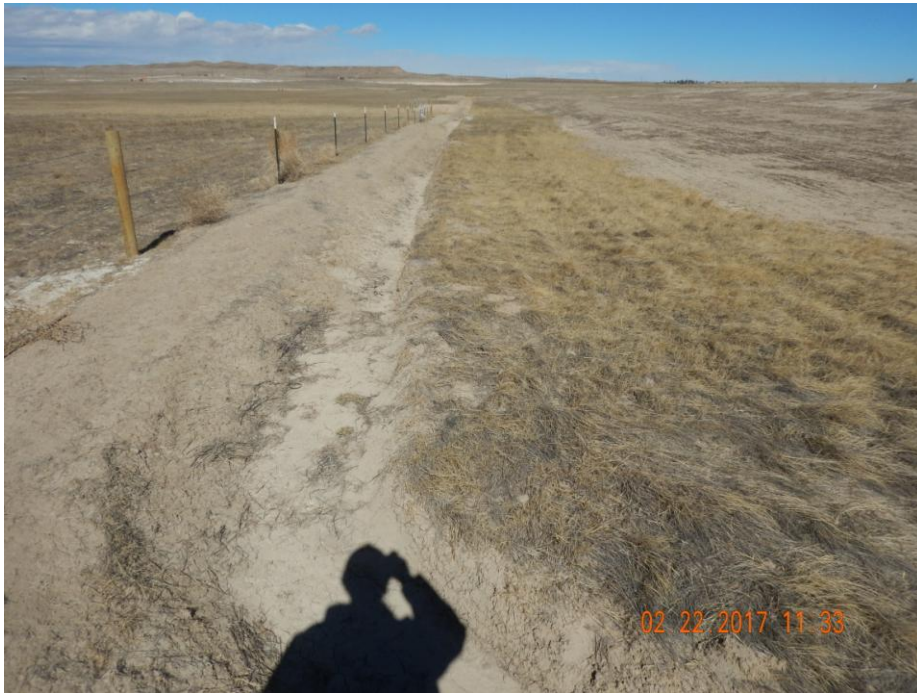
Photo 11: Photo taken from the southwest corner of the location, facing north. Photo shows stormwater and sediment control ditch along western perimeter of location.

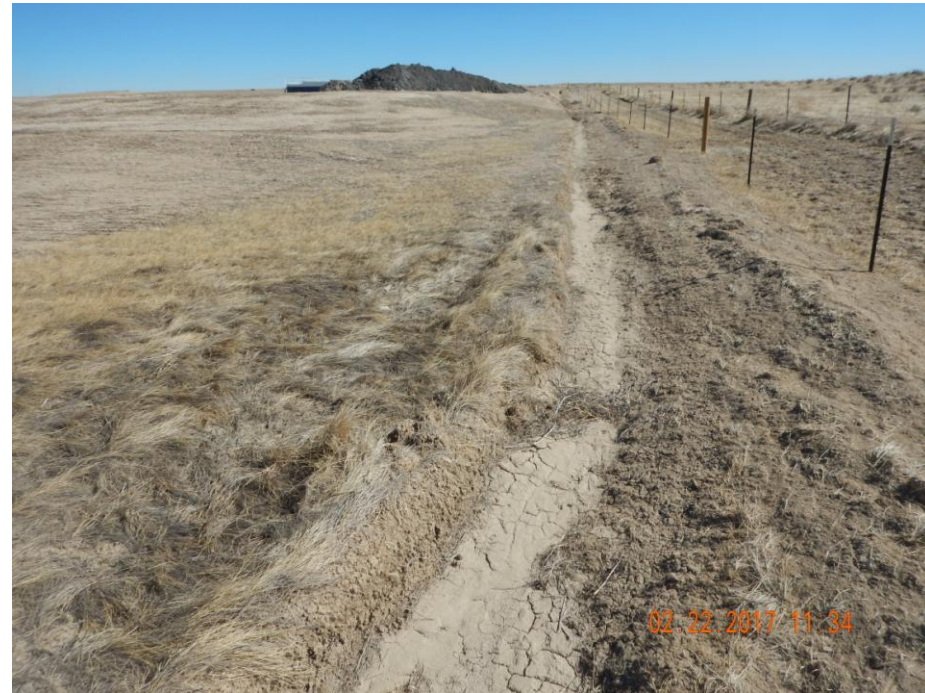
Photo 12: Photo taken from the southwest corner of the location, facing east. Photo shows stormwater and sediment control ditch along southern perimeter of location. Ditch has become inundated with sediment and will require maintenance.

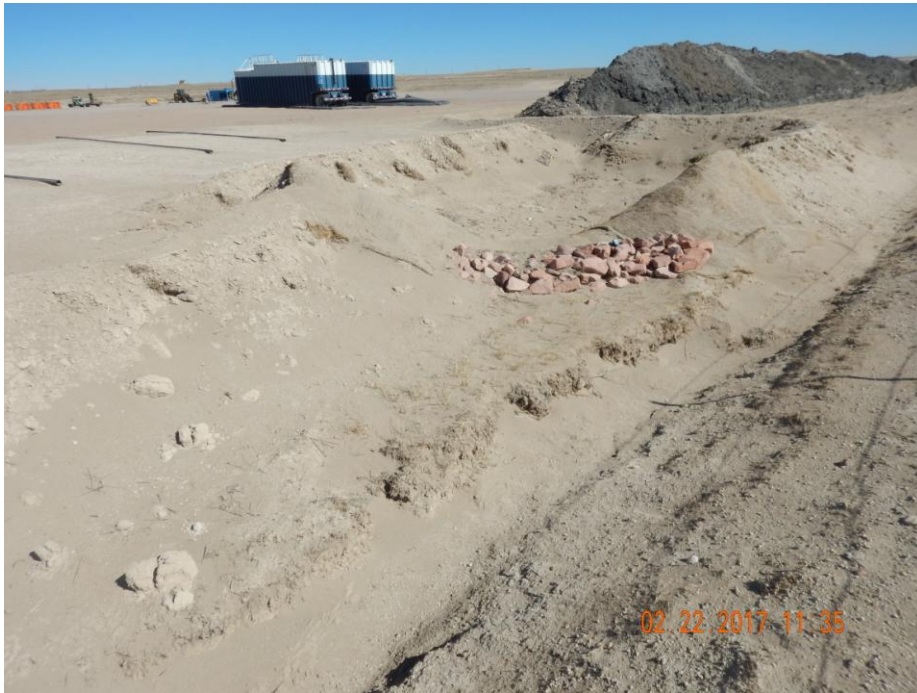
Photo 13: Photo taken from the south end of the location, facing northeast. Photo of stormwater and sediment trap on the south end of the location. Photo shows outlet of trap leading into perimeter ditch does not appear to be properly constructed

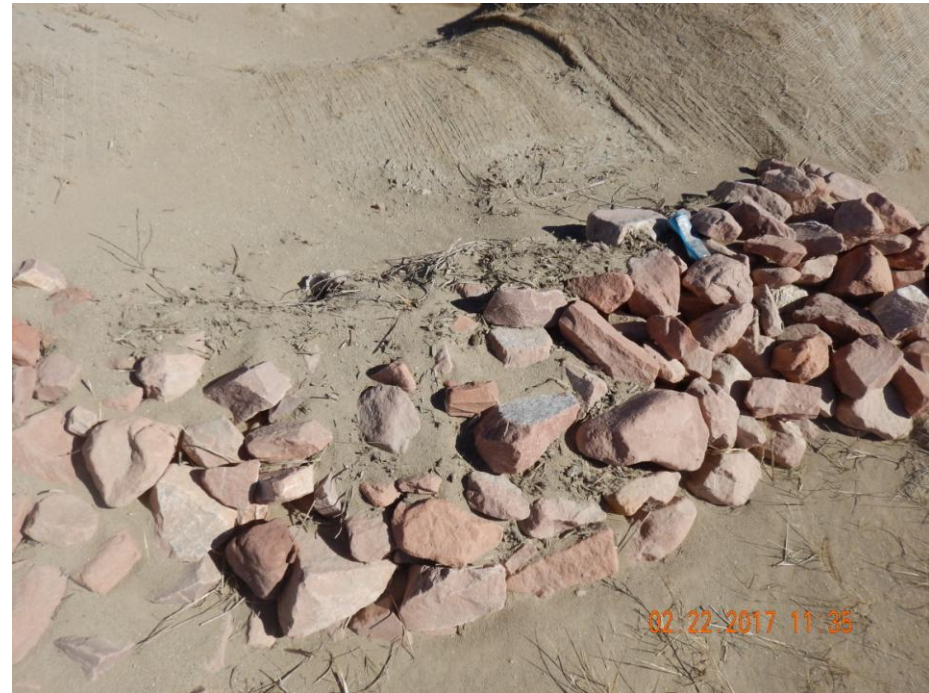
Photo 14: Photo taken from sediment trap on the south end of the location. Photo shows sediment trap has filled with soil and will require maintenance.

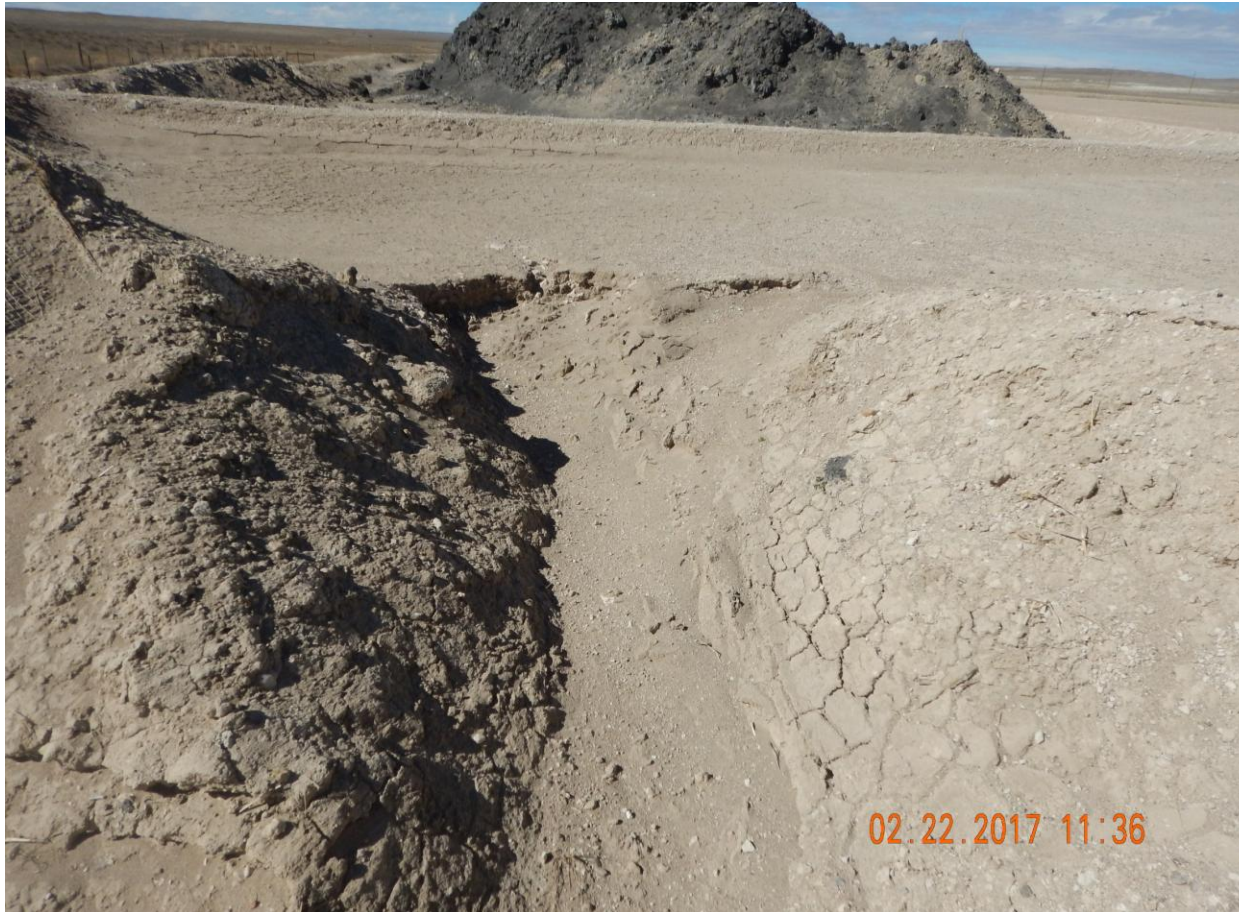
Photo 15: Photo taken from the sediment trap on the south end of the location, facing west. Photo shows sediment trap has not been properly constructed and is missing inlet protection. Sediment and location is experiencing degradation from erosion.

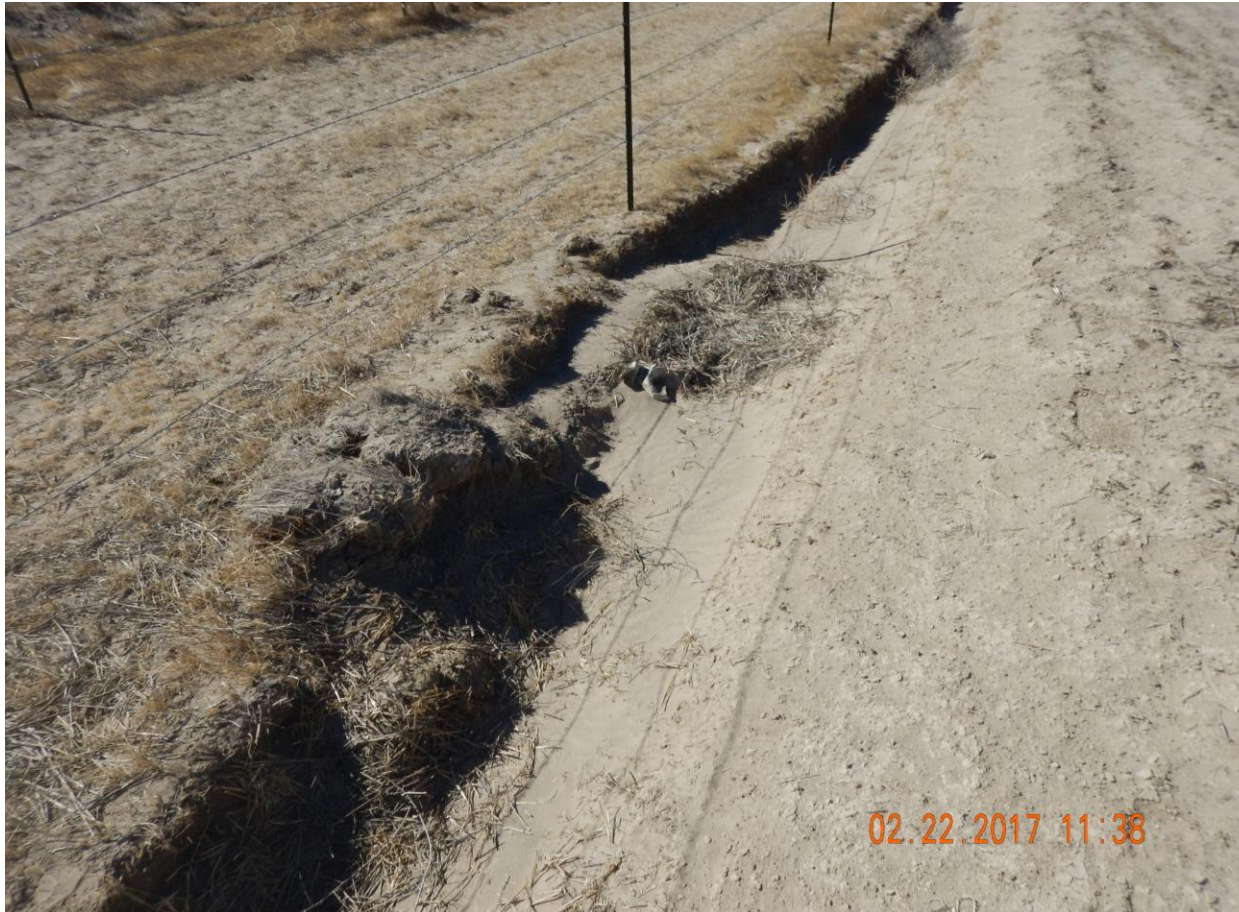
Photo 16: Photo taken from the stormwater control ditch on the south end of the location. Photo shows ditch has become inundated with sediment and will require maintenance.

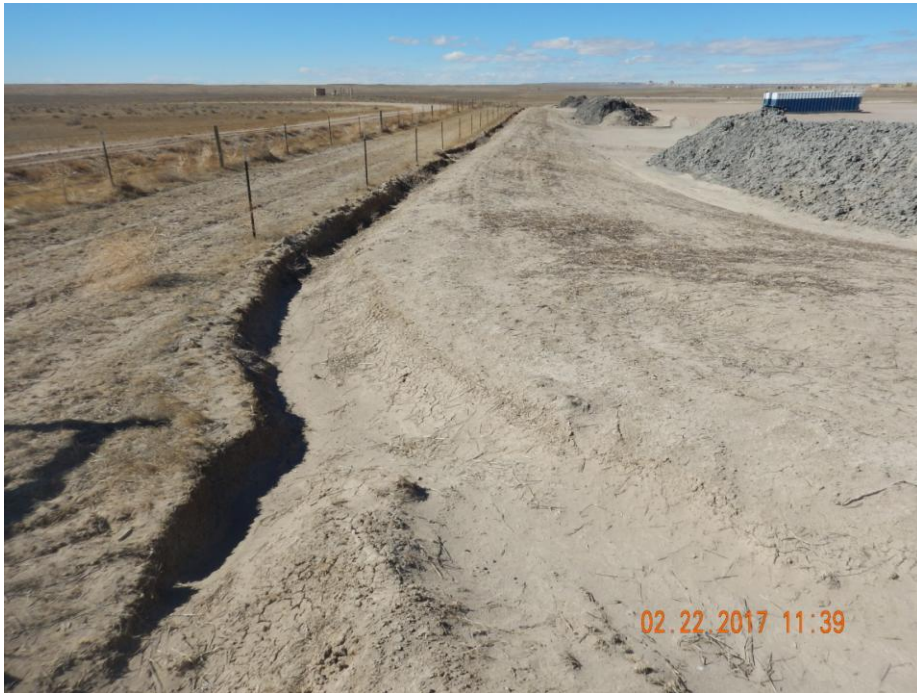
Photo 17: Photo taken from the southeast corner of the location, facing west. Photo shows stormwater and sediment control constructed on the northern perimeter of the location. Note area of the ditch leading east of the location does not have controls to trap sediment transport from location onto adjacent lands.

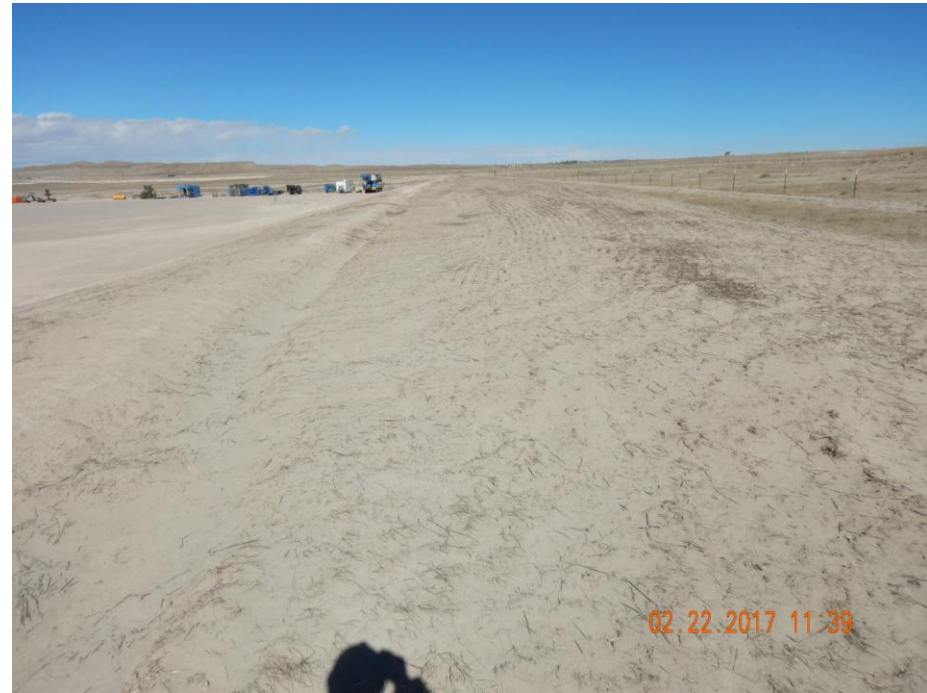
Photo 18: Photo taken from the southeast corner of the location, facing north. Photo shows stormwater and sediment control ditch along eastern perimeter of location. Photo also shows topsoil berm on east end of location.

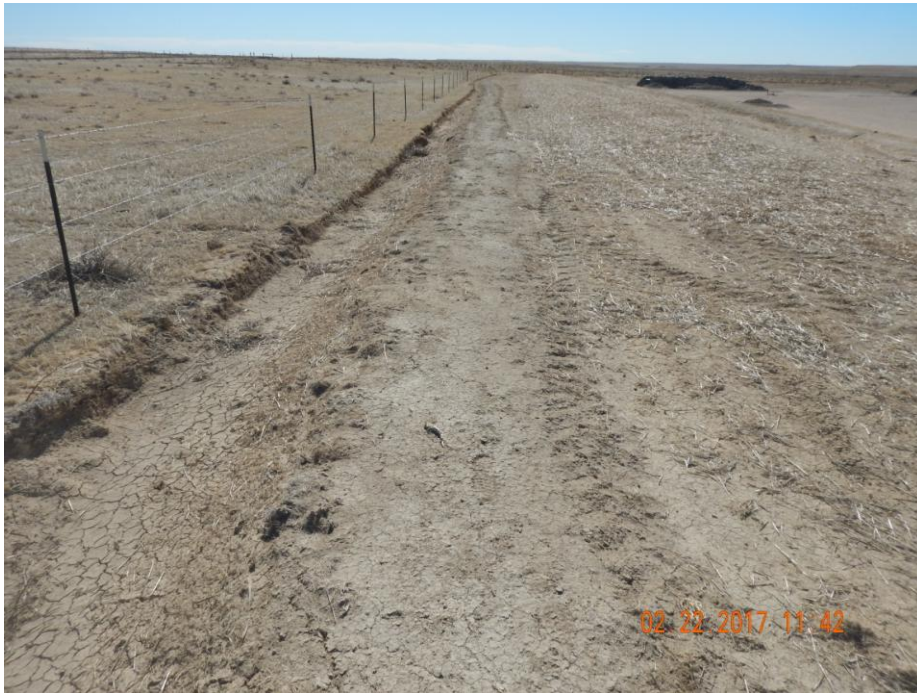
Photo 19: Photo taken from the northeast corner of the location, facing south. Photo shows stormwater control ditch along eastern perimeter of the location. Stormwater ditch has become inundated with sediment and will require maintenance.

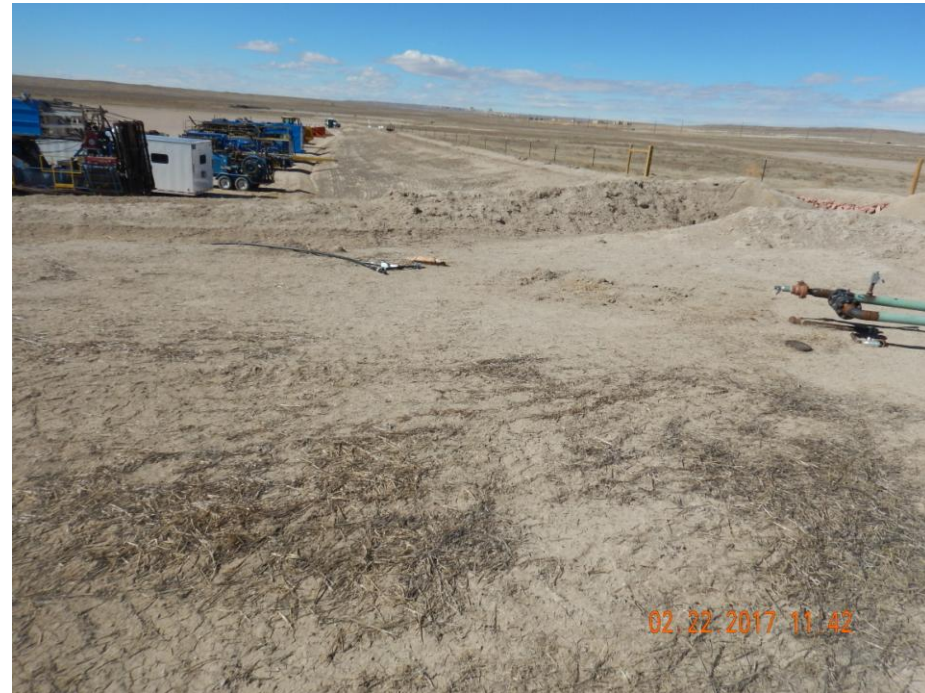
Photo 20: Photo taken from the northeast corner of the location, facing west. Photo shows stormwater control ditch along northern perimeter of the location.

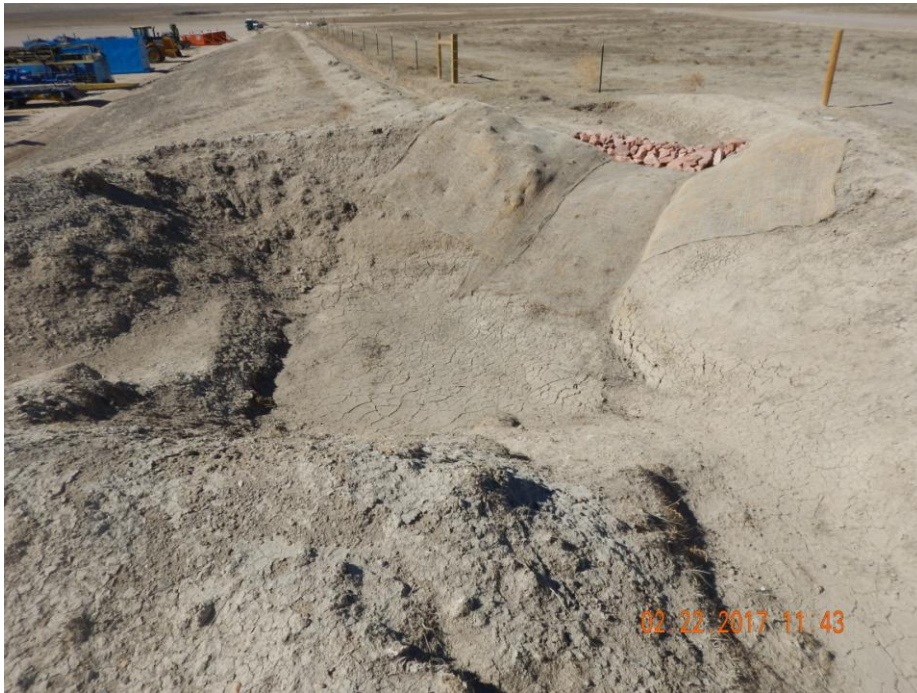
Photo 21: Photo taken from the northeast corner of the location, facing south. Photo shows stormwater and sediment control trap BMP. Trap does not have adequate inlet protection.

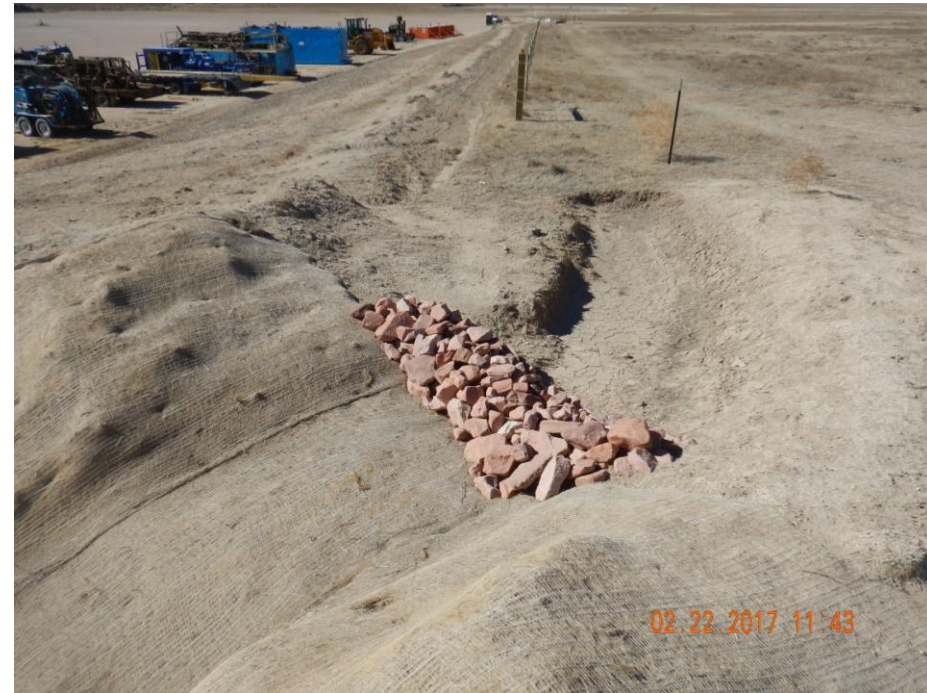
Photo 22: Photo taken from the northeast corner of the location, facing south. Photo shows stormwater and sediment control trap BMP. Photo shows outlet does not appear to be connected to the stormwater control ditch on the north perimeter of the location.

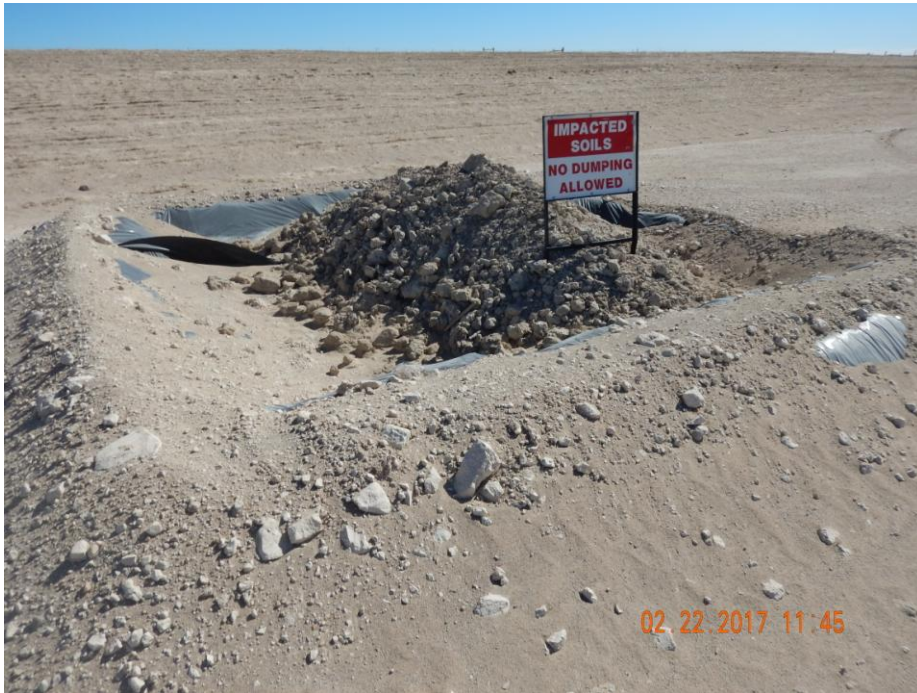
Photo 23: Photo taken from the south central are of the location. Photo shows berm constructed around impacted soil has been line and appears sufficient.

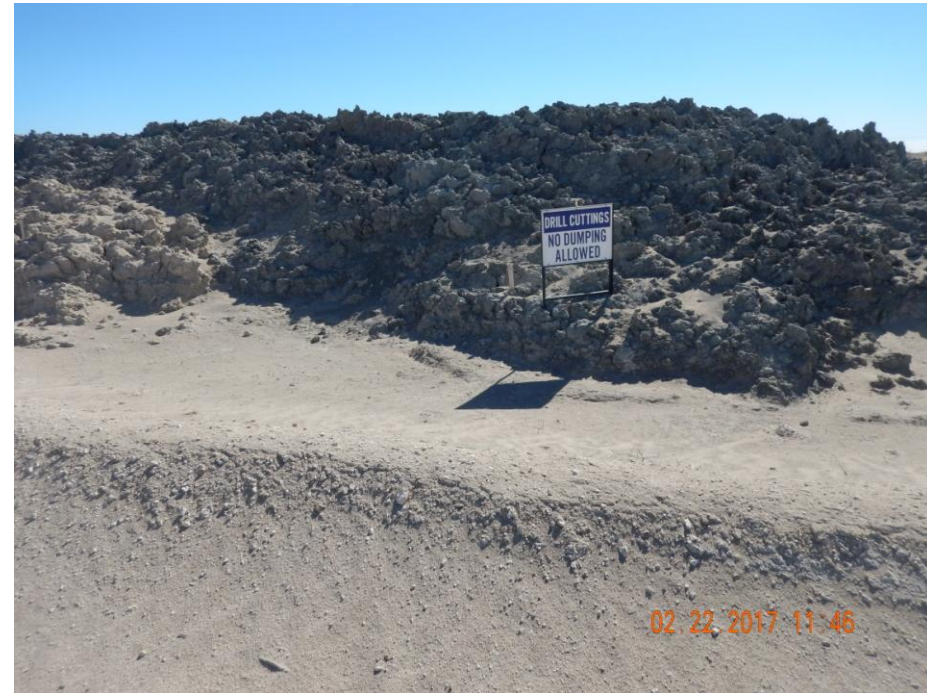
Photo 24: Photo taken from the south end of the location. Photo of drill cuttings on the south end of the location.

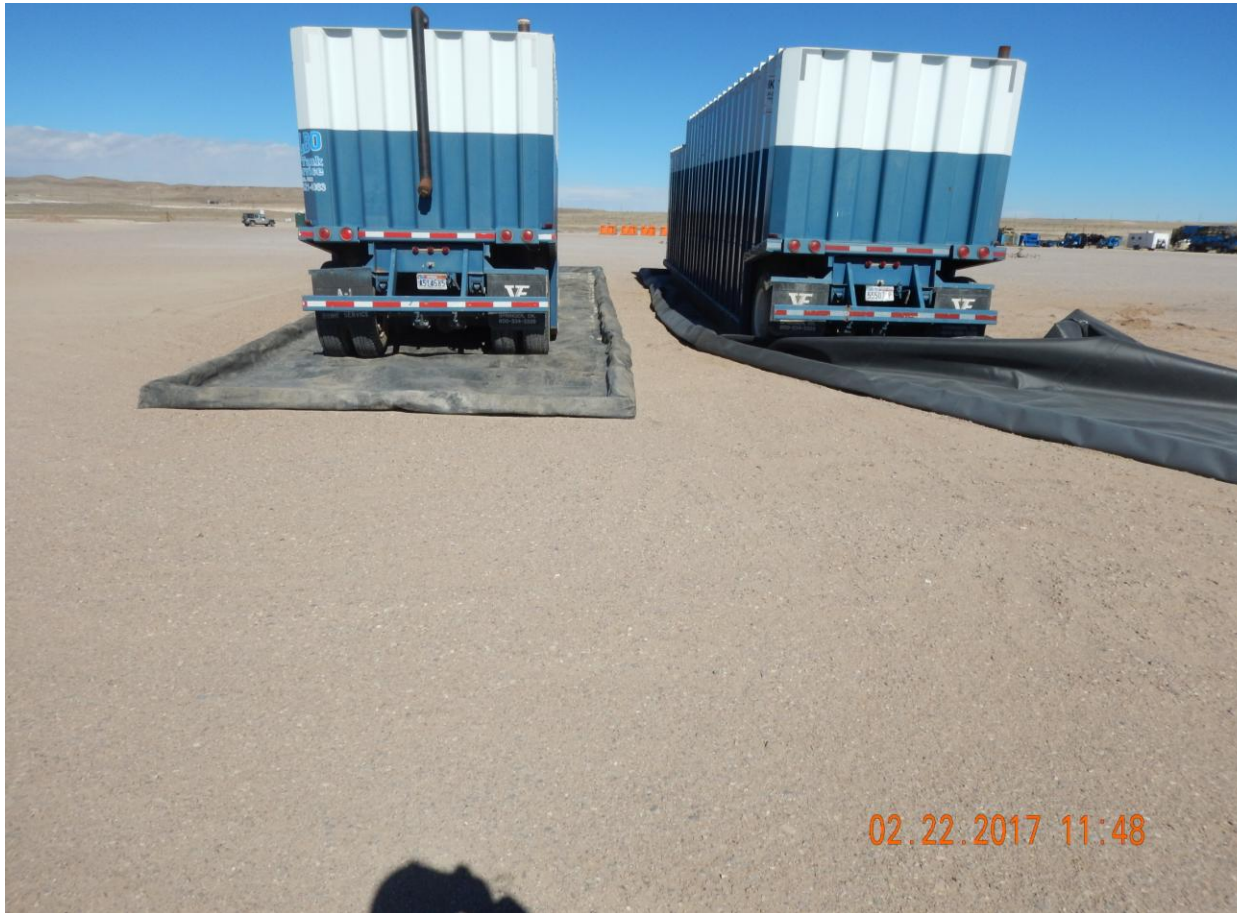
Photo 25: Photo taken from the south central end of the location. Photo of berms used around tanks.
