Inspection Photos
Location Name: Sidney Strear 1
API: 05-123-07883

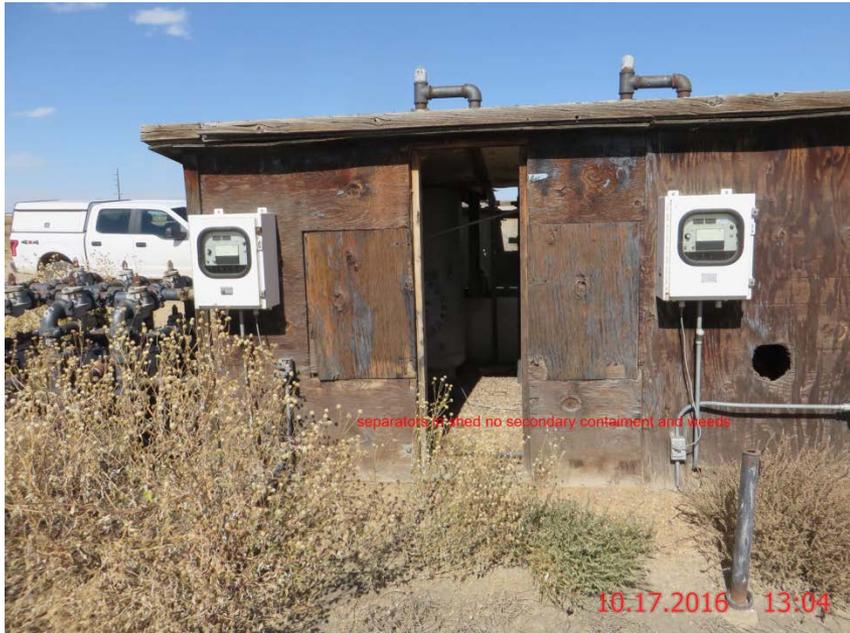
Photo from prior inspection for comparison

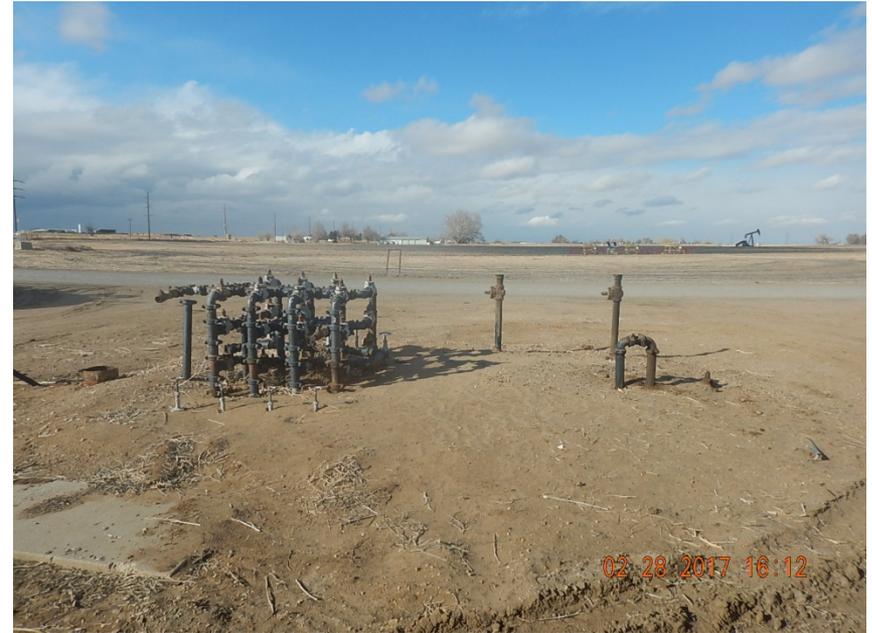
Photo 1: Weeds controlled, shed removed.

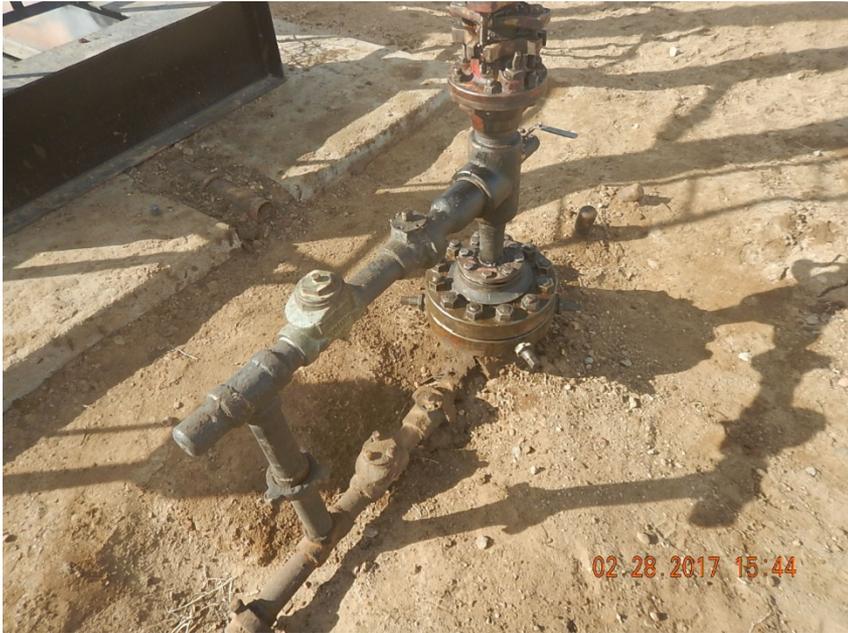
Photo 2: Stained soil at wellhead, no bradenhead plumbed to surface.

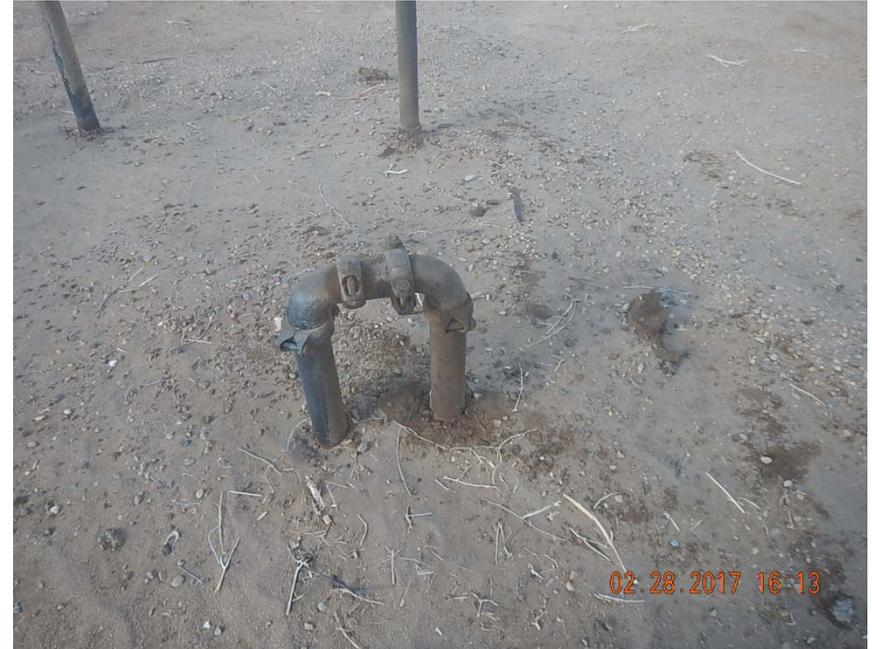
Photo 3: Stained soil at risers near manifold

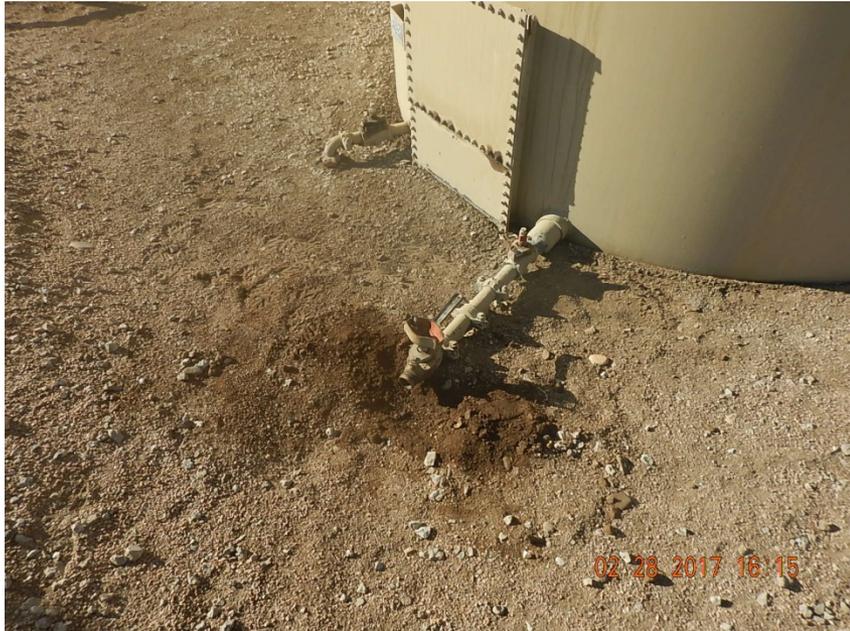
Photo 4: Stained soil at valve around tank

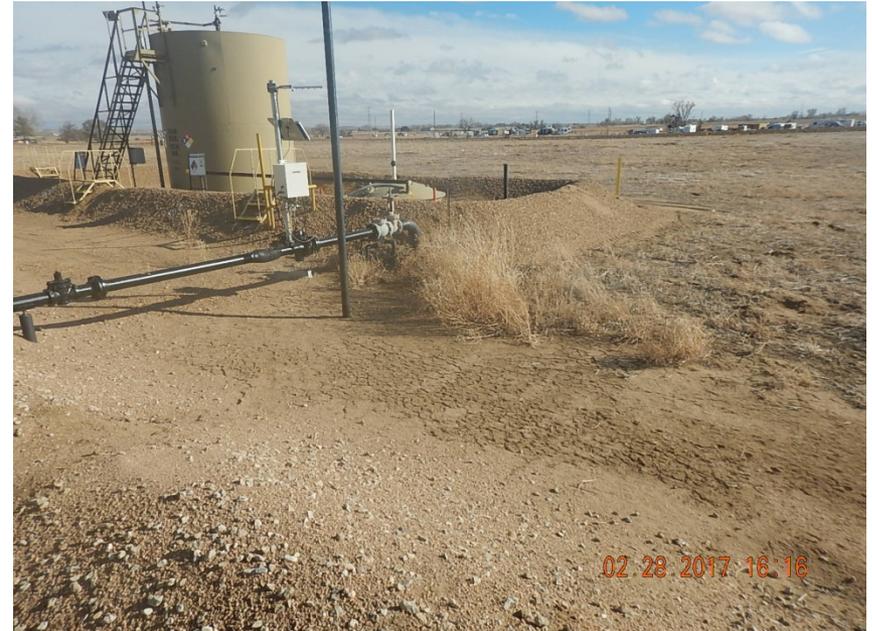
Photo 5: Weeds around meter run. (Battery is Kerr-McGee)
