Inspection Photos

Operator: Foundation Energy #10112

Location ID: 330865

Inspection Doc. Number: 682501708

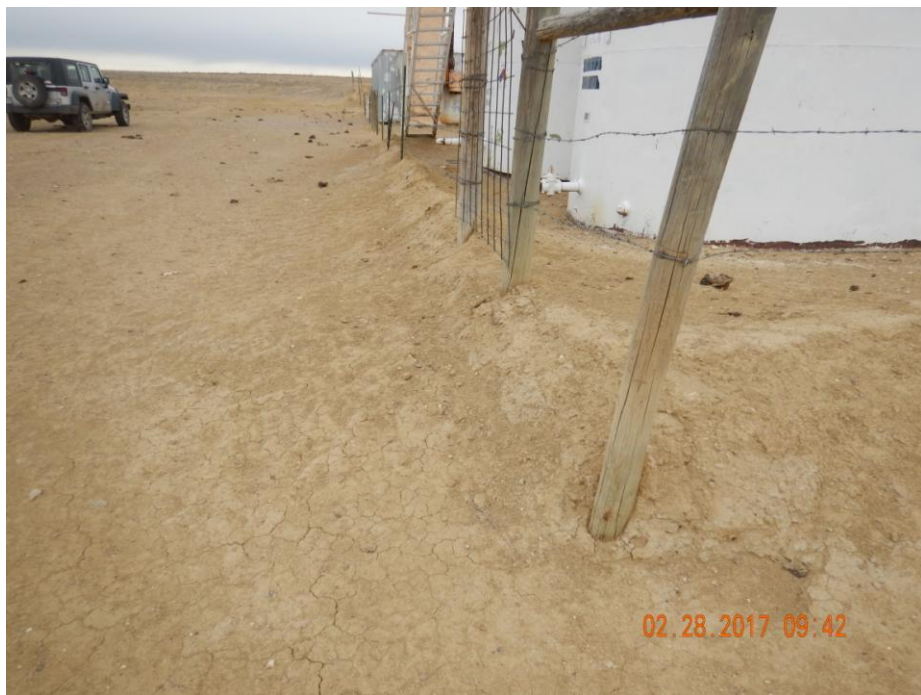
Photo 1: Photo taken southwest corner of the tank battery, on the southeast end of the location facing north. Photo shows berms remain low, insufficient and unrepaired.

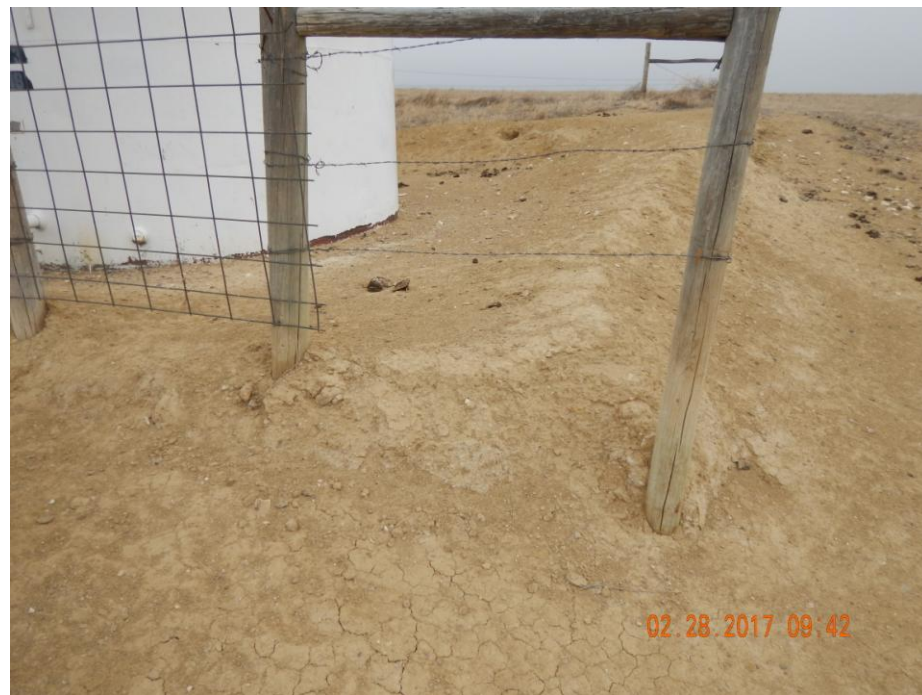
Photo 2: Photo taken southwest corner of the tank battery, on the southeast end of the location facing east. Photo shows berms remain low, insufficient and unrepaired.

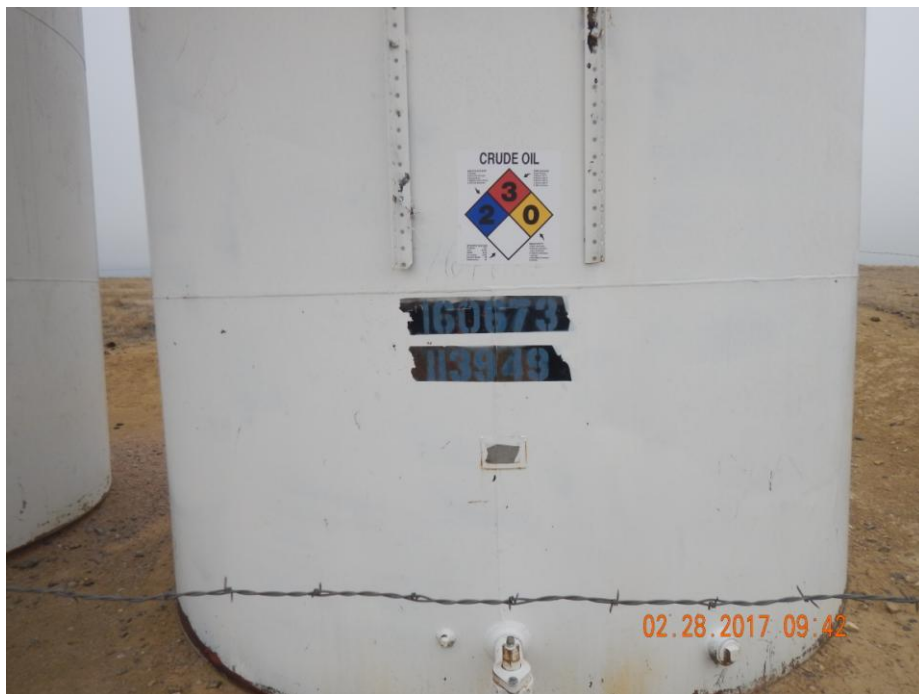
Photo 3: Photo taken from the southern tank, on the southeast end of the location. Photo show placard labels are still missing information such as name of operator, operator's emergency contact telephone number, and tank capacity.

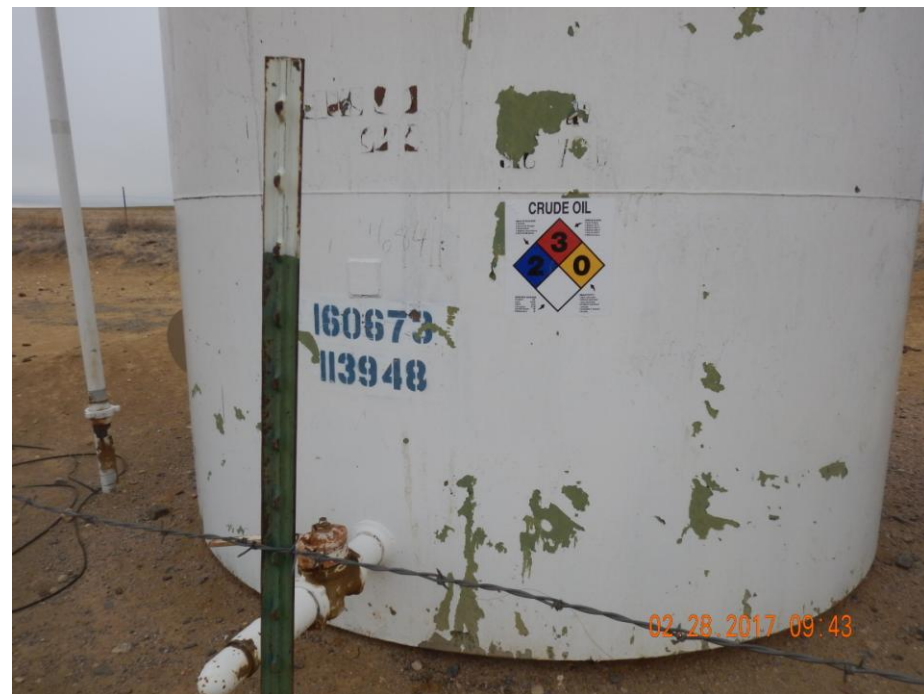
Photo 4: Photo taken from the northern tank, on the southeast end of the location. Photo show placard labels are still missing information such as name of operator, operator's emergency contact telephone number, and tank capacity.

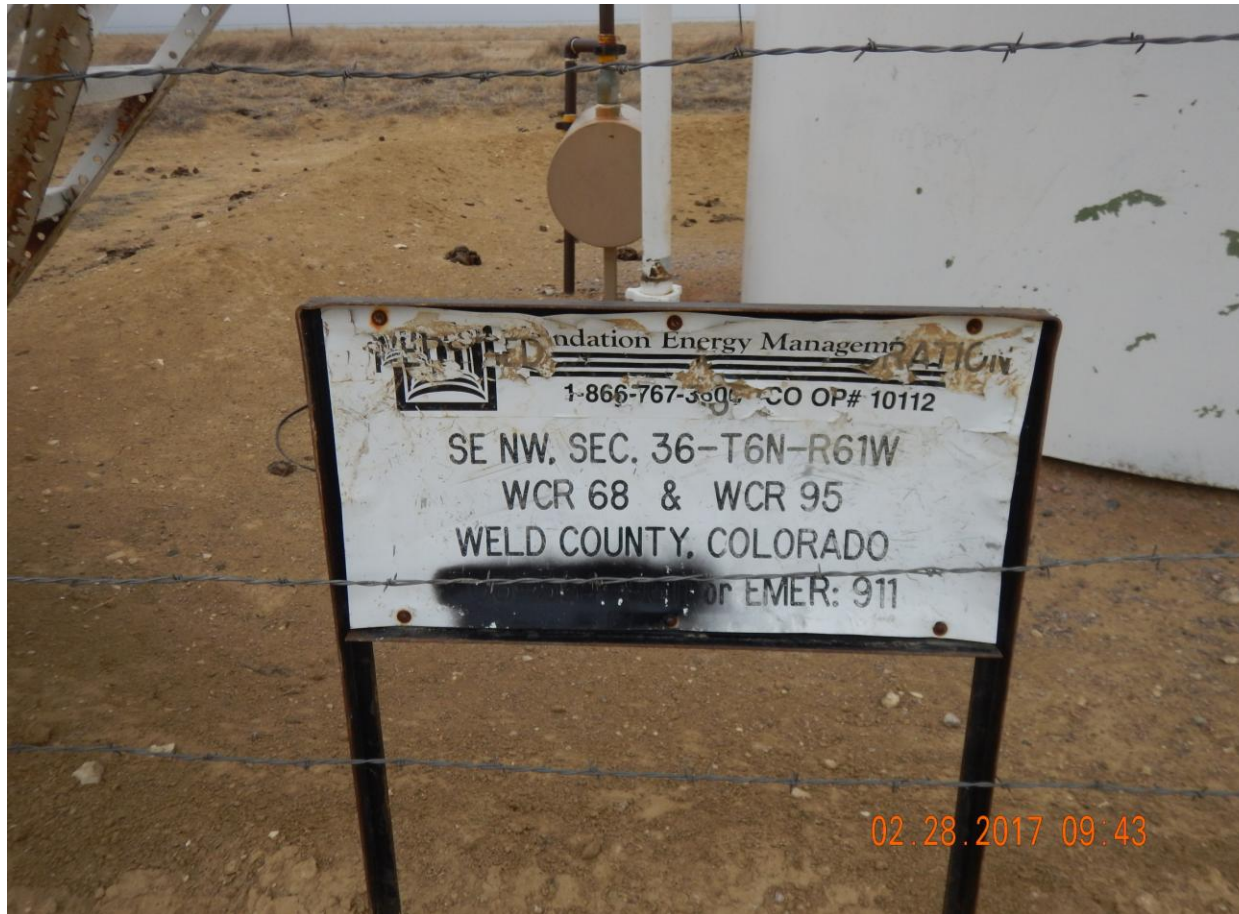
Photo 5: Photo of sign at tank battery. Photo shows sign remains deteriorated in such a manner that the operator emergency contact information is illegible.

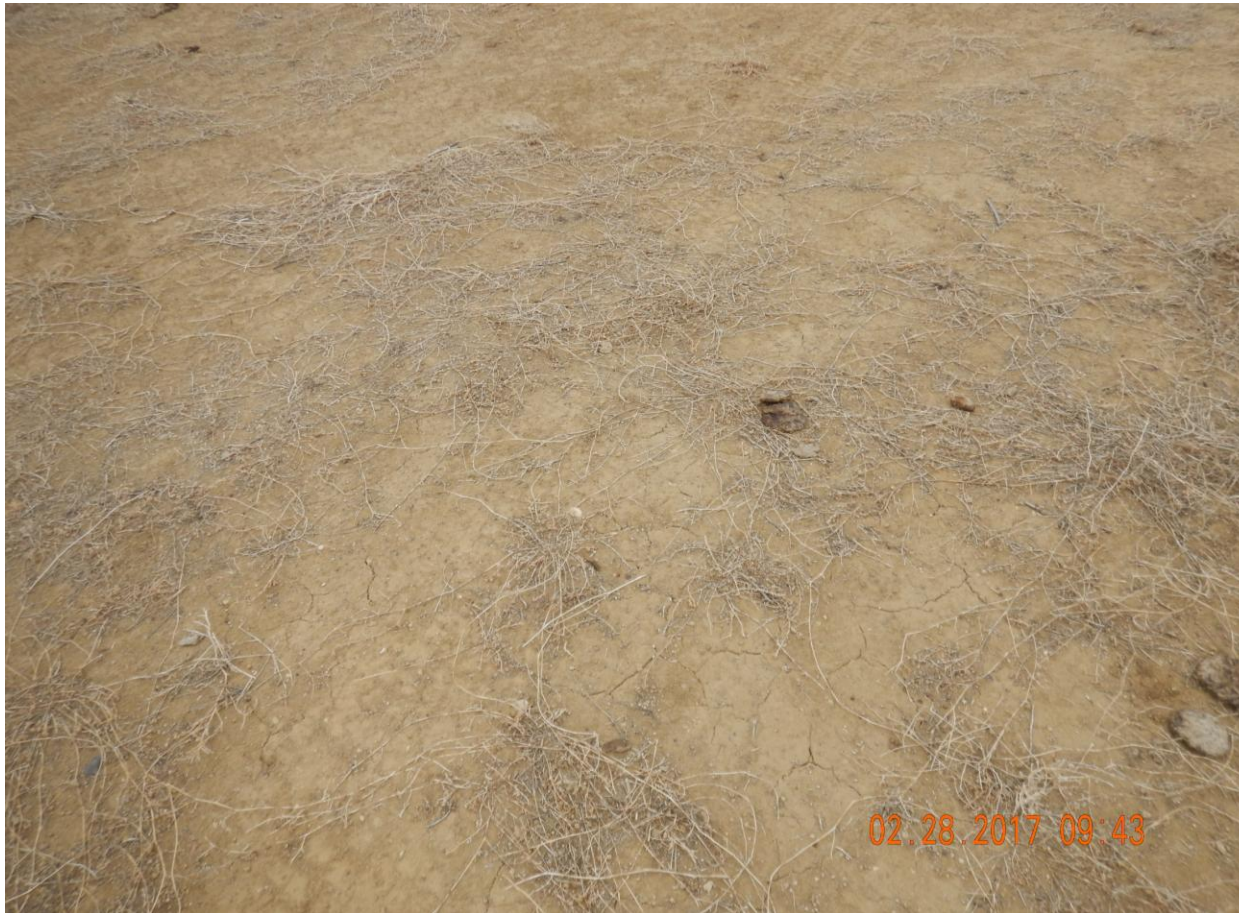
Photo 6: Photo taken from location. Photo shows high abundance of *Tribulus terrestris* (Puncturevine, goat-head). This is a Colorado State noxious weed. Weeds need to be managed and removed.

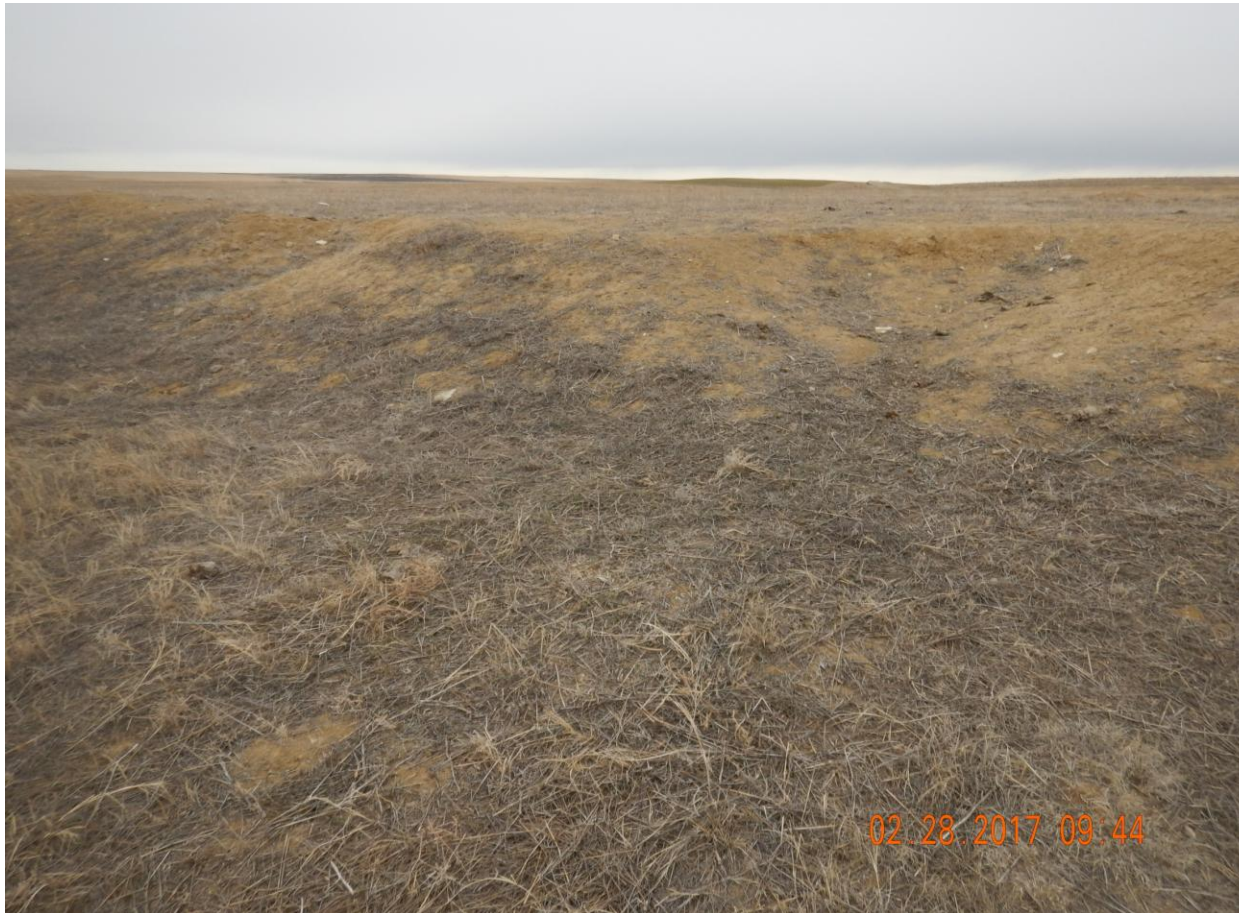
Photo 7: Photo taken from the south end of the location, facing north. Photo shows erosion degradation on the location. Photo shows stormwater and sediment control BMPs have not been installed.

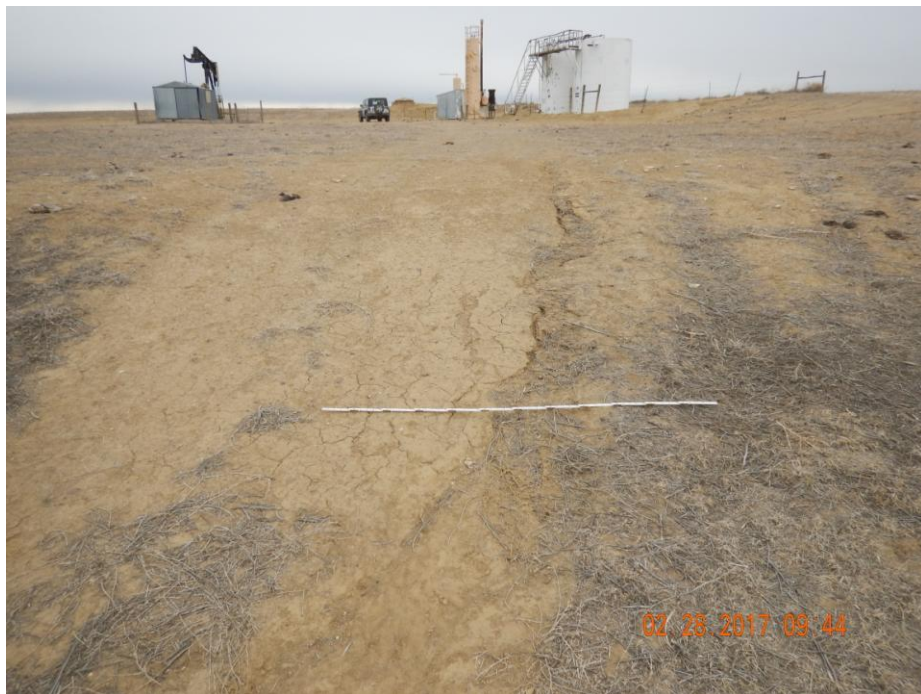
Photo 10: Photo taken from the south end of the location, facing north. Photo shows erosion degradation on the location. Photo shows stormwater and sediment control BMPs have not been installed. 6 foot measuring stick for reference.

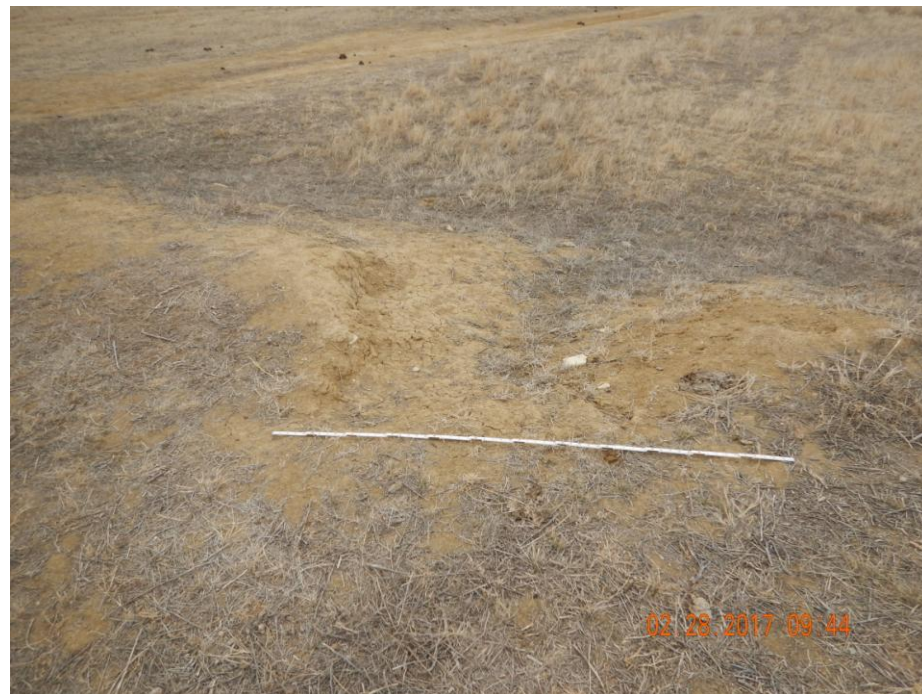
Photo 11: Photo taken from the south end of the location. Photo shows erosion degradation on the location. Photo shows stormwater and sediment control BMPs have not been installed. 6 foot measuring stick for reference.

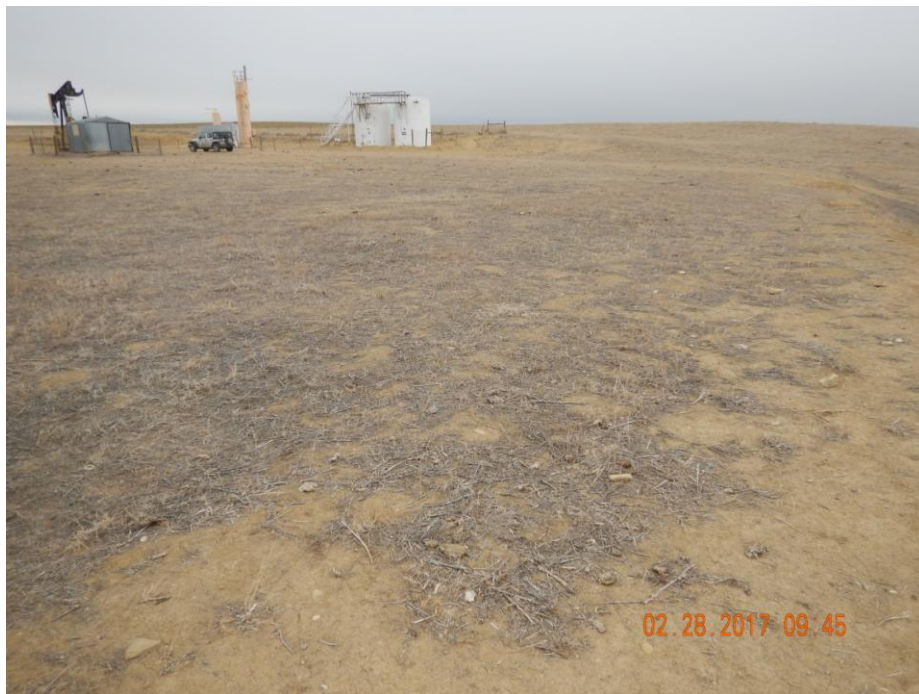
Photo 12: Photo taken from the southwest corner of the location, facing east. Photo vegetation over the interim area. Note vegetation is predominantly undesirable weedy plant species. Very little evidence of perennial vegetation establishment found.

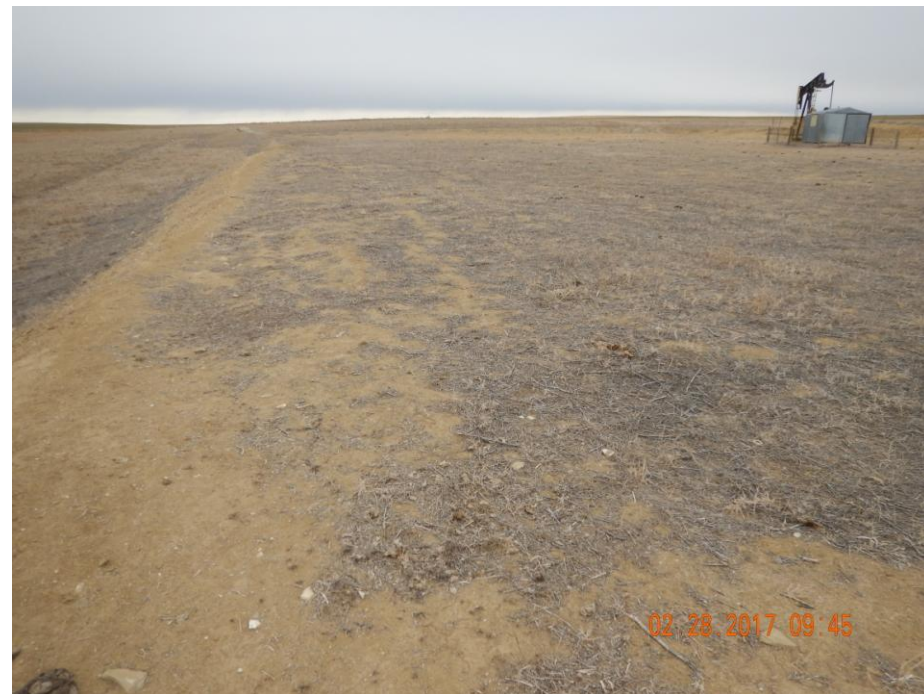
Photo 13: Photo taken from the southwest corner of the location, facing north. Photo vegetation over the interim area. Note vegetation is predominantly undesirable weedy plant species. Very little evidence of perennial vegetation establishment found.

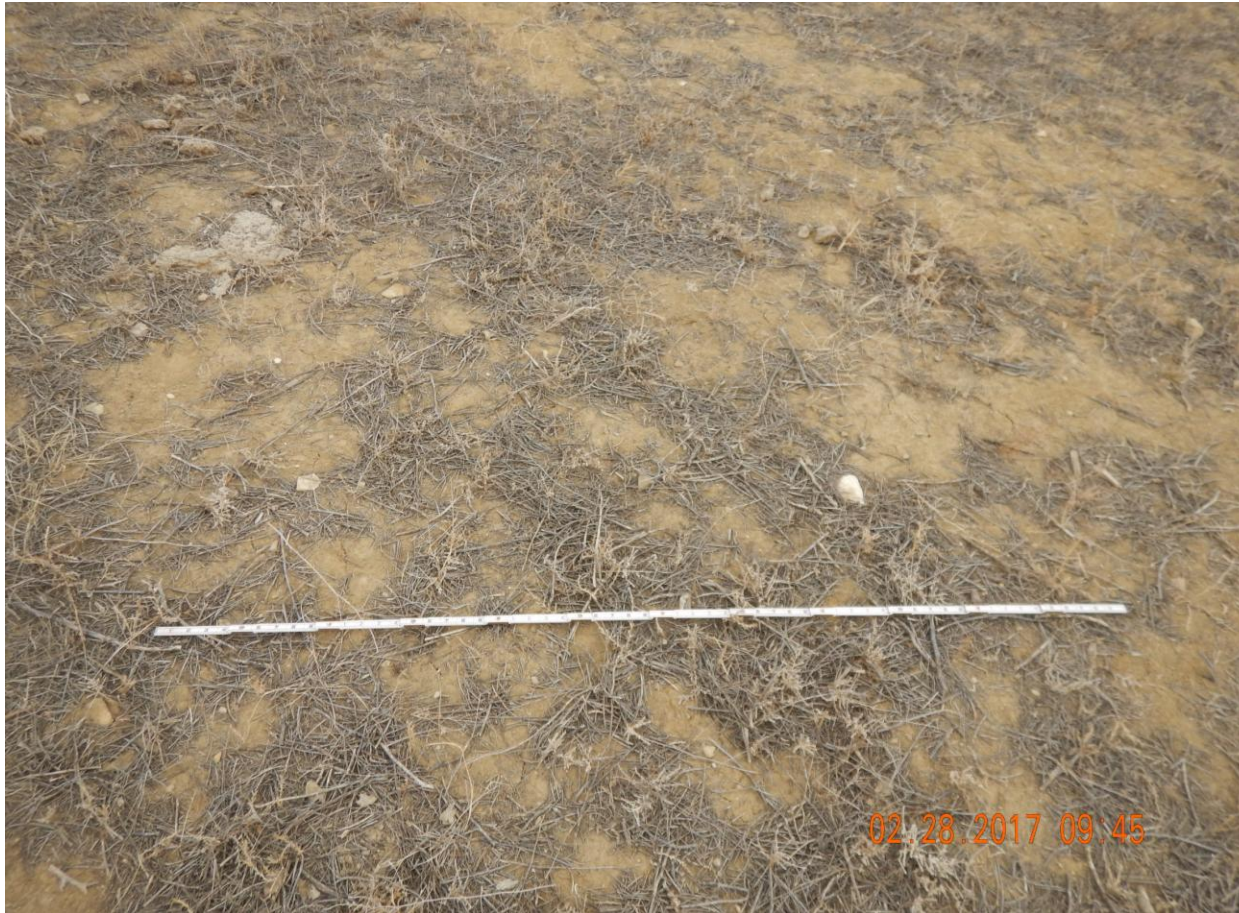
Photo 14: Photo taken from the interim area of the location. Photo shows vegetation over the interim area. Note vegetation is predominantly undesirable weedy plant species. Very little evidence of perennial vegetation establishment found. 6 foot measuring stick for reference.

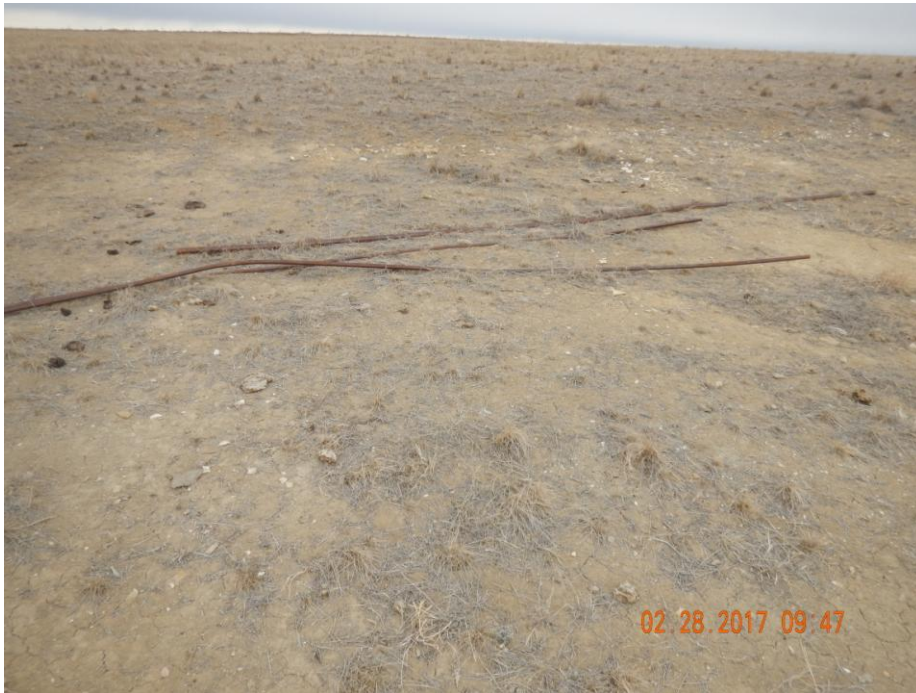
Photo 15: Photo taken from the northwest end of the location. Photo shows square iron tubing has not been removed or properly stored from location.

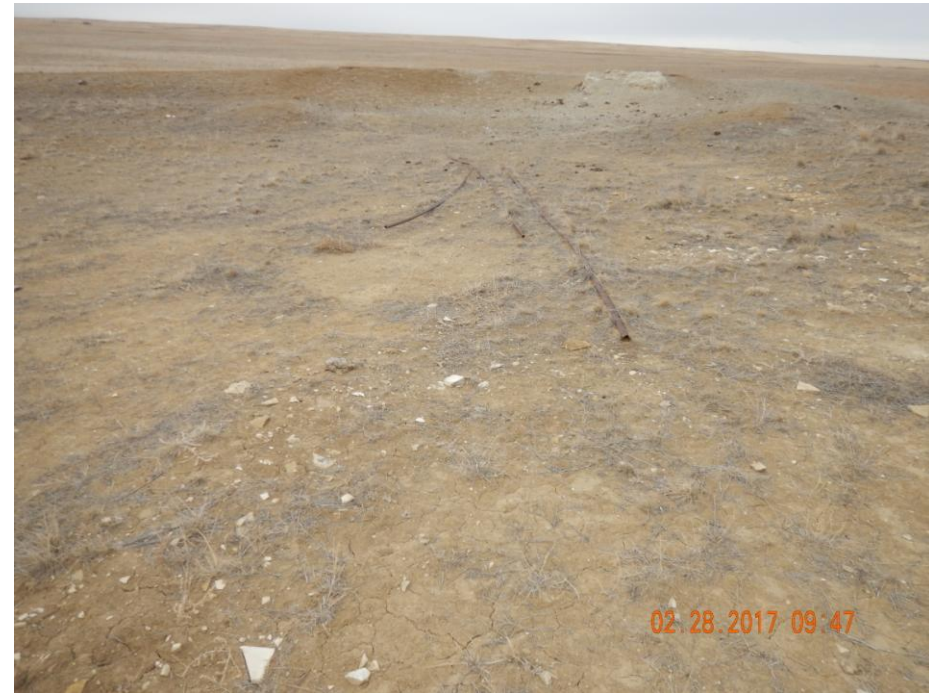
Photo 16: Photo taken from the northwest end of the location. Photo shows square iron tubing has not been removed or properly stored from location.

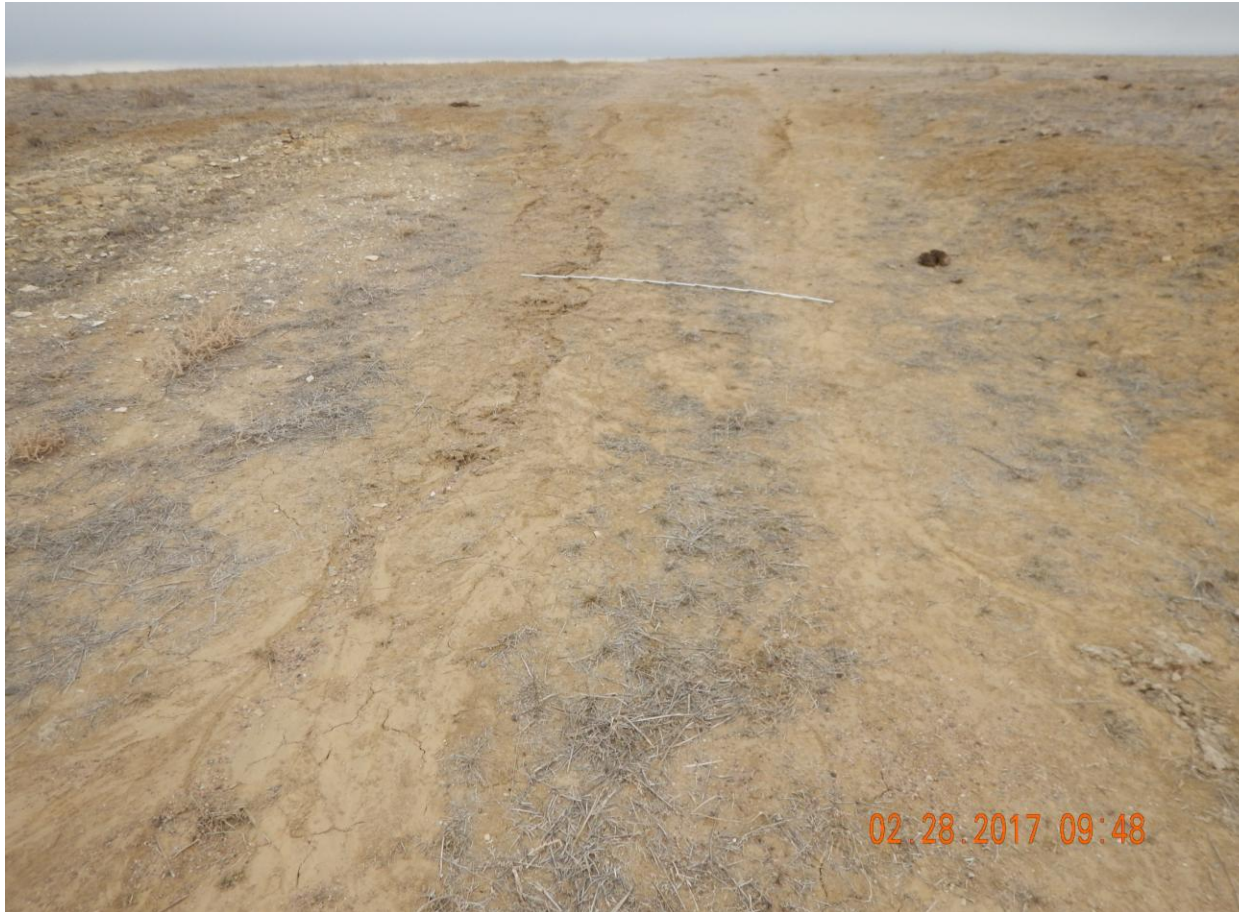
Photo 17: Photo taken from the north end of the location, facing north. Photo shows erosion degradation on the location. Photo shows stormwater and sediment control BMPs have not been installed. 6 foot measuring stick for reference.

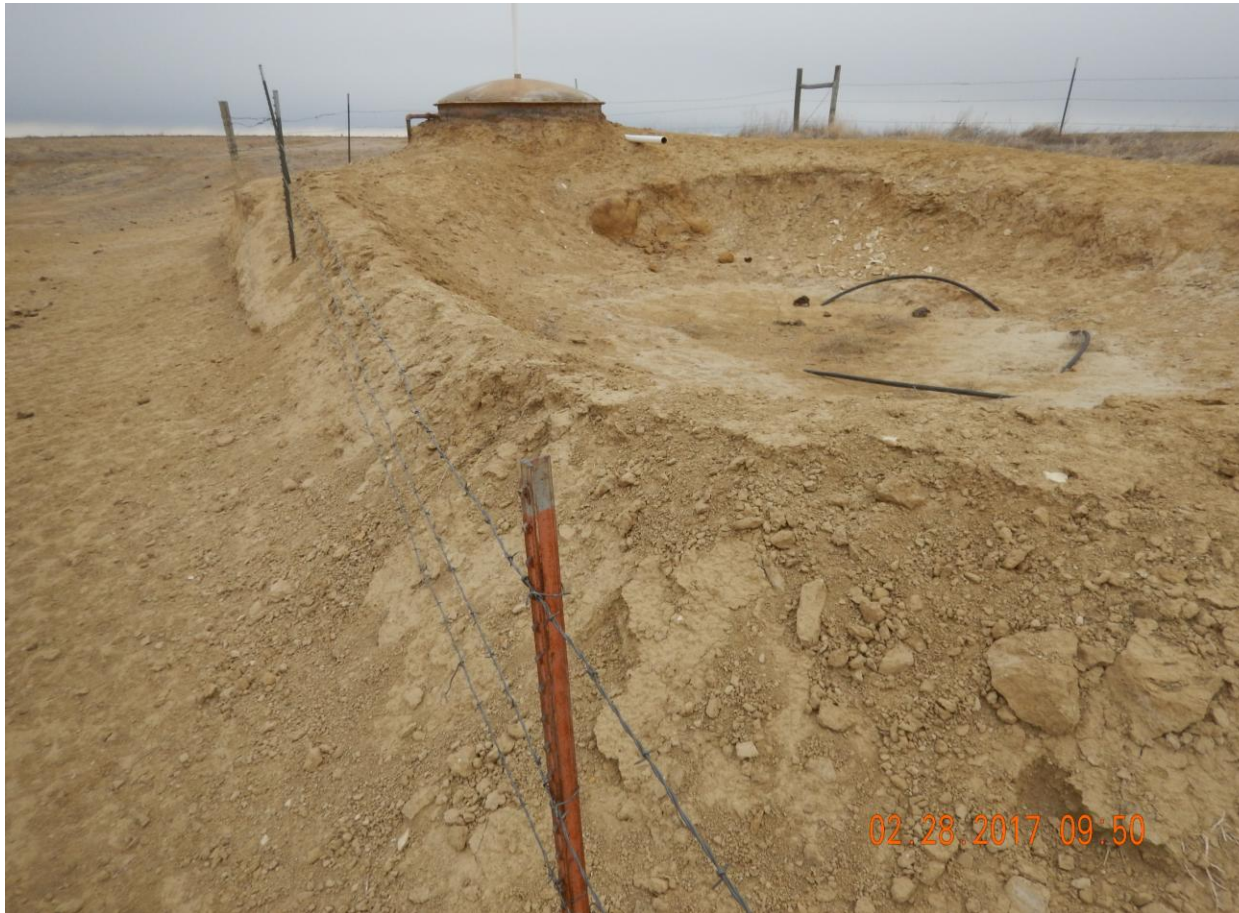
Photo 18: Photo taken from northeast end of the location at skim pit. Inspection Doc. #684901990 required operator to Submit form 15 eform pit report (10 days); No form 15 found in well or location records for a produced water skim pit.

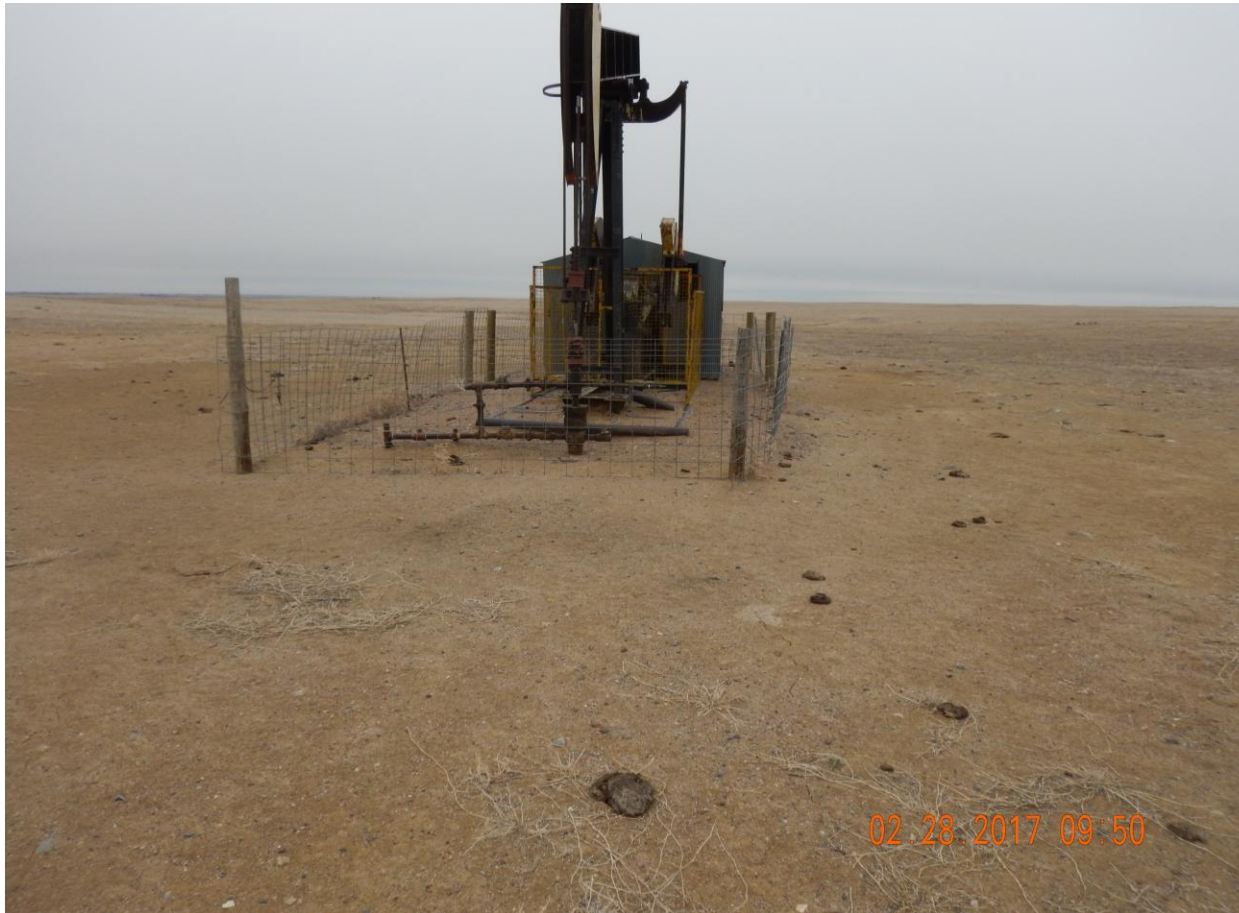
Photo 19: Photo taken at well. Photo shows sign remains missing from wellhead.
