Stormwater Inspection

February 27, 2017

Operator: CONOCO PHILLIPS COMPANY - # 19160

API: 005-07177

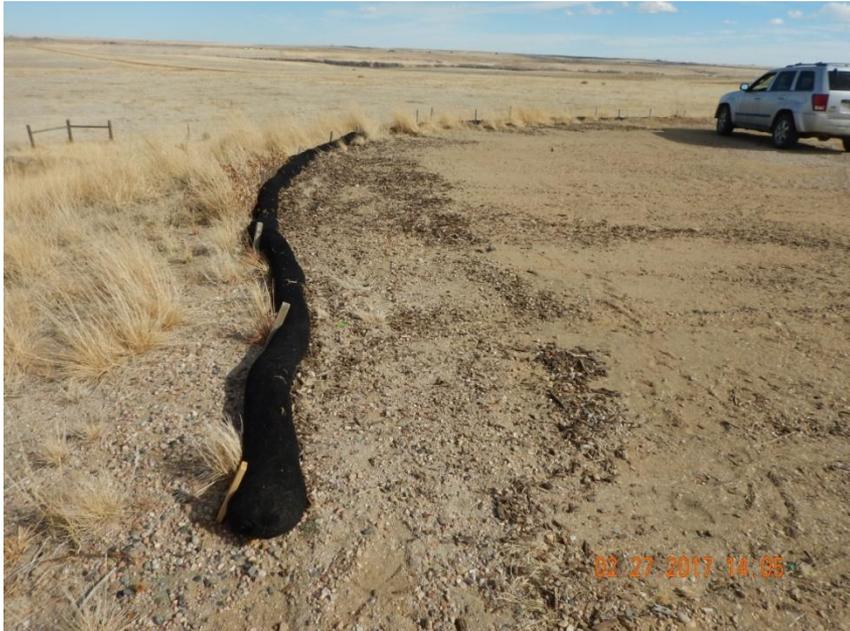
Photo 1. Photo taken from the northeast location, facing East. Wattles have been replaced along the northeast production area and interim areas. Wattles do not appear to be trenched or backfilled along this portion. Stormwater runoff might undermine the wattle and not properly function.

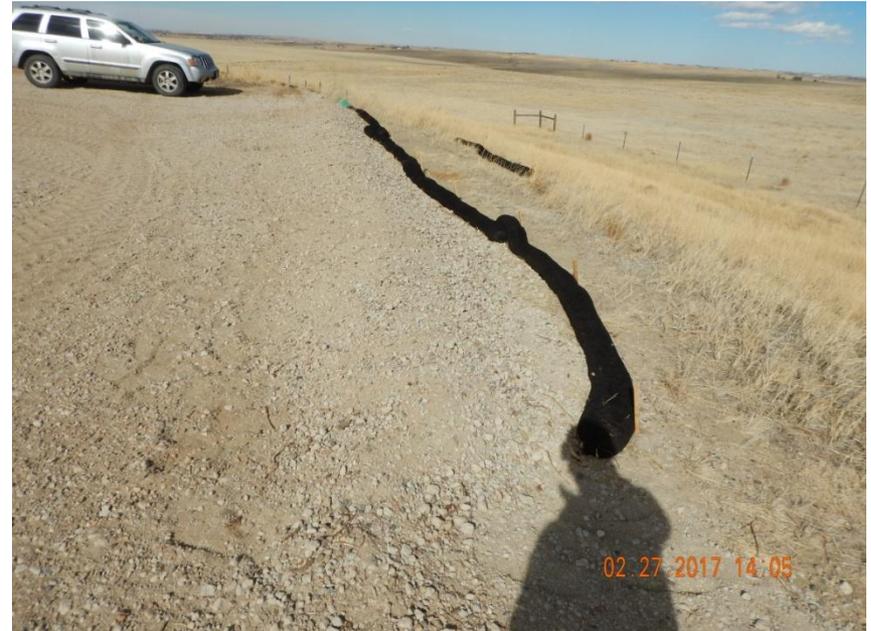
Photo 2. Photo taken from the northeast location, facing North. Wattles have been replaced along the northeast production area and interim areas. Appears gravel has been built up in front of wattle to prevent stormwater runoff from undermining the wattles. Wattles have been overlapped at the joints.

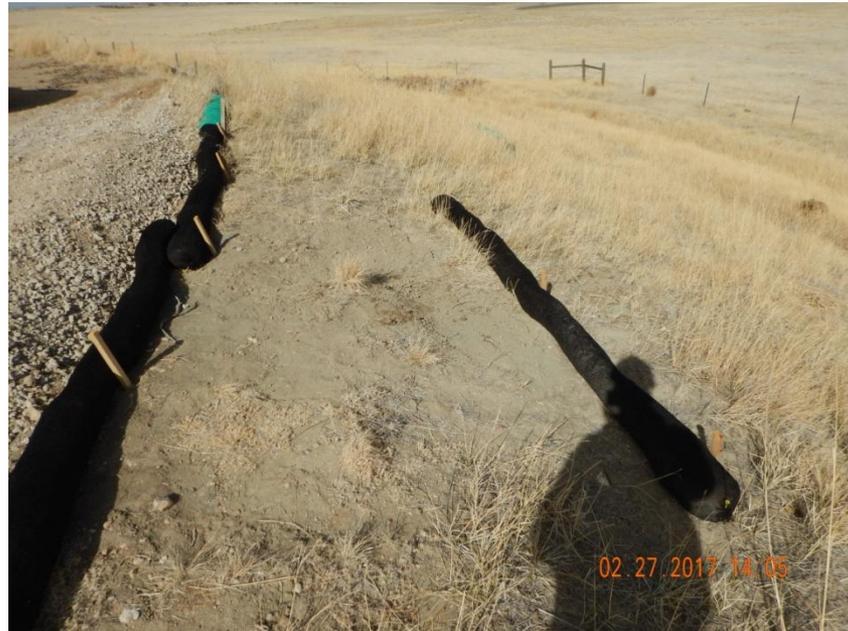
Photo 3. Photo taken from the northeast location along the current interim area, facing North. Gully erosion has been repaired in addition to installing wattles.
