NW Graylin D Sand Unit 33 Flowline Spill #442501 Excavation Photographs

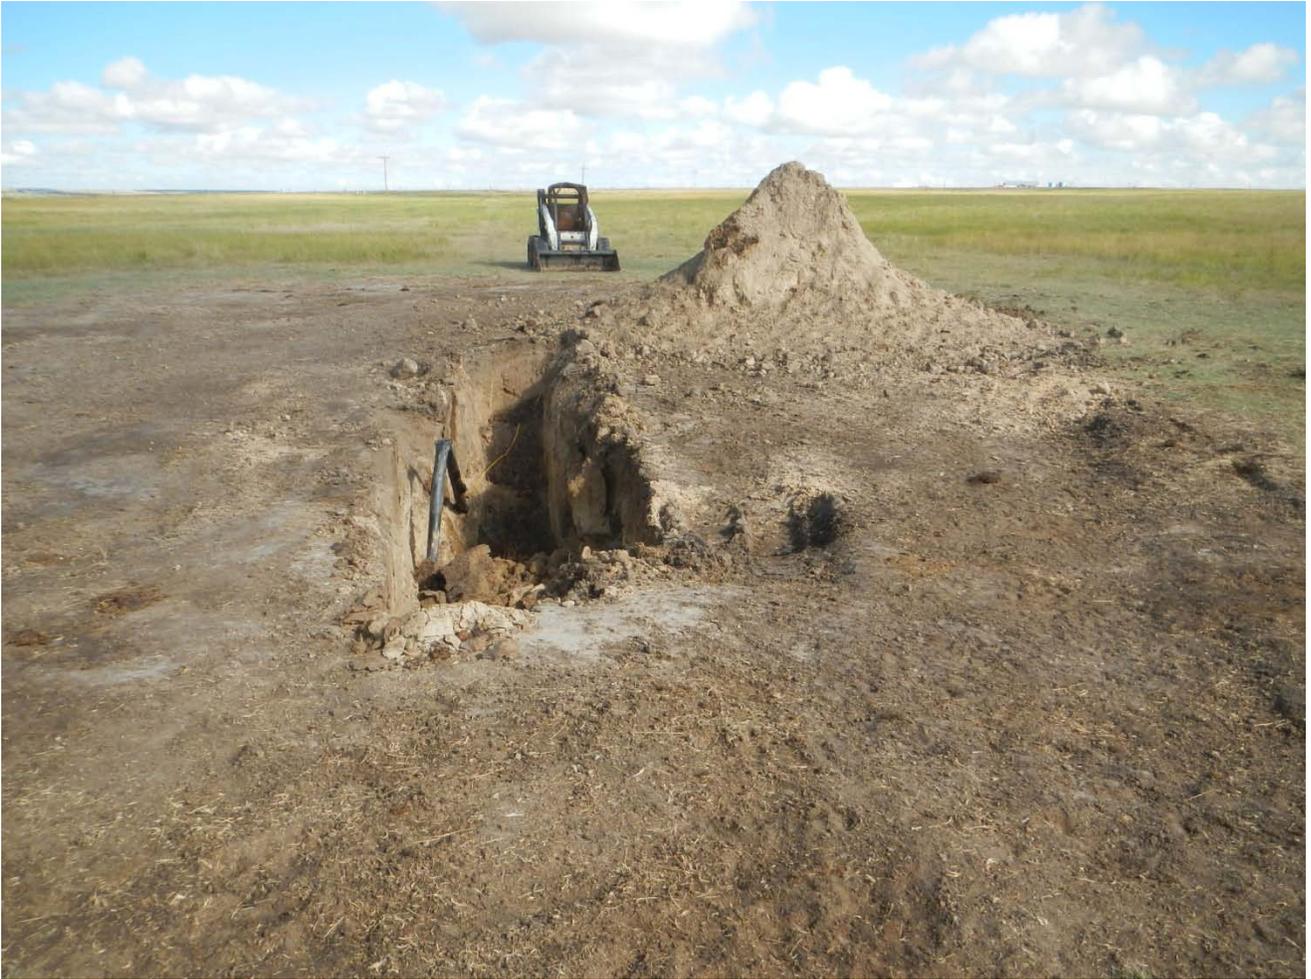
August 19, 2015 view north to the flowline leak area initial excavation performed by Benchmark Energy LLC

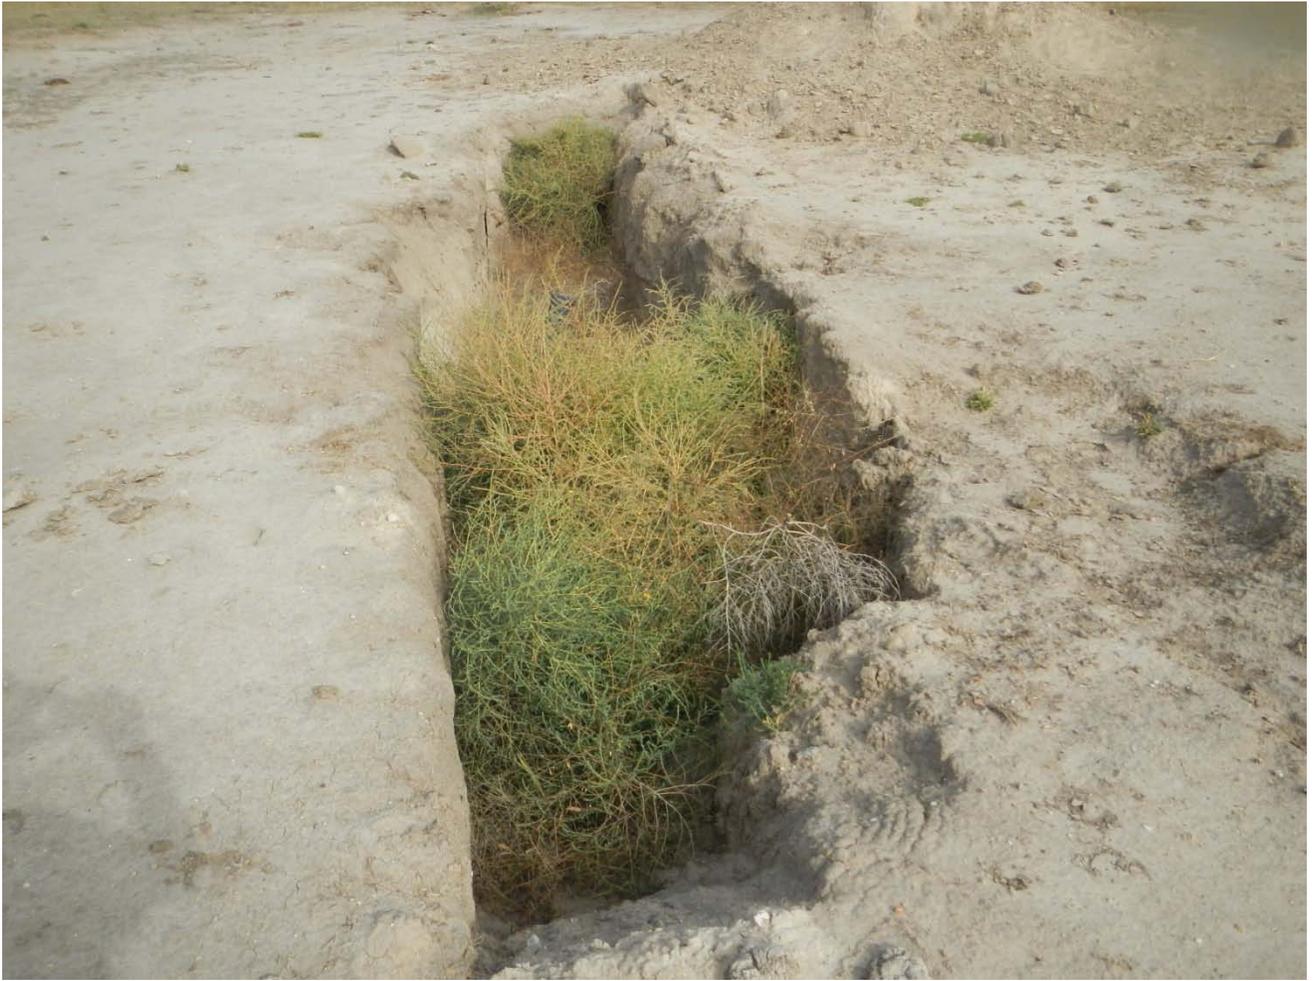
August 15, 2016 view (N) of open flowline leak excavation prior to additional COGCC excavation.

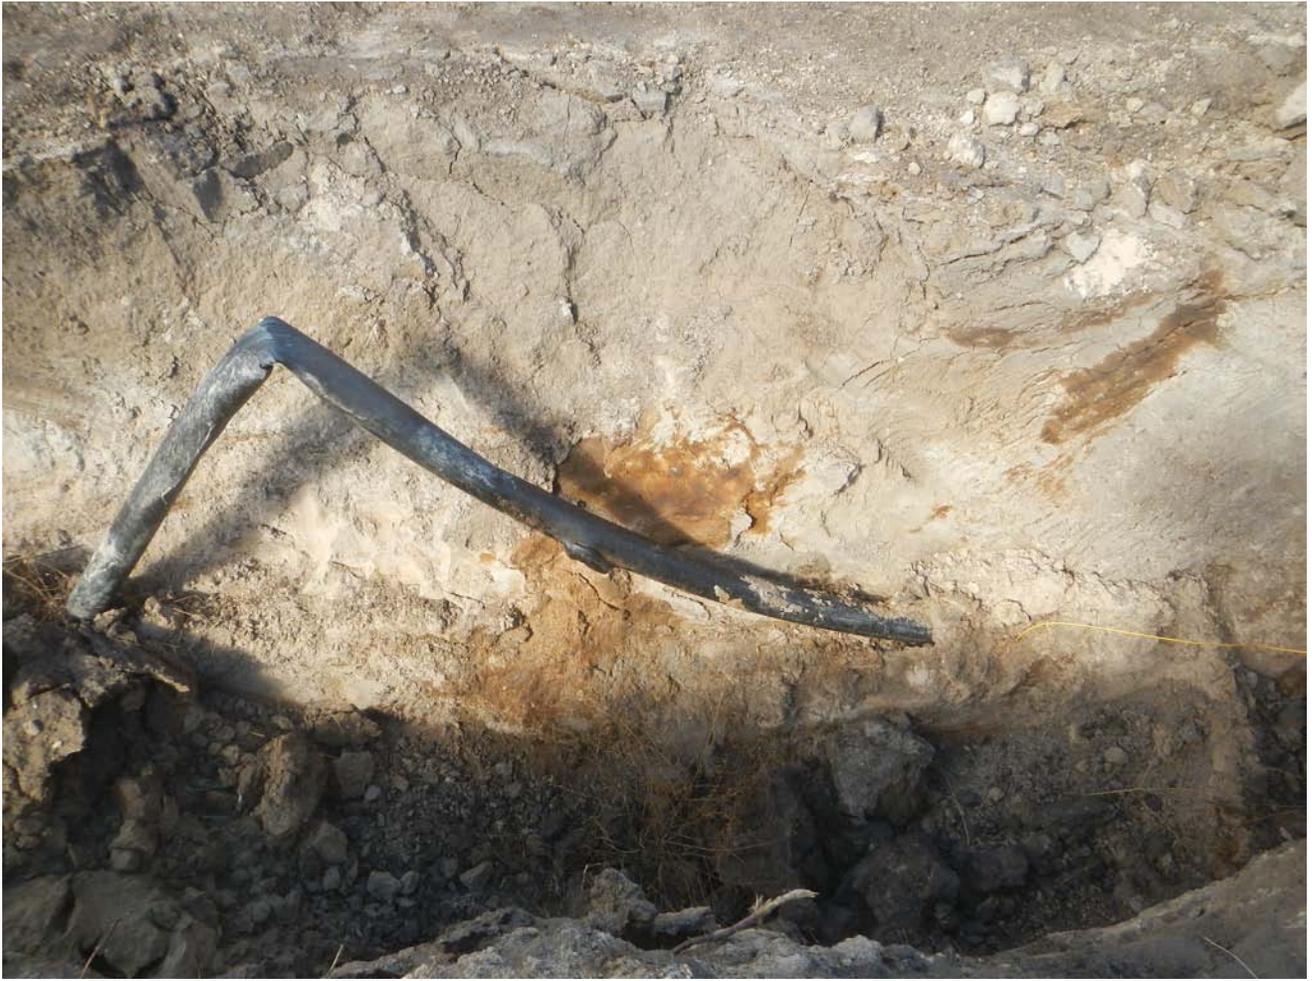
August 19, 2015 view of petroleum hydrocarbon stains in west wall of open excavation.

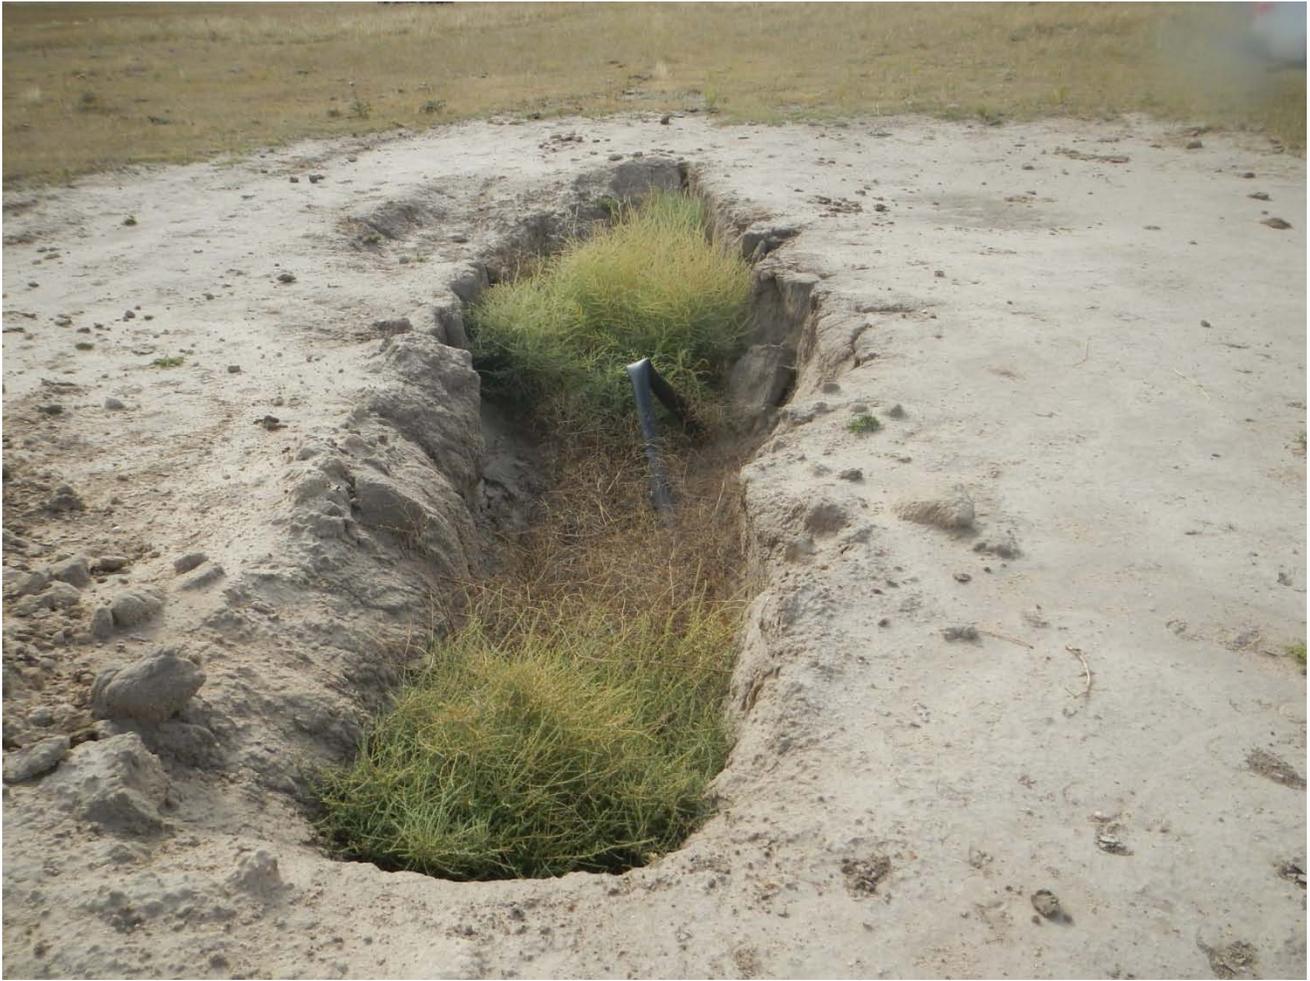
September 21, 2016 view southeast of open flowline leak excavation prior to additional COGCC excavation.

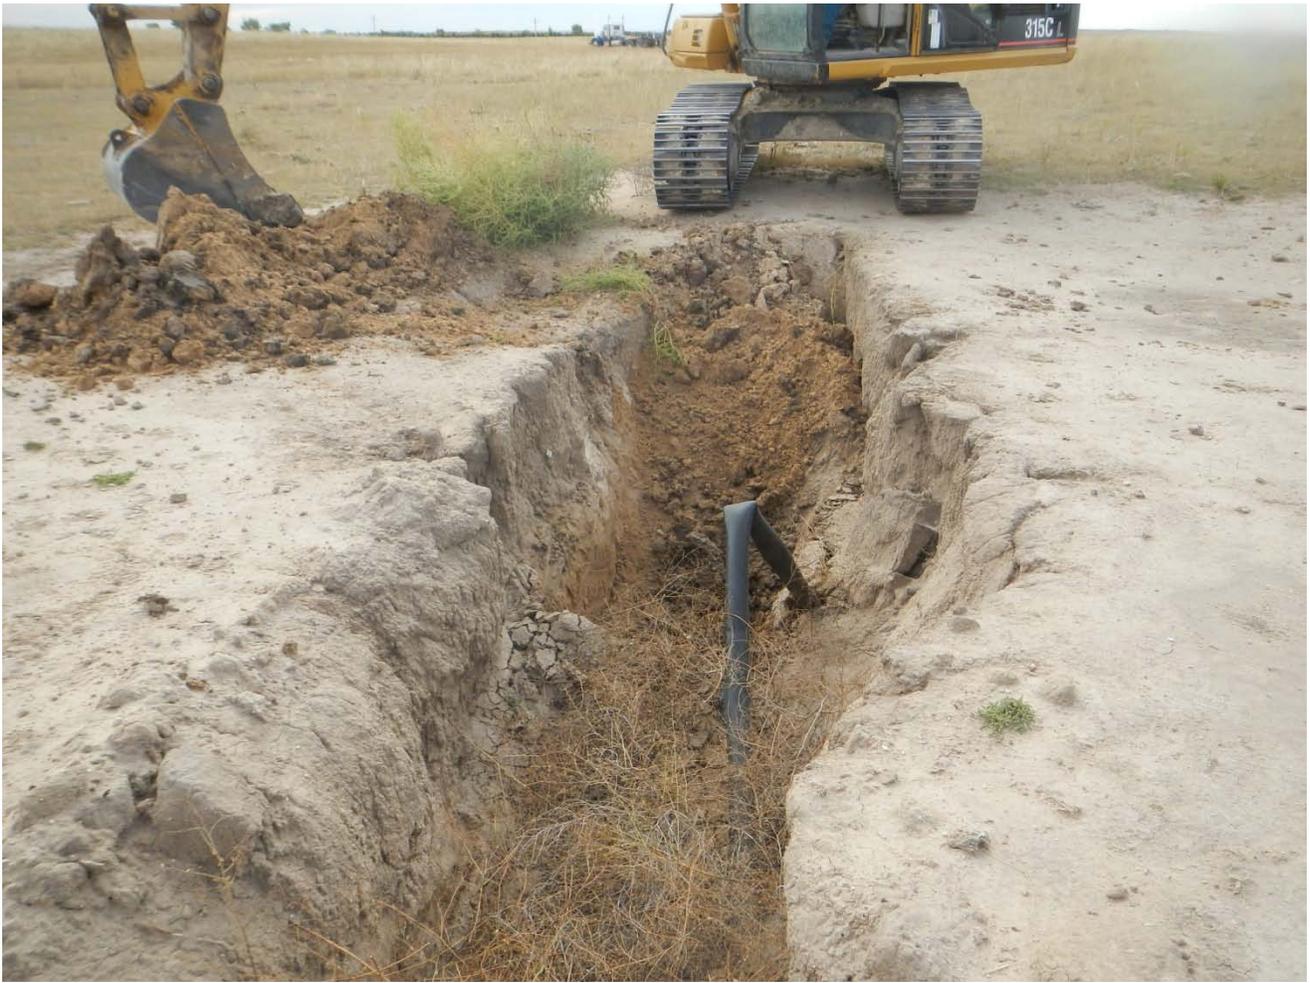
September 21, 2016 view southeast at subsequent COGCC excavation.

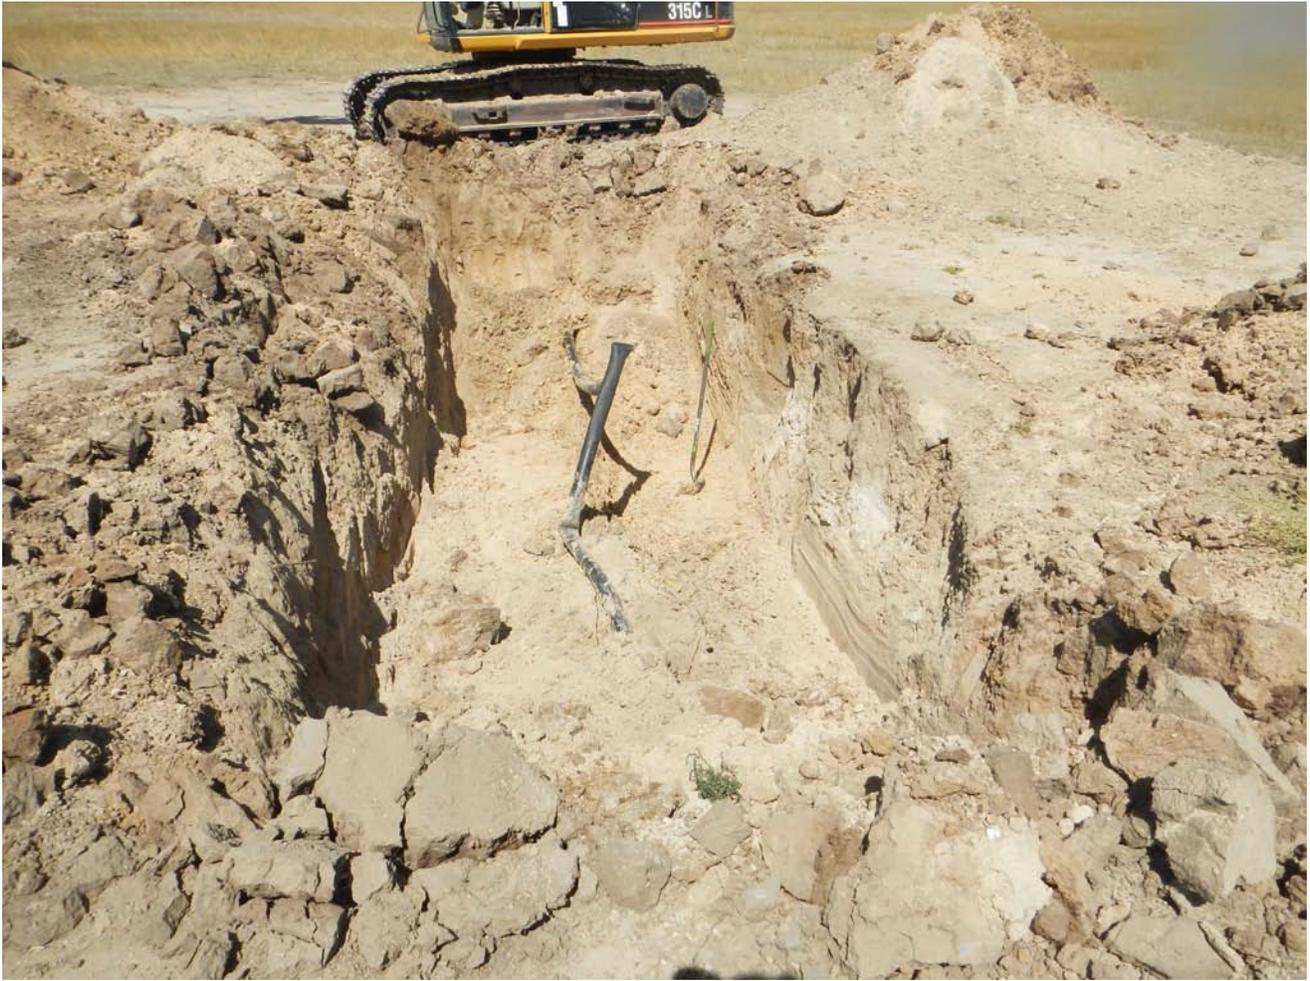
September 21, 2016 view northwest into the subsequent COGCC excavation area. Soil stockpile from initial (Benchmark) excavation is in the upper right corner of the photograph.

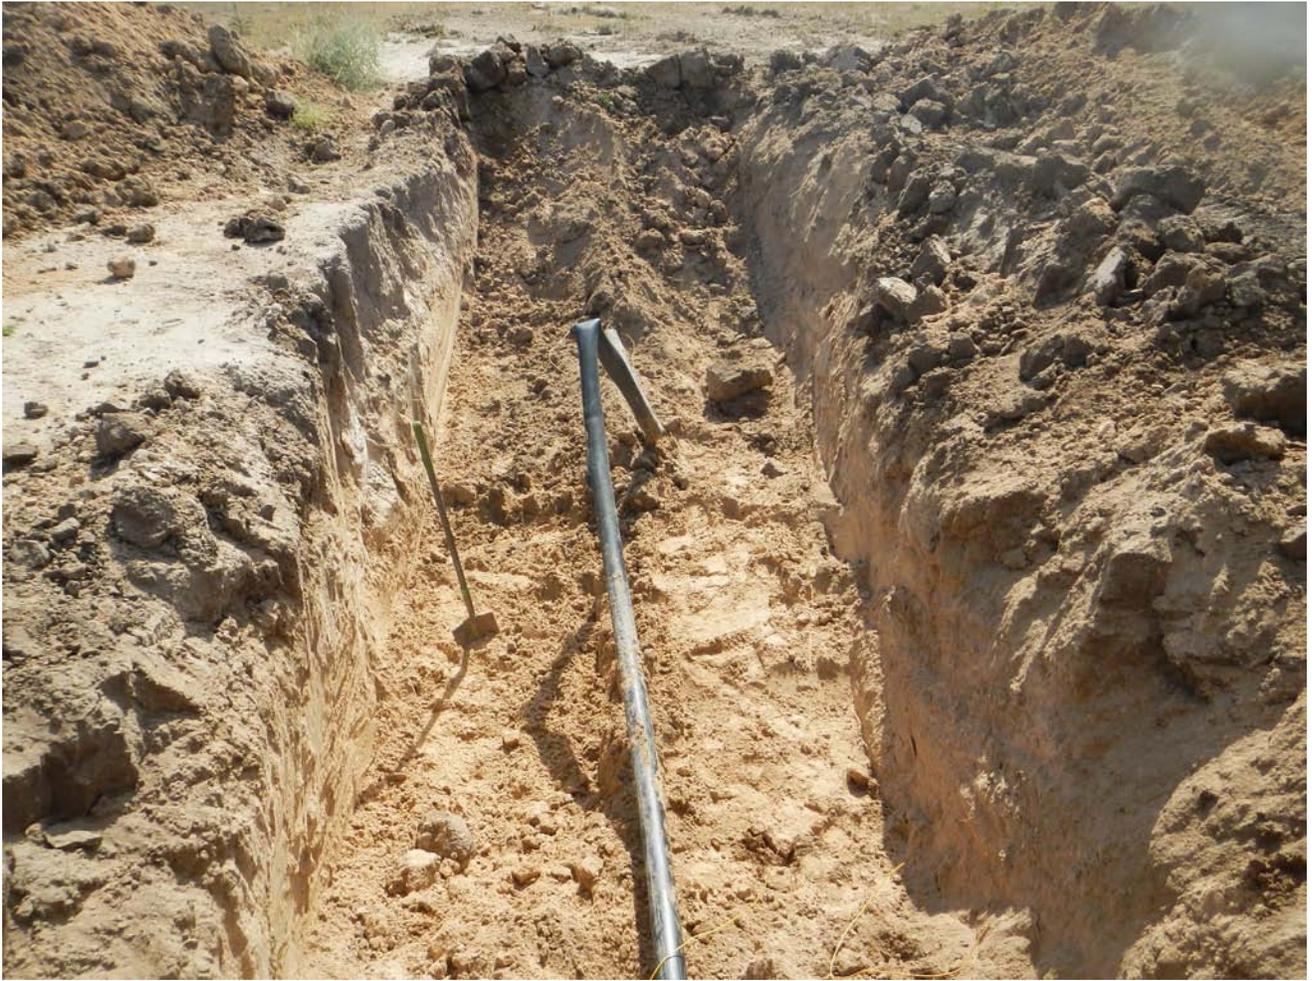
September 21, 2016 view of open excavation prior to cutting out and capping off the damaged flowline segment.

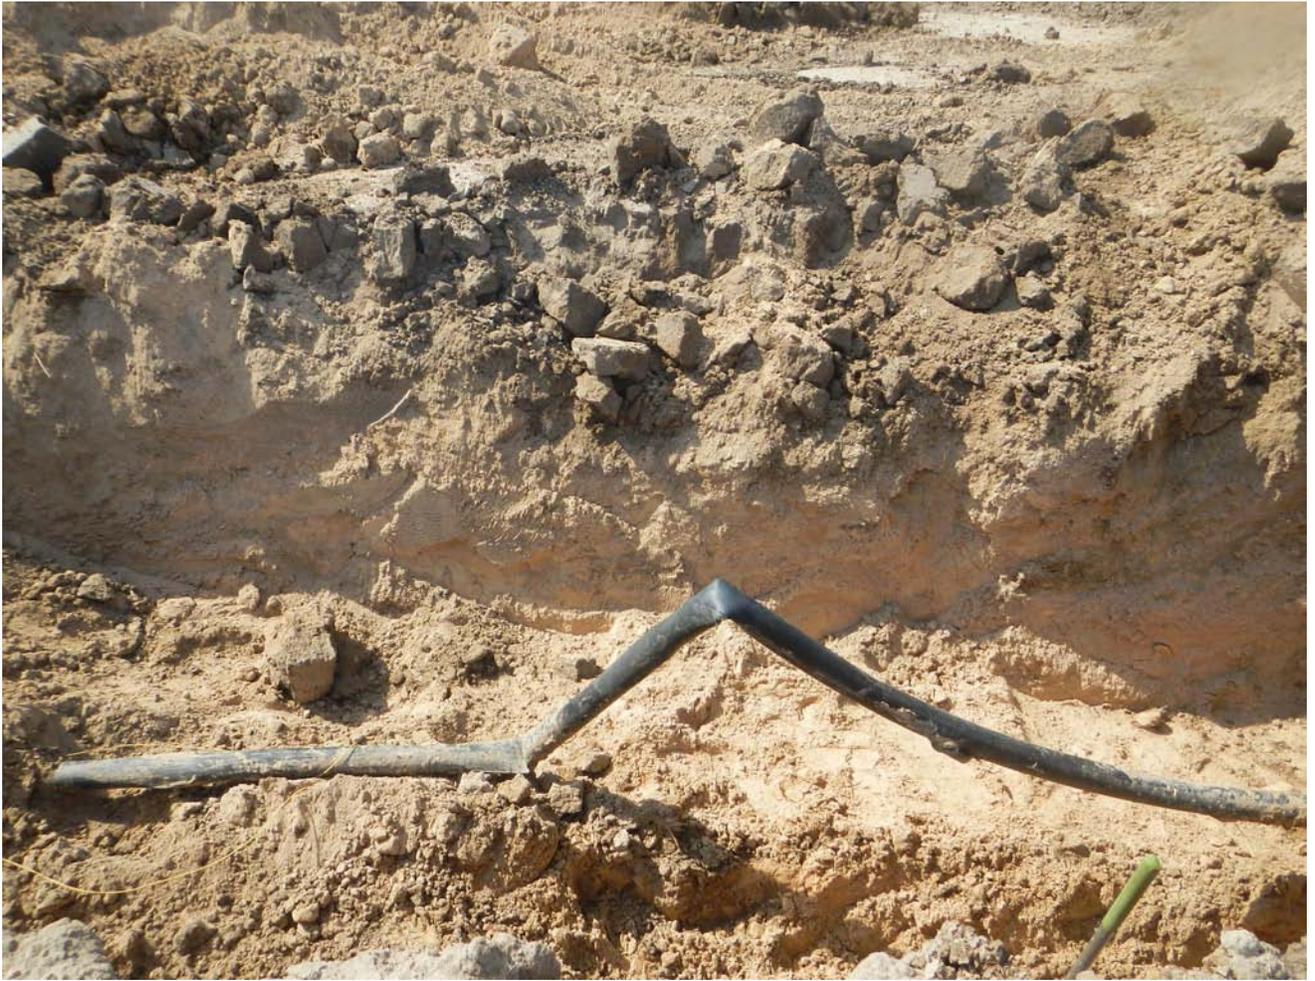
September 21, 2016 view southwest at the damaged flowline section and additional excavation area.

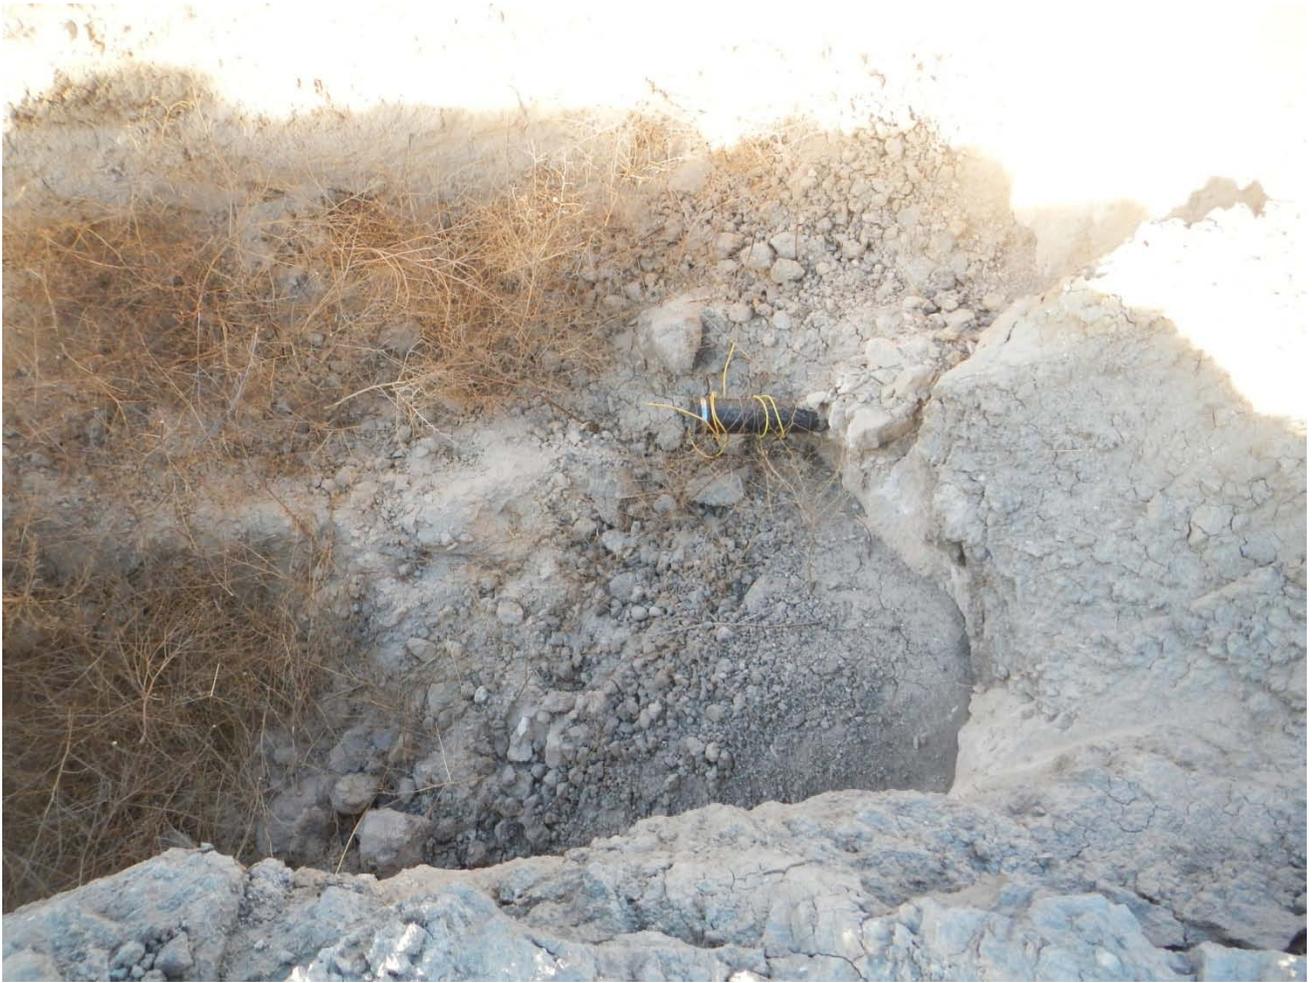
October 14, 2016 view of the northwest end of flowline capped prior to backfilling.

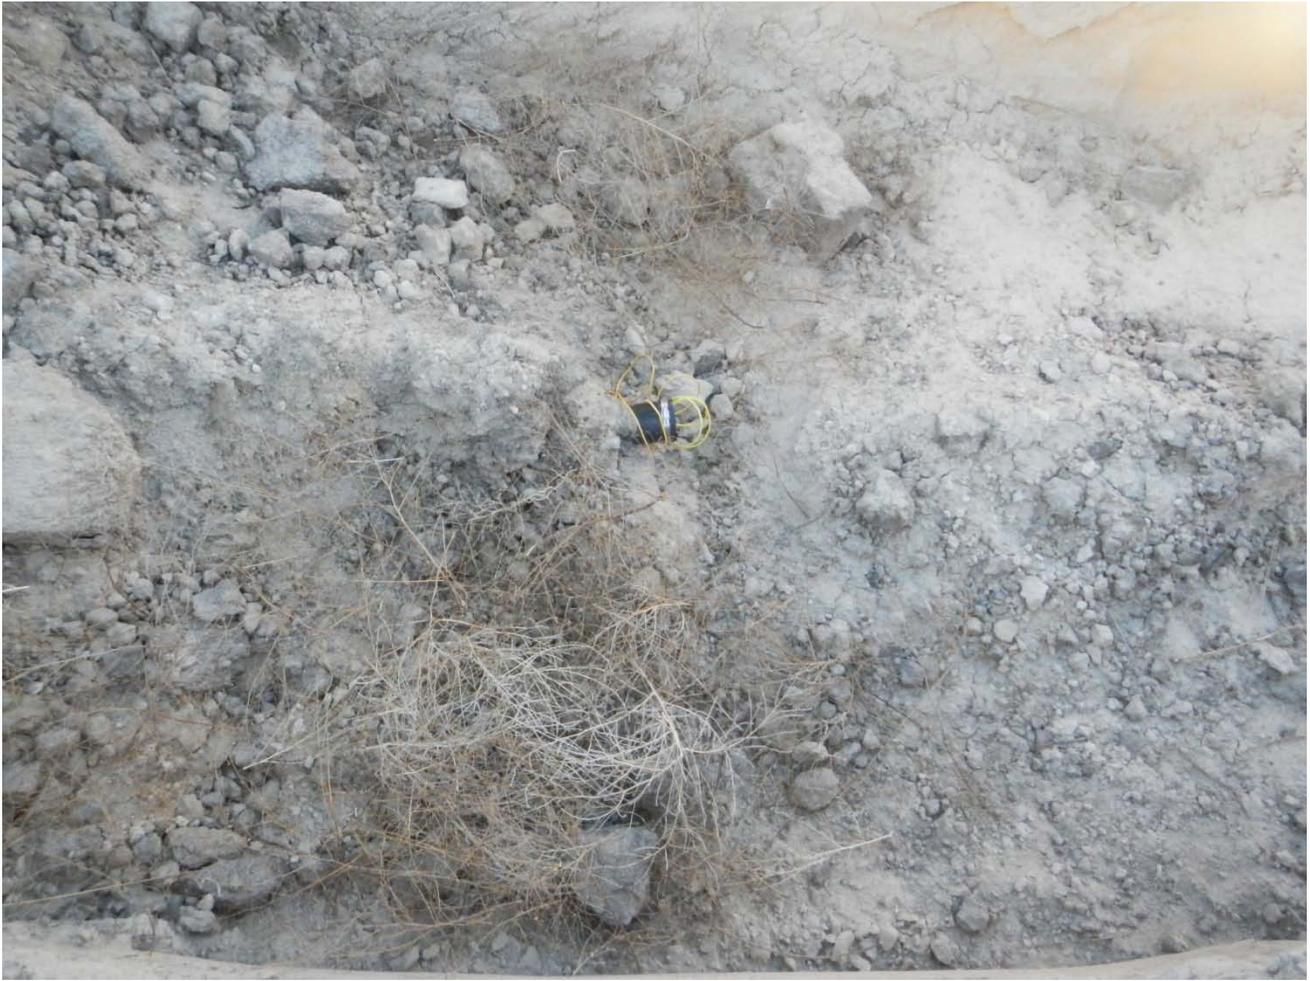
October 14, 2016 view southeast end of flowline capped prior to backfilling.

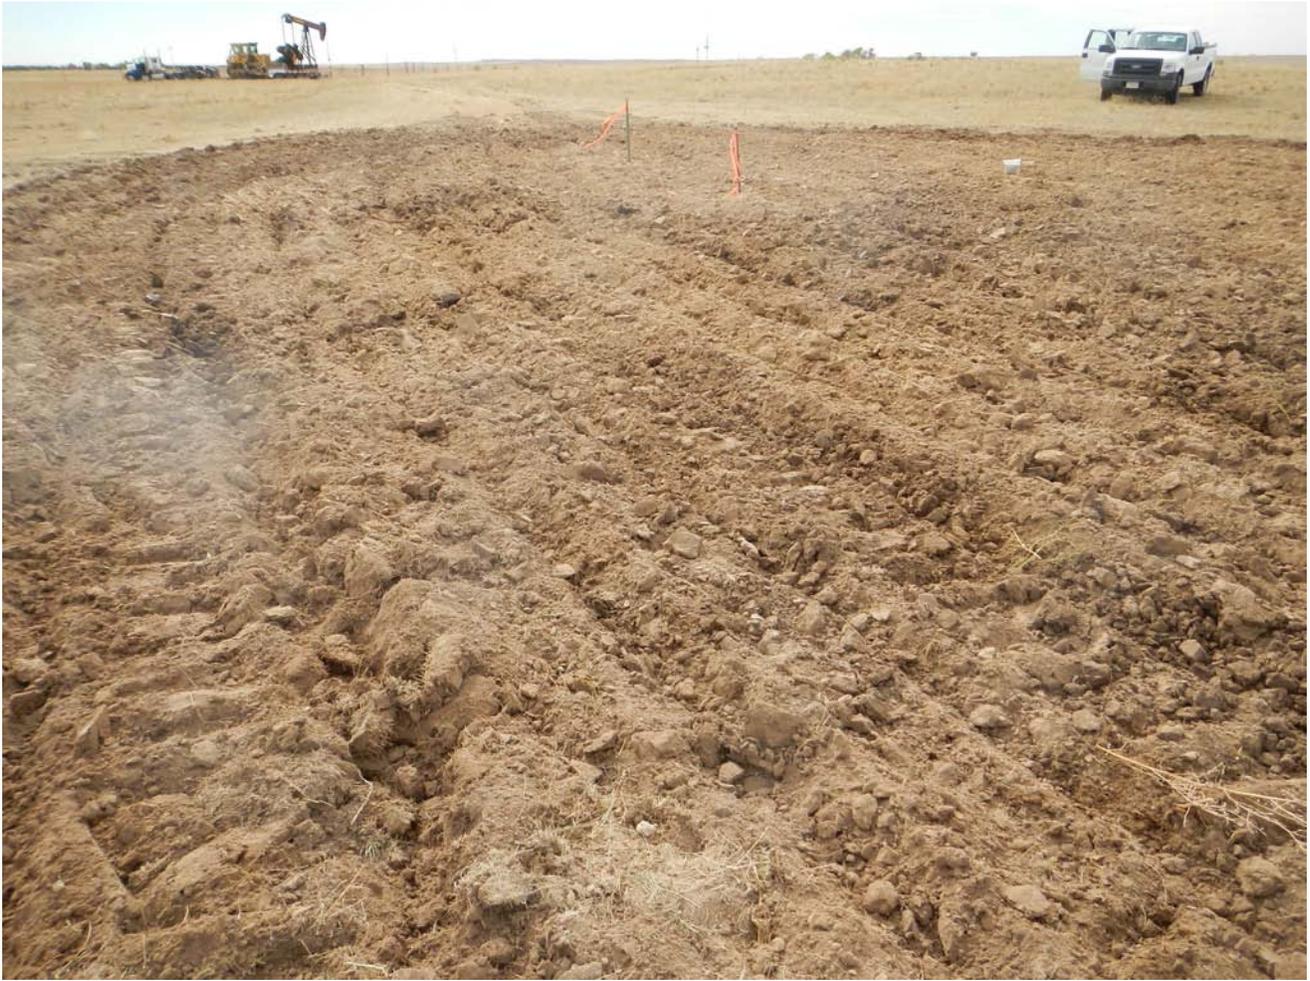
October 14, 2016 view SE across cross ripped area showing flowline cap markers.
