Inspection Photos
Location Name: Carl R. Deepe C 1
API: 05-123-07871

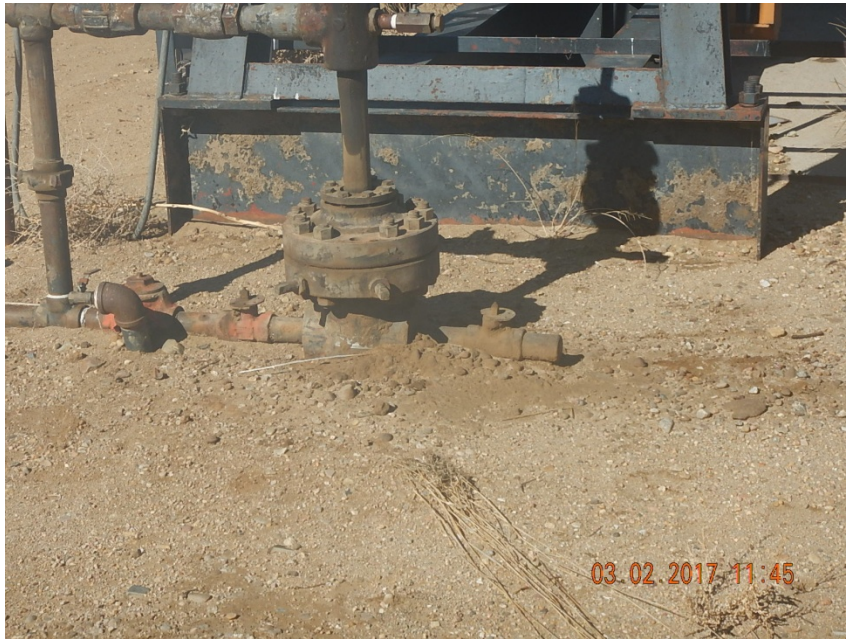
Photo 1: Stained soil at wellhead

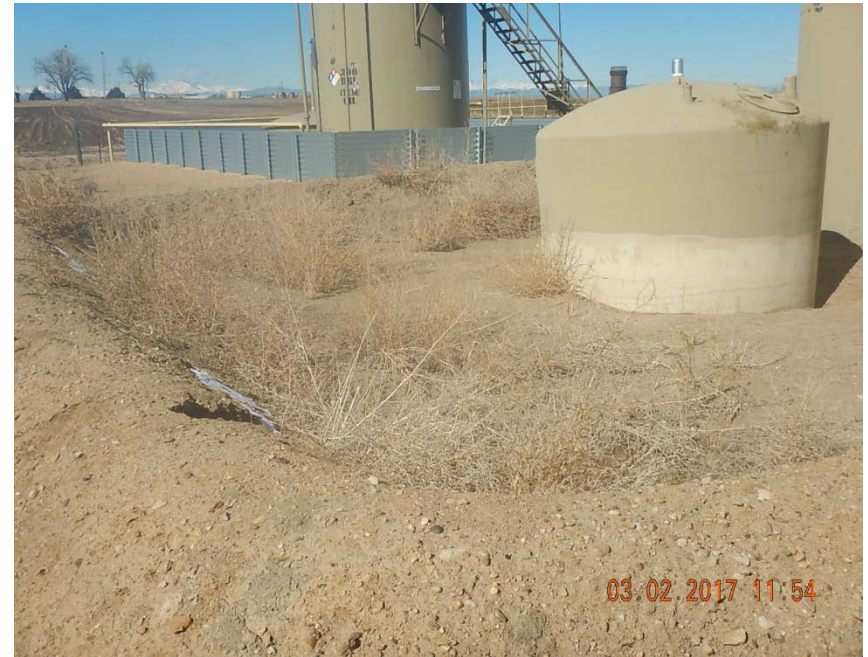
Photo 2: Weeds in tank battery berm

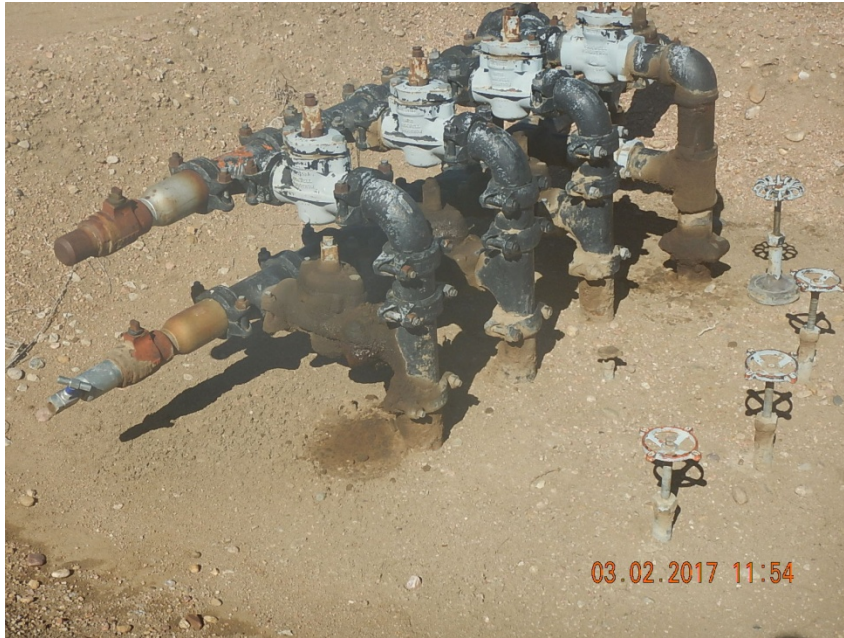
Photo 1: Stained soil at manifold

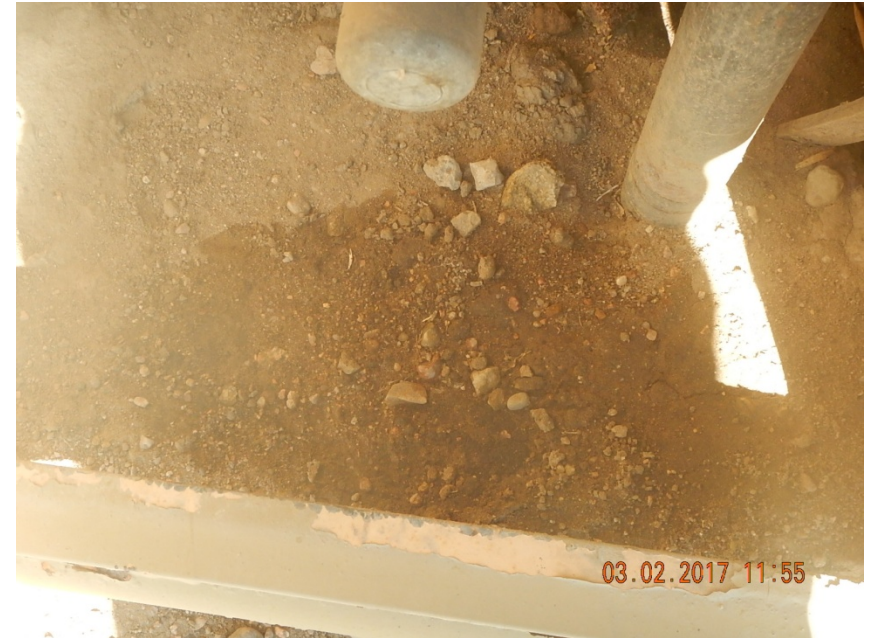
Photo 2: Stained soil in horizontal separator house

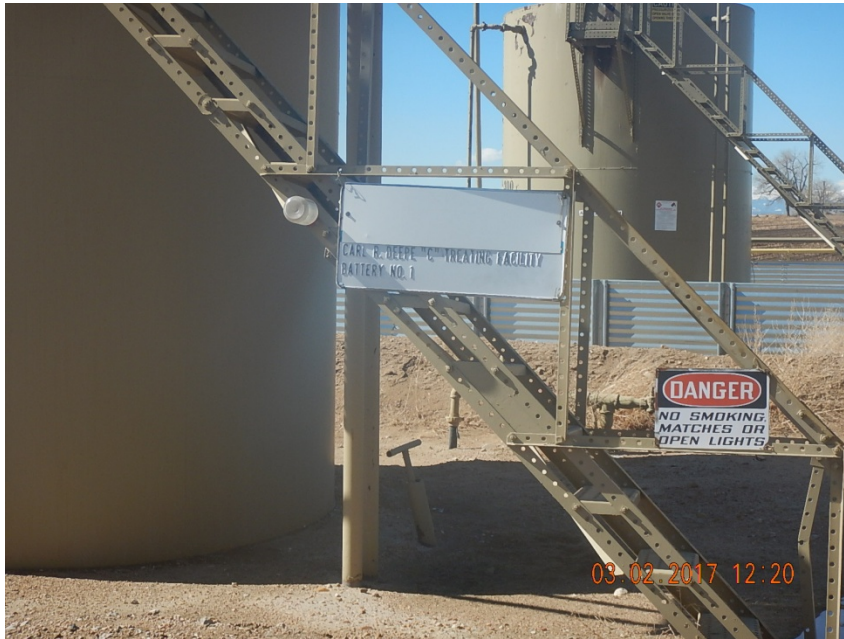
Photo 1: Placard on battery sign is faded, no visible emergency number
