**Inspection Photos**  
**Location Name: Martin T Hart H 1**  
**API: 05-123-08829**

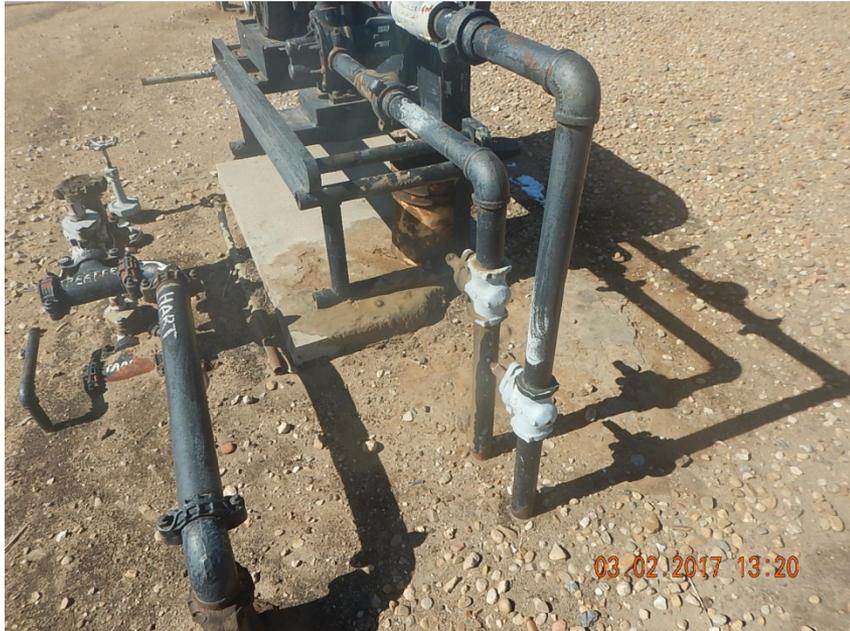
**Photo 1: Stained soil at small engine**

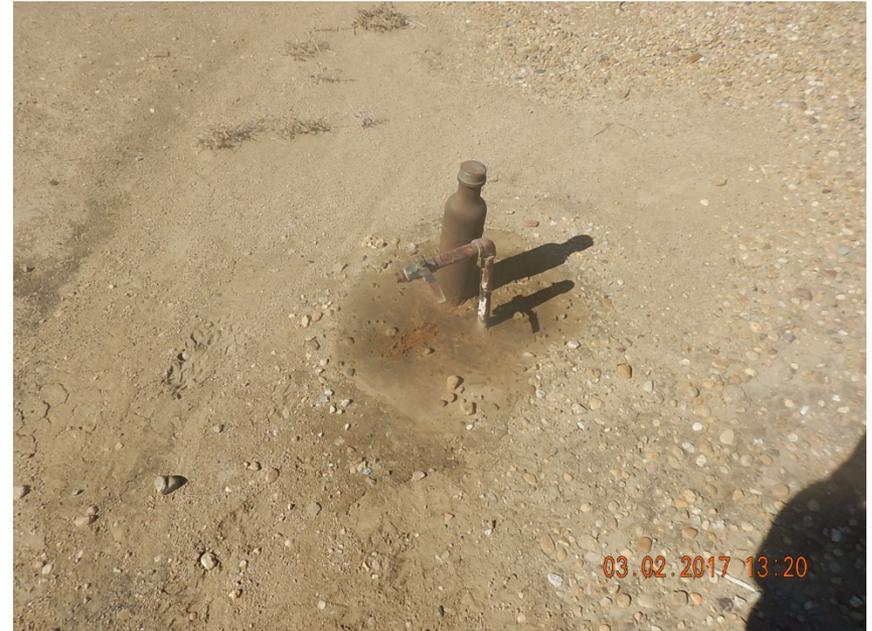
**Photo 2: Stained soil at riser**

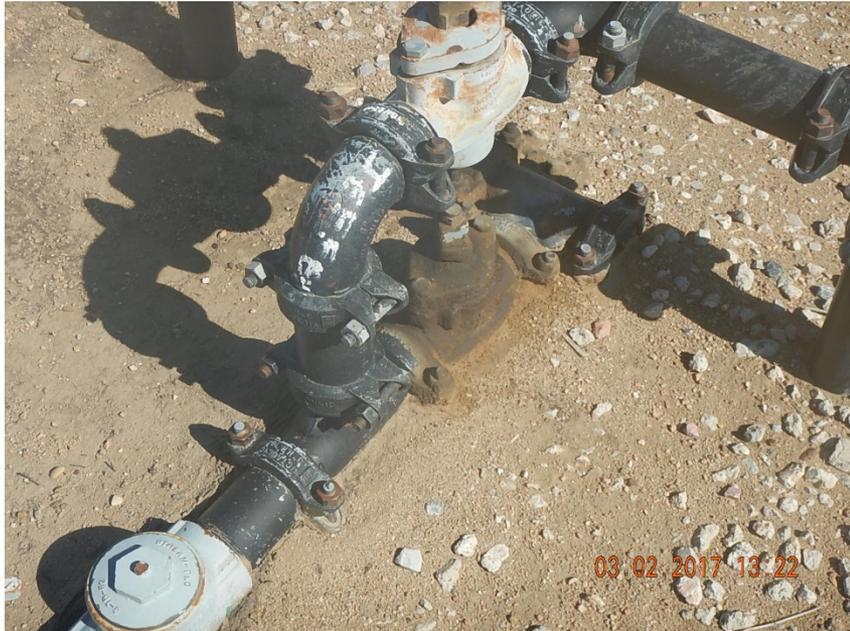
**Photo 3: Stained soil at fitting**

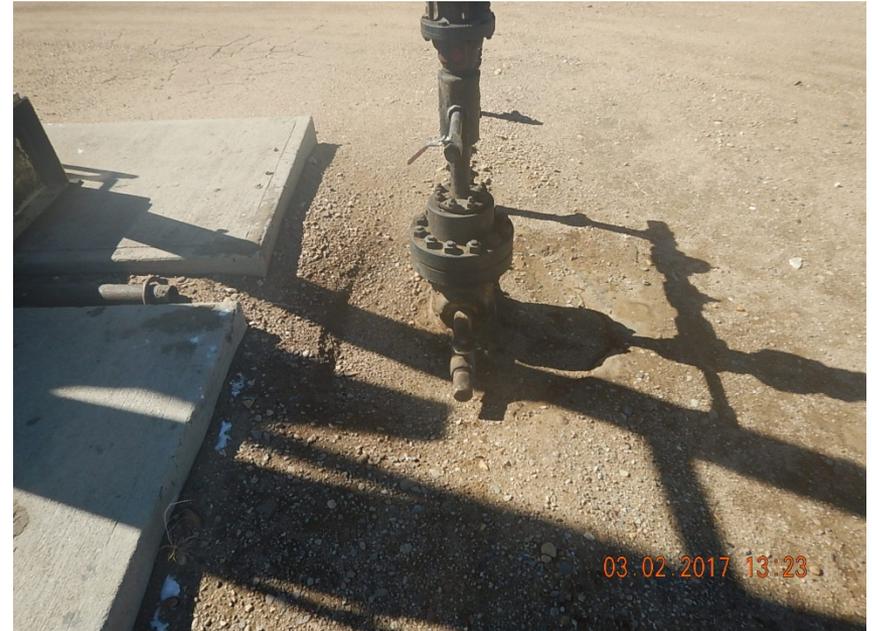
**Photo 4: No bradenhead at surface**

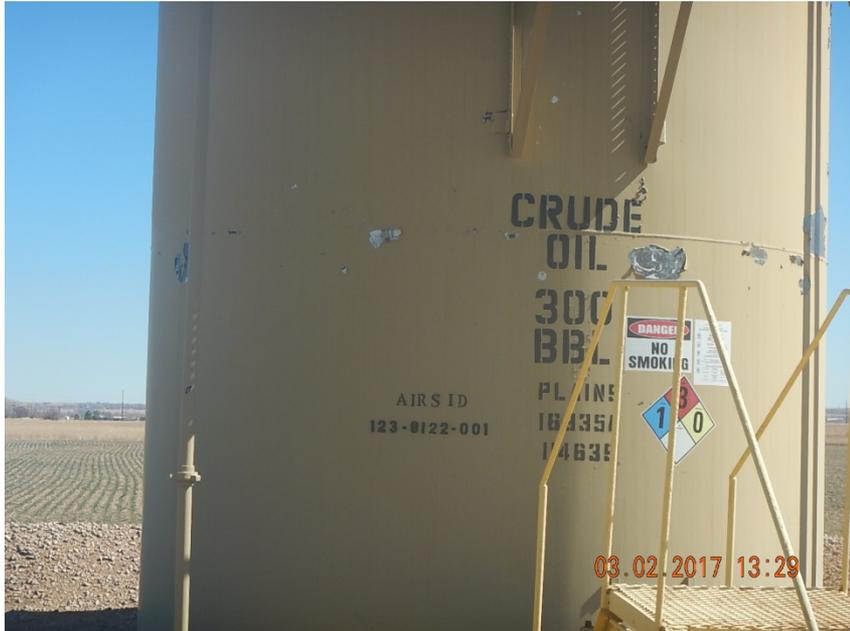
Photo 5: Paint is cracked and peeling
