February 16, 2017

Inspection Photos: Chevron PA Sharpes McLaughlin 1-32
API#103-01074

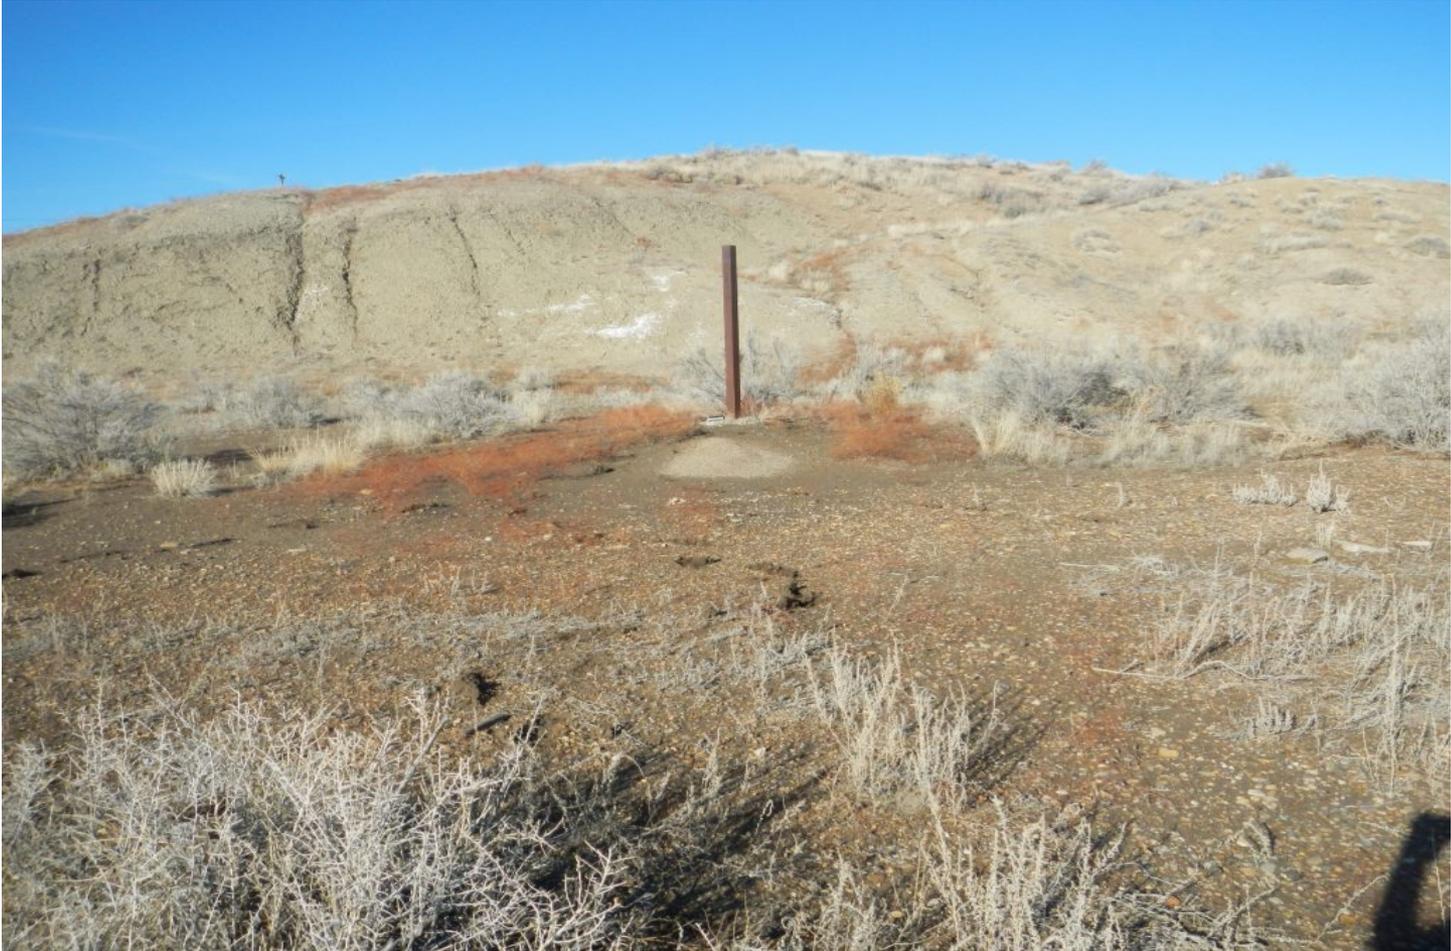
Photo#1: Overview of Location to North

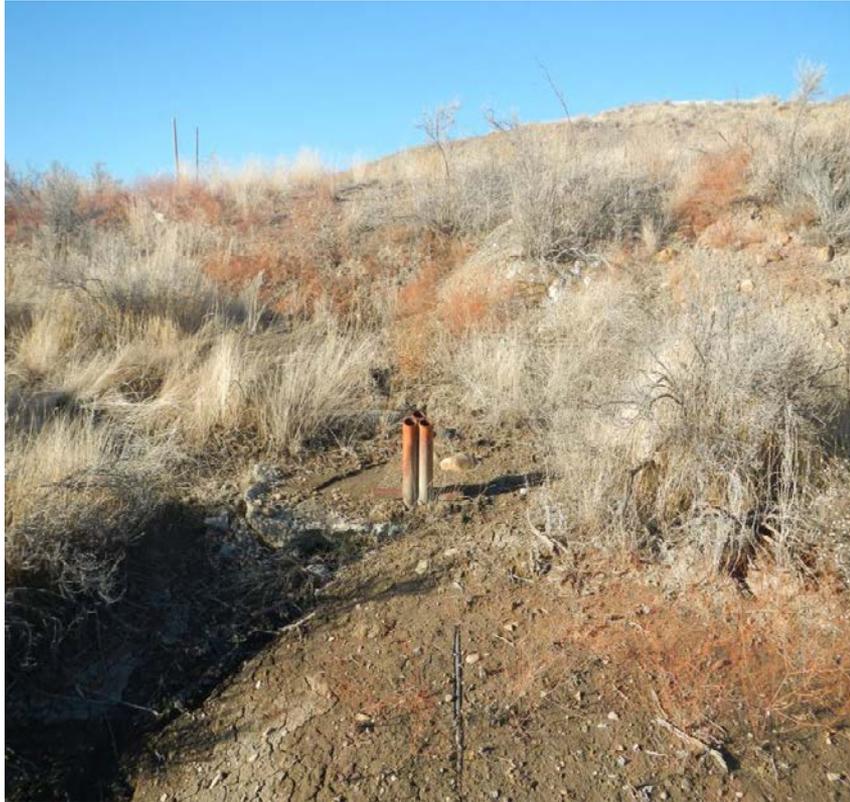
Photo#2:

Pipe Risers and Concrete South down slope from PA Marker

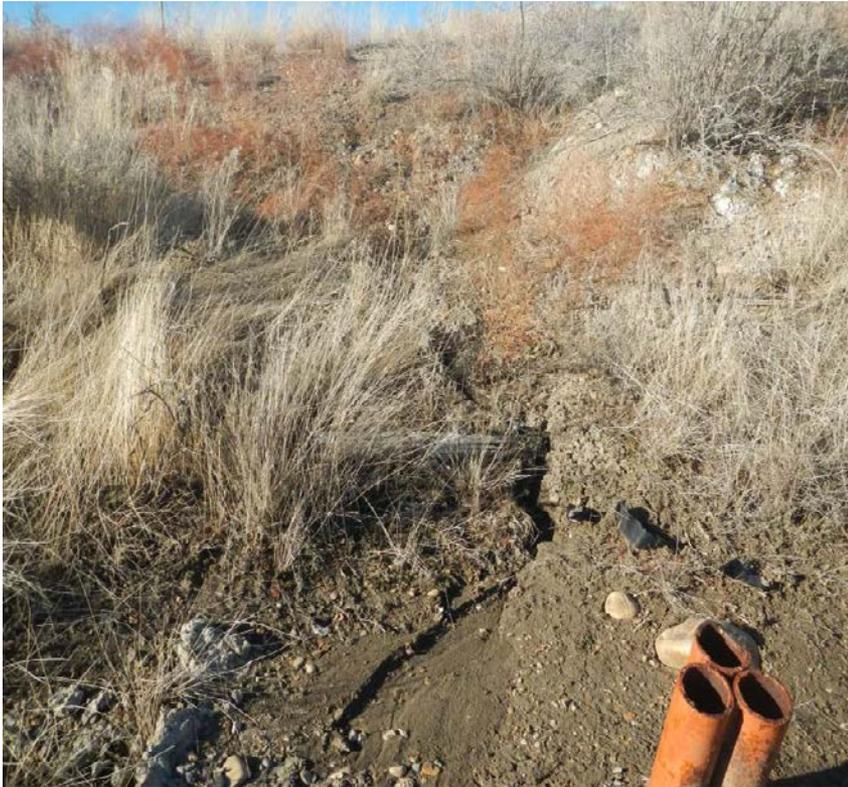
Photo#4:

Erosion occurring North & South of Pipes /Risers

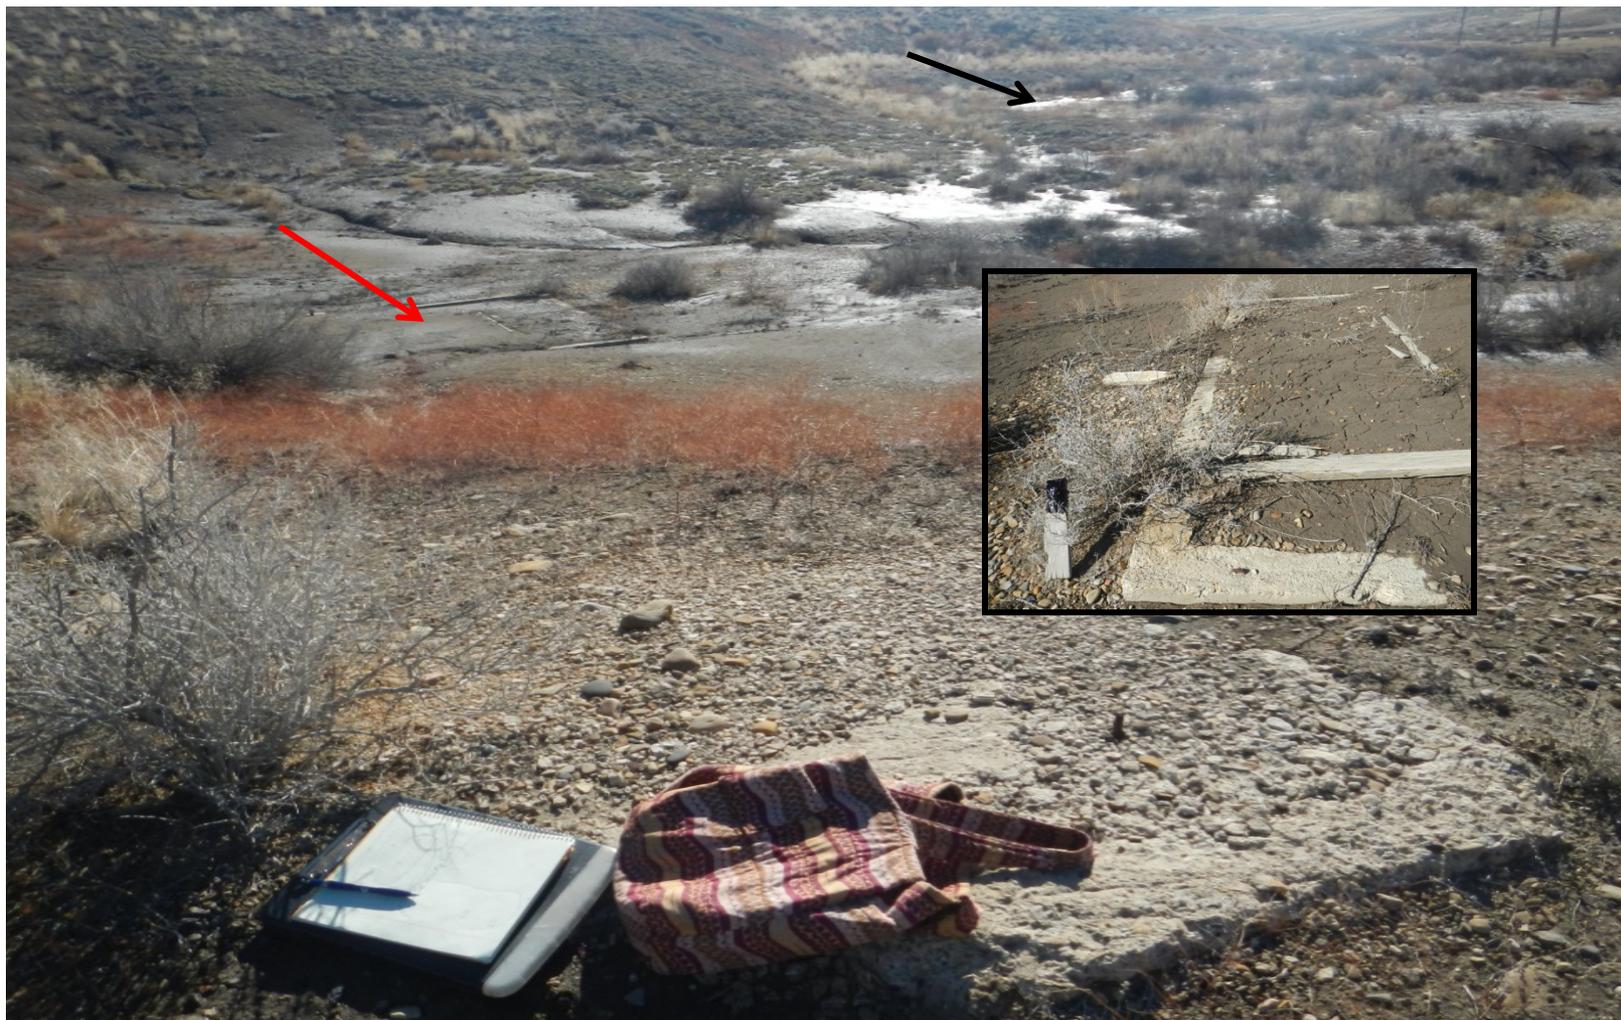
Photo#6:

Concrete Pad Remnant at East edge of Loc. Red Arrow indicates 2cd Pad Remnant. Black Arrow indicates lower Facilities Site. Insert is close up of 2cd pad remnant.

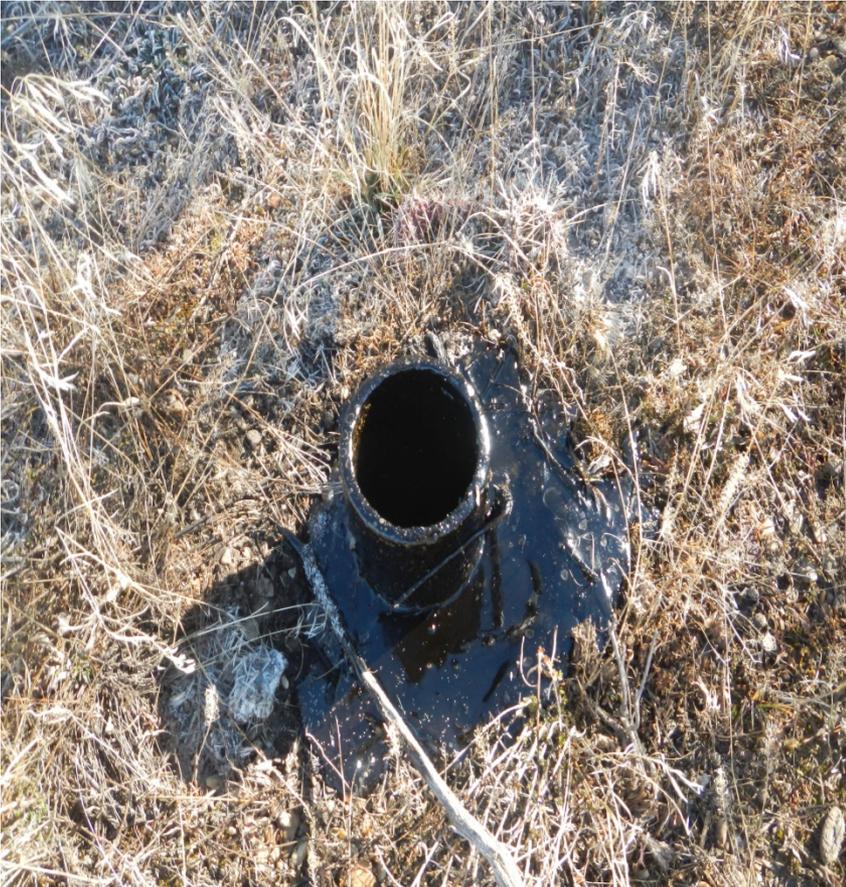
Photo#7:

Lower Unknown Facilities showing 1st open Pipe 5 ft SE of Stubbed Pipe. 4" open pipe; 14" from top of pipe to TD where it feels as if pipe heads to West

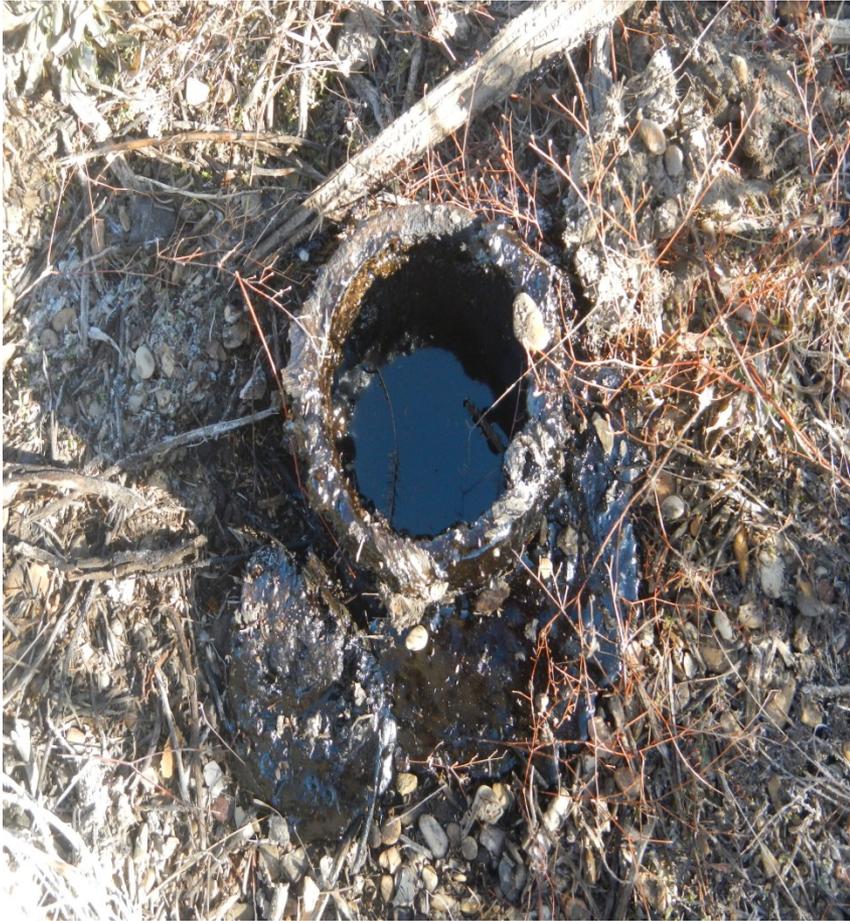
Photo#9:

2cd Pipe 19 ft South of 1st Pipe; 4" open pipe; 14" from top of pipe to TD where it feels as if pipe heads to West.

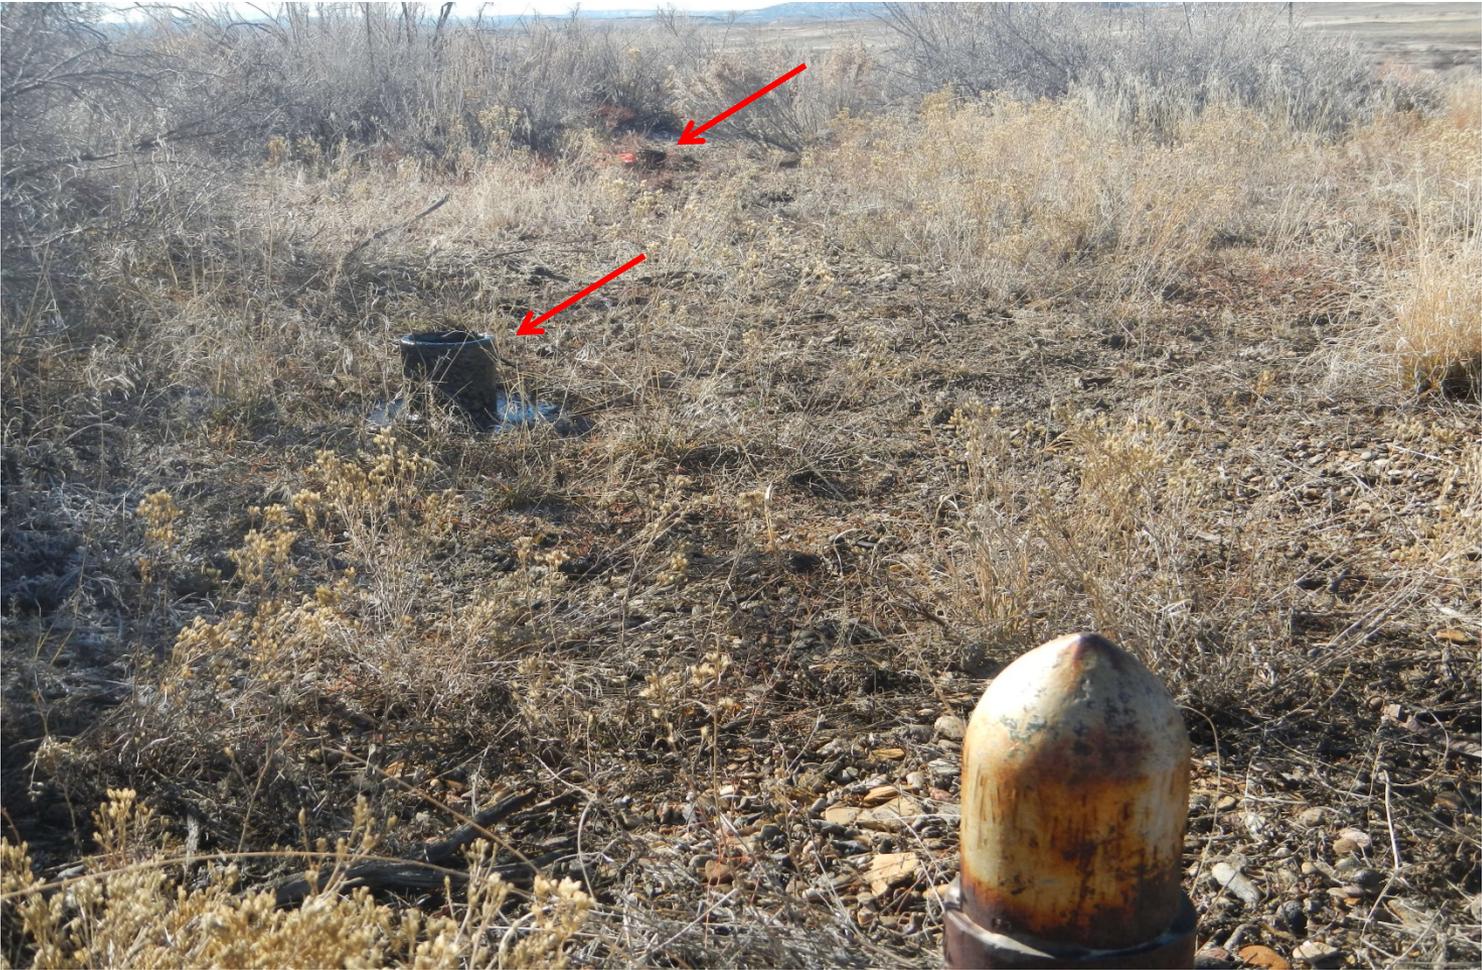
Photo#11: View N to S of stubbed pipe; With arrows indicating open Pipe riser positions.

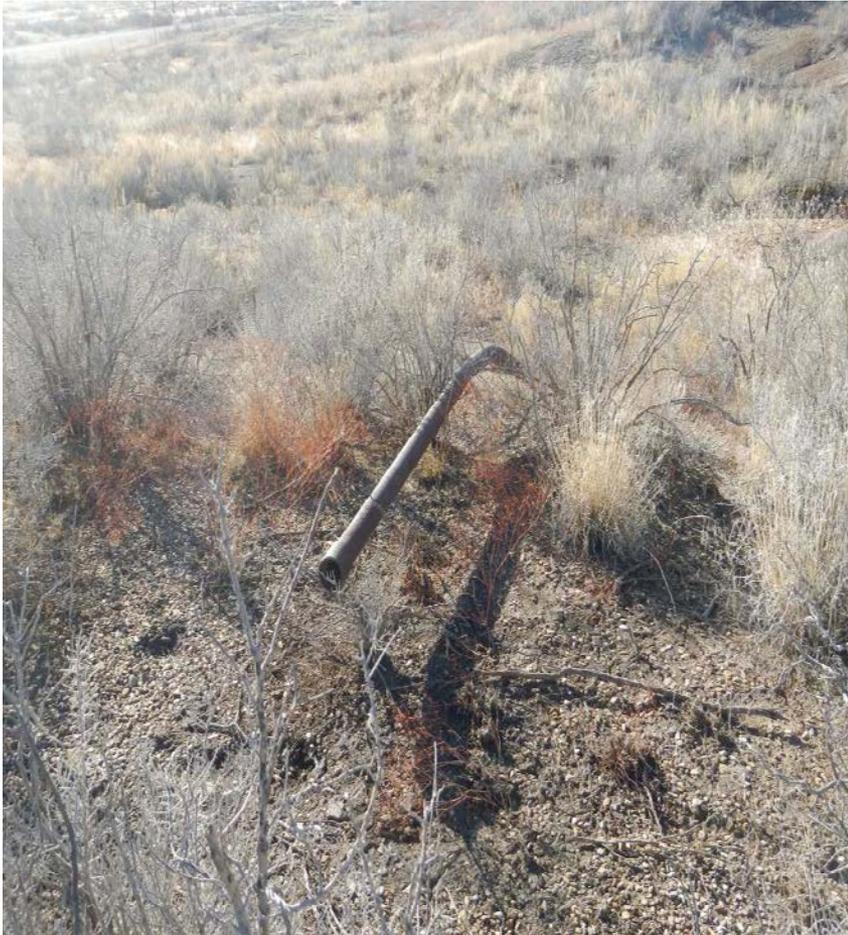
Photo#12:

Flow -lines piping between two Sites; view from SE to NW.

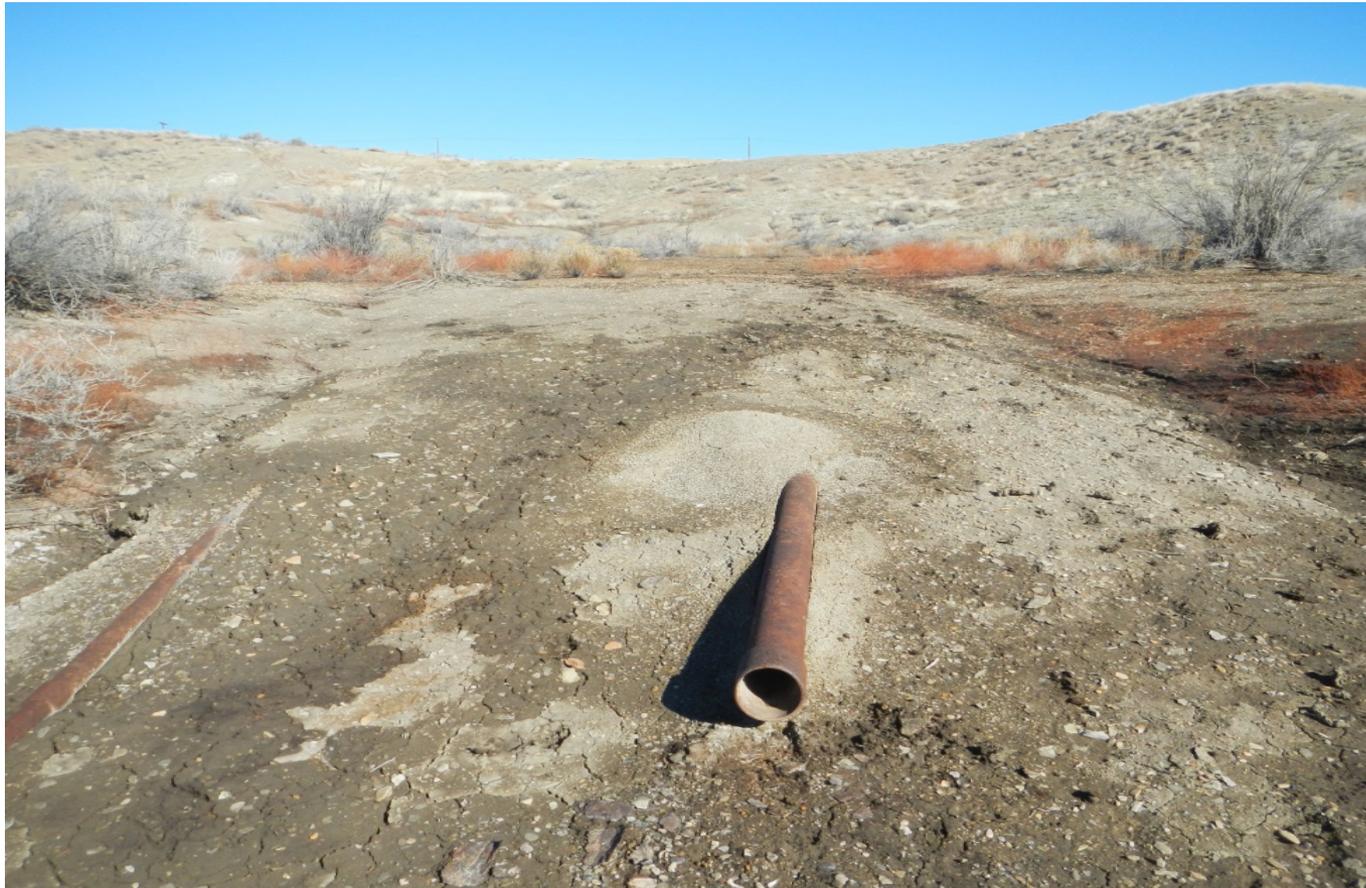
Photo#14:
Lines / Pipe exiting base of Lower Facilities site.
