Inspection Photos
Location Name: Suckla D Unit 2
API: 05-123-08845

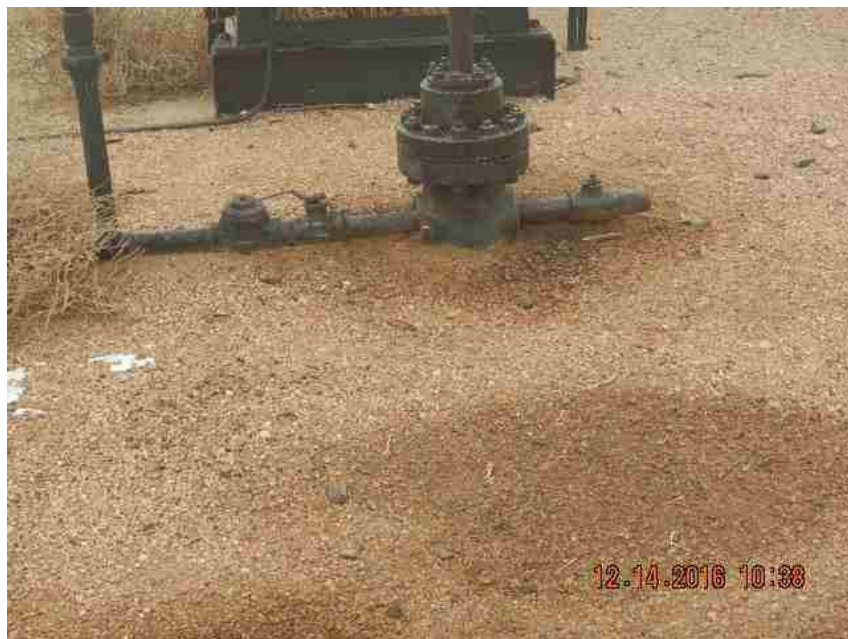
Photo from prior inspection for comparison purposes

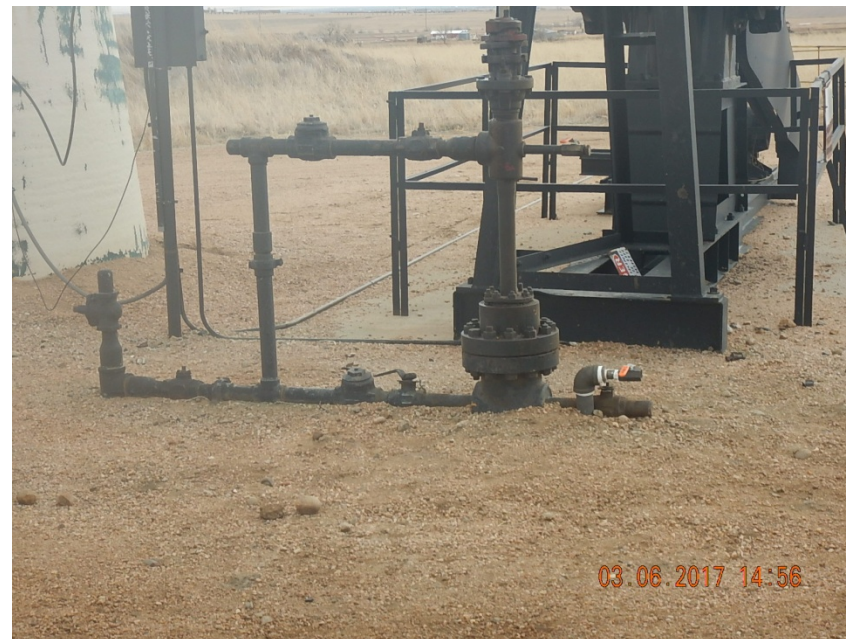
Photo 1: Stained soil removed, bradenhead installed
