**COLORADO**  
Oil & Gas Conservation  
Commission  
Department of Natural Resources

Inspection Photos: Laramie Gunderson Loc#449070

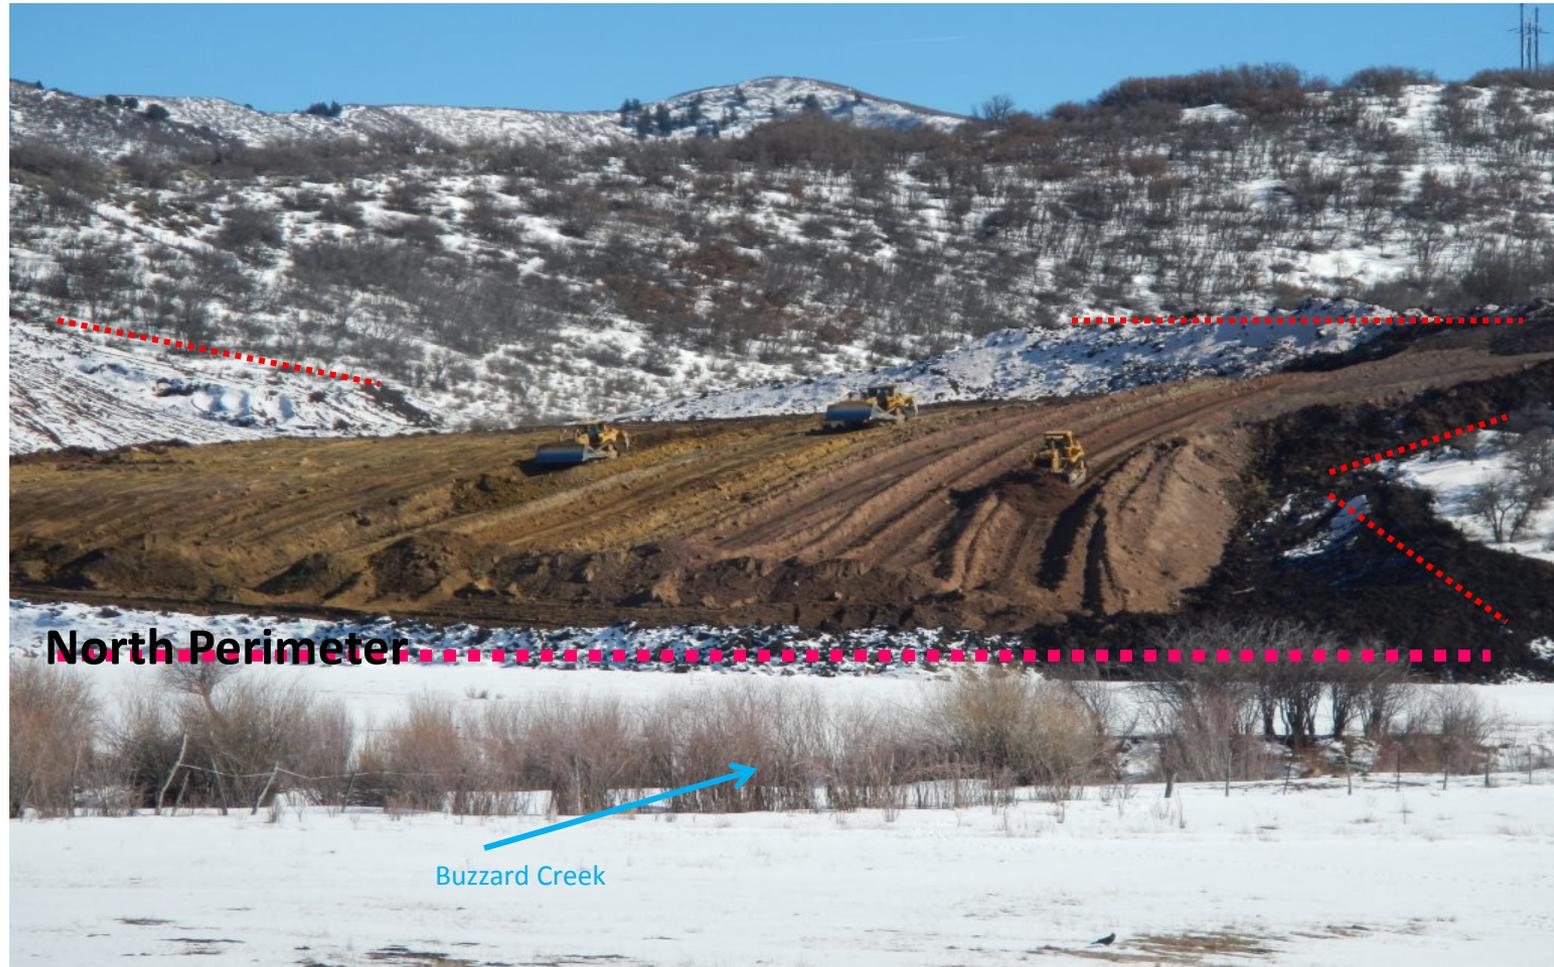
Photo#1:

View of Location From 330 E Rd to SE. Red dotted lines indicate Top soil salvaged & stored around Location Perimeter. BMPs have not been installed along outside base of Soil piles to prevent Run-off / Sediment Migration to nearby surface water or any drainages leading to surface water. North Perimeter is of most Concern

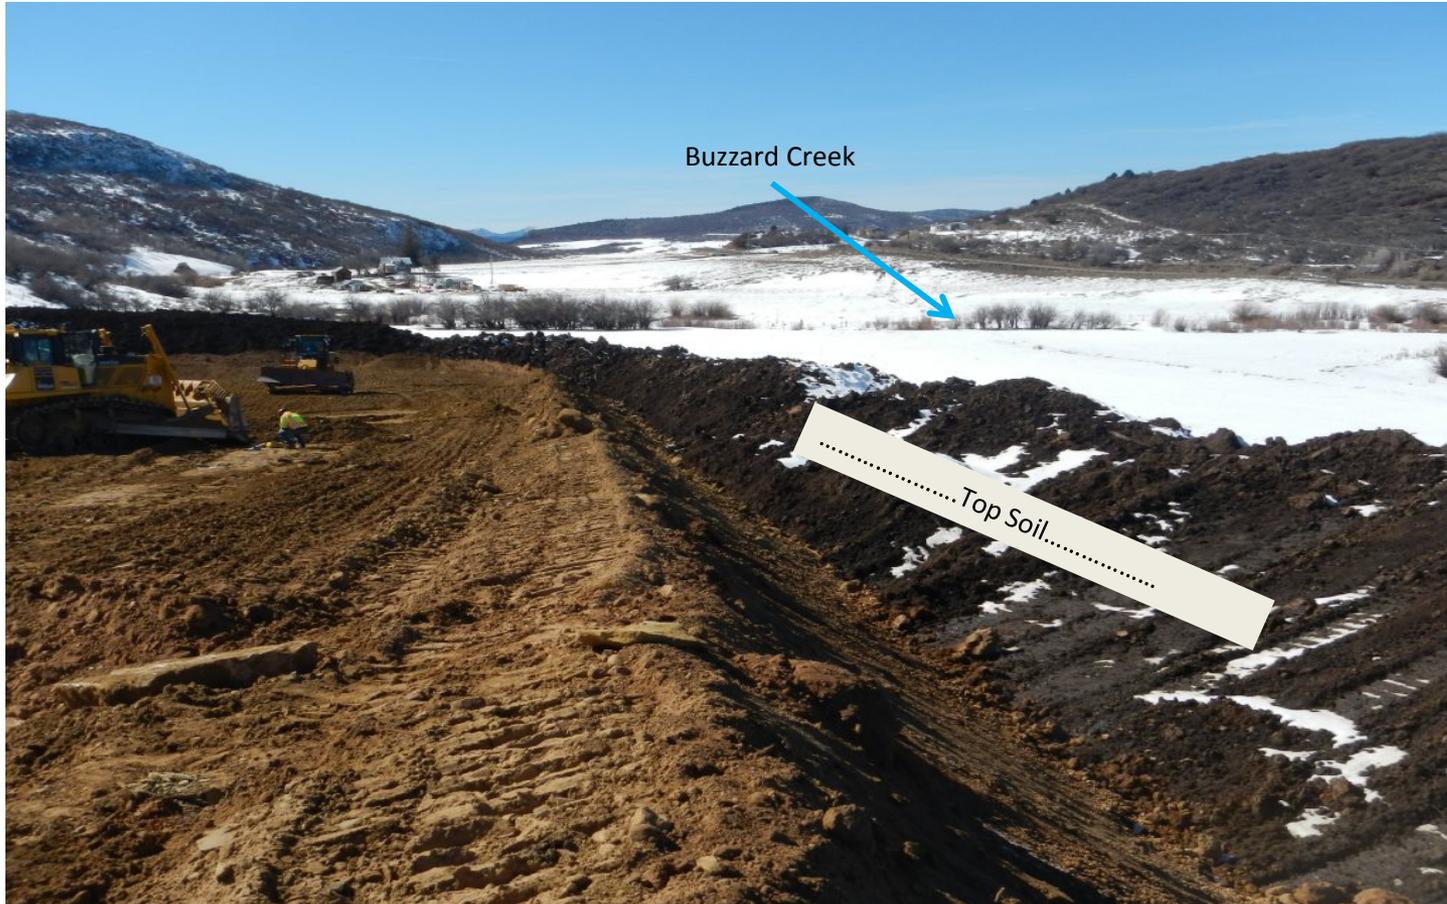
Photo#2:

View from Location Edge to NW.

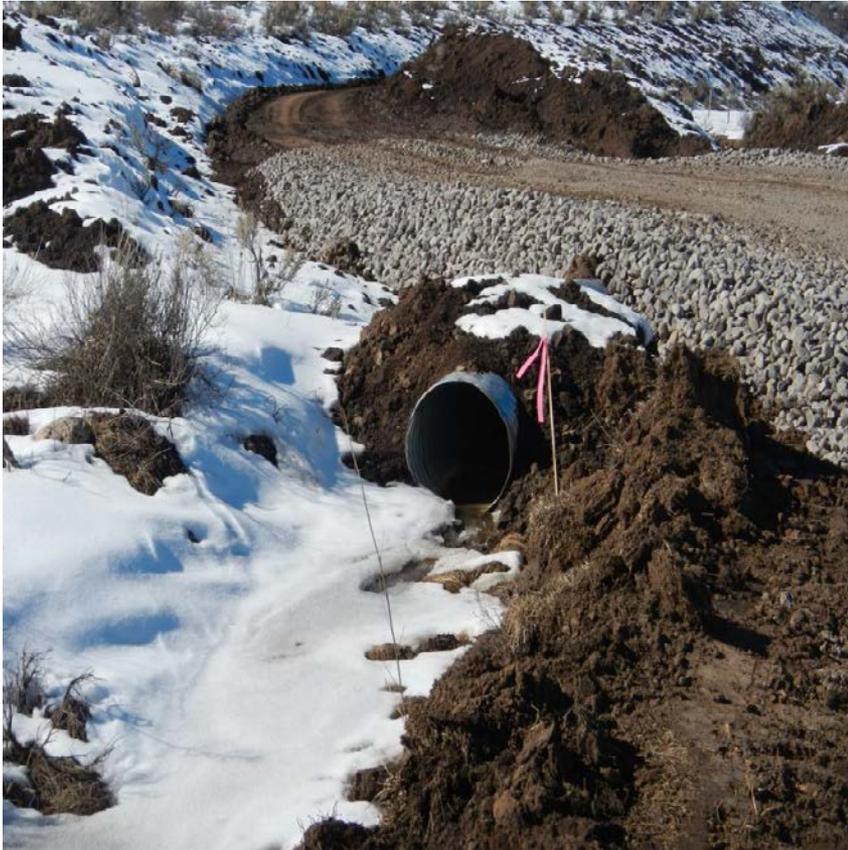
Photo#3:

Culvert , Gravel & Wattles Installed at beginning of Access Rd at point where it diverts off Local, Ground Hog Gulch Rd.

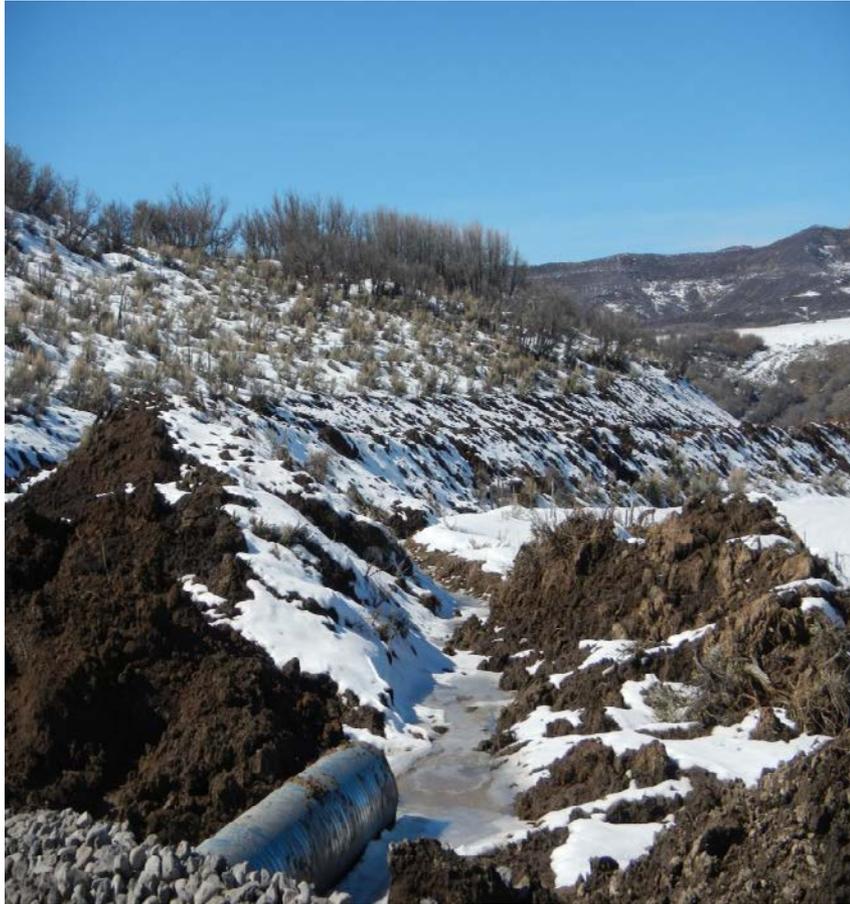
Photo#5:

Culvert empties into Ditch that runs along base of Access Rd.

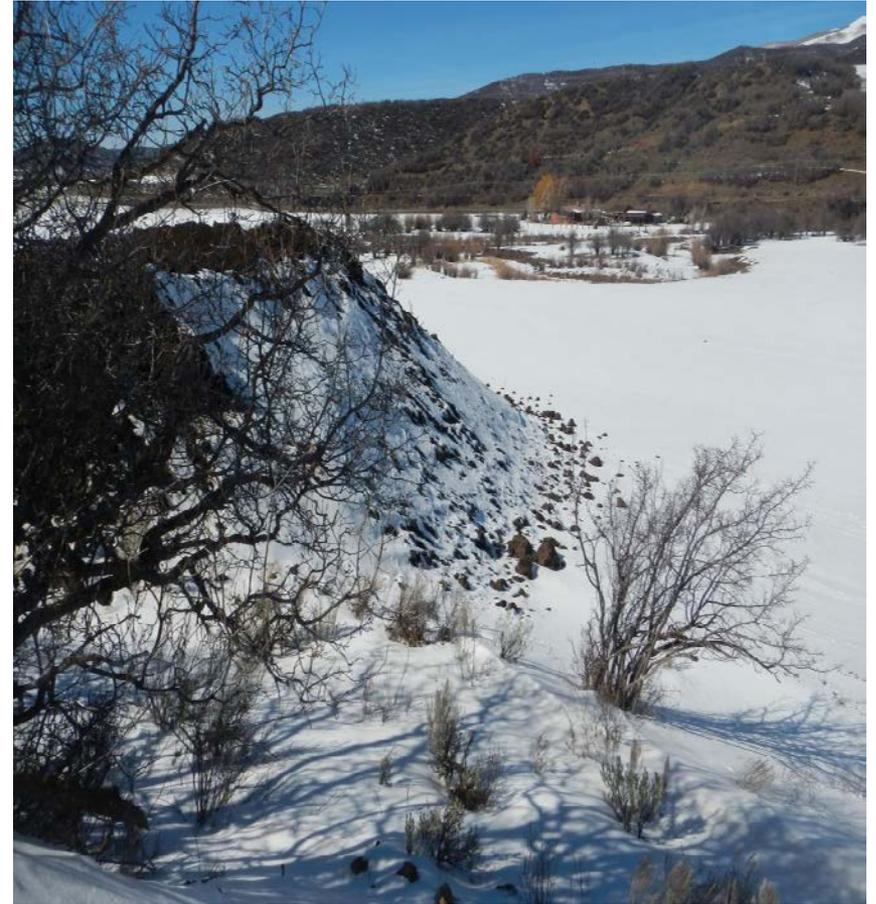
Photo#6:

No BMPs contain Top Soil around perimeter of Location or Access Rd.

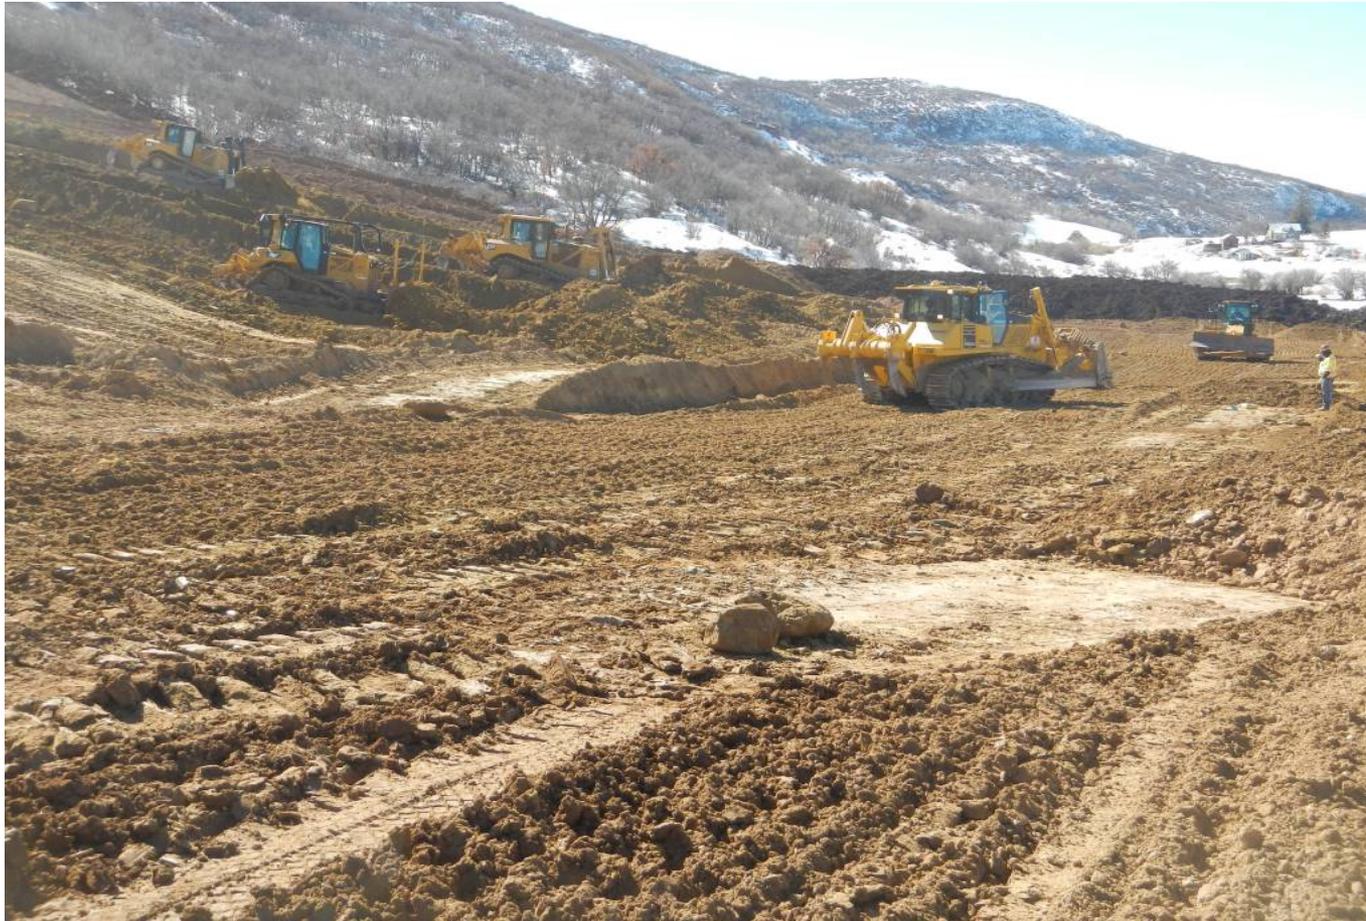
Photo#7:  
Overview of Work on Location to SW.
