**Inspection Photos**  
**Location Name: UPRR 42 Pan Am G 4**  
**API: 05-123-08958**

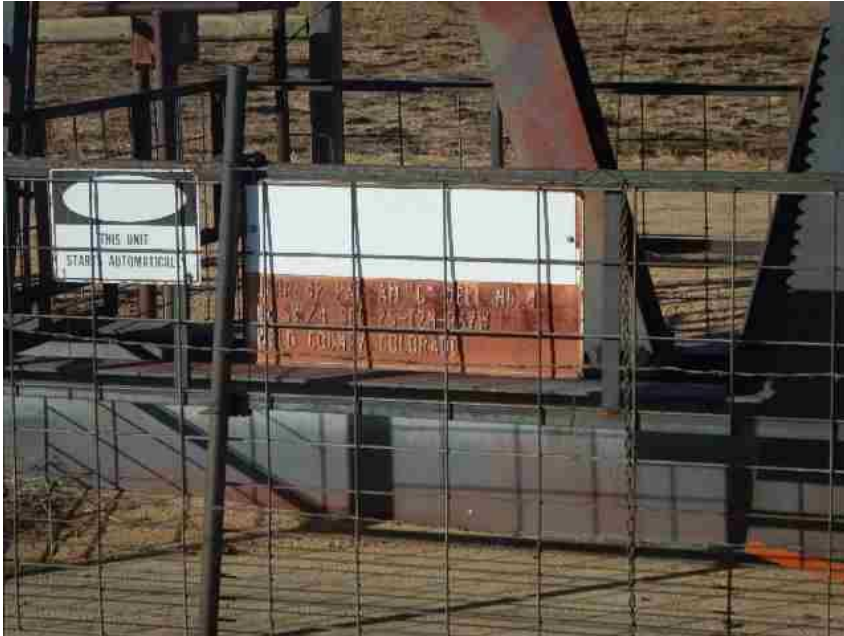
**Photo from prior inspection for comparison purposes**

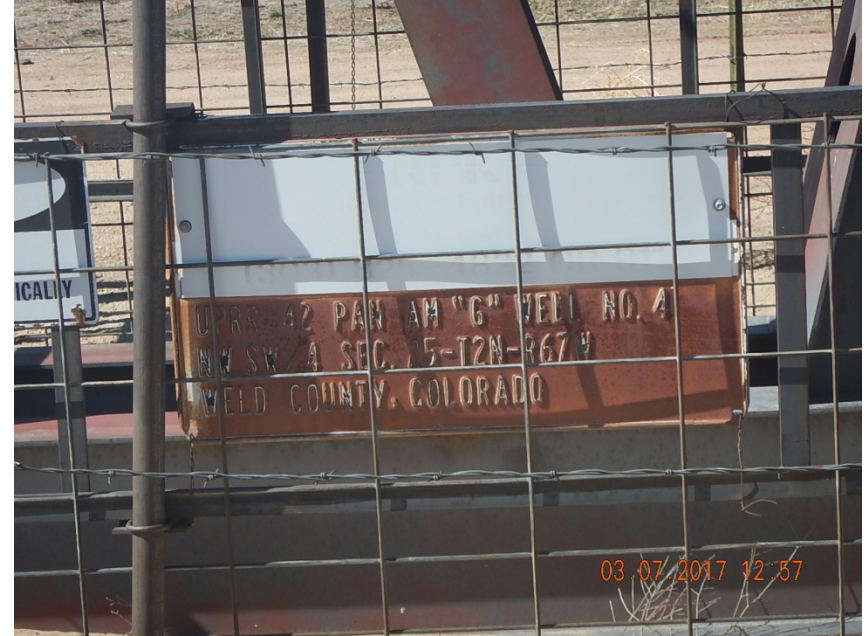
**Photo 1: Faded sign**

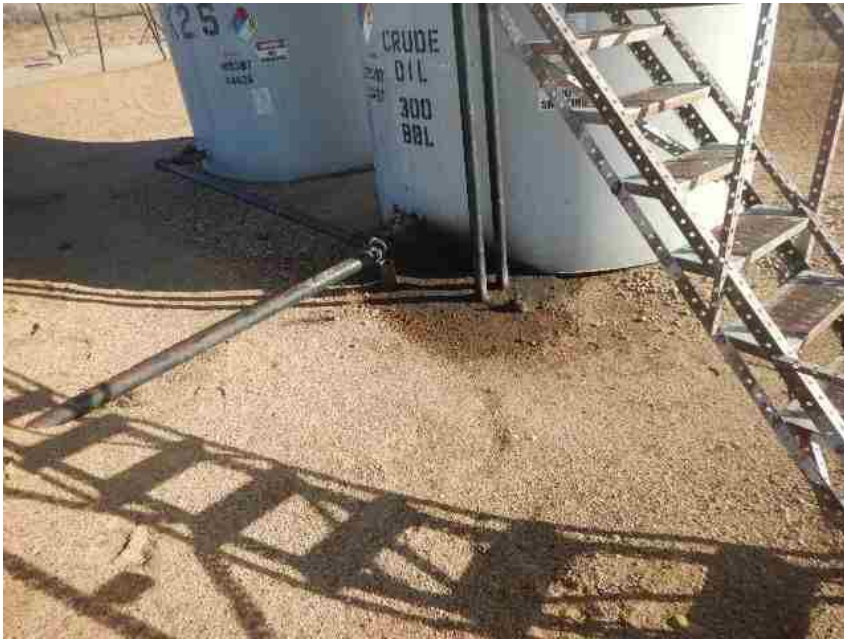
**Photo from prior inspection for comparison purposes**

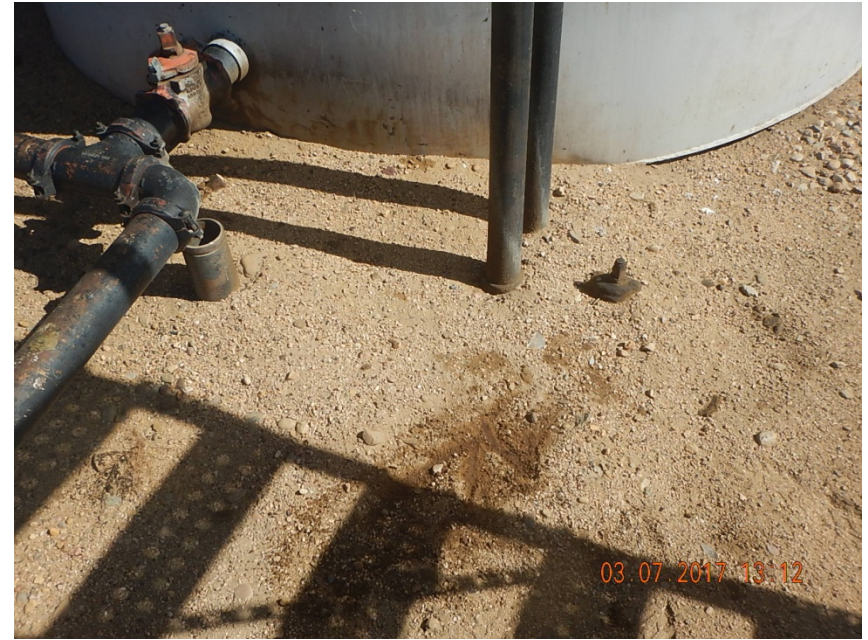
**Photo 2: Stained soil at tank loadout**

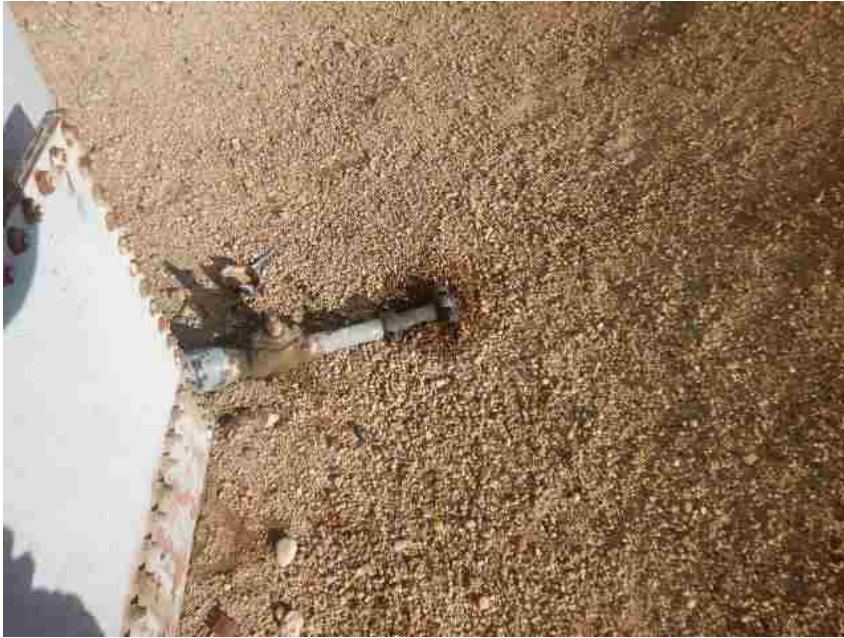
**Photo from prior inspection for comparison purposes**

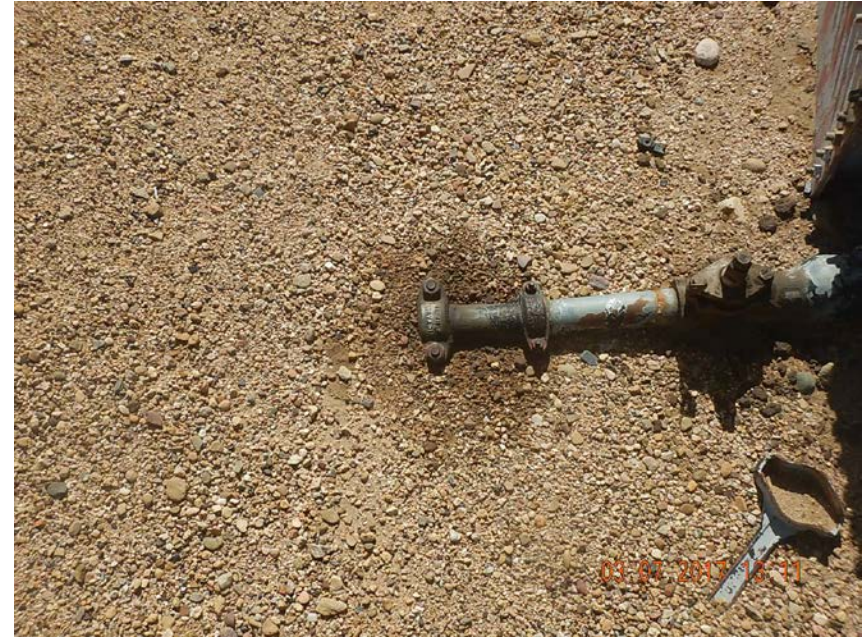
**Photo 3: Stained soil at valve**

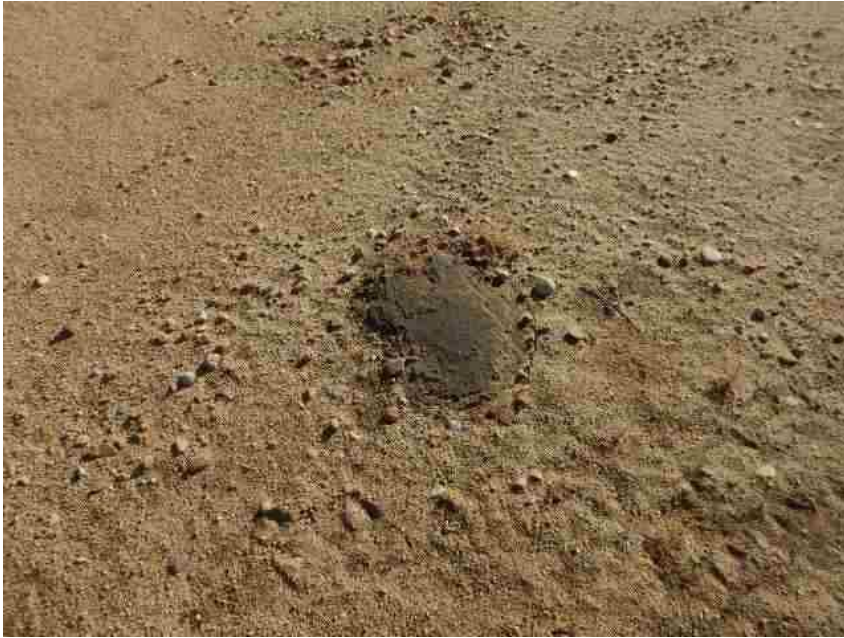
**Photo from prior inspection for comparison purposes**

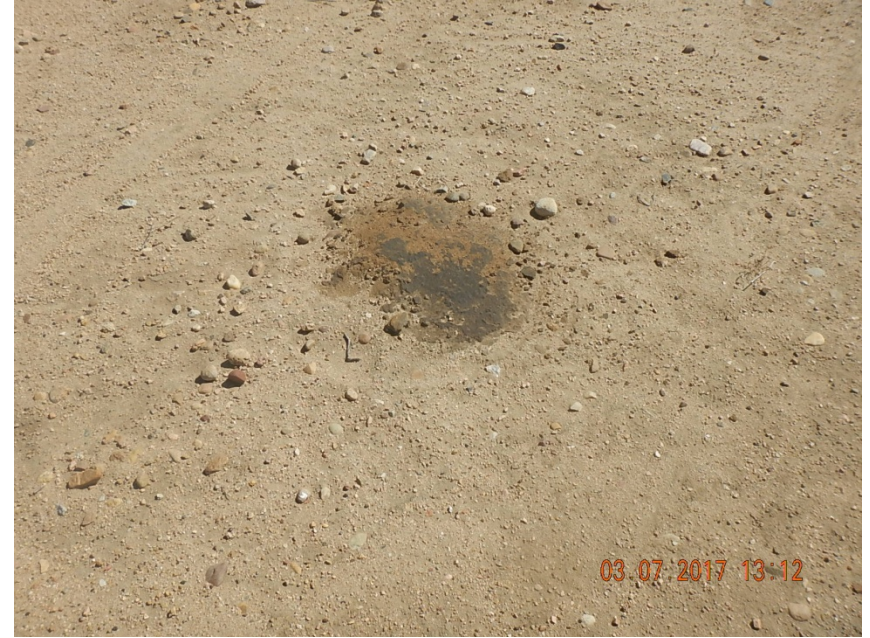
**Photo 4: Stained soil near battery, to south**

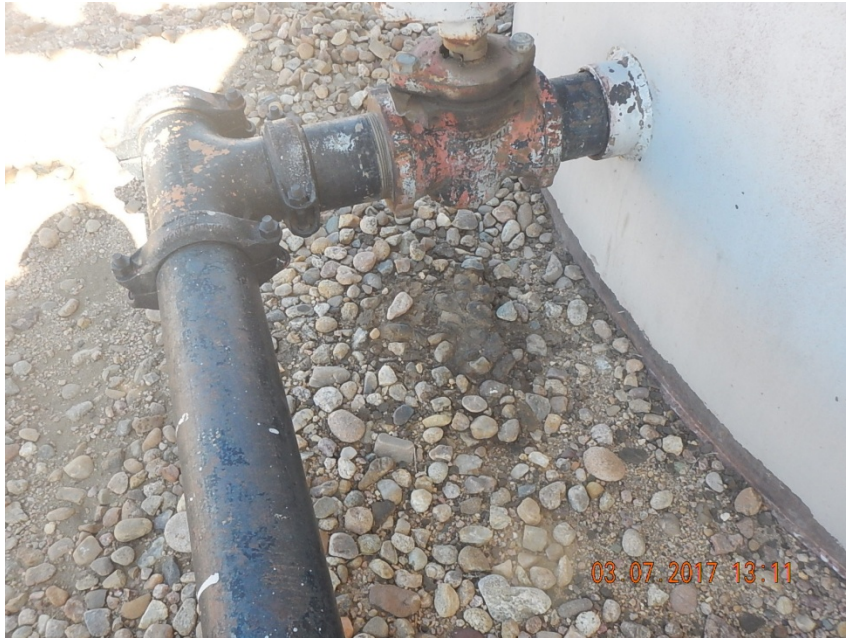
**Photo 5: Stained soil beneath loadout**

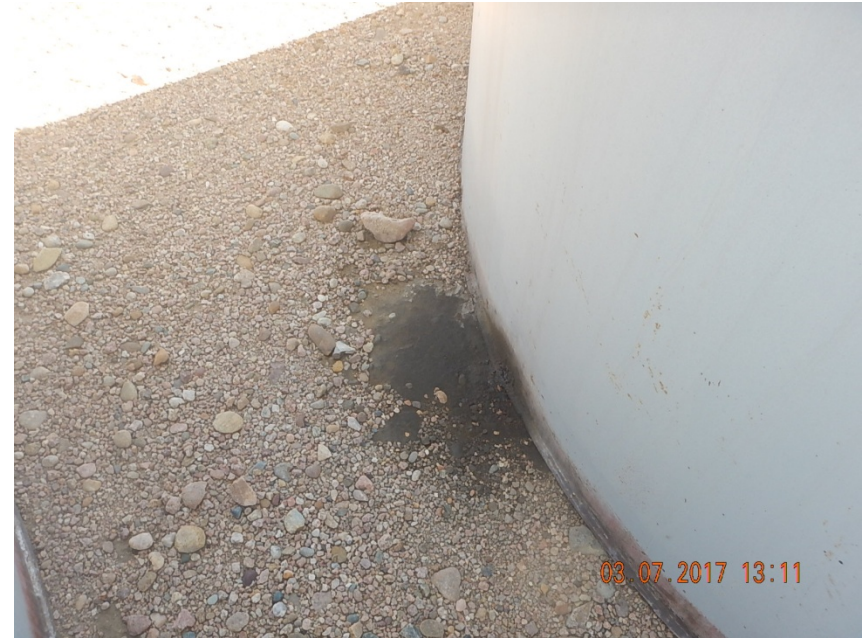
**Photo 6: Stained soil at tank**

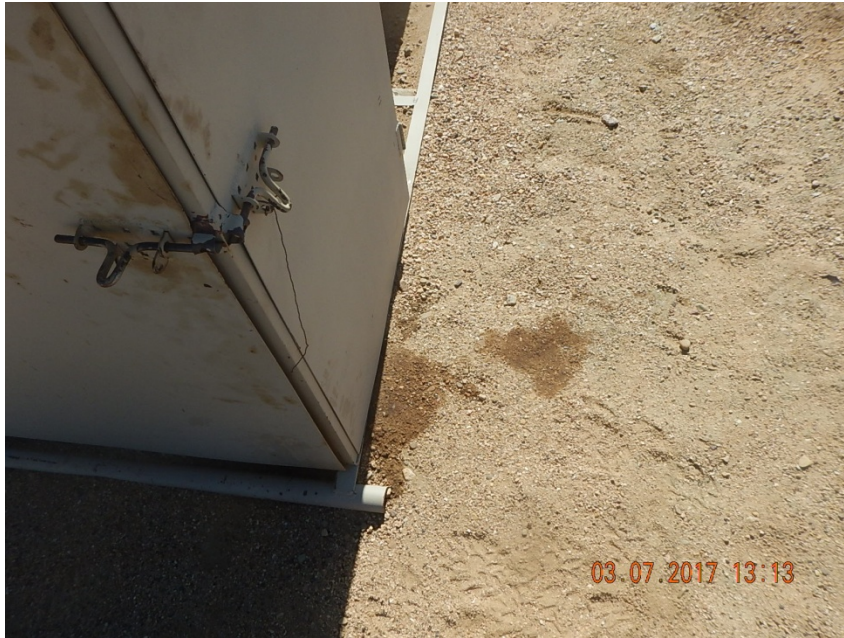
**Photo 7: Stained soil at separator**

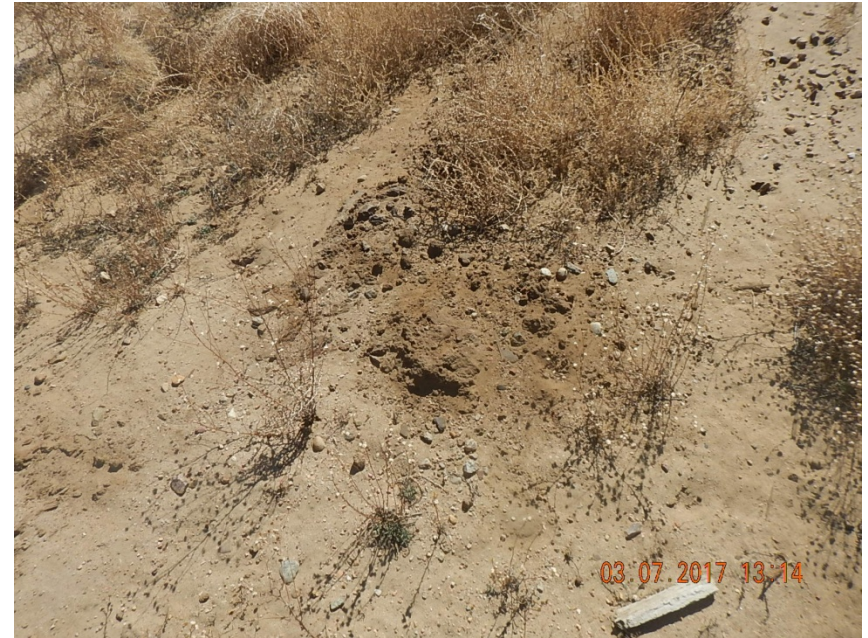
**Photo 8: Stained soil, weeds at produced water tank on east side**
