Inspection Photos
Location Name: Ronald Grabrian Unit-True 1
API: 05-123-11439

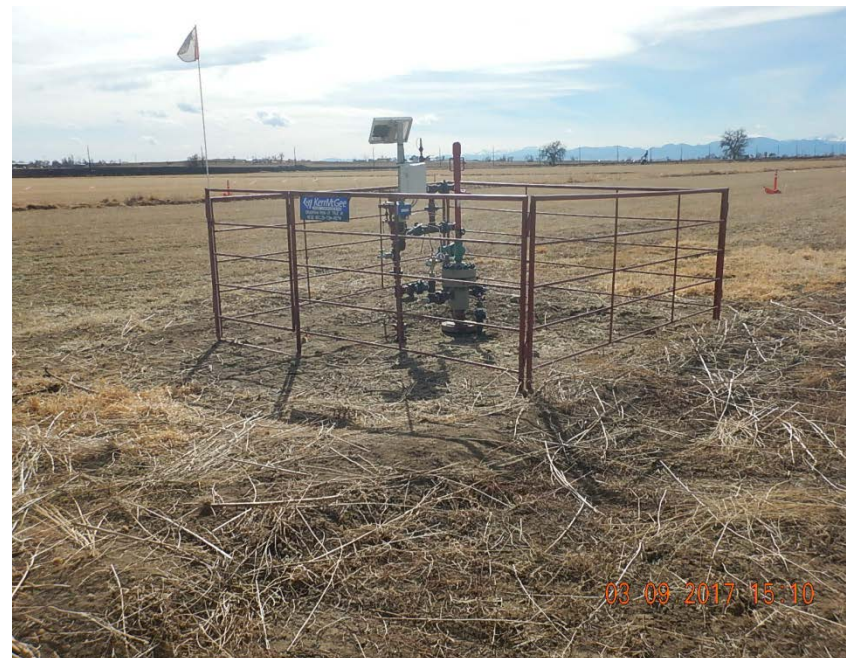
Photo 1: Wellhead, looking SW. Weeds have been controlled

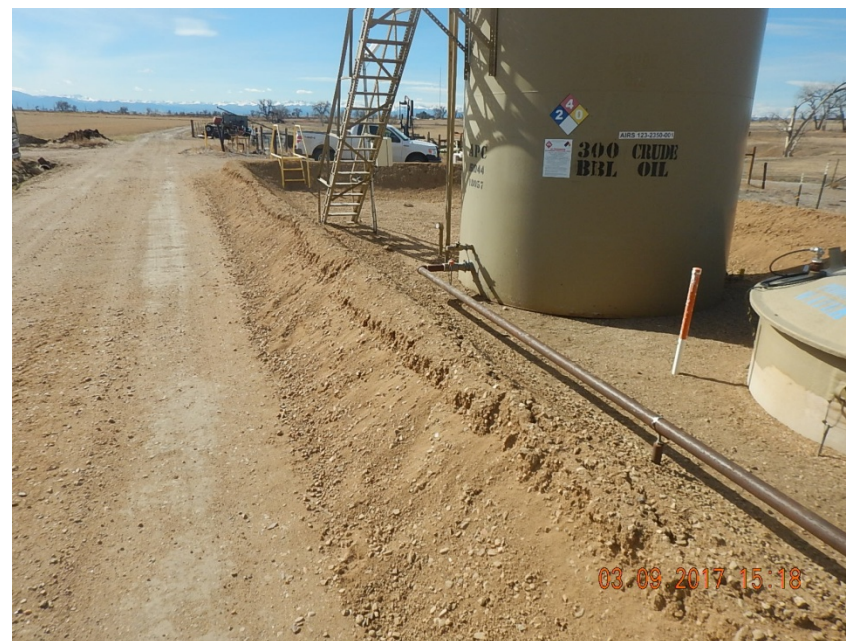
Photo 2: Berms at tank battery have been repaired.
