Inspection Photos
Location Name: Donald M Vynckier 2
API: 05-123-08941

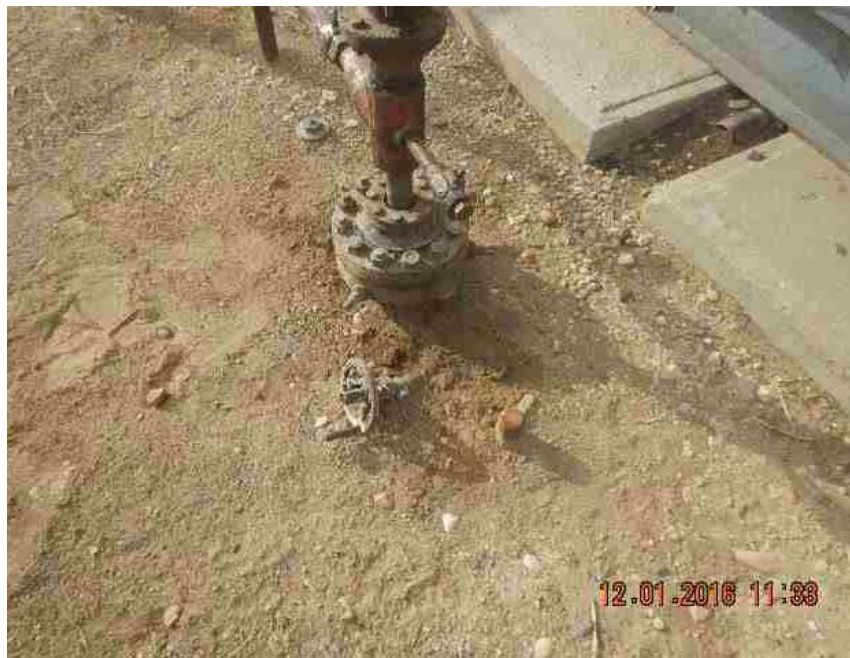
Photo from prior inspection for comparison

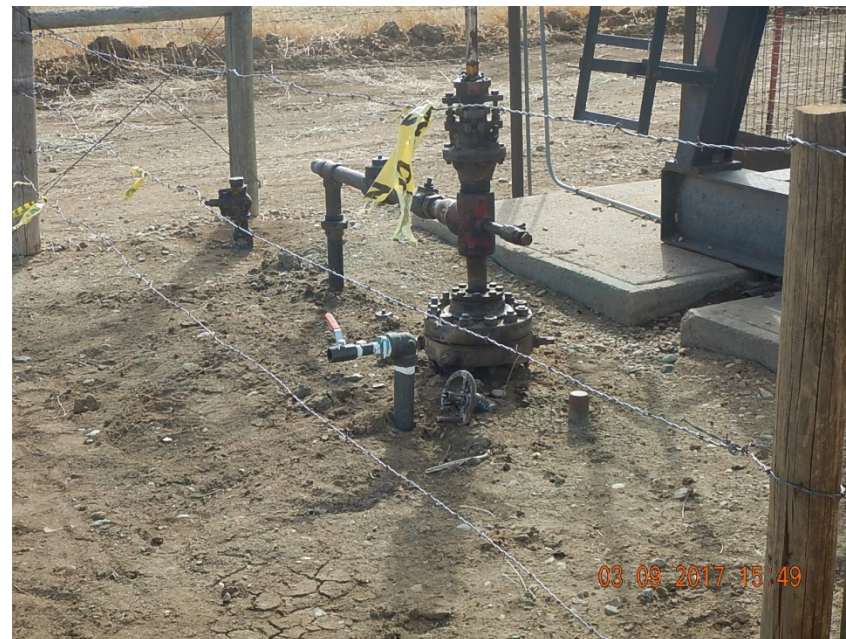
Photo 1: Bradenhead plumbed to surface, stained soil remediated

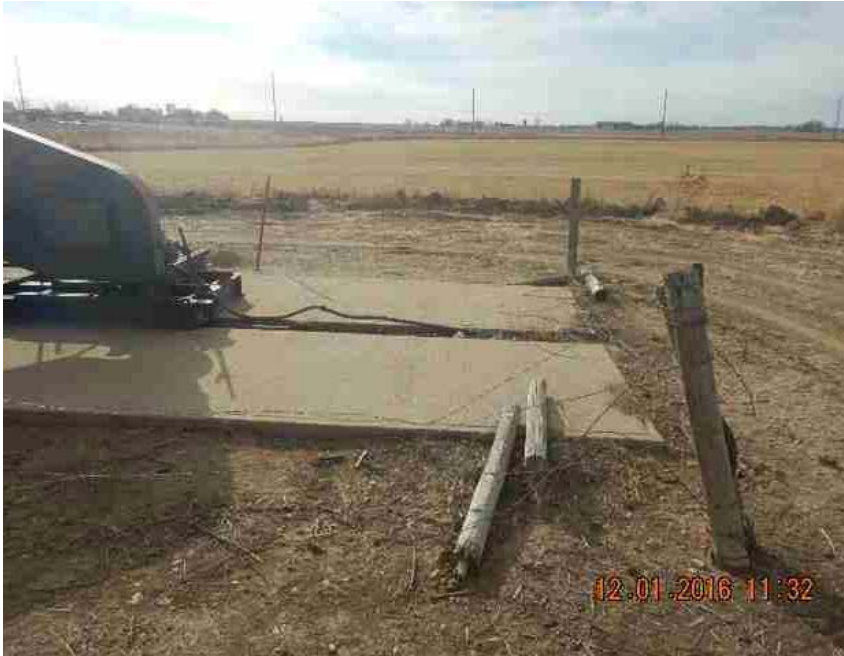
Photo from prior inspection for comparison

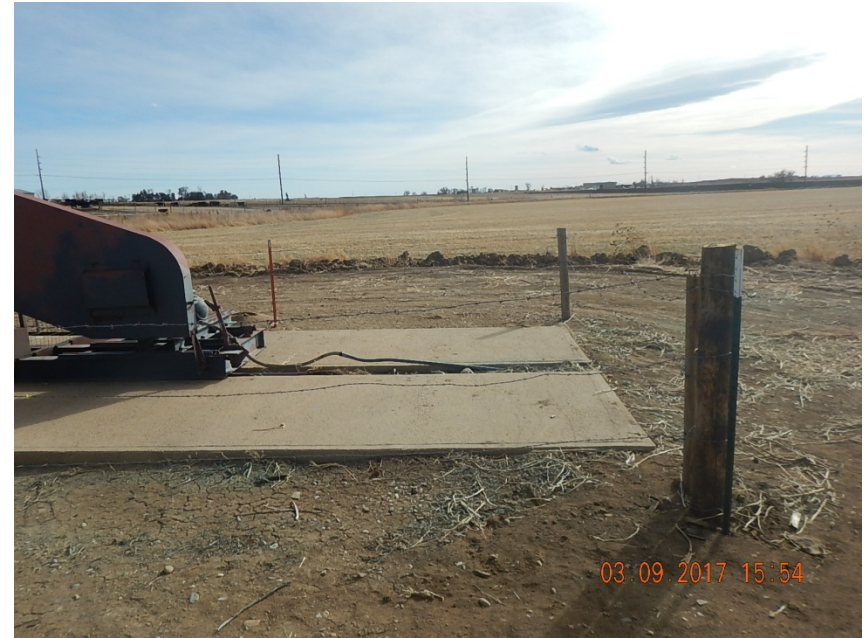
Photo 2: Fence has been repaired.
