Inspection Photos
Location Name: Jack Berger A 4
API: 05-123-07717

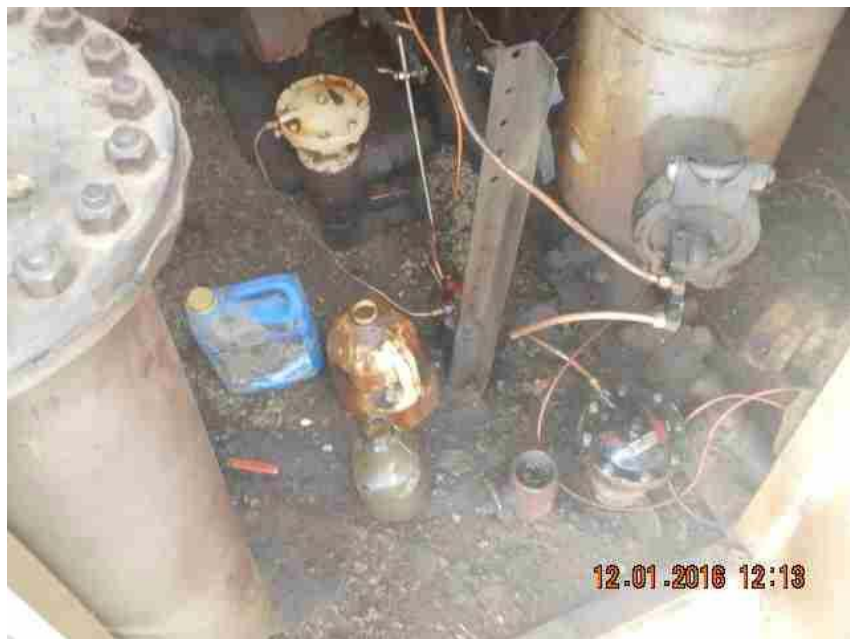
Photo from prior inspection for comparison

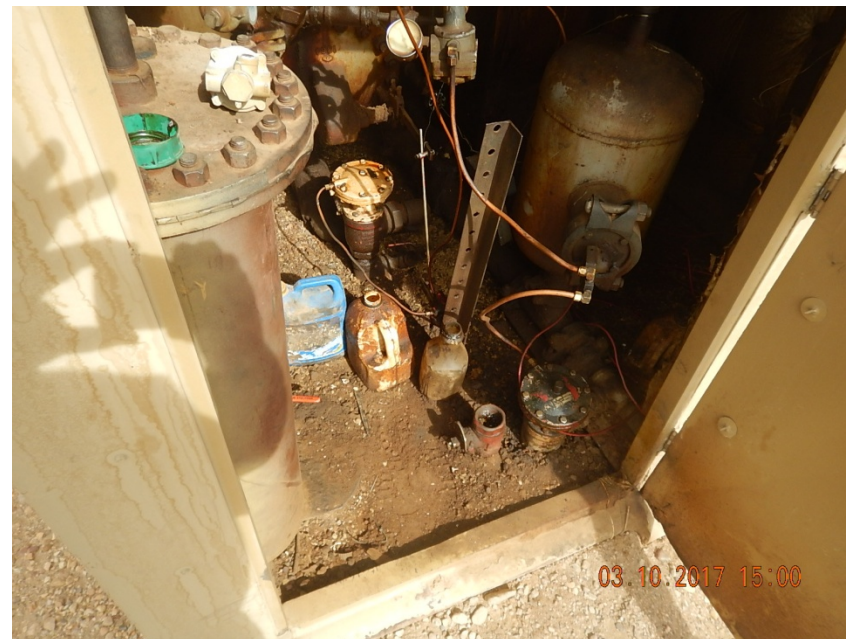
Photo 1: Stained soil in separator house, SW corner

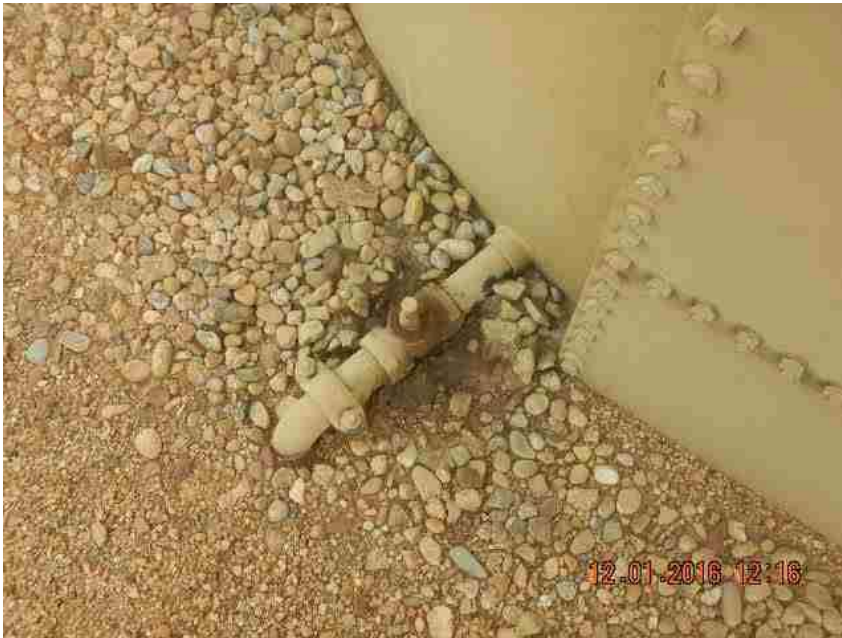
Photo from prior inspection for comparison

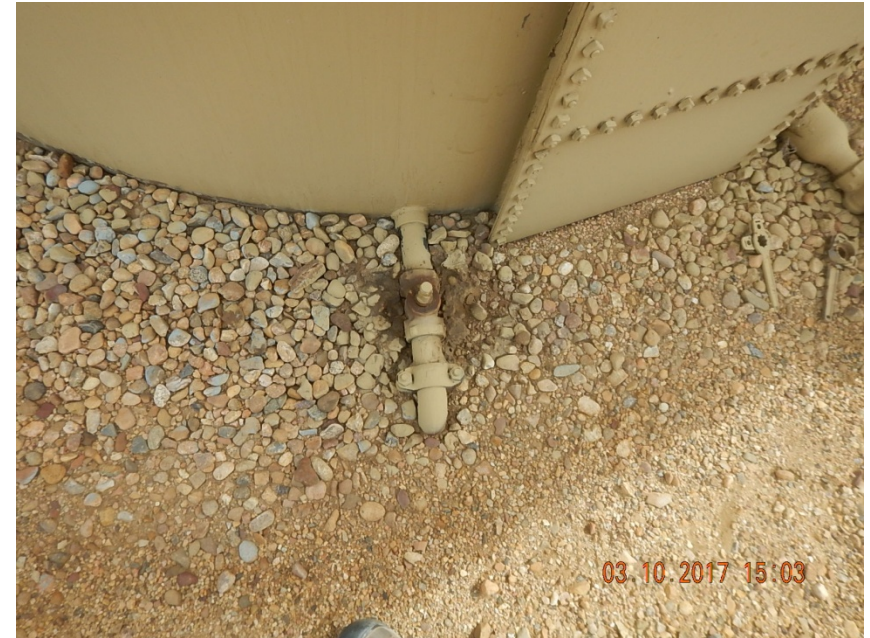
Photo 2: Stained soil at valve

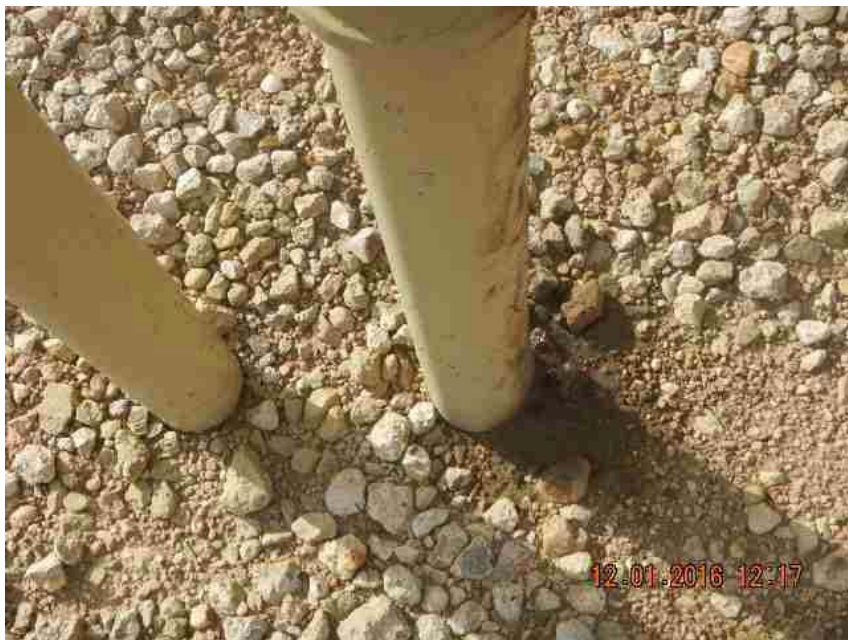
Photo from prior inspection for comparison

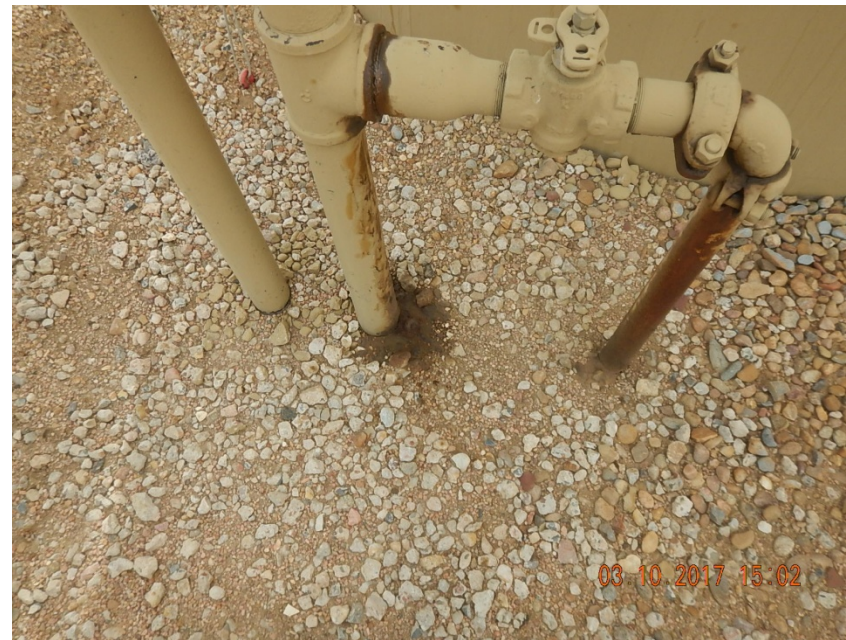
Photo 3: Stained soil at risers

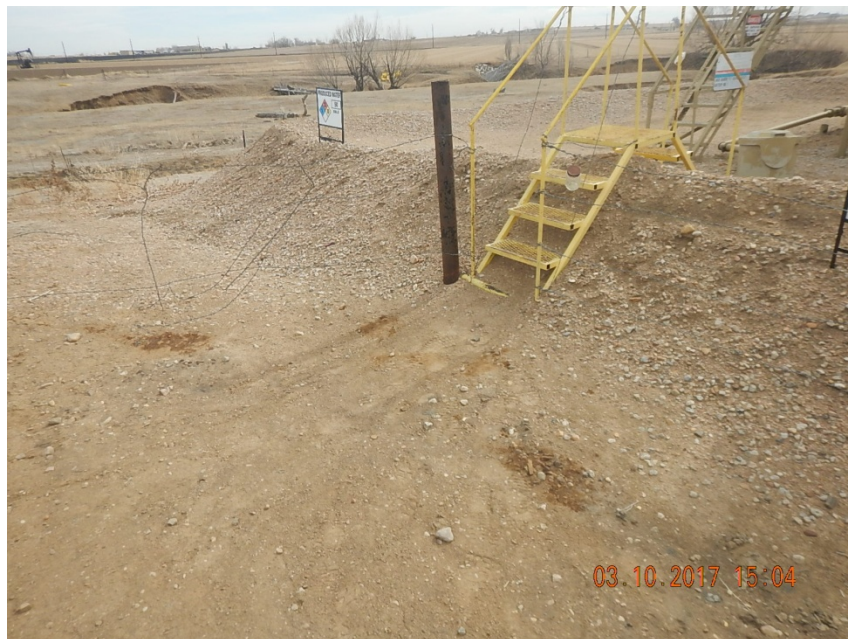
Photo 4: Stained soil patches outside of berm

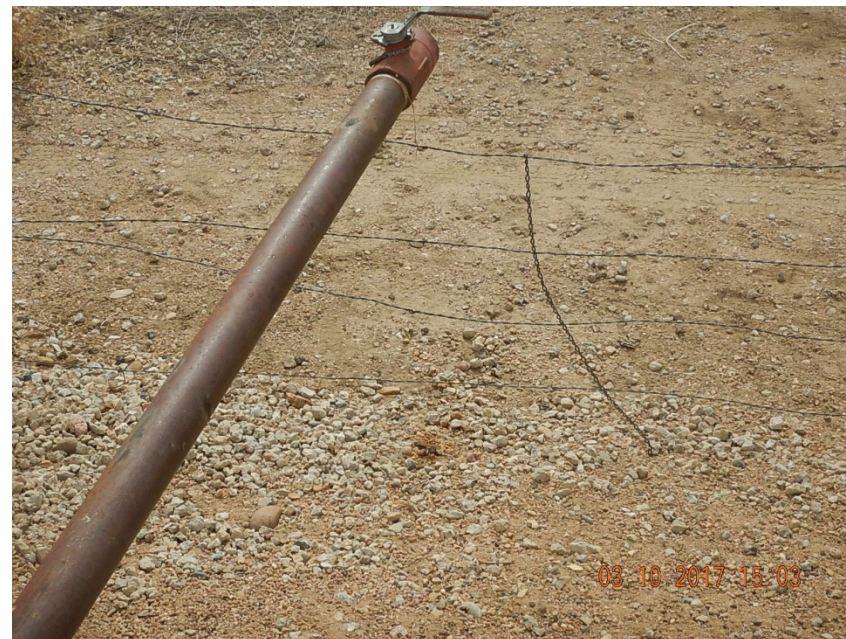
Photo 5: Stained soil at produced water loadout on S side.

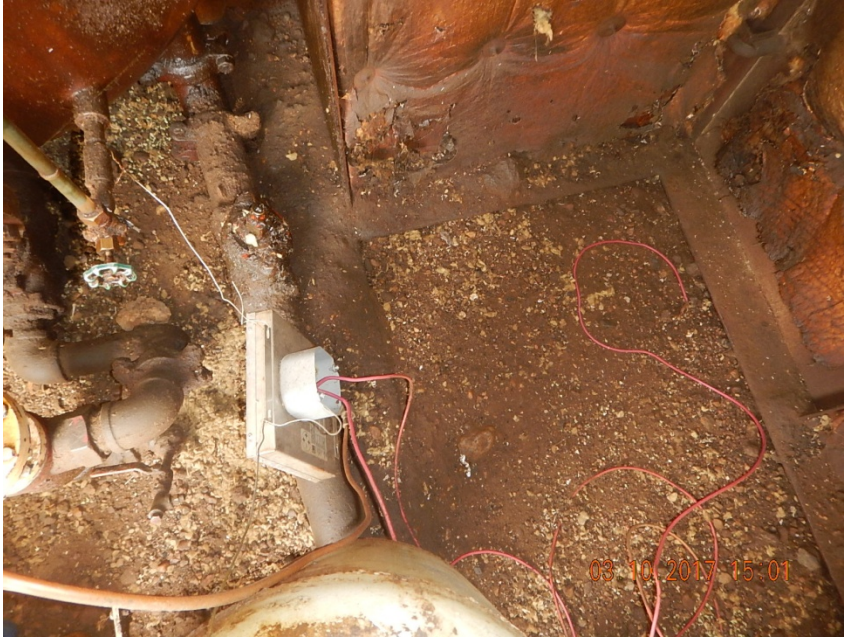
Photo 6: Stained soil in separator house, NE corner
