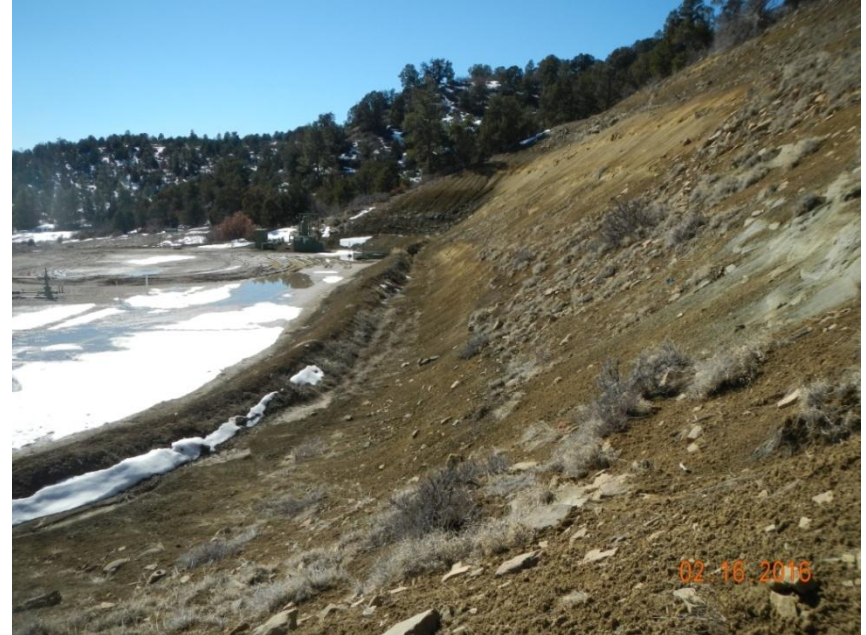
**Photo 2:** View of the northern portion of the project area from the northeastern corner facing westward. Revegetation is largely comprised of grasses such as James galleta (*Pleuraphis jamesii*).

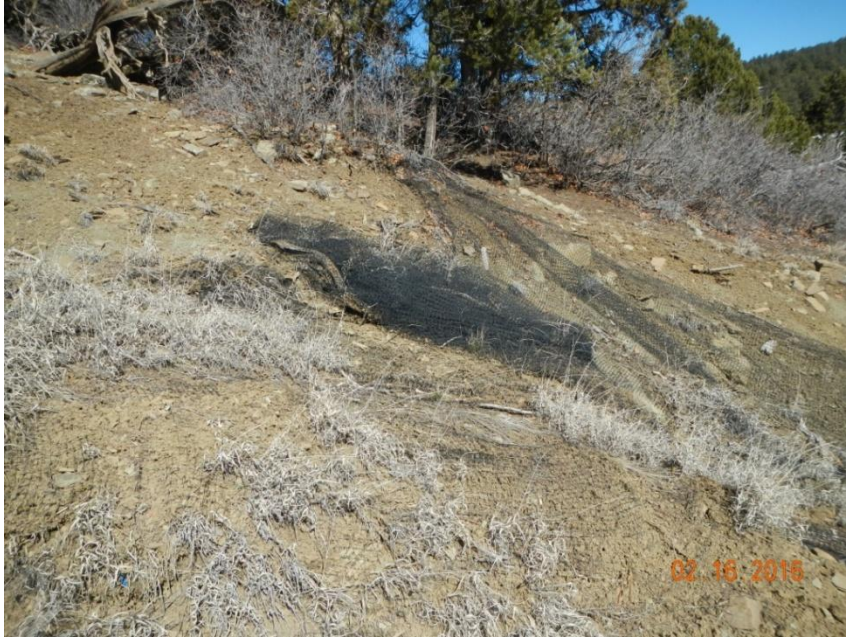
**Photo 5: View of netting debris in the northeastern portion of the project area that needs to be removed.**

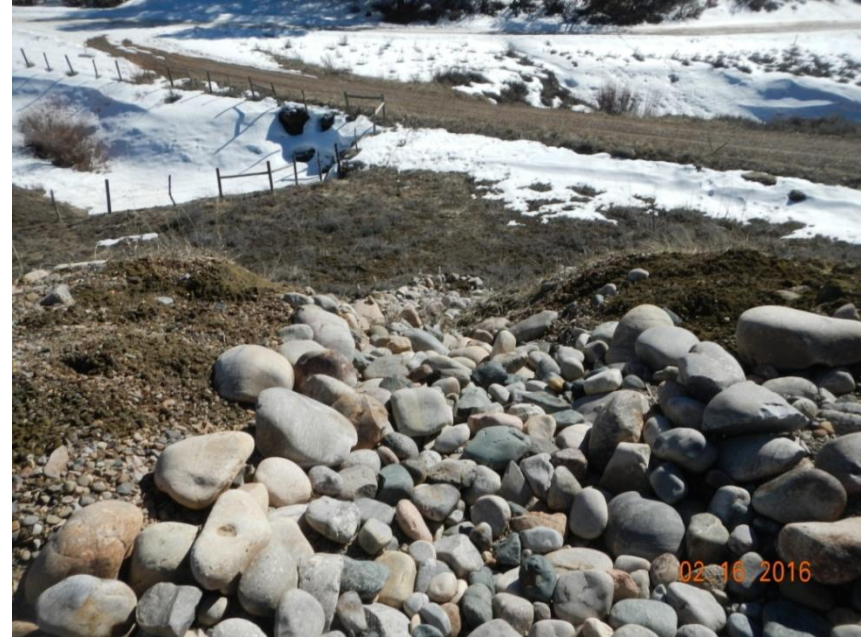
**Photo 6: View of cobble run-down in the southeastern portion of the project area. This and other stormwater controls appear to be functioning at this time.**
