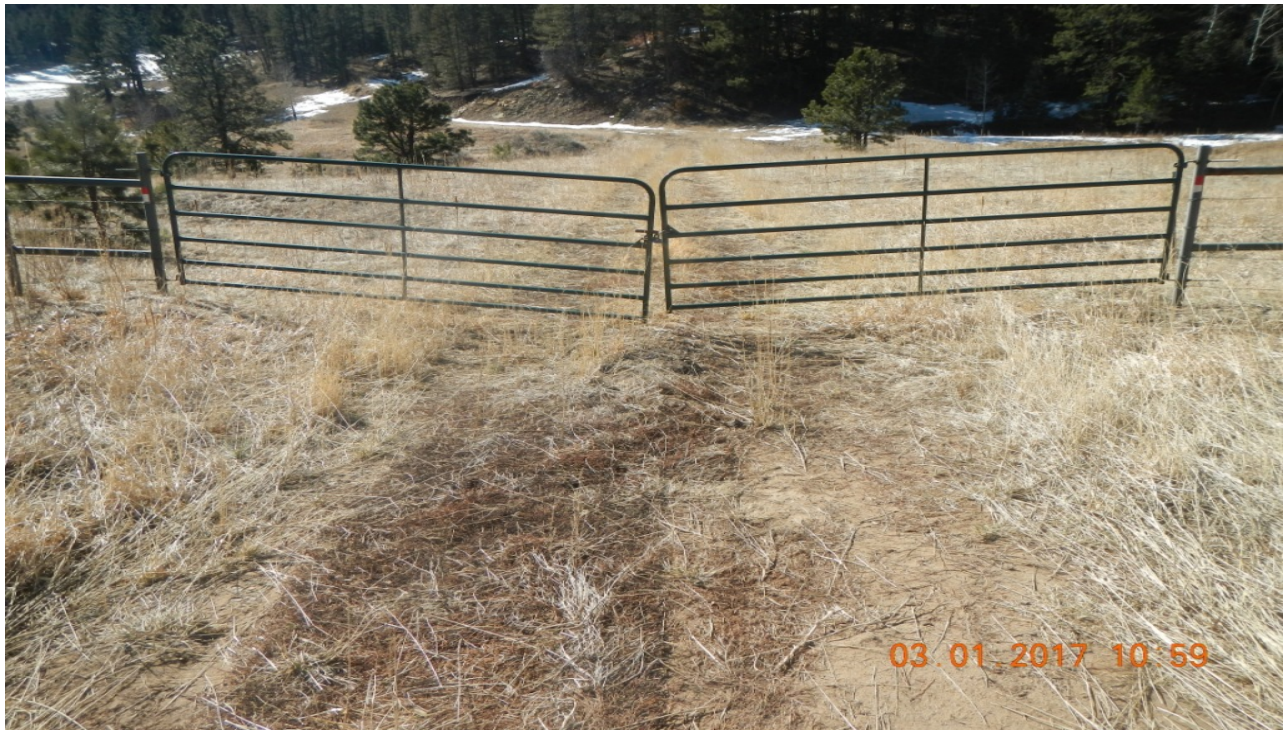
photo 1: Facing south at the beginning of the access road.

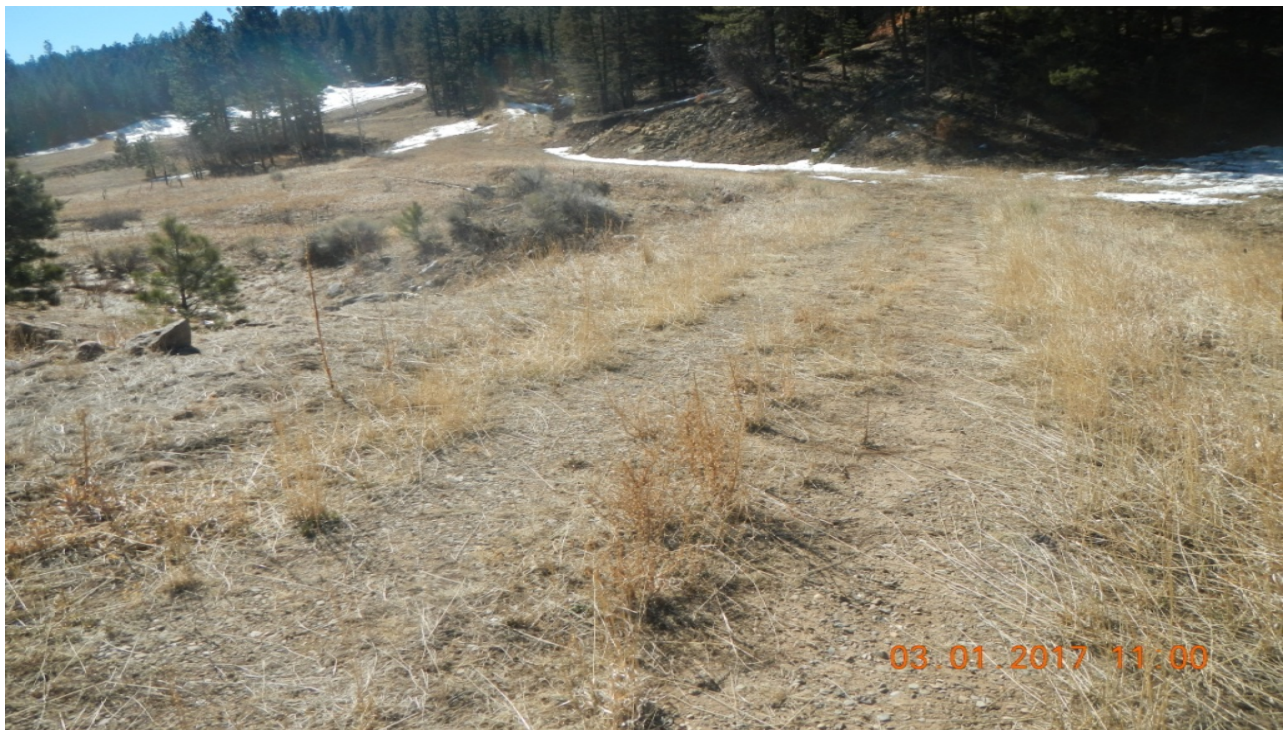
photo 2: Facing southeast along the access road.

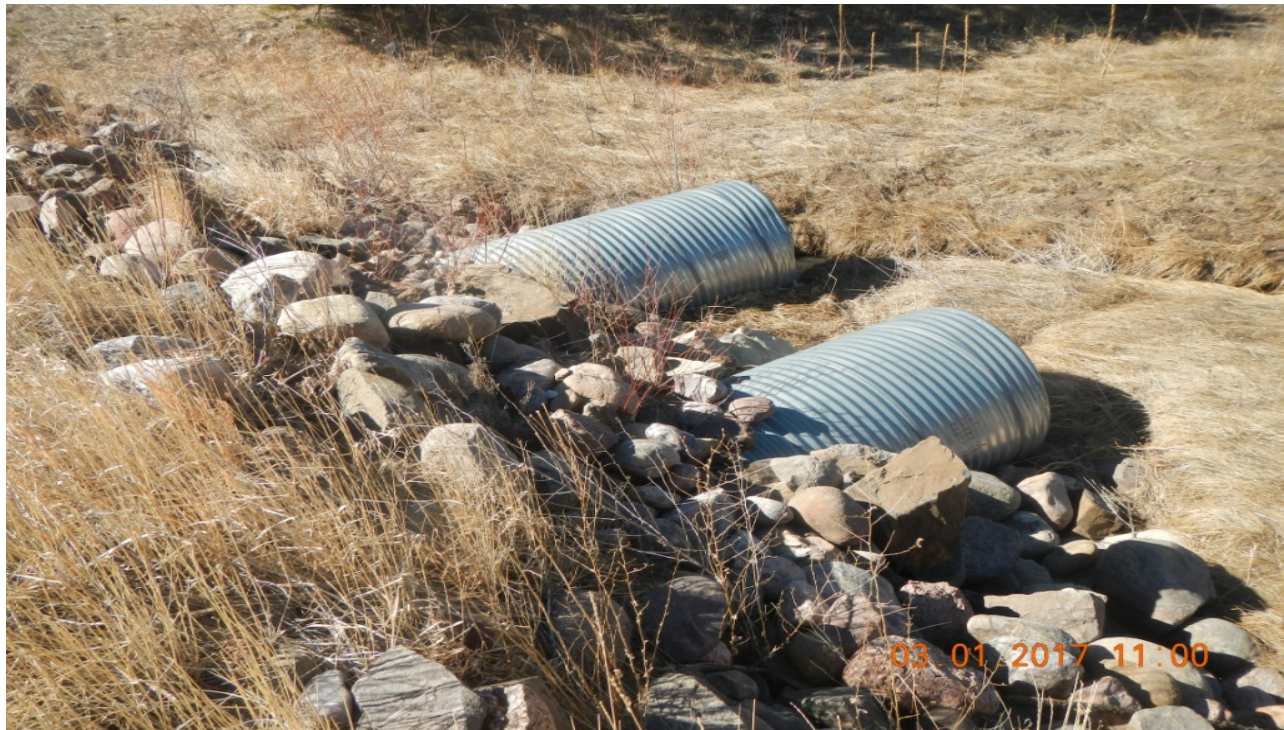
photo 3: The culverts installed along the road for the intermittent creek.

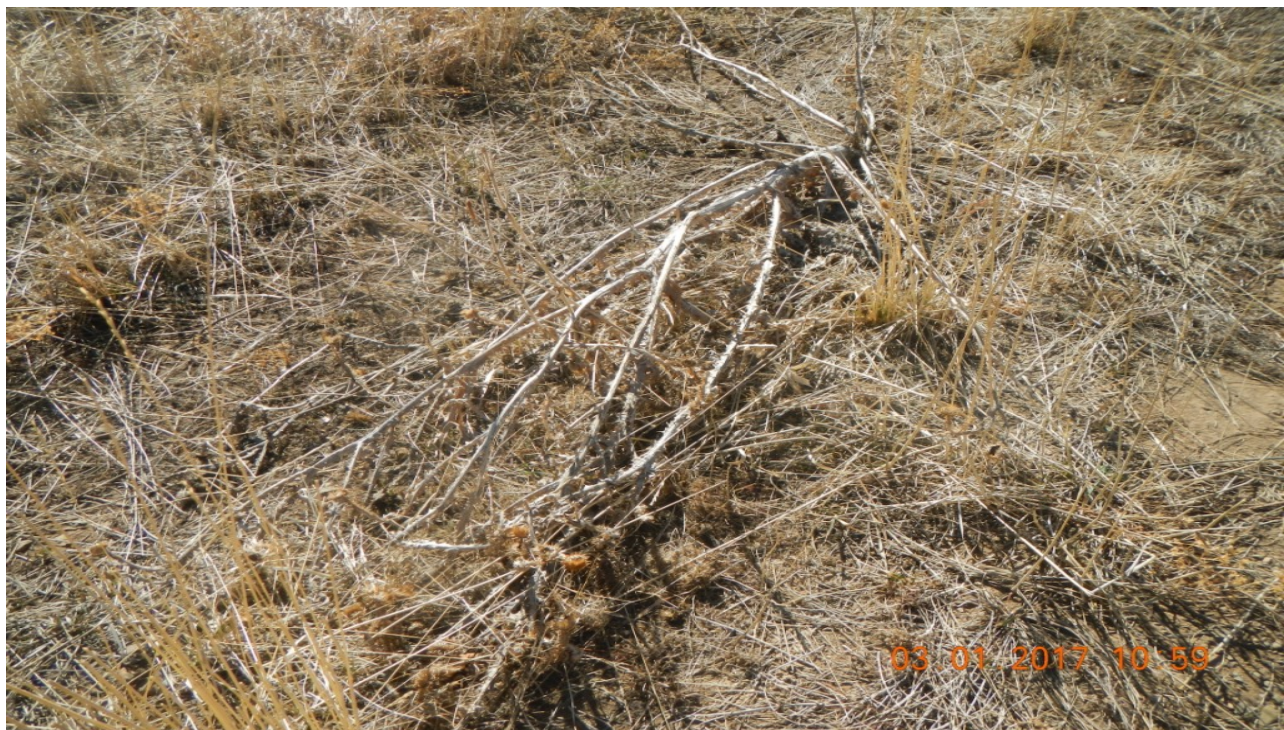
photo 4: This appears to be Plueless thistle (list B noxious weed) along the access road.

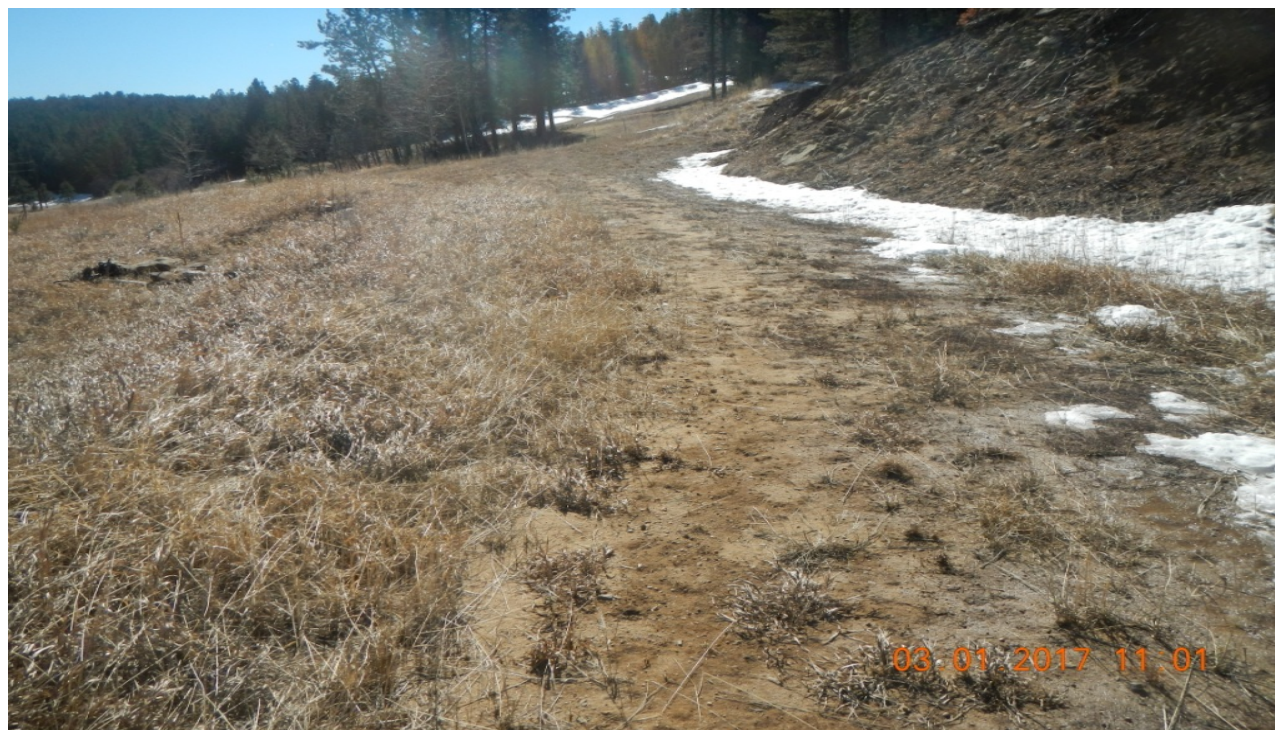
photo 5: Facing southeast along the access road.

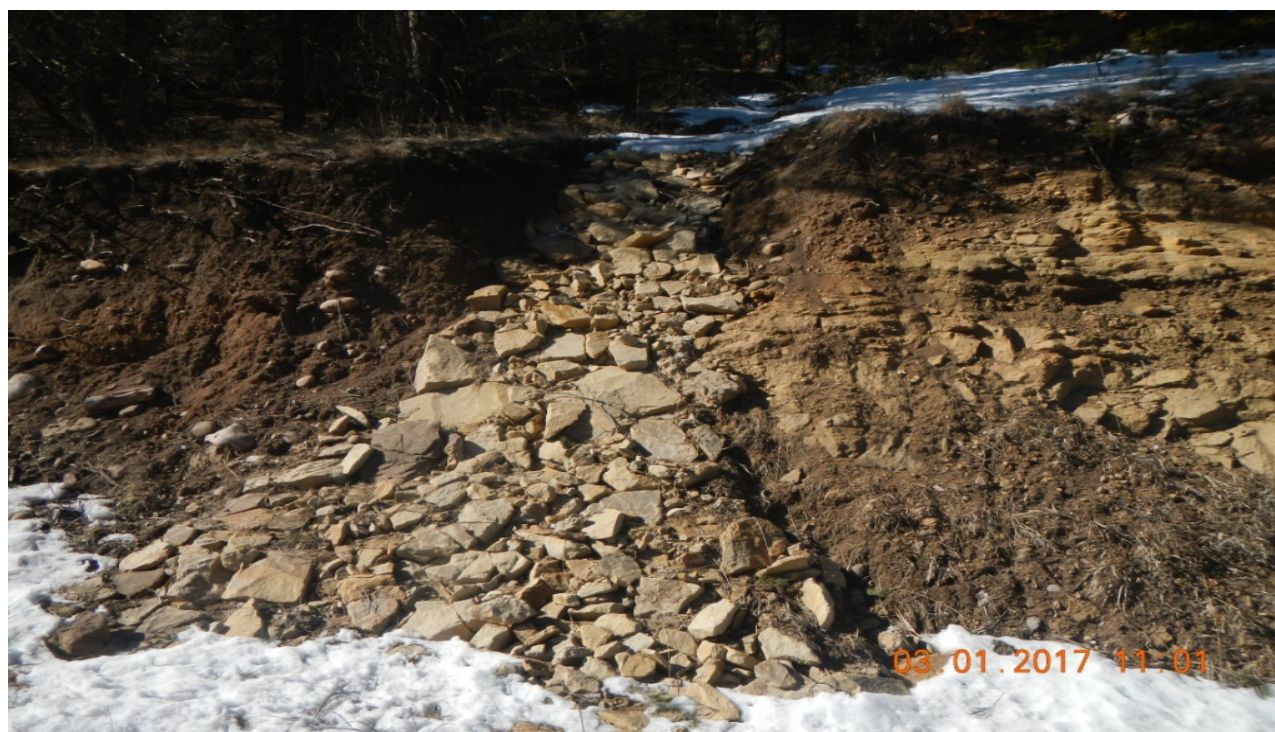
photo 6: Rock rip/rap placed along the cut slope of the road.

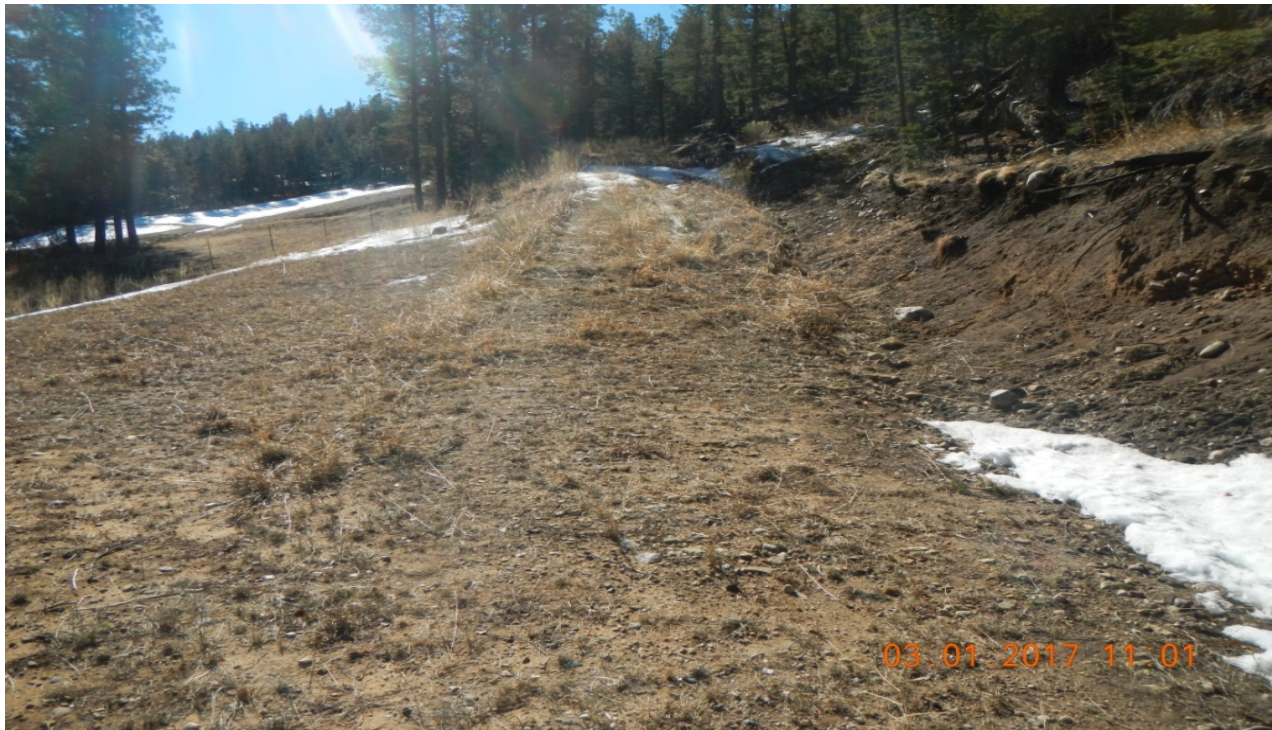
photo 7: The access road continues past the location.

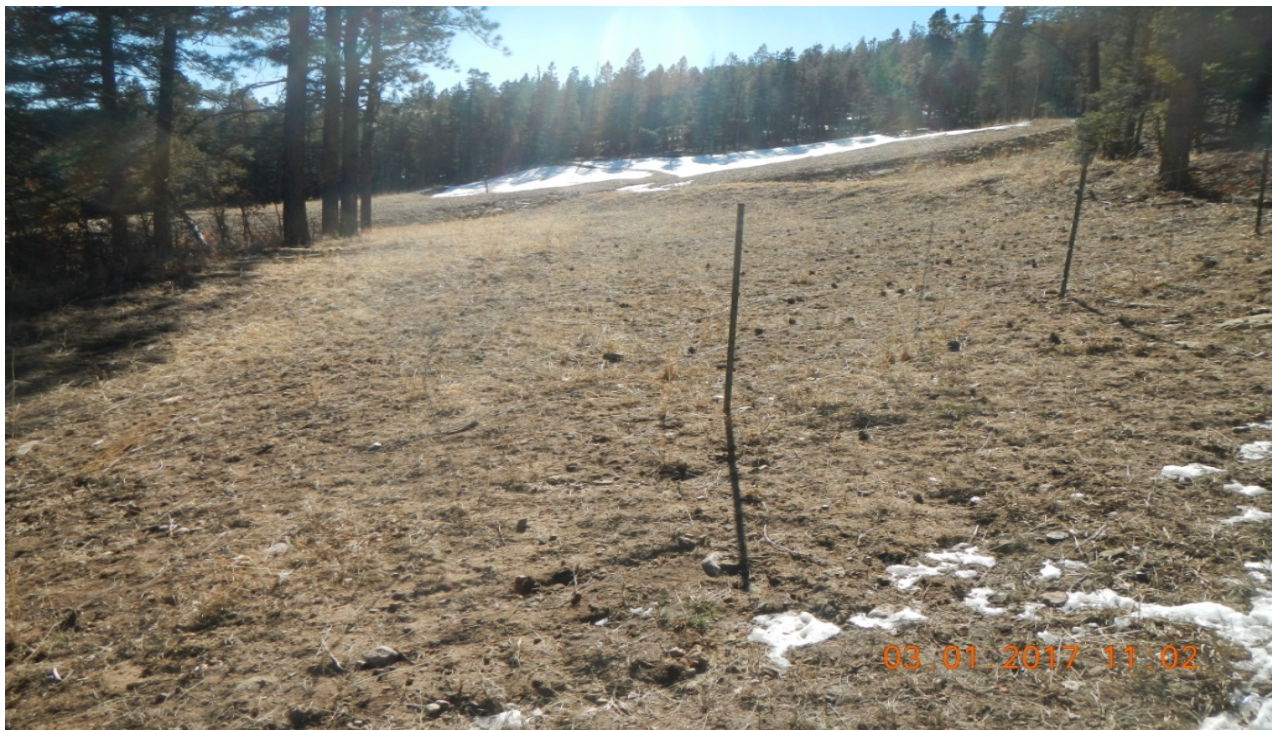
photo 8: Facing southeast toward the location.

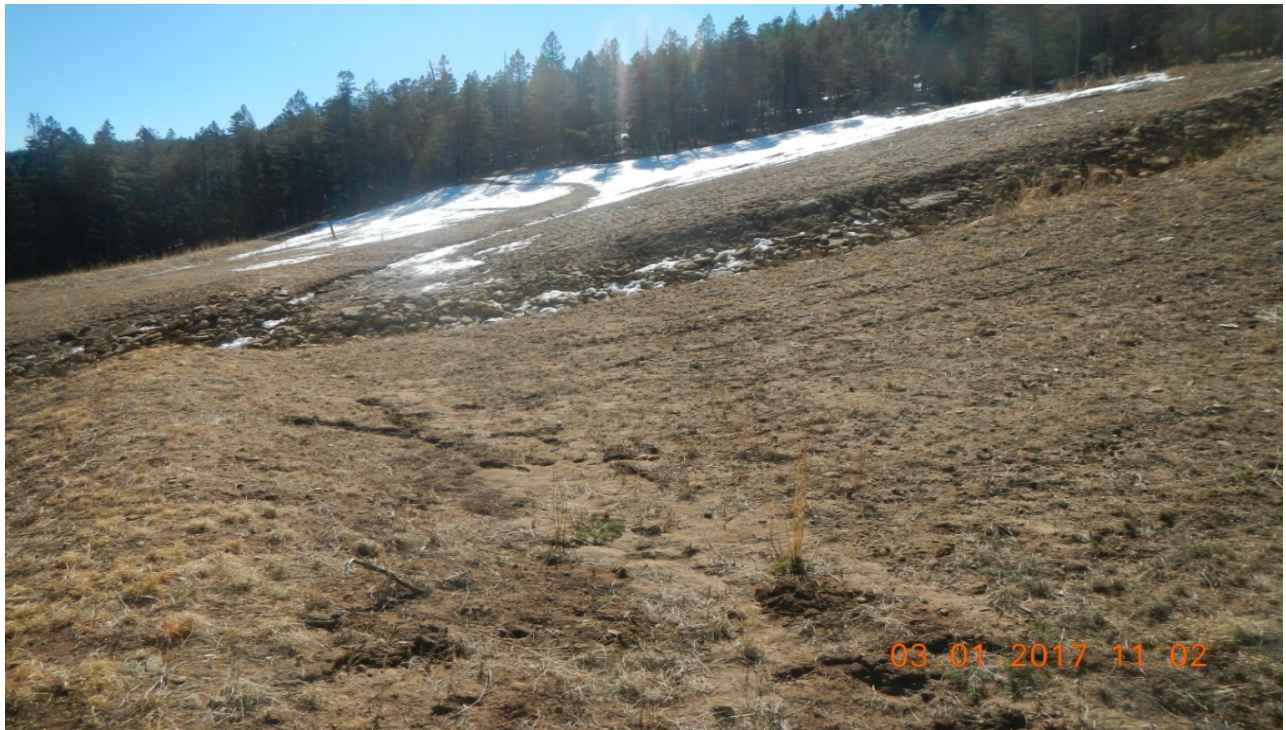
photo 9: Facing southeast toward the location.

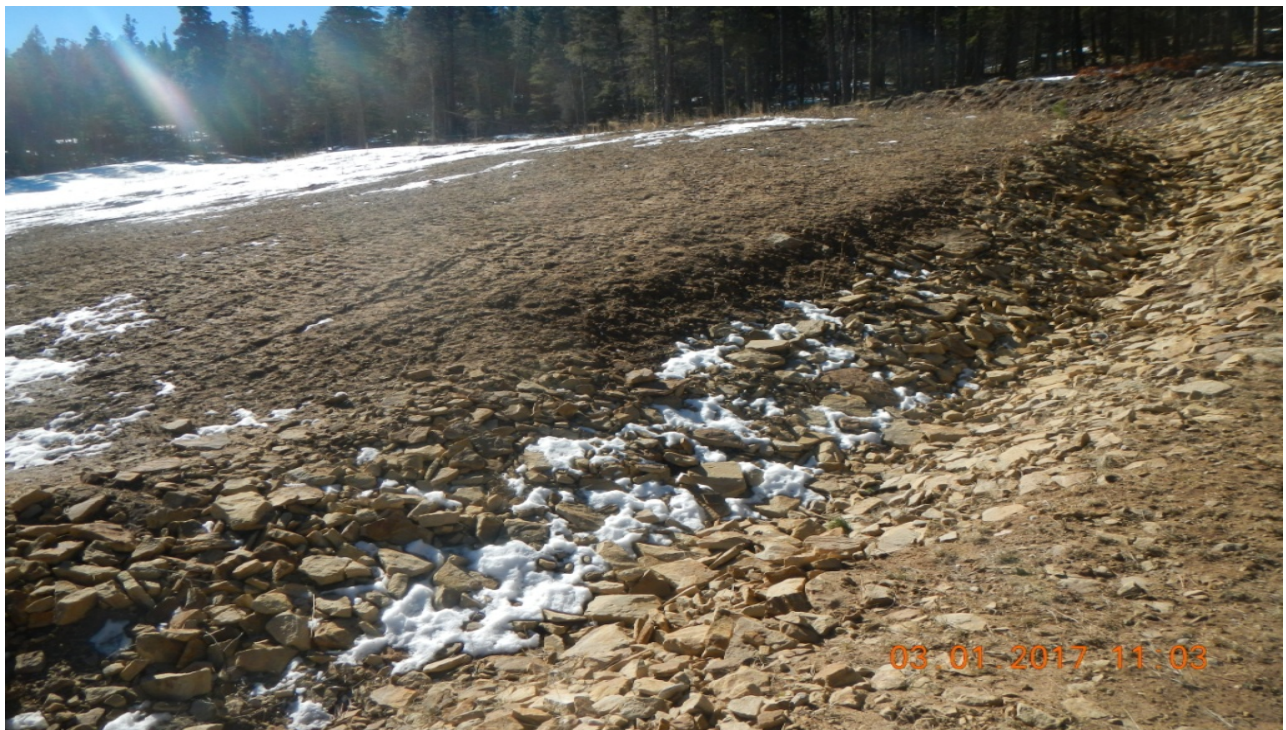
photo 10: Rock rip/rap placed along the diversion ditch.

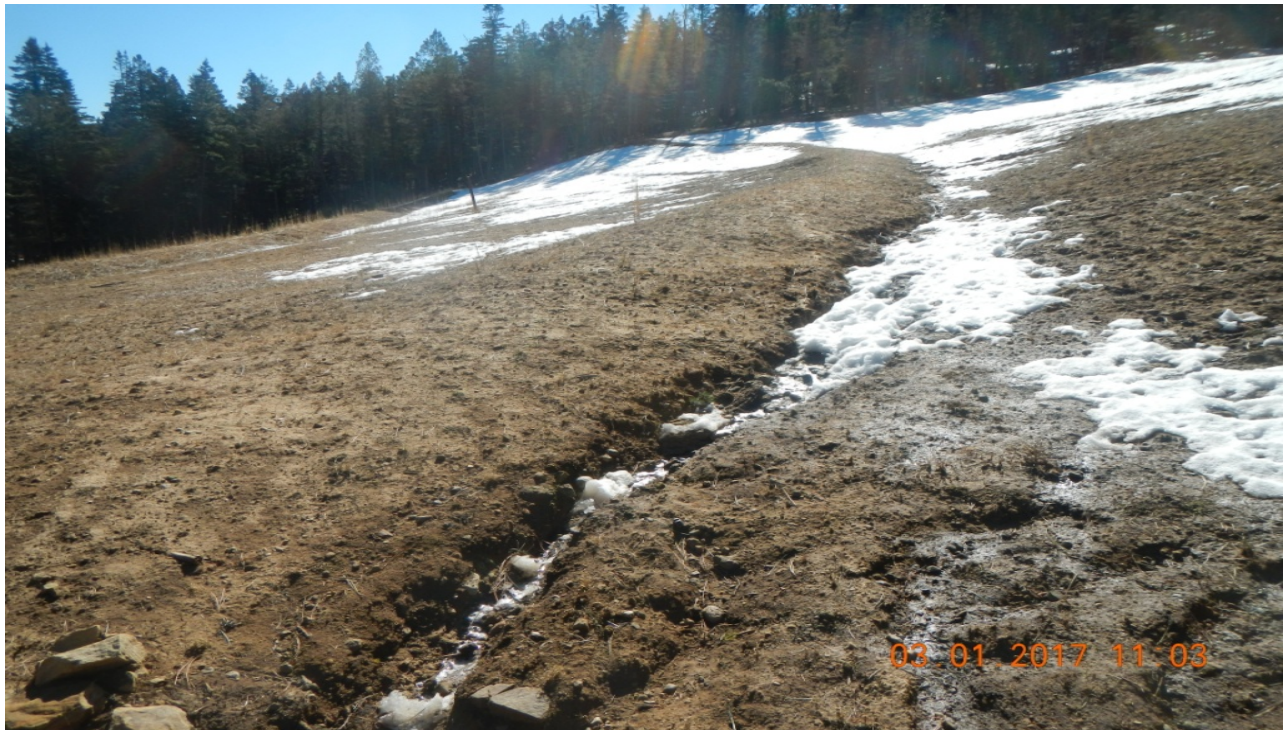
photo 11: A diversion ditch is installed along the contour of the slope.

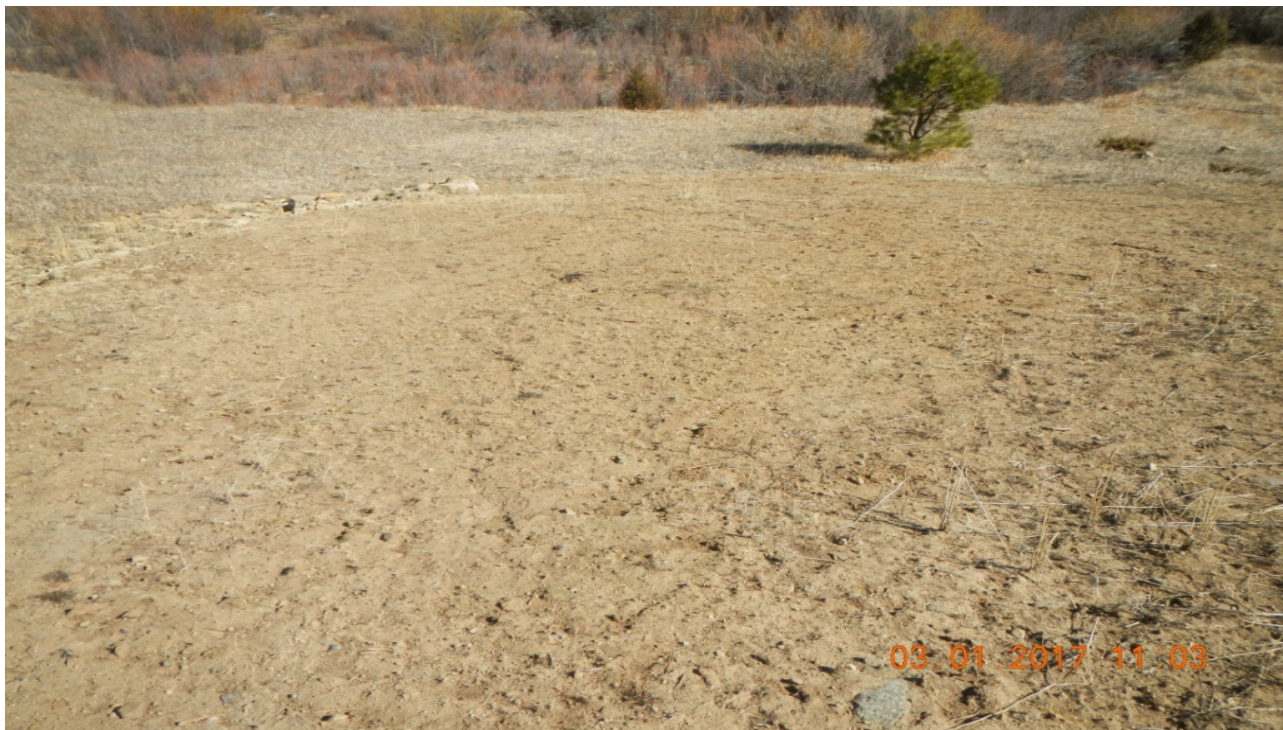
photo 12: Facing down along the northwest slope. The vegetation does not appear to be established.

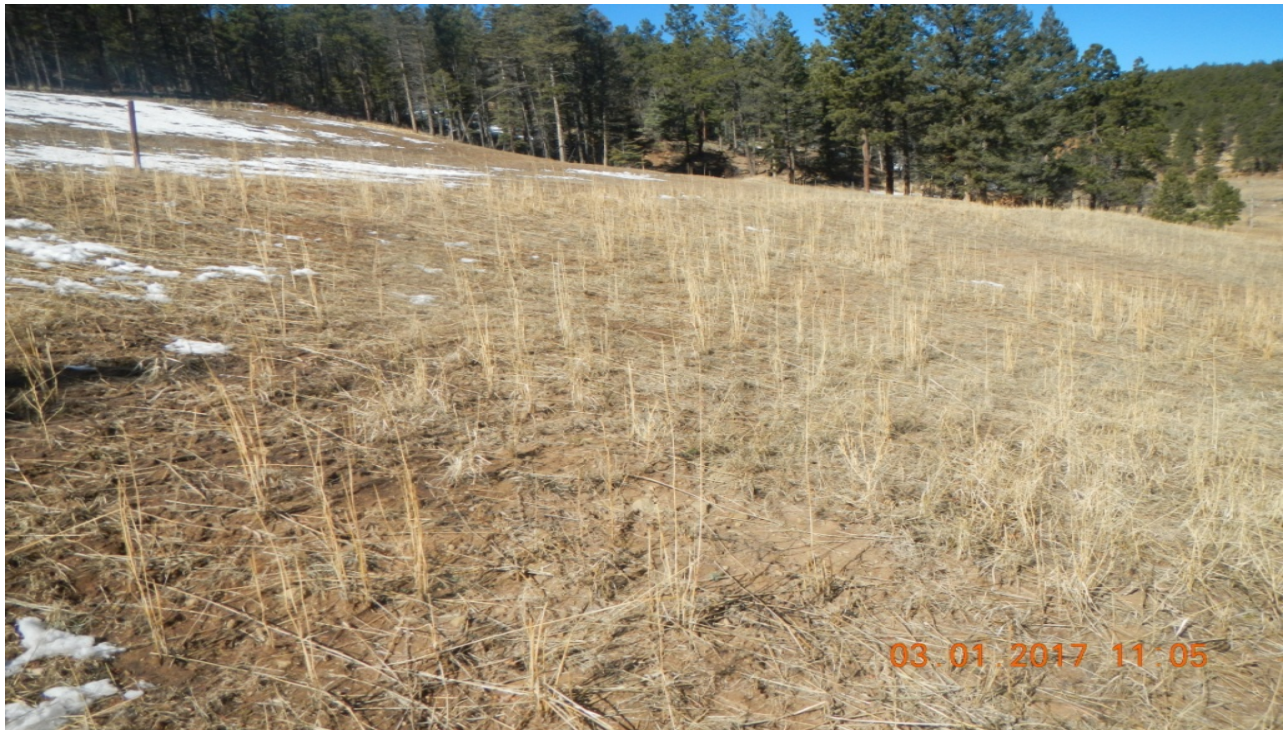
photo 13: East side of the location facing west.

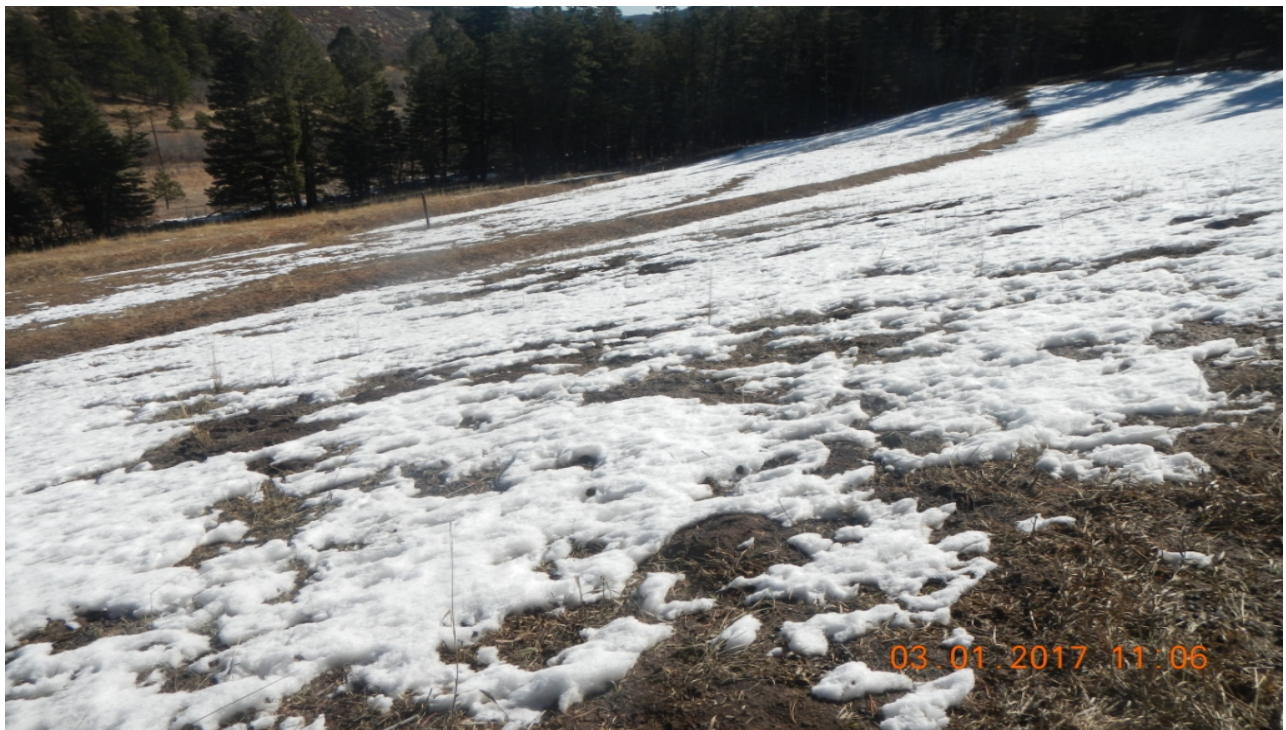
photo 14: Southwest side of the location facing northeast.
