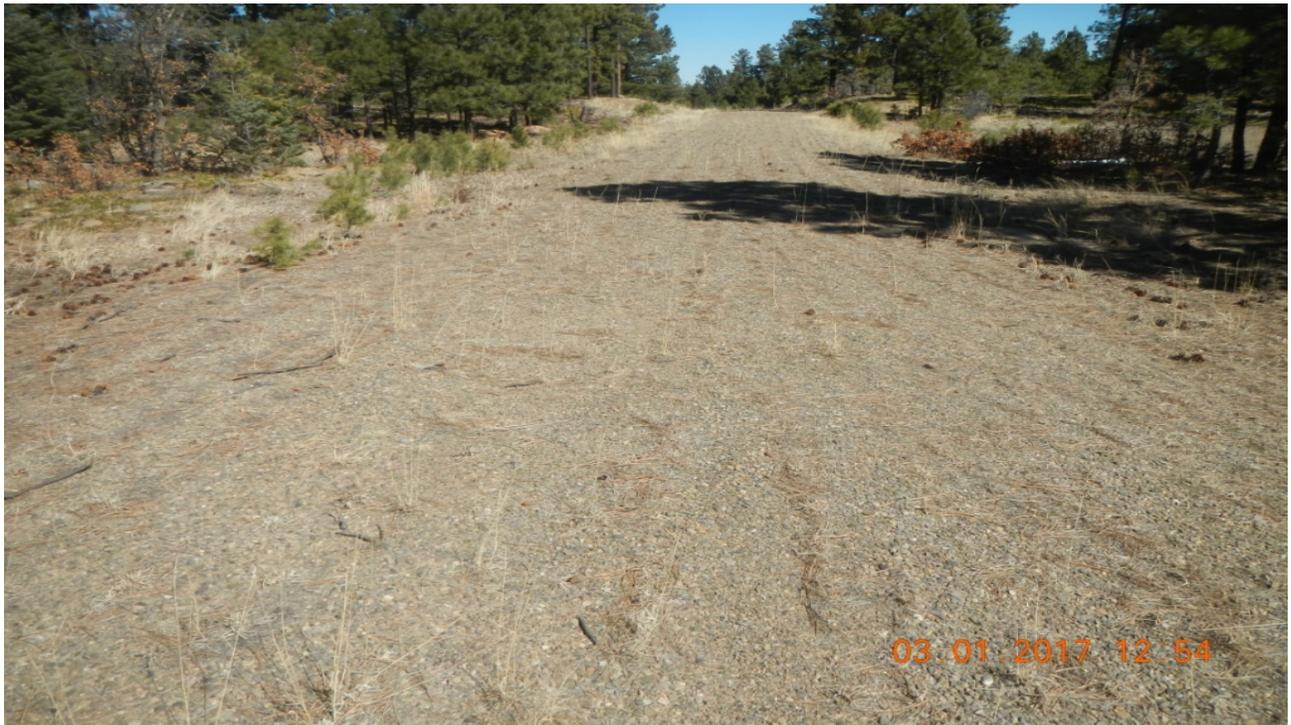
photo 1: Facing northeast along the access road.

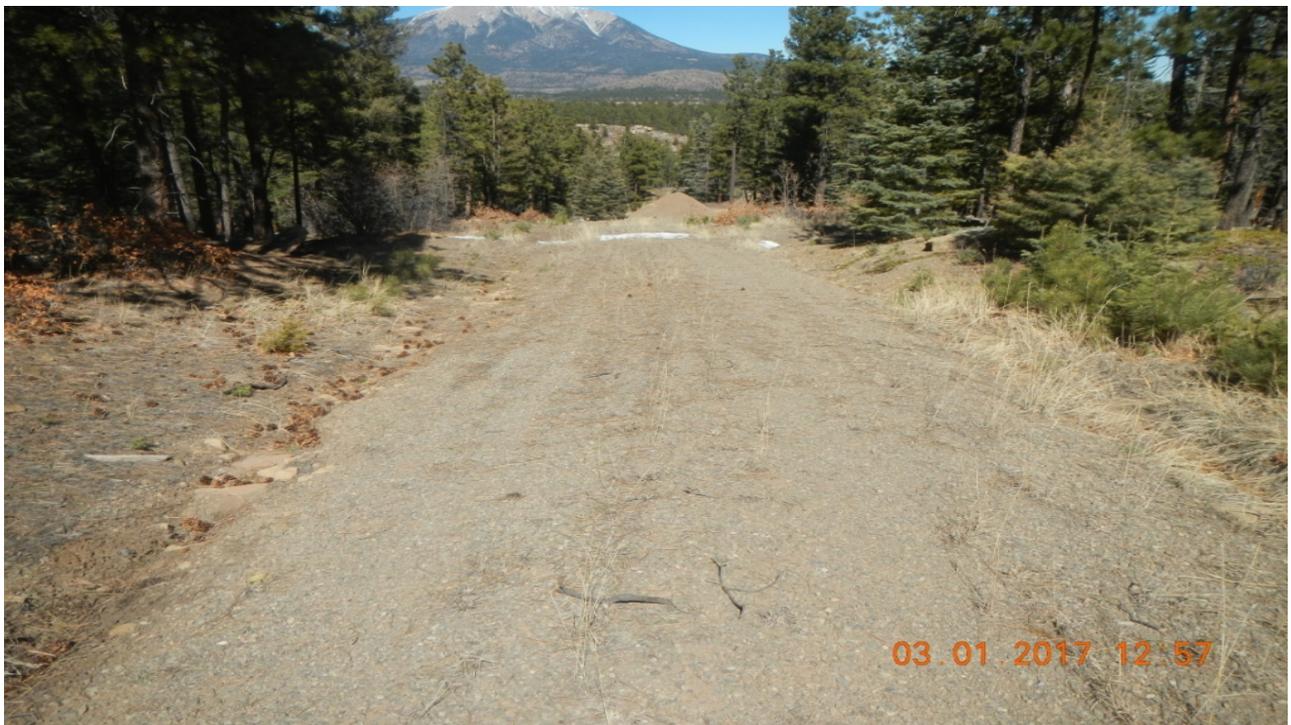
photo 2: Facing north along the access road.

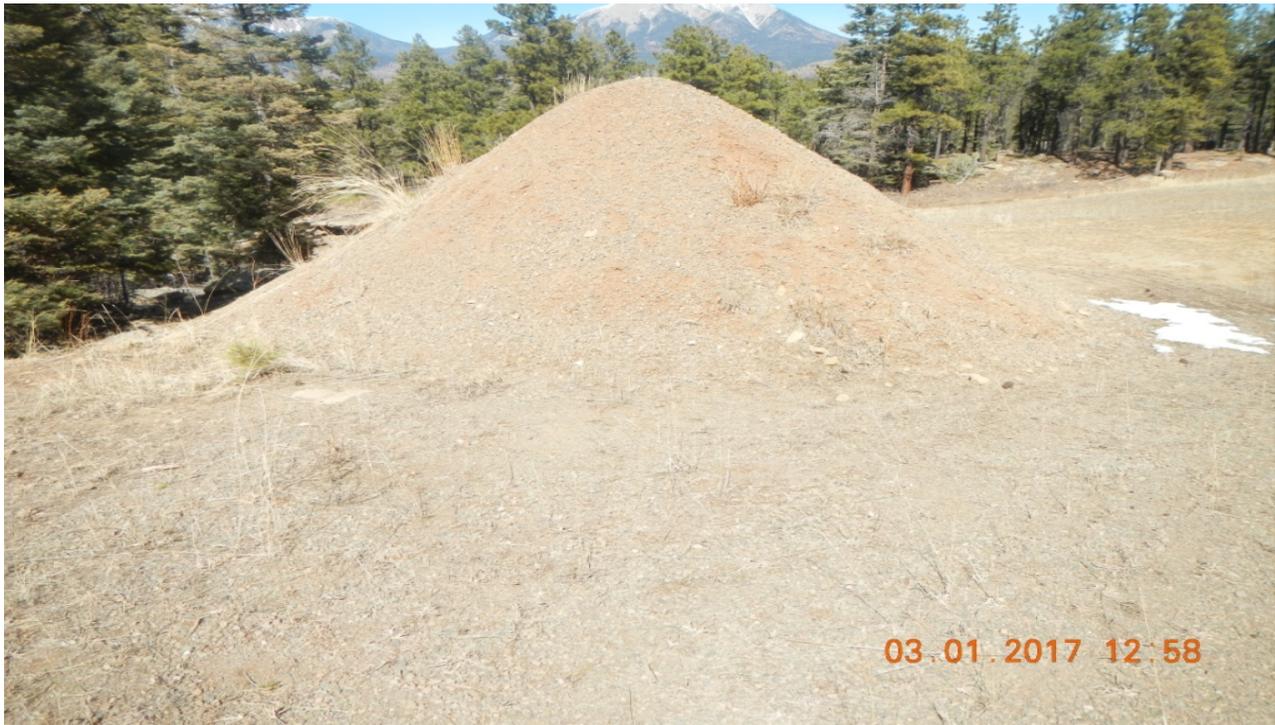
photo 3: A gravel pile remains at the end of the access road at the location.

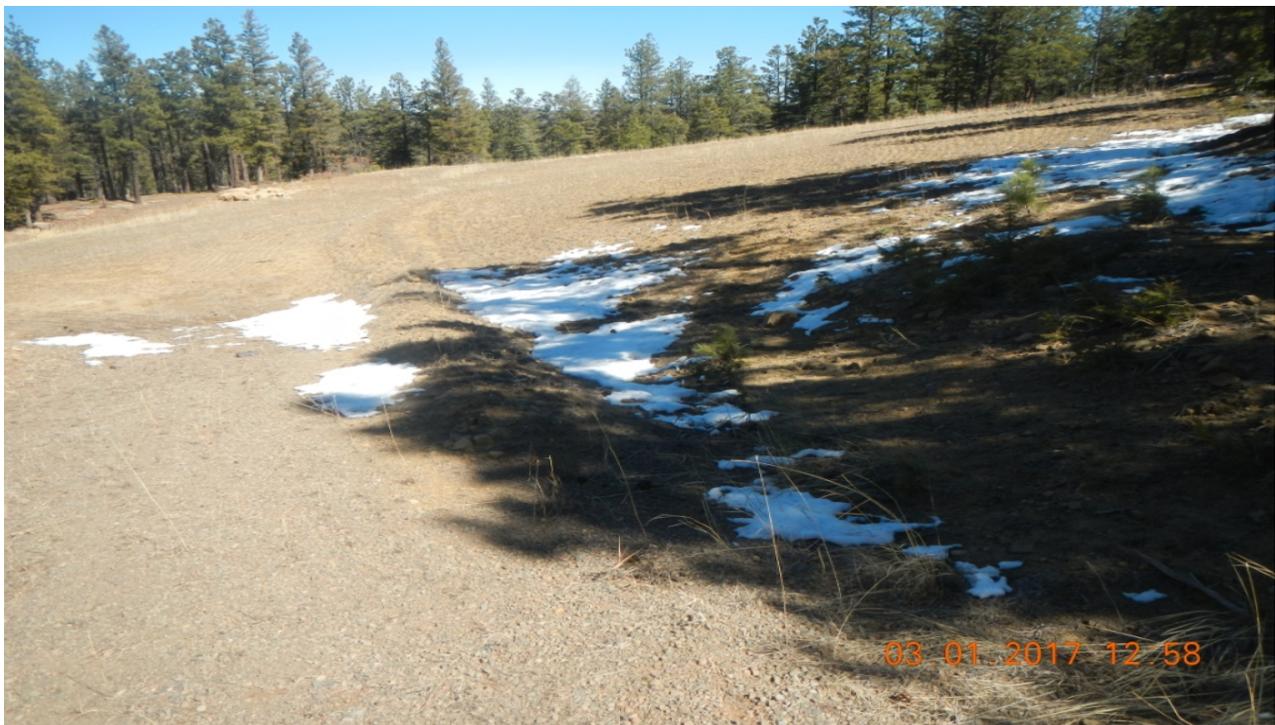
photo 4: Facing northeast toward the location.

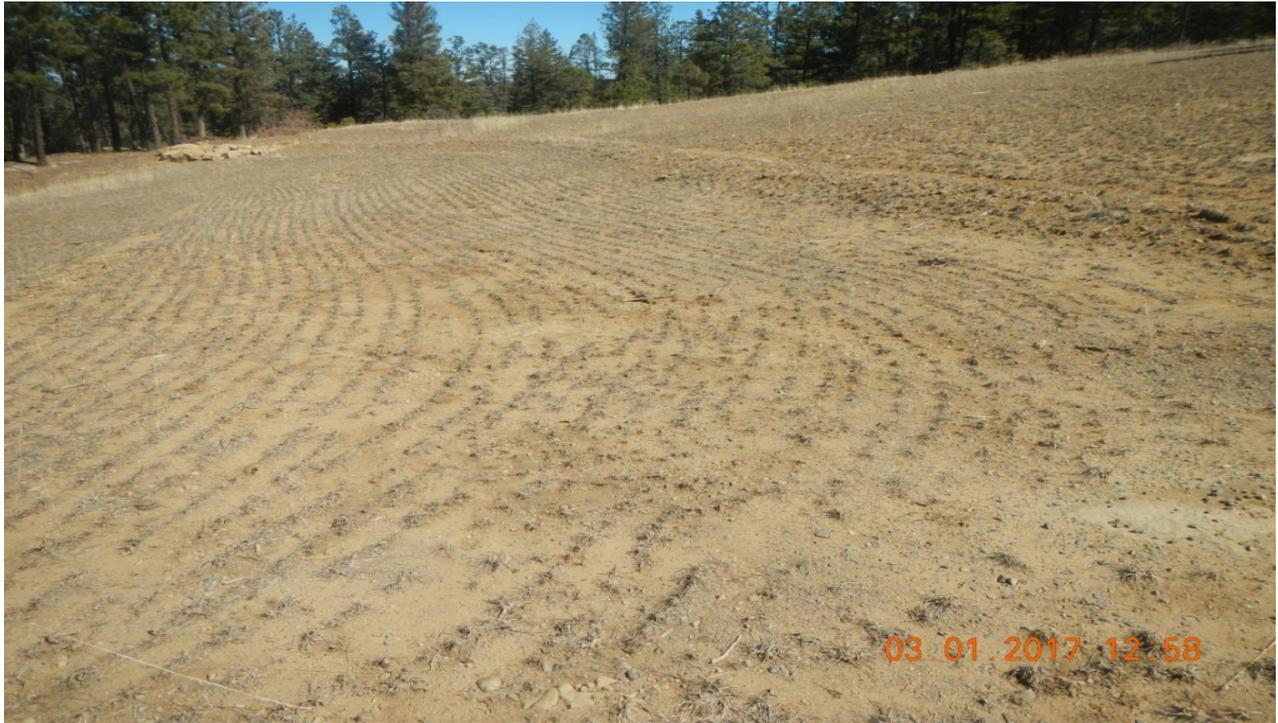
photo 5: Facing east toward the location. There are rows of vegetation establishing.

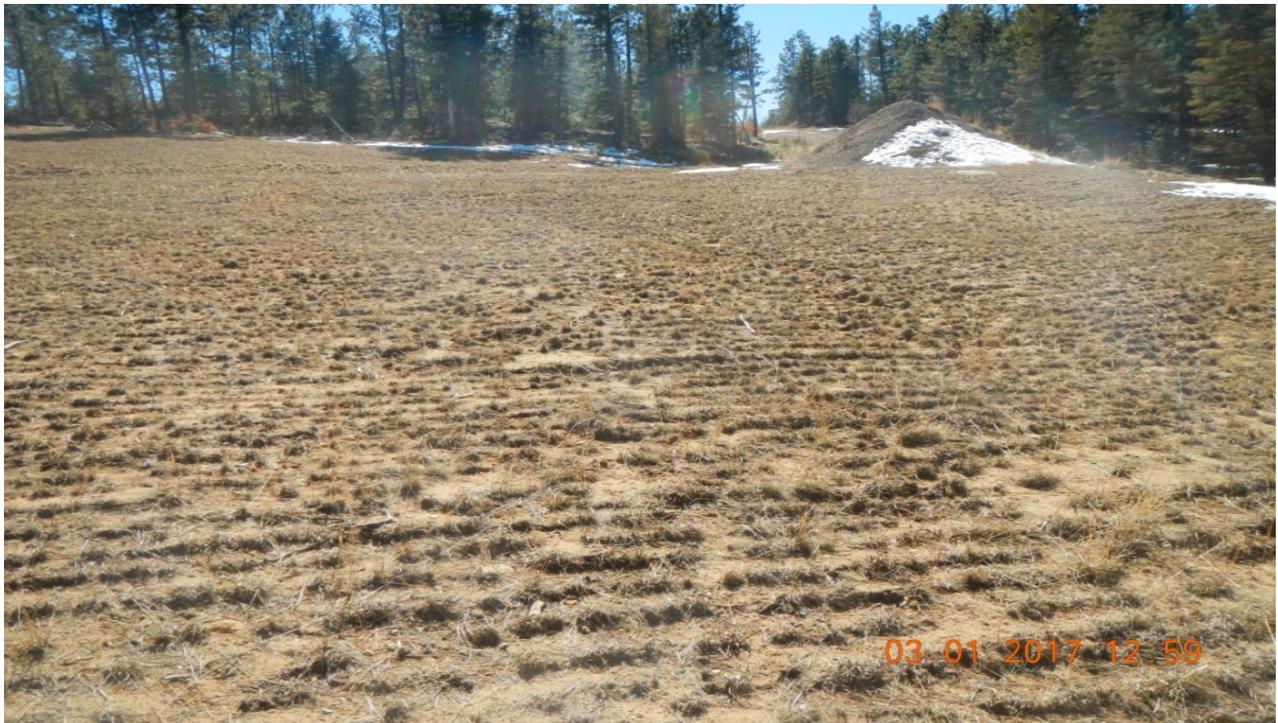
photo 6: North side of the location facing south.

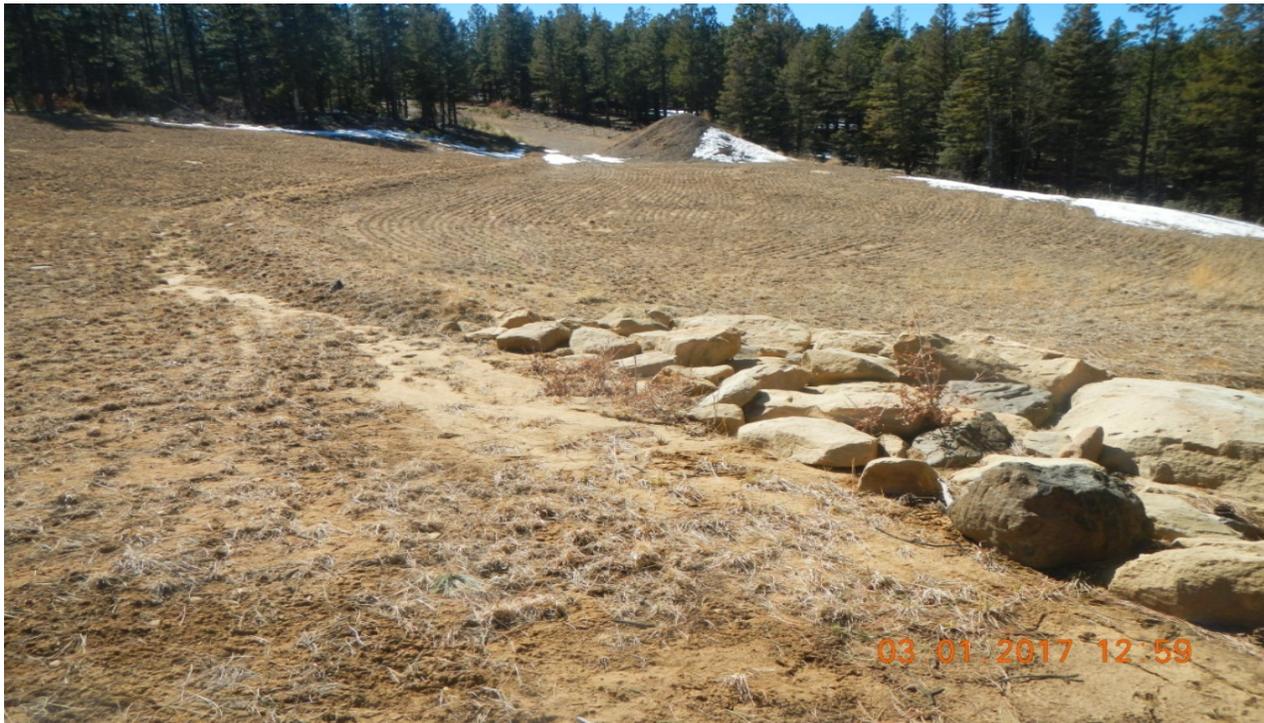
photo 9: Northeast side of the location facing southwest. Rock rip/rap is placed at the end of the diversion berm.

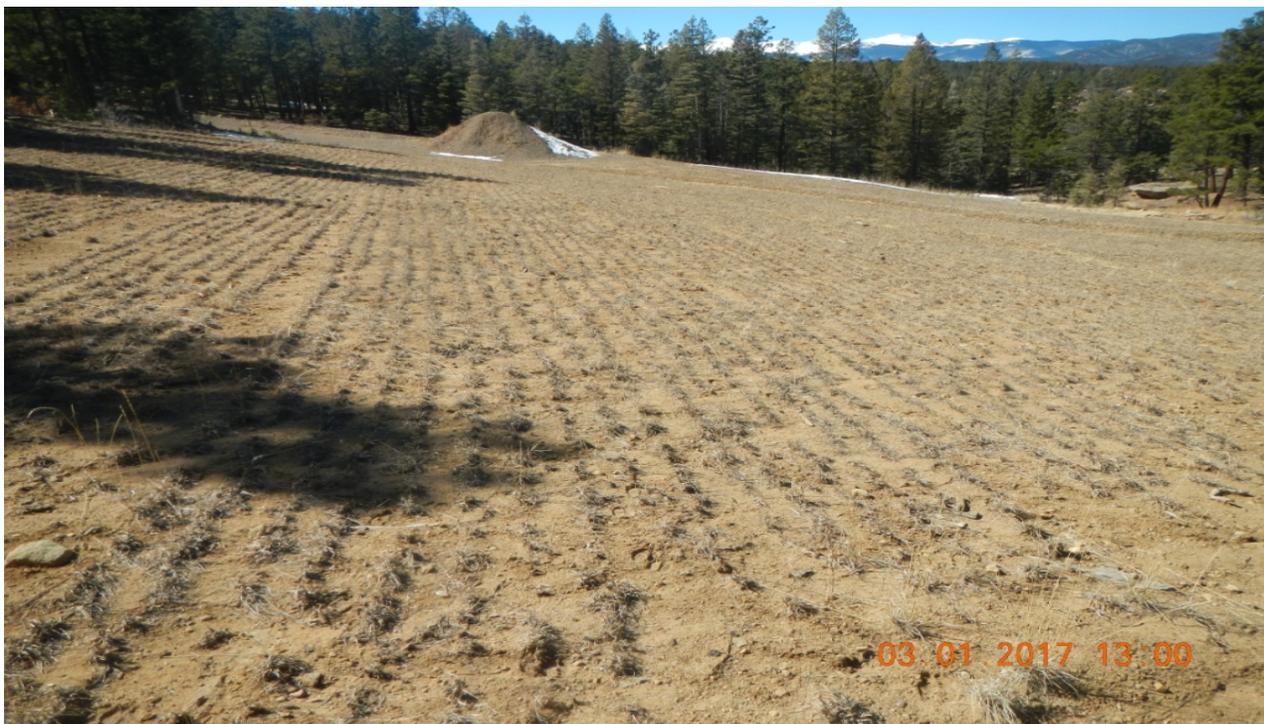
photo 10: East side of the location facing west.
