Construction and Stormwater Inspection

March 3, 2017

Operator: SYNERGY RESOURCES CORPORATION

Inspection Photos
Location Name: Hood-Doles /37-20
Location ID: 449336

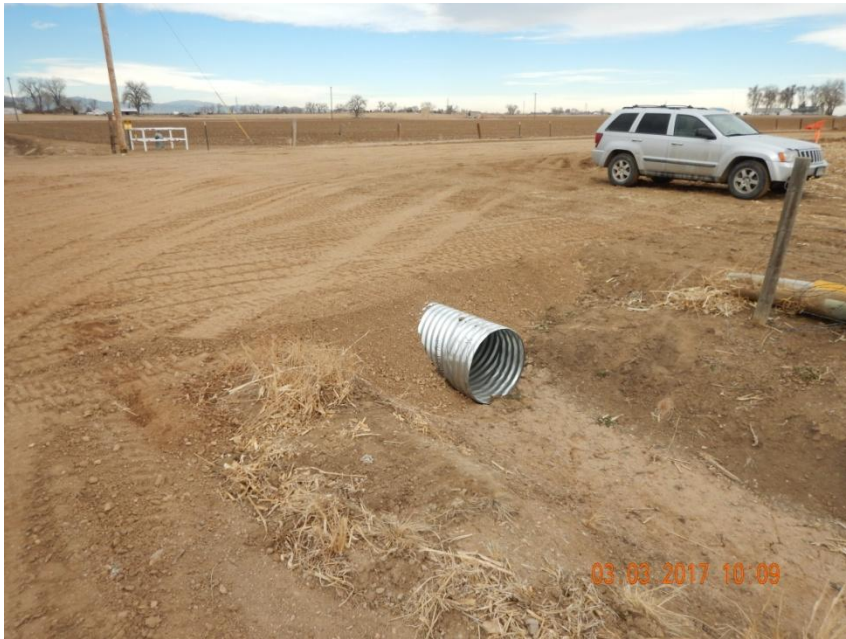
Photo 1. Photo taken from the entrance of location, facing Northwest. Culvert installed in conjunction with the existing roadside ditch.

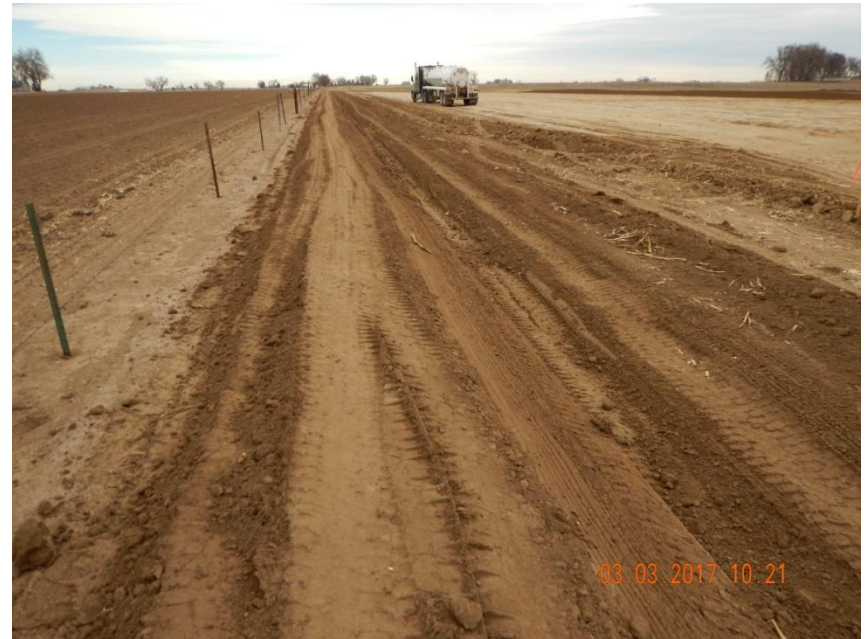
Photo 2. Photo taken from the western location, facing North. Ditch and berm BMP installed around perimeter of location.

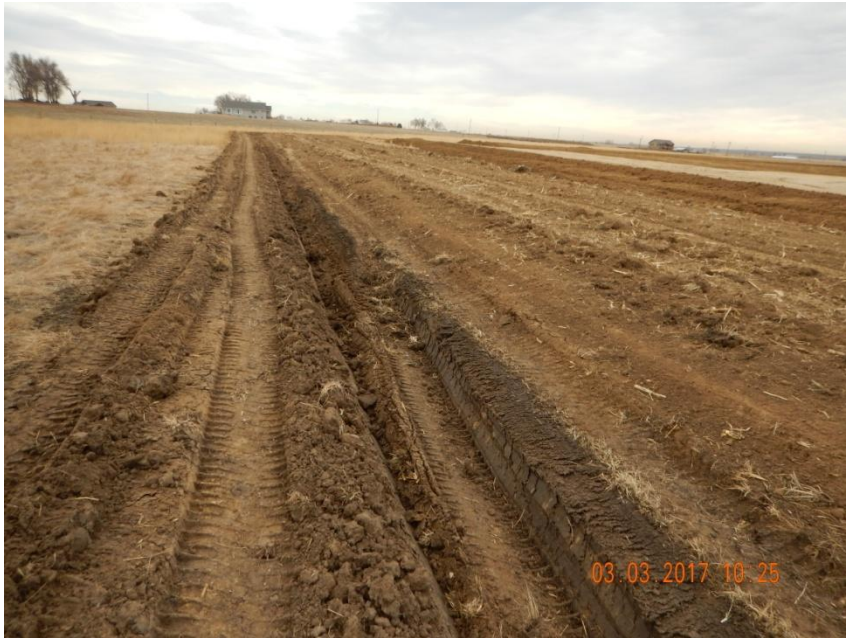
Photo 3. Photo taken from the northern location, facing East. Ditch and berm BMP installed around perimeter of location. Ensure berm BMPs are consistently compacted throughout location.

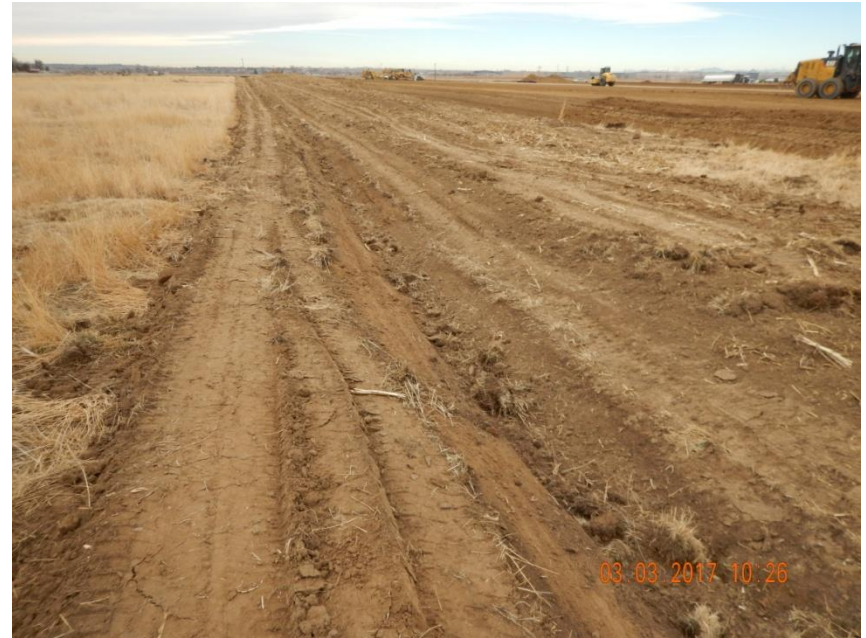
Photo 4. Photo taken from the eastern location, facing South. Ditch and berm BMP installed around perimeter of location.

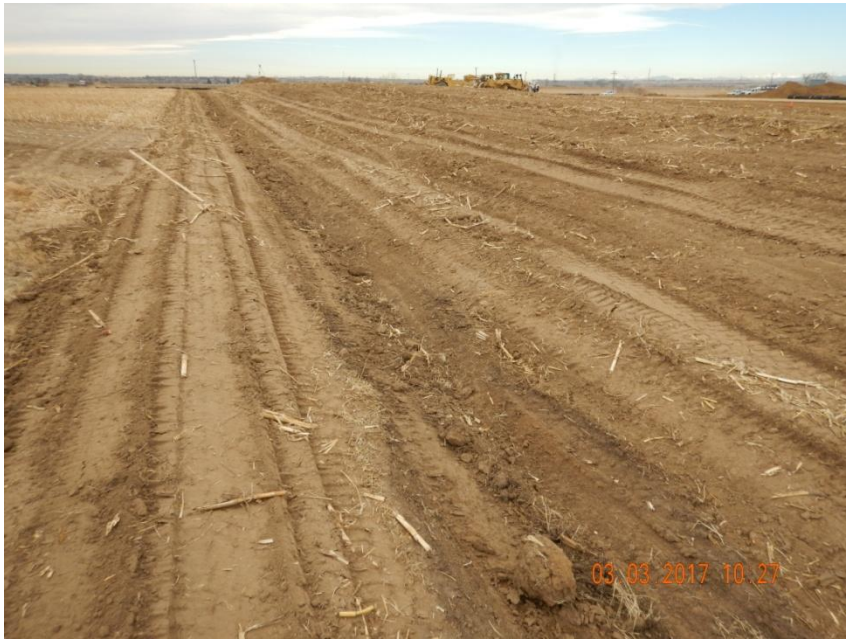
Photo 5. Photo taken from the eastern location, facing South. Ditch and berm BMP installed around perimeter of location. Also, topsoil stockpile stored along eastern perimeter of location.

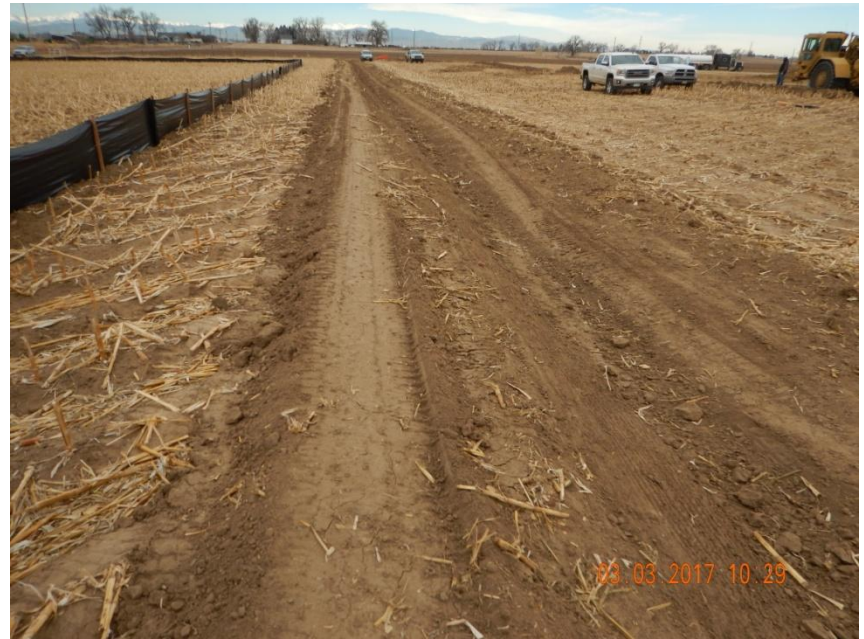
Photo 6. Photo taken from the southern location, facing West. Ditch and berm BMP installed around perimeter of location. Location with silt fence to the south is not part of this location or Operator.
