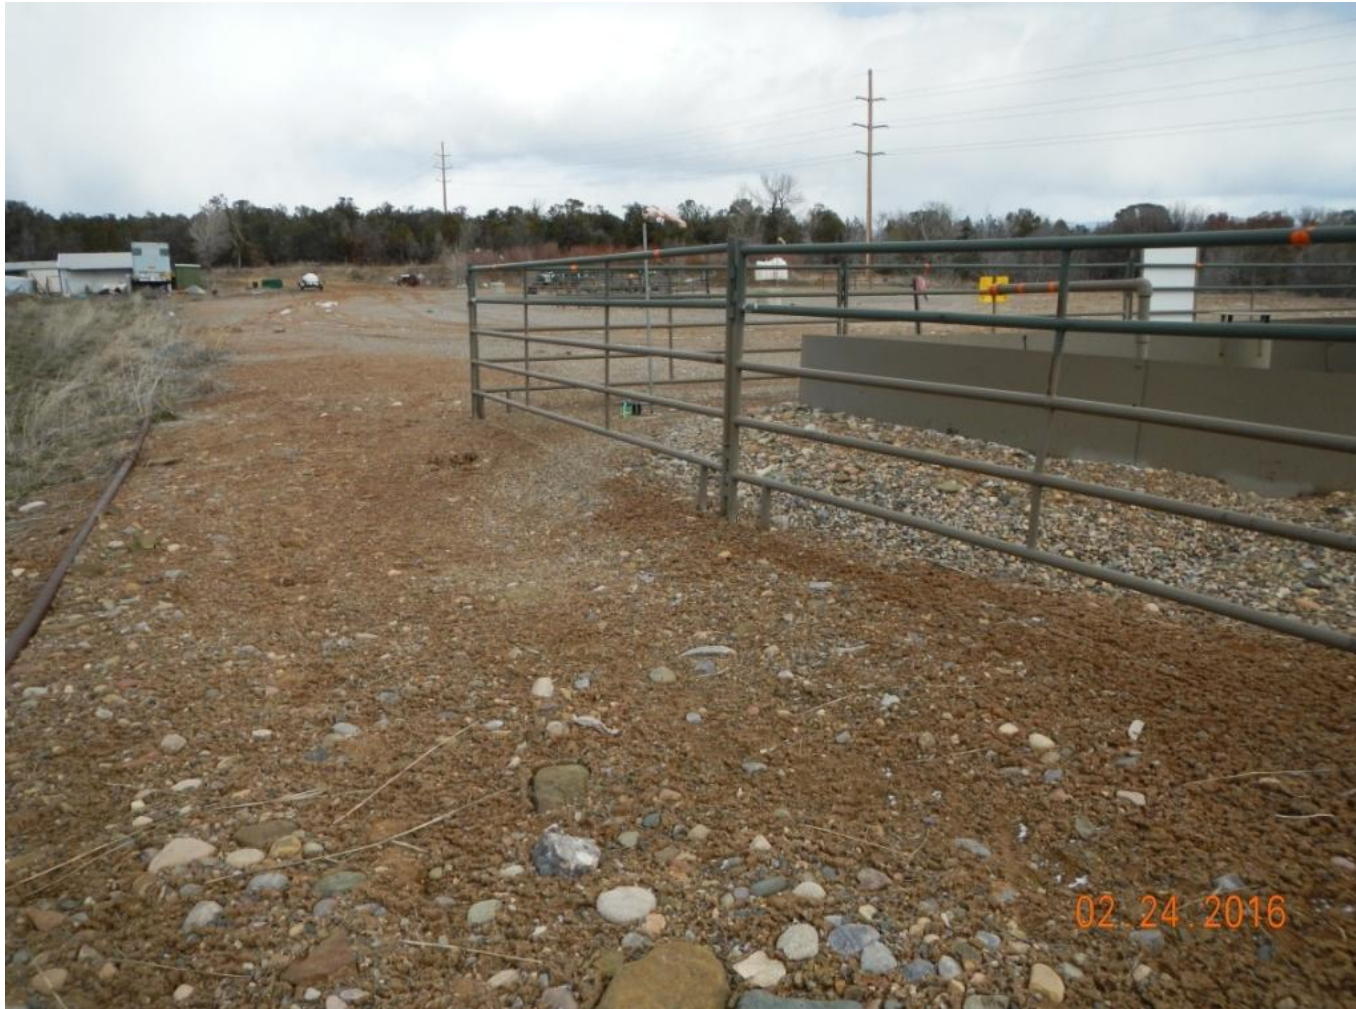
Photo 1: View of the project area from the southwestern corner facing center.

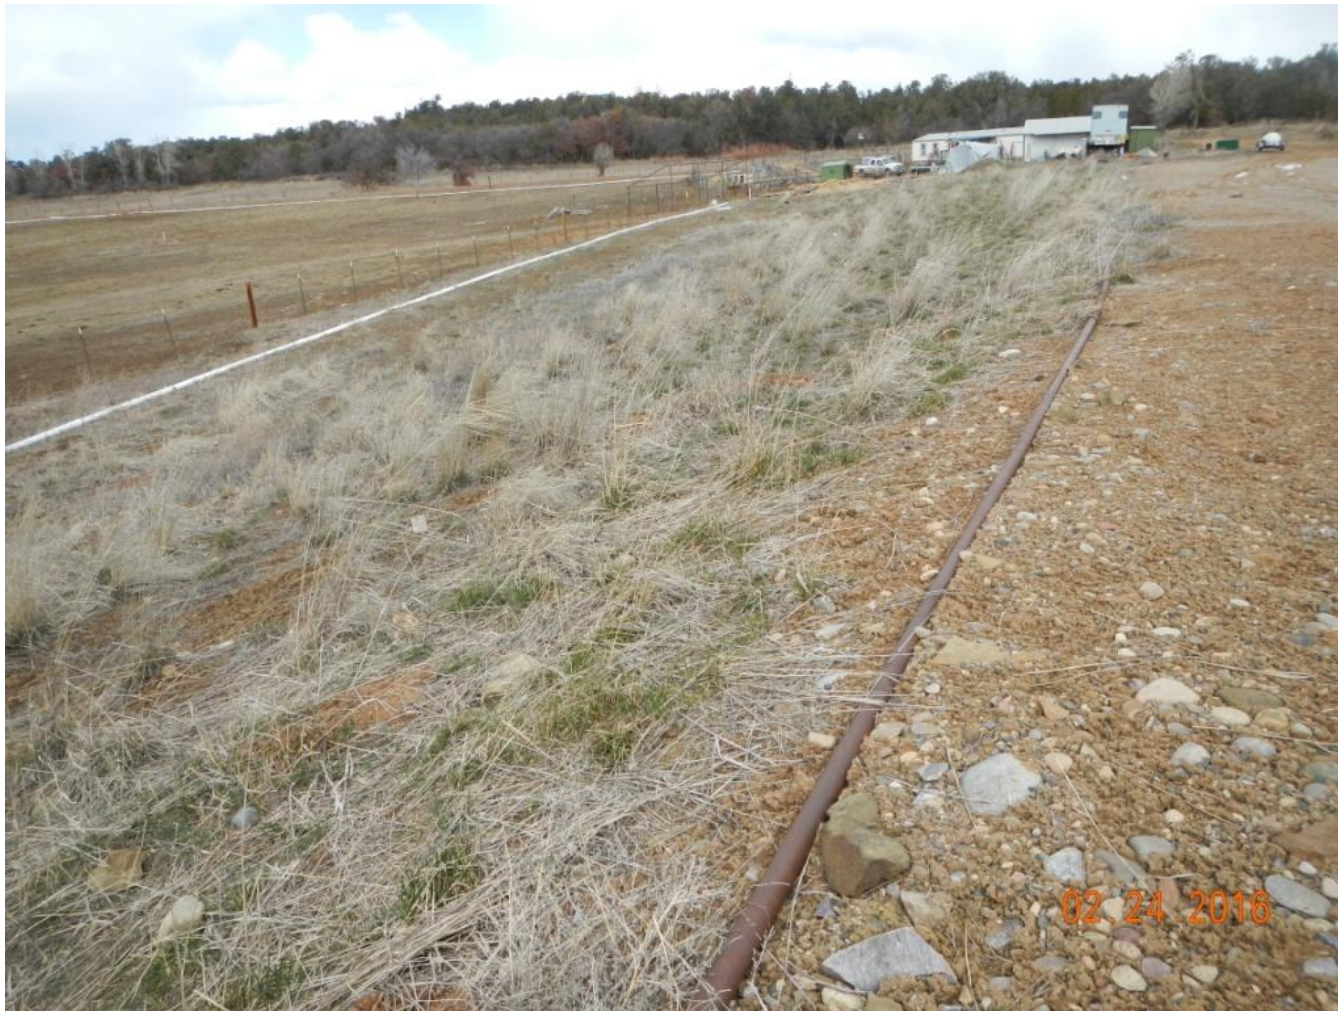
Photo 2: View of the western portion of the project area from the southwestern corner facing northward. Revegetation is progressing with western wheatgrass (*Pascopyrum smithii*) and intermediate wheatgrass (*Thinorpyum intermedium*). What appears to be surface owner equipment stored in the northwestern portion of the project area.

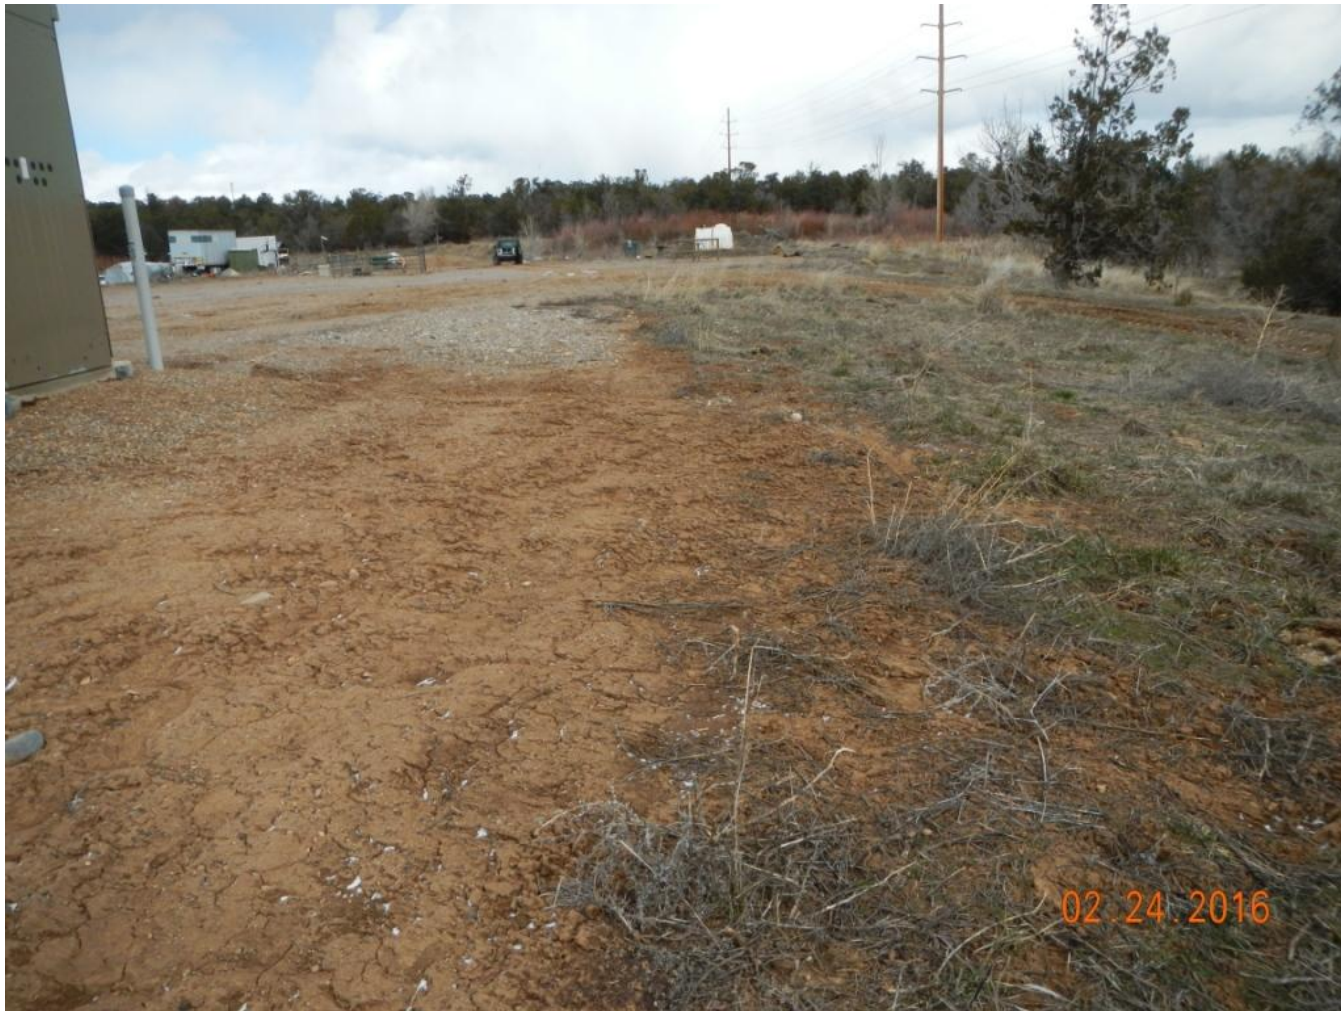
Photo 3: View of the eastern portion of the project area from the southeastern corner facing northward.

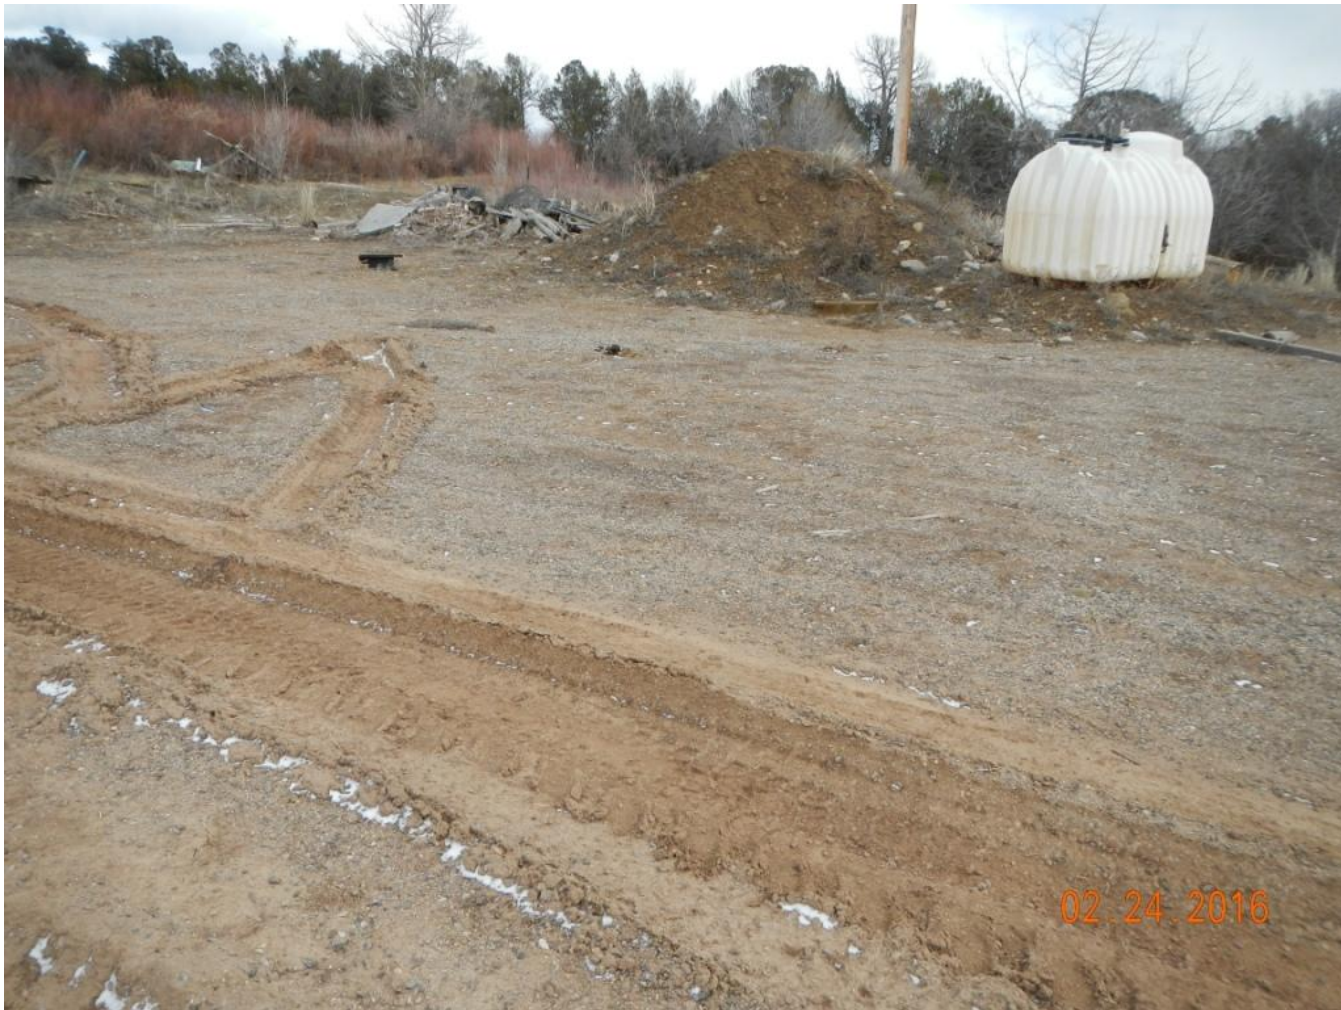
Photo 4: View of debris and stored materials in the northeastern portion of the project area.

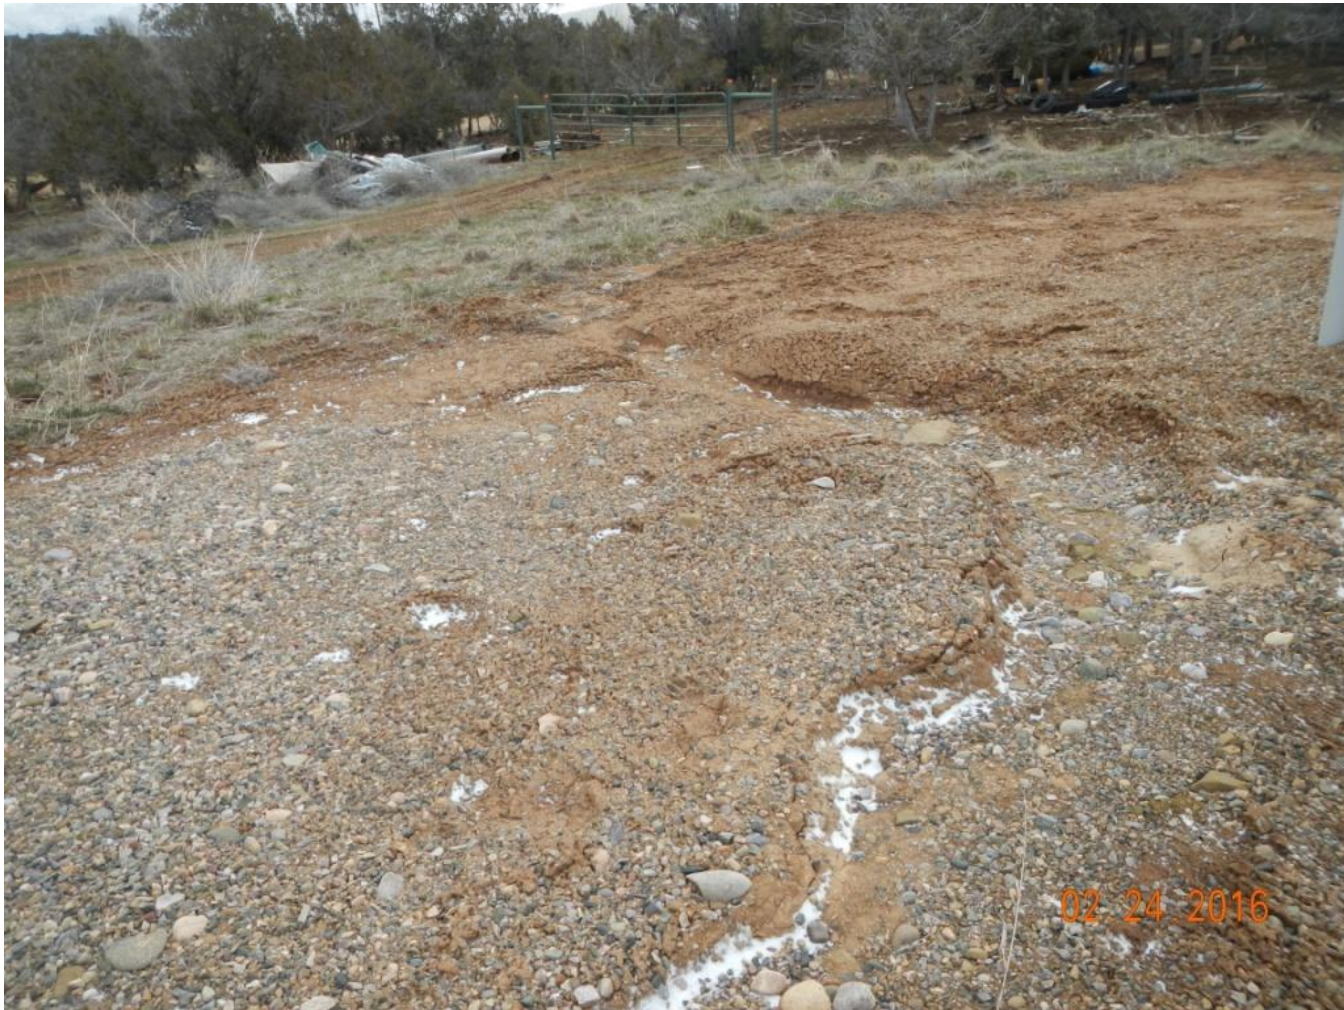
Photo 4: View of erosional channel in the northeastern portion of the project area that needs stabilization.
