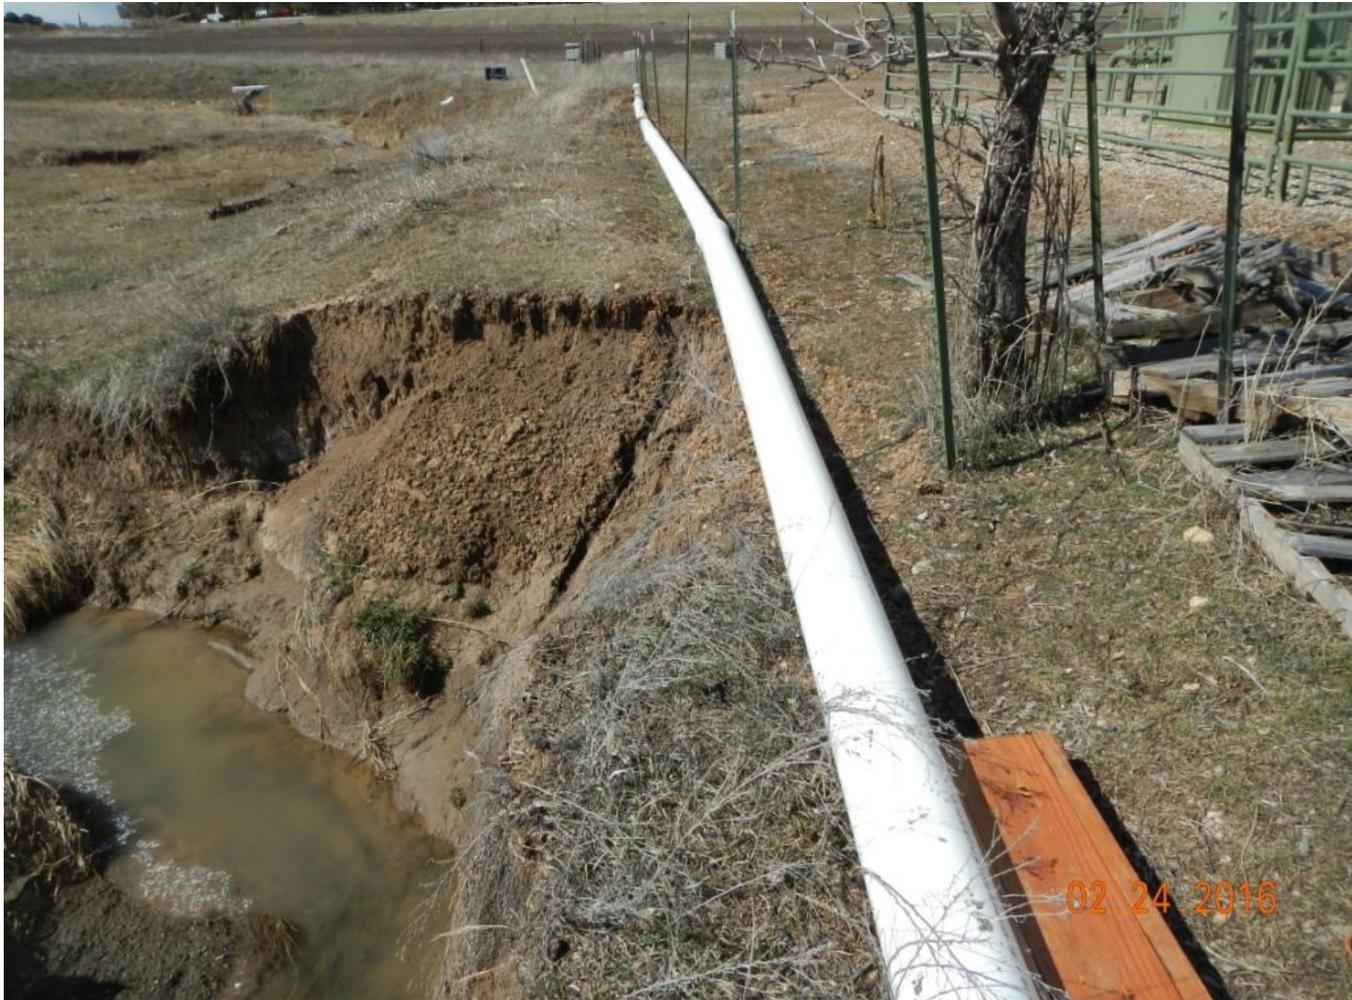
Photo 4: View of the southern edge of the well pad that is adjacent to an erosional cut-bank.

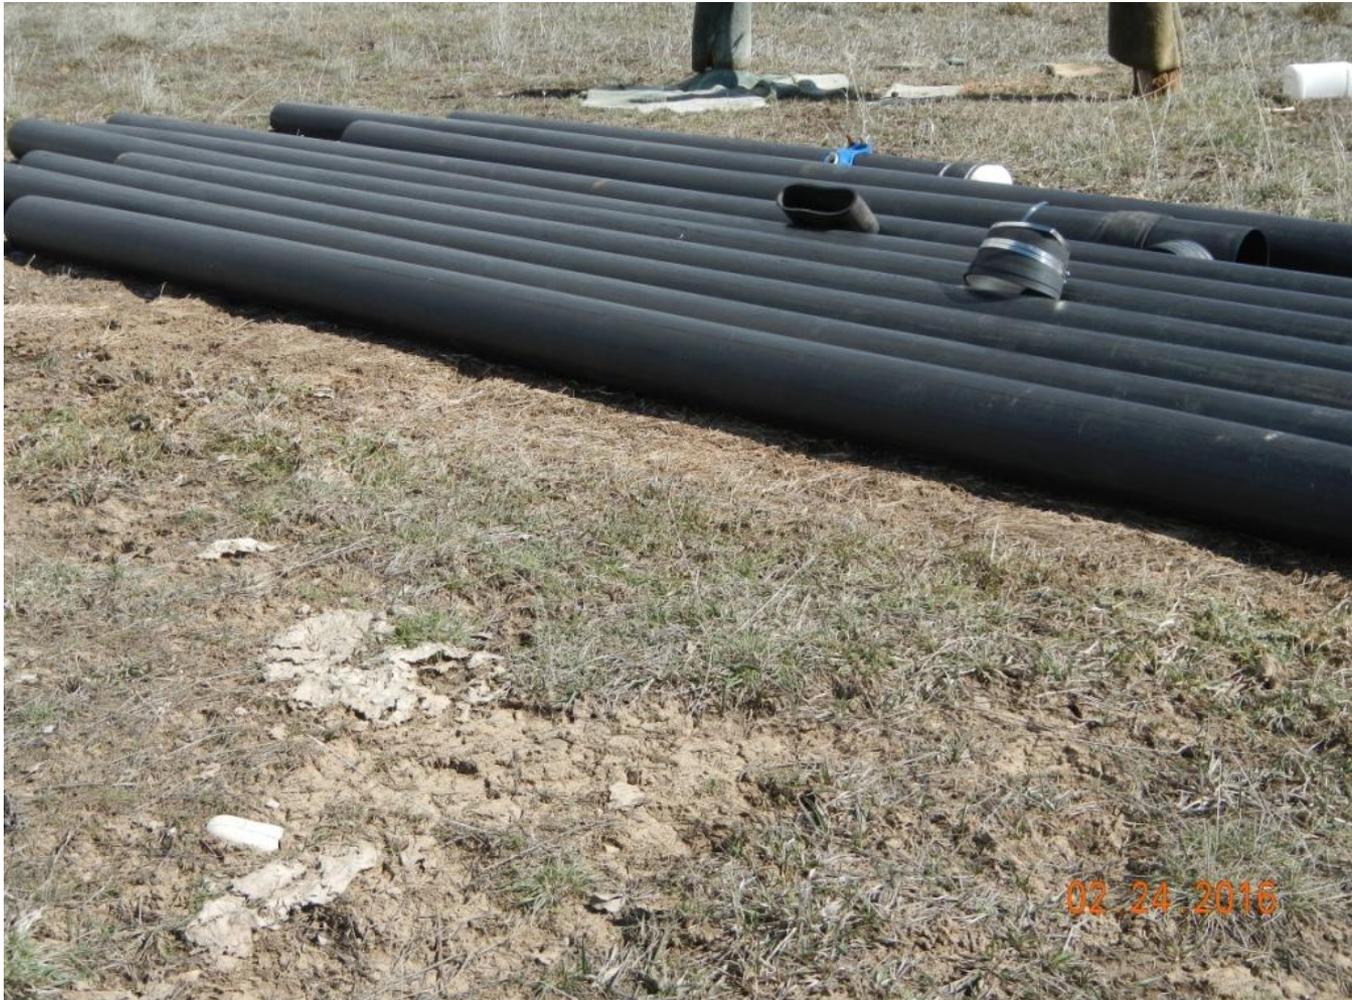
Photo 5: View of pipe in the eastern portion of the project area.

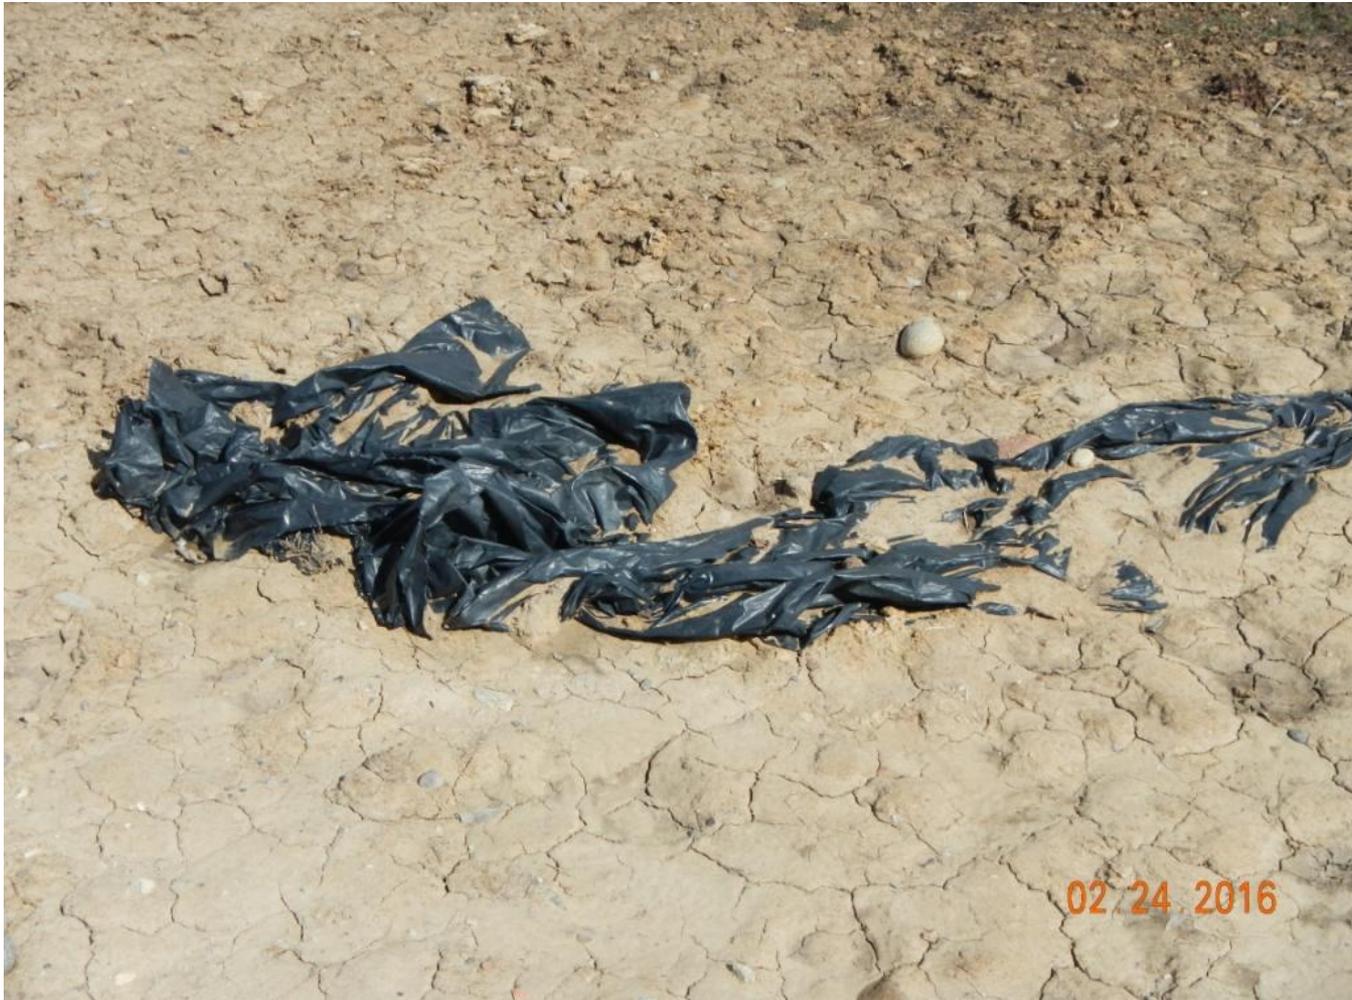
Photo 6: View of junk in the eastern portion of the project area.

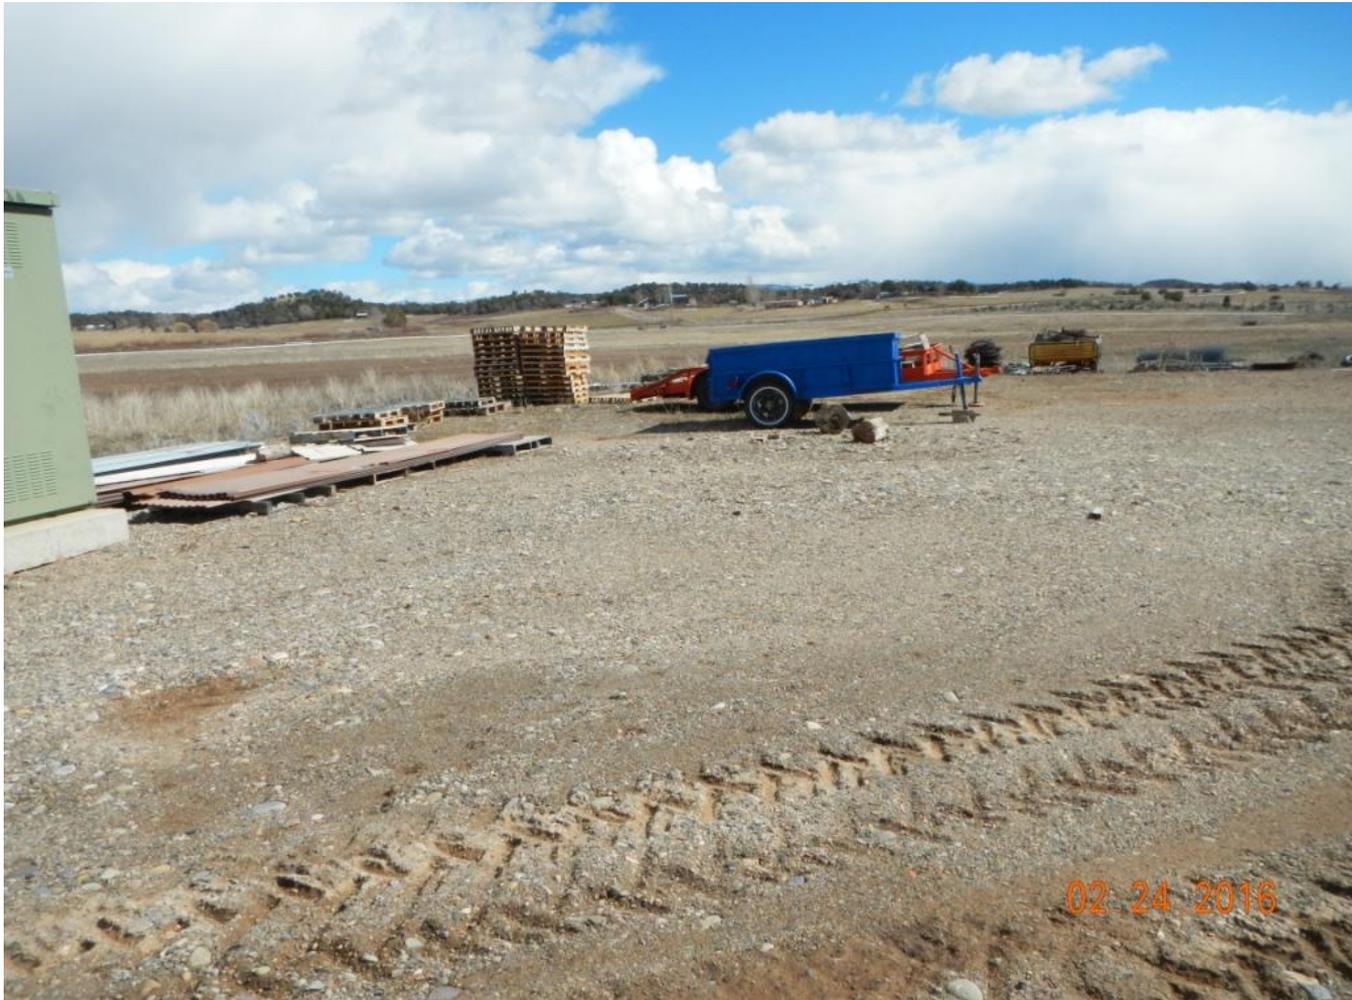
Photo 7: View of what appears to be surface owner debris in the northeastern portion of the project area.
