Reclamation and Stormwater Inspection

March 14, 2017

Operator: CRESTONE PEAK RESOURCES
OPERATING LLC

Location ID: 434248

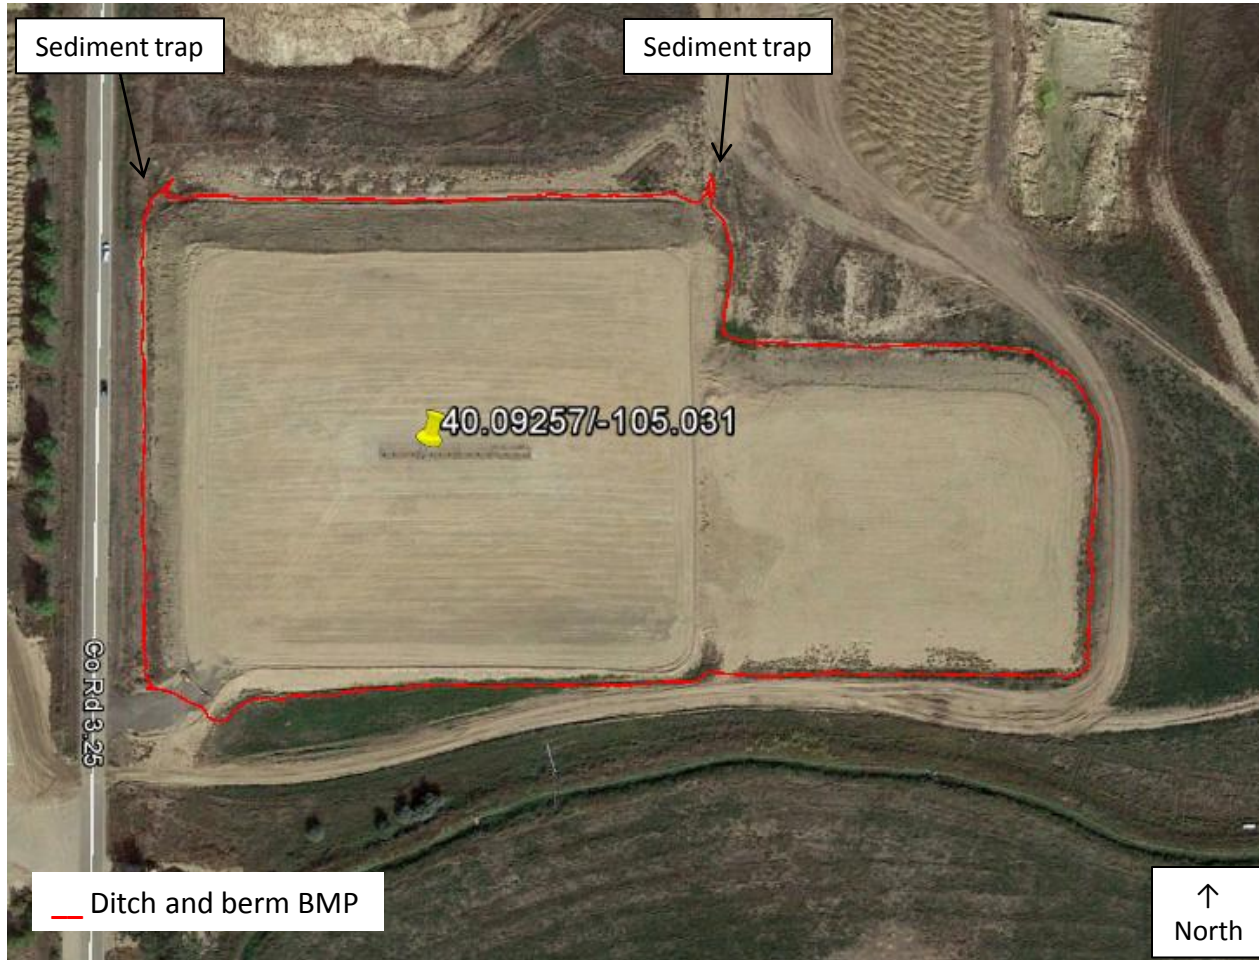
Google Earth aerial imagery taken October 9, 2015, and overlaid with field collected data on March 14, 2017 using a Trimble handheld GPS. Total construction disturbance of 10.49 acres was collected using the Trimble handheld GPS.

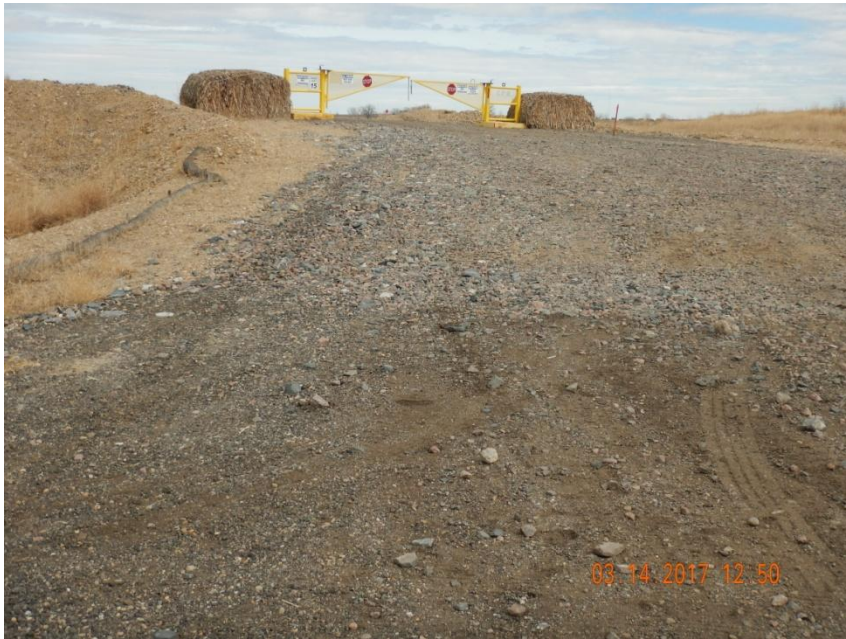
Photo 1. Photo taken from the entrance of location, facing East. Vehicle tracking pad installed.

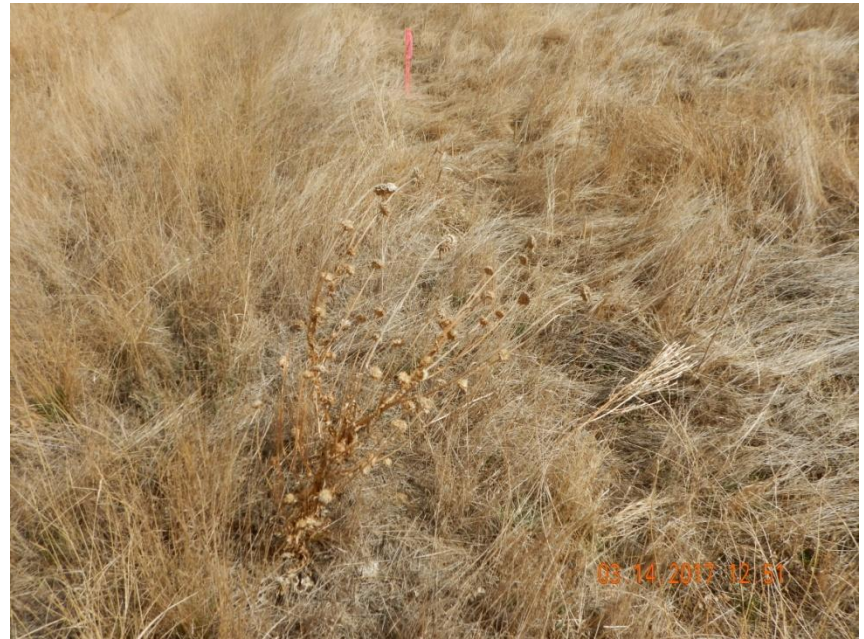
Photo 2. Photo taken from the southwest location, facing East. Vegetative growth makes it difficult to observe but a ditch and berm BMP has been installed around the perimeter of the location.

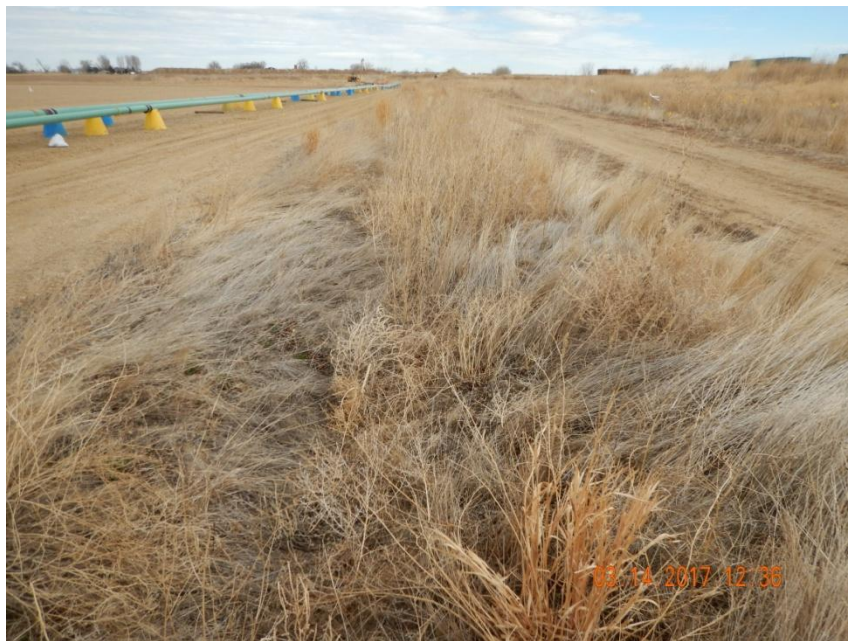
Photo 3. Photo taken from the southern location, facing East. Vegetative growth makes it difficult to observe but a ditch and berm BMP has been installed around the perimeter of the location. Pipeline construction was observed along the eastern, south location area.

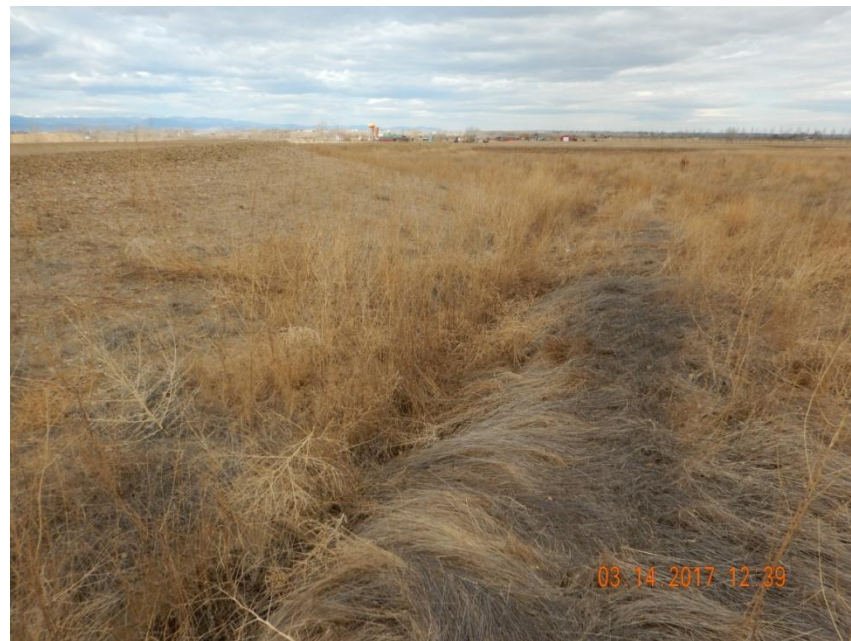
Photo 4. Photo taken from the southeastern location, facing North. Vegetative growth makes it difficult to observe but a ditch and berm BMP has been installed around the perimeter of the location.

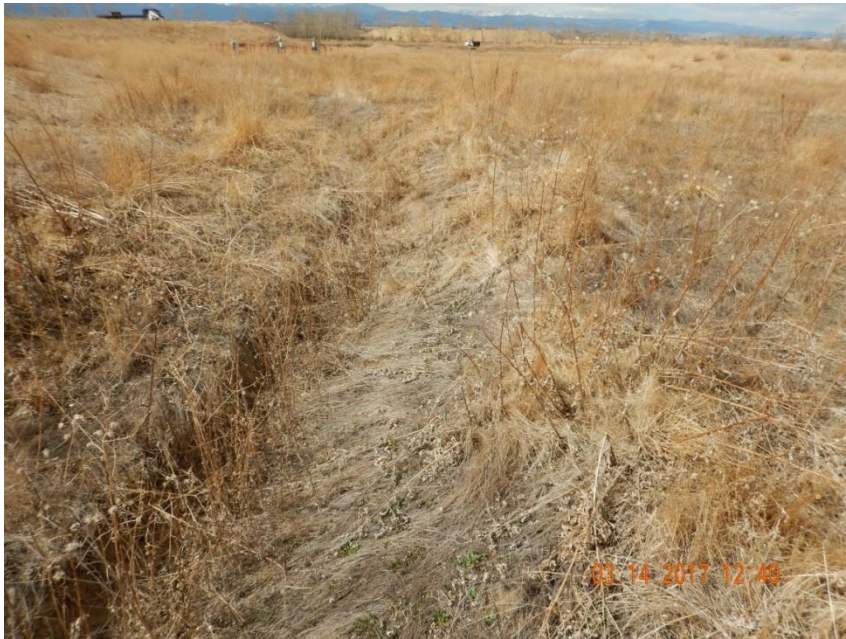
Photo 5. Photo taken from the northeast location, facing West. Vegetative growth makes it difficult to observe but a ditch and berm BMP has been installed around the perimeter of the location. Canada thistle vegetative growth from last year was observed. Rosettes are starting to grow for this year.

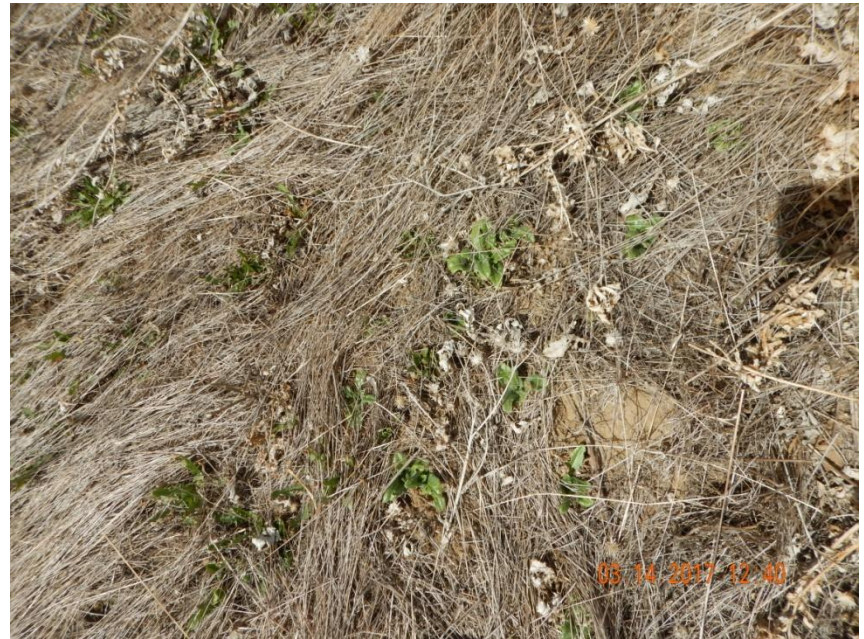
Photo 6. Photo taken from the previous photo illustrating Canada thistle rosettes.

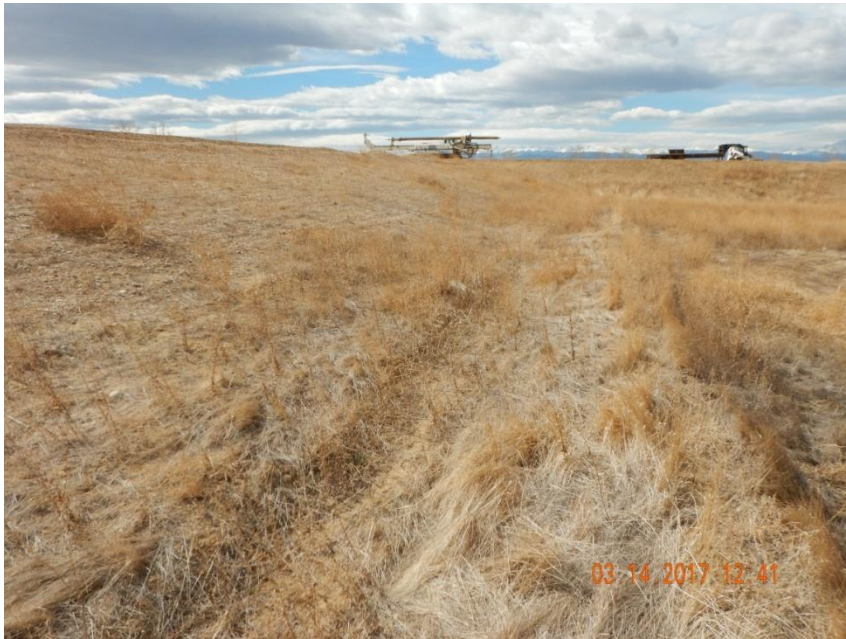
Photo 7. Photo taken from the northeastern location, facing West. Vegetative growth makes it difficult to observe but a ditch and berm BMP has been installed around the perimeter of the location. Fill slope appears to be stabilized along this portion of the location.

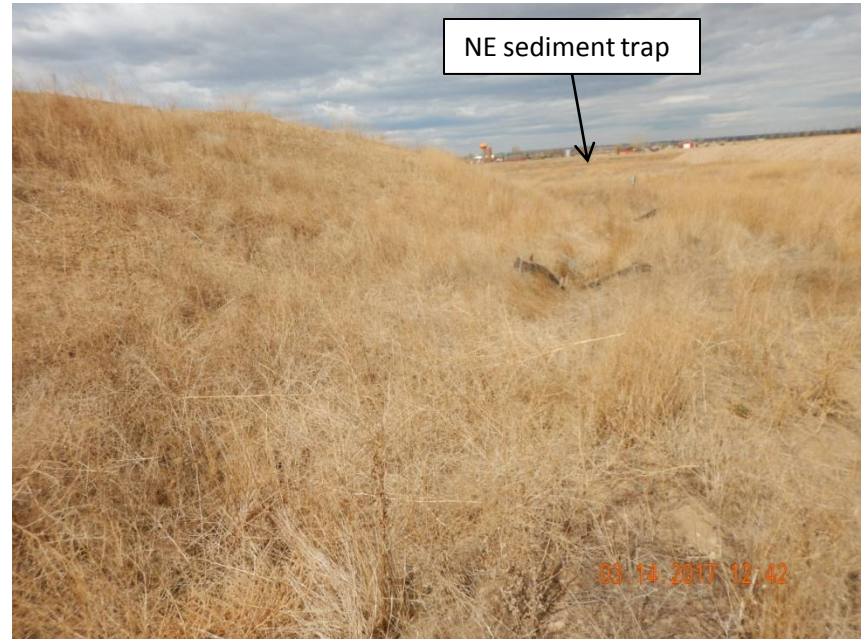
Photo 8. Photo taken from the northeastern location, facing North. Vegetative growth makes it difficult to observe but a ditch and berm BMP has been installed around the perimeter of the location in conjunction with wattles. Fill slope appears to be stabilized along this portion of the location.

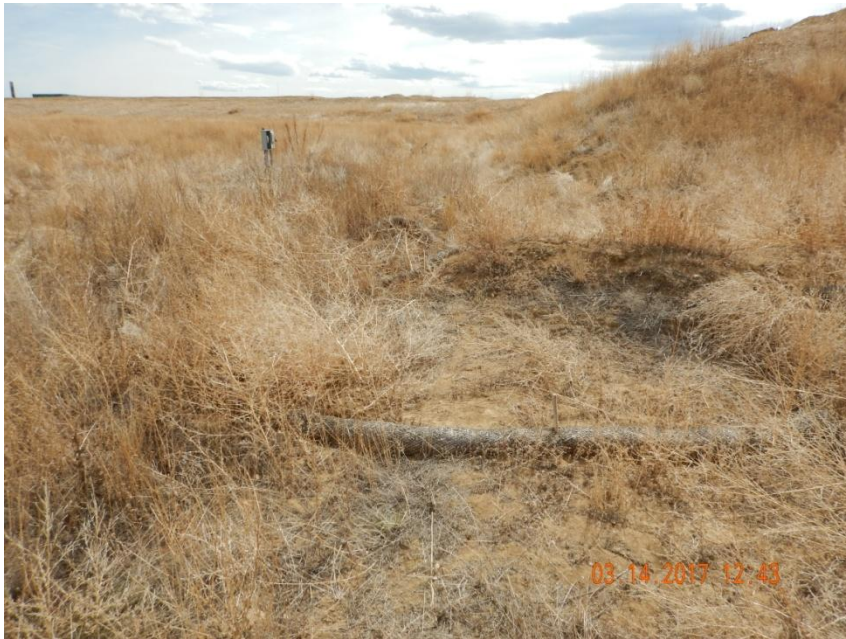
Photo 9. Photo taken from the northeast sediment trap, facing South. Vegetative growth makes it difficult to observe but outlet protection in the form of straw wattles may need maintenance or repair. Wattles do not appear to be properly installed (trenched and backfilled).

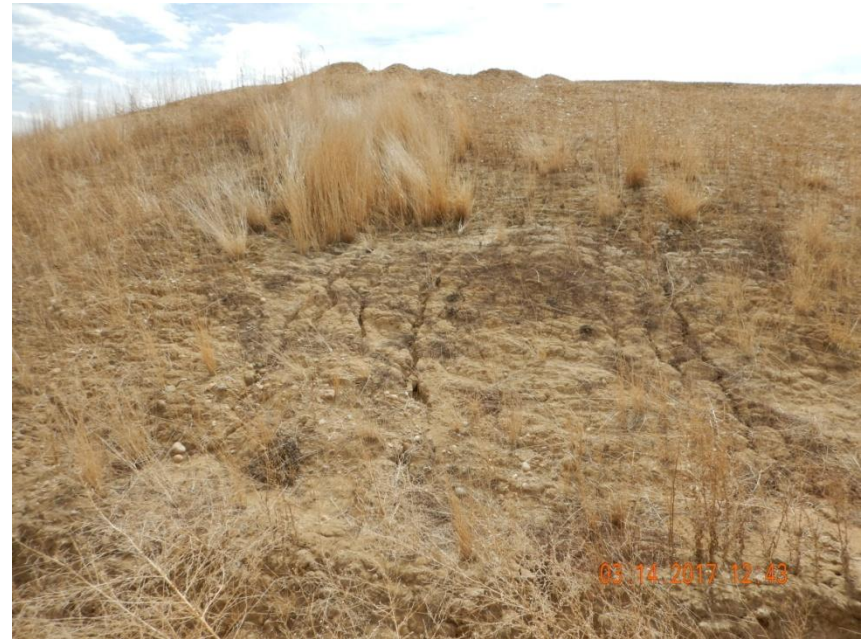
Photo 10. Photo taken from the northeast sediment trap, facing Southwest. Rill erosion occurring along portions of the fill slope. Vegetative growth is sparse so additional stabilization may be required.

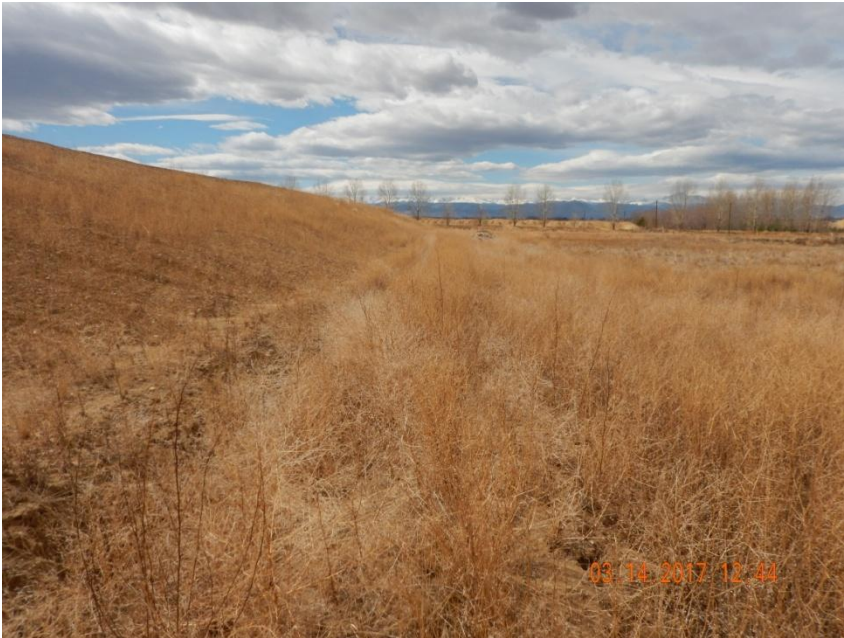
Photo 11. Photo taken from the northern location, facing West. Vegetative growth makes it difficult to observe but a ditch and berm BMP has been installed around the perimeter of the location. Vegetative growth is sparse along the fill slope so additional stabilization may be required.

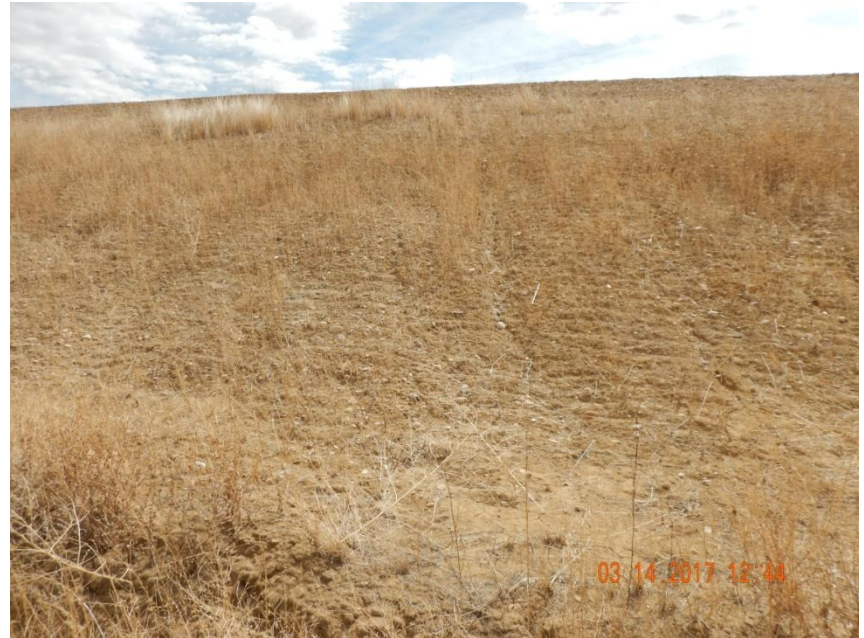
Photo 12. Photo taken from the northern location, facing South. Vegetative growth is sparse along the fill slope so additional stabilization may be required. Appears rill erosion is starting to form throughout portions of the fill slope.

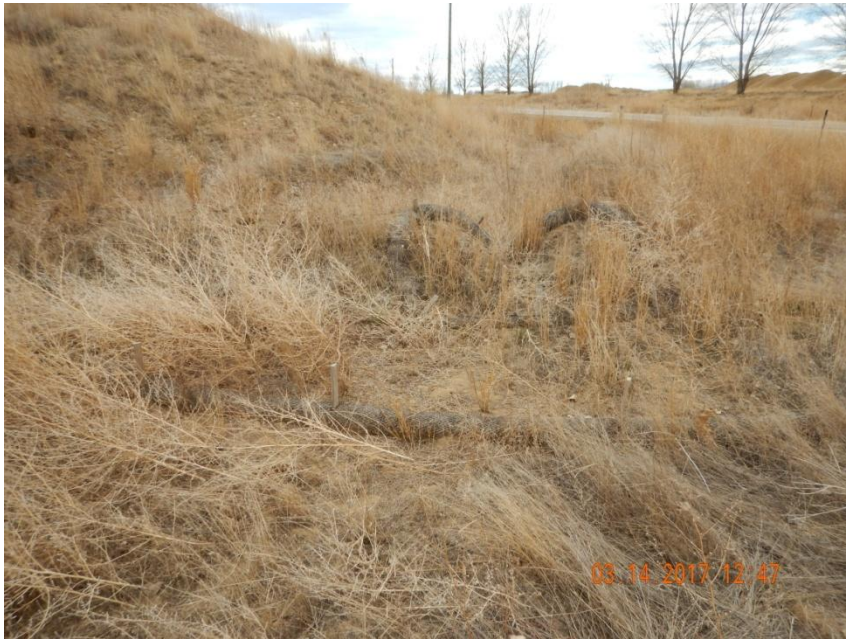
Photo 13. Photo taken from the northwest sediment trap, facing South. Vegetative growth makes it difficult to observe but outlet protection in the form of straw wattles may need maintenance or repair. Some sediment discharge was observed outside of the outlet protection (i.e. wattle). Wattles do not appear to be properly installed (trenched and backfilled).

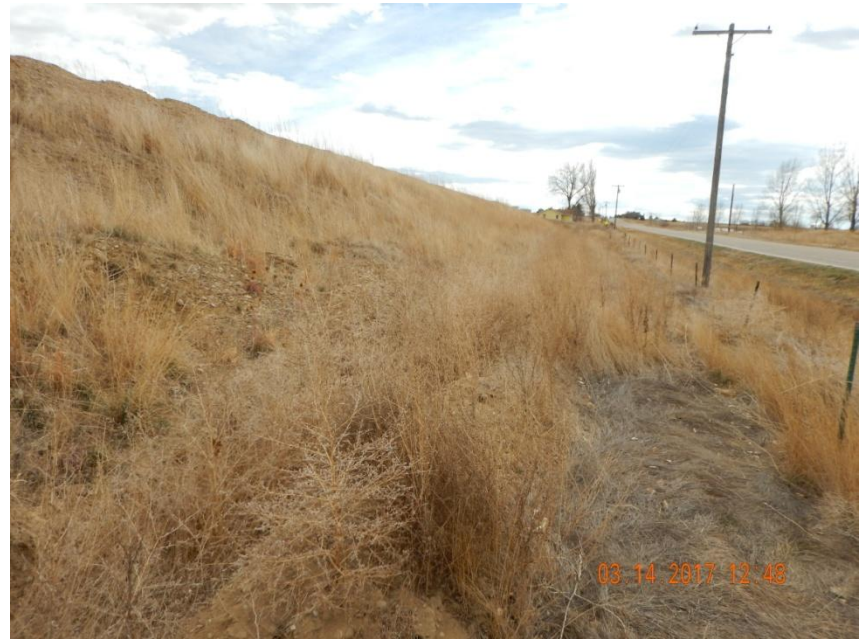
Photo 14. Photo taken from the northwest location, facing South. Vegetative growth makes it difficult to observe but a ditch and berm BMP has been installed around the perimeter of the location. Fill slope along the northwest corner does not appear to be stable. Appears portions have shifted and settled out over time. Additional stabilization may be required.
