# Reclamation and Stormwater Inspection

March 14, 2017

Operator: CRESTONE PEAK RESOURCES  
OPERATING LLC

Location ID: 434554

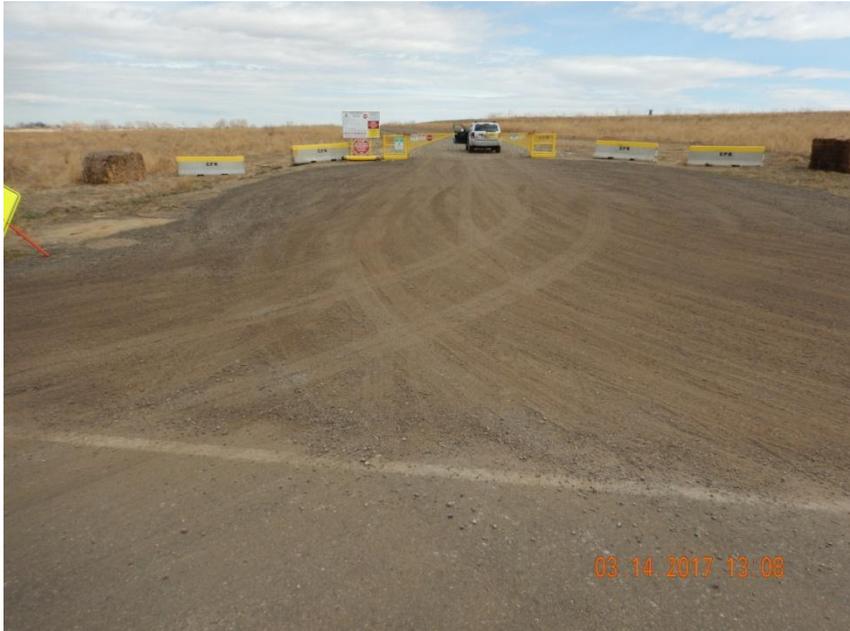
**Photo 1.** Photo taken from the entrance of location off County Road 3 1/4, facing East. Vehicle tracking pad installed.

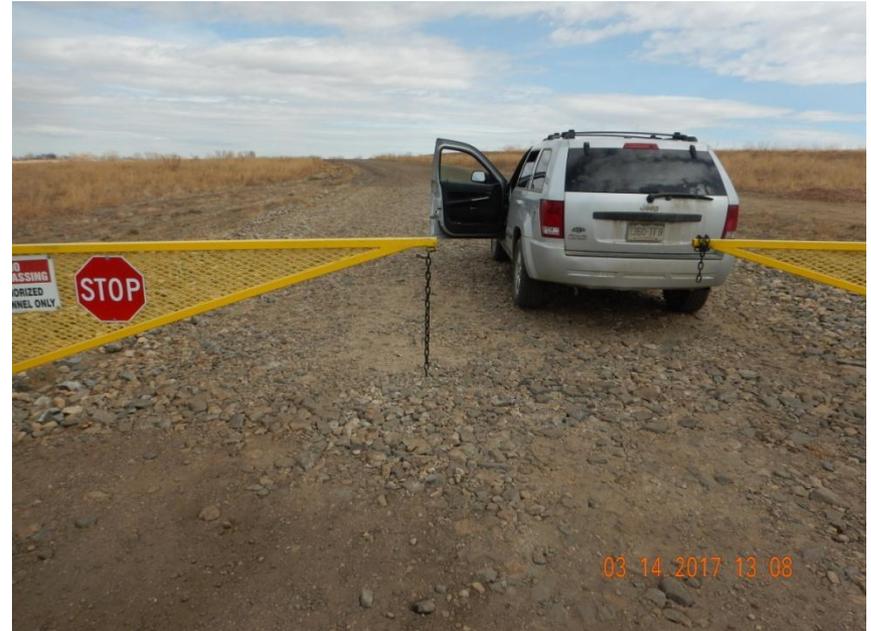
**Photo 2.** Photo taken from the entrance of location off County Road 3 1/4, facing East. Vehicle tracking pad installed.

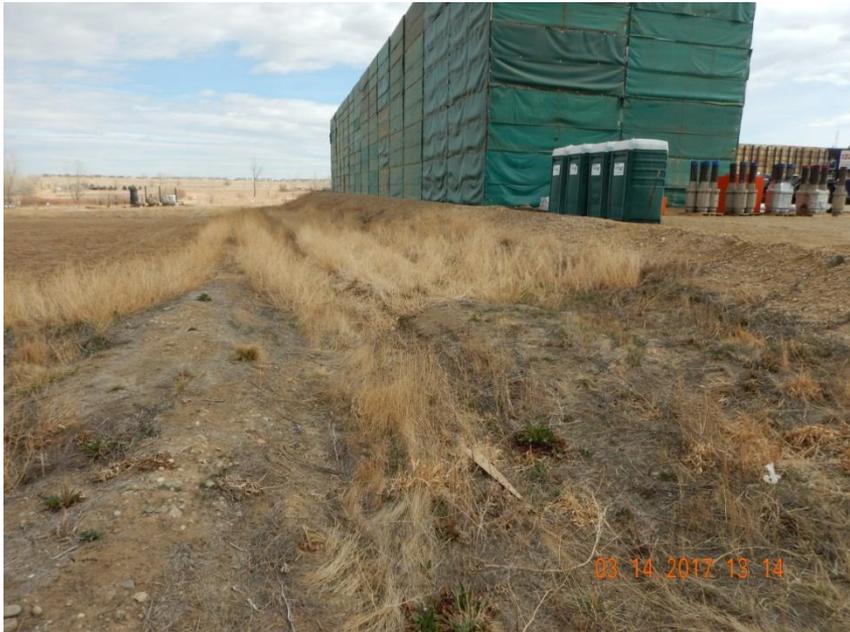
**Photo 3.** Photo taken from the entrance of the well site, facing East. Vegetative growth makes it difficult to observe but a ditch and berm BMP has been installed around the perimeter of the location.

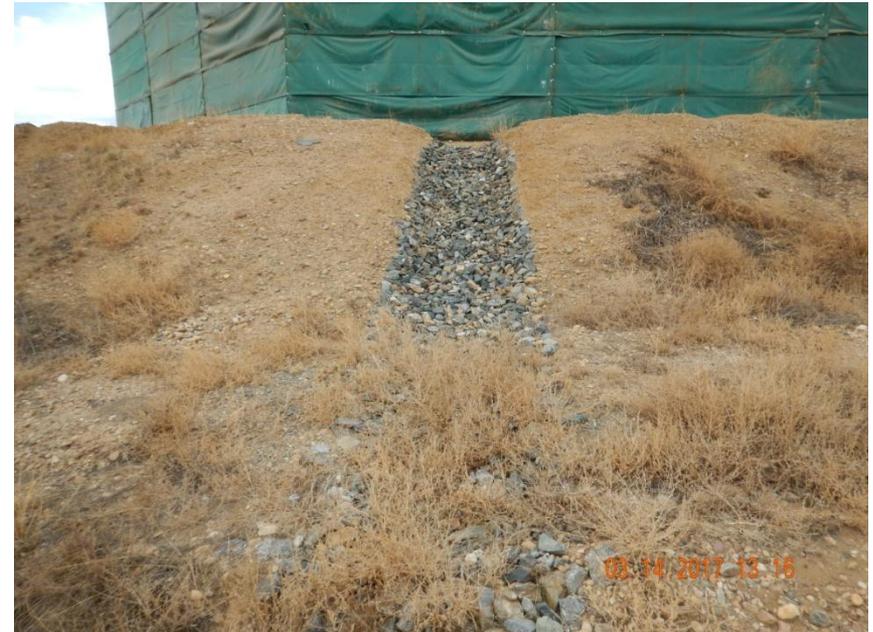
**Photo 4.** Photo taken from the northeastern location, facing South. The northeast fill slope has a stabilized outlet that is directed to the ditch and berm BMP.

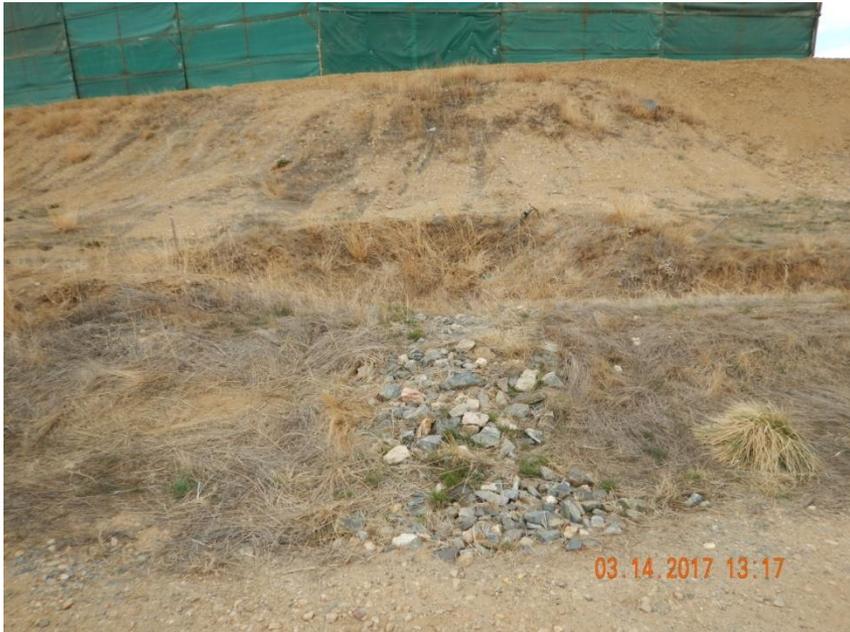
**Photo 5.** Photo taken from the northeast sediment trap, facing Southwest. Stabilized outlet in the form of rip rap has been installed.

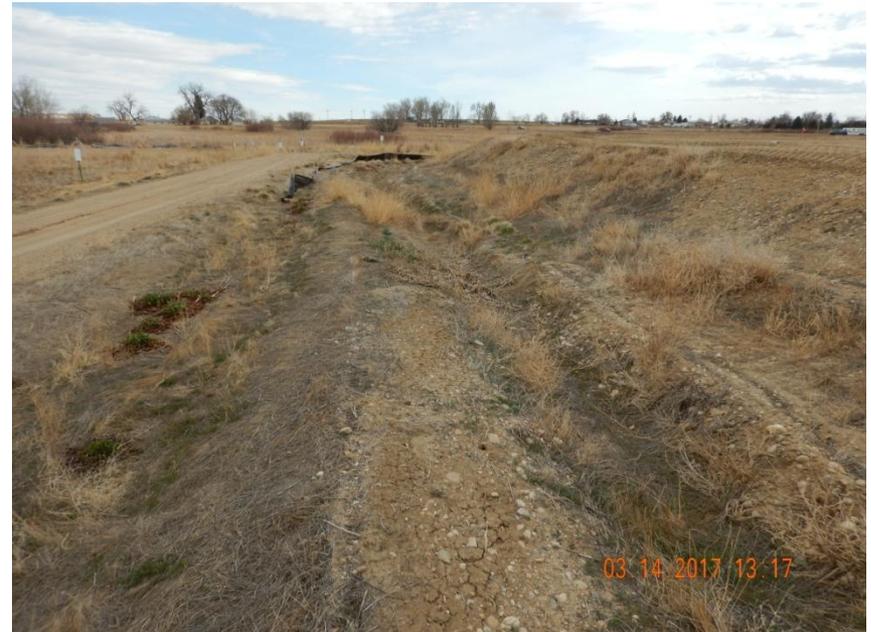
**Photo 6.** Photo taken from the northeastern location, facing South. A ditch and berm BMP has been installed around the perimeter of the location. Canada thistle vegetative growth from last year was observed throughout the eastern location.

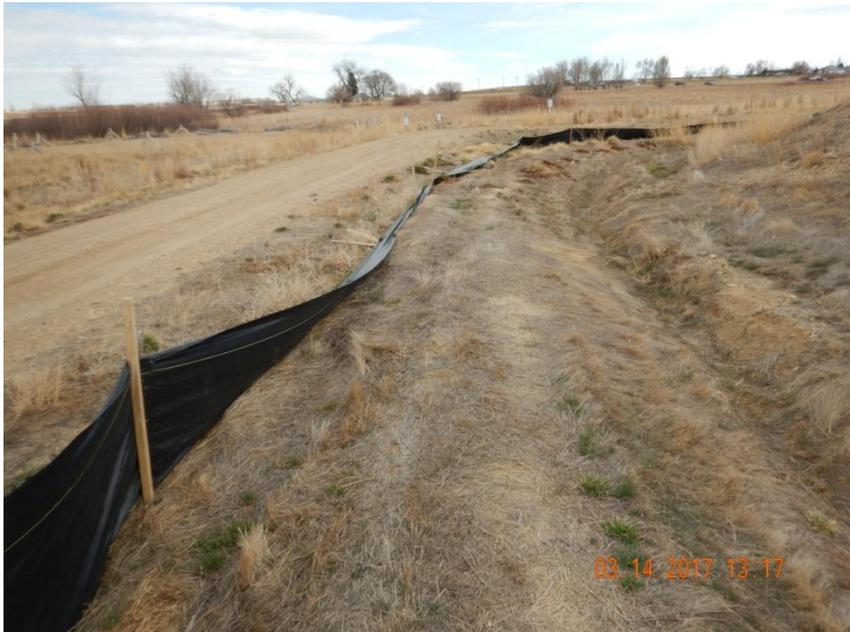
**Photo 7.** Photo taken from the eastern location, facing South. A ditch and berm BMP has been installed around the perimeter of the location in conjunction with silt fence. Silt fence is in disrepair and needs maintenance. Canada thistle vegetative growth from last year was observed throughout the eastern location.

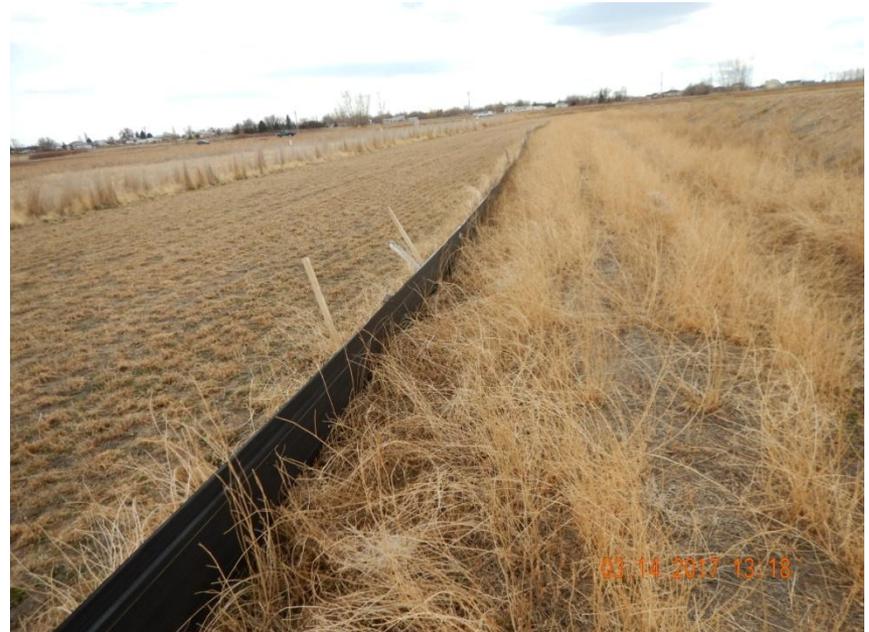
**Photo 8.** Photo taken from the eastern location, facing South. A ditch and berm BMP has been installed around the perimeter of the location in conjunction with silt fence. Silt fence is in disrepair and needs maintenance.

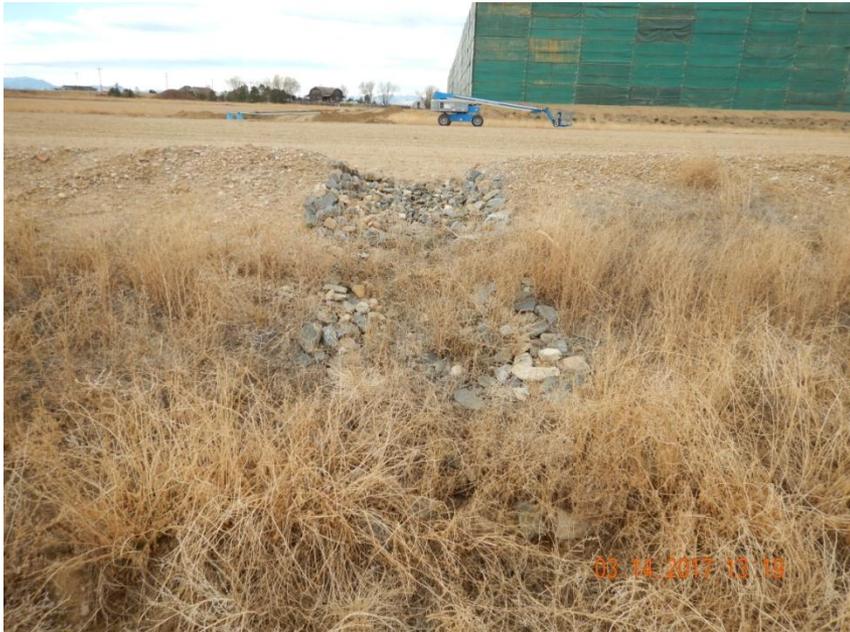
**Photo 9.** Photo taken from the eastern location, facing West. Fill slope has a stabilized outlet that is directed to the ditch and berm BMP.

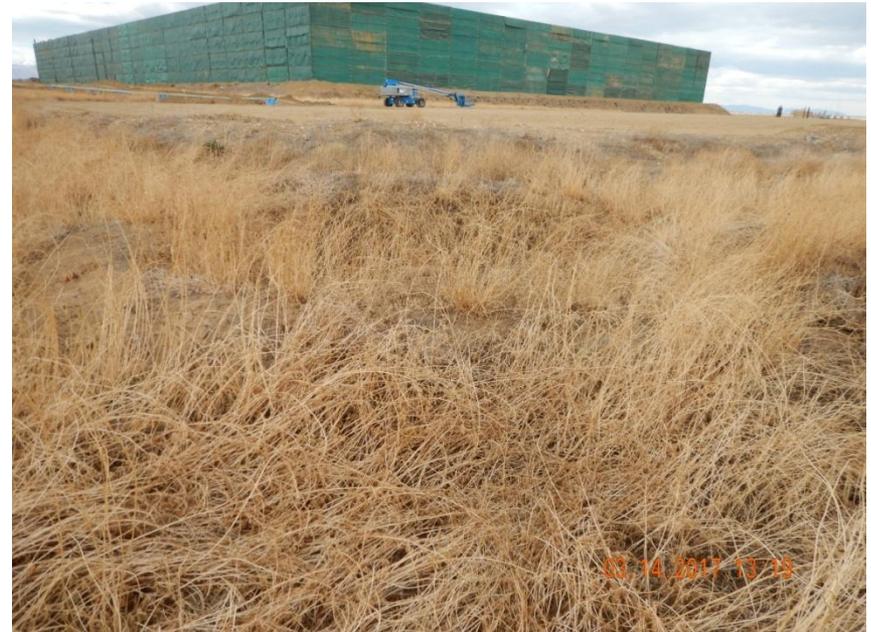
**Photo 10.** Photo taken from the southeast sediment trap, facing Northwest. Vegetative growth makes it difficult to observe but outlet protection in the form of straw wattles may need maintenance or repair.

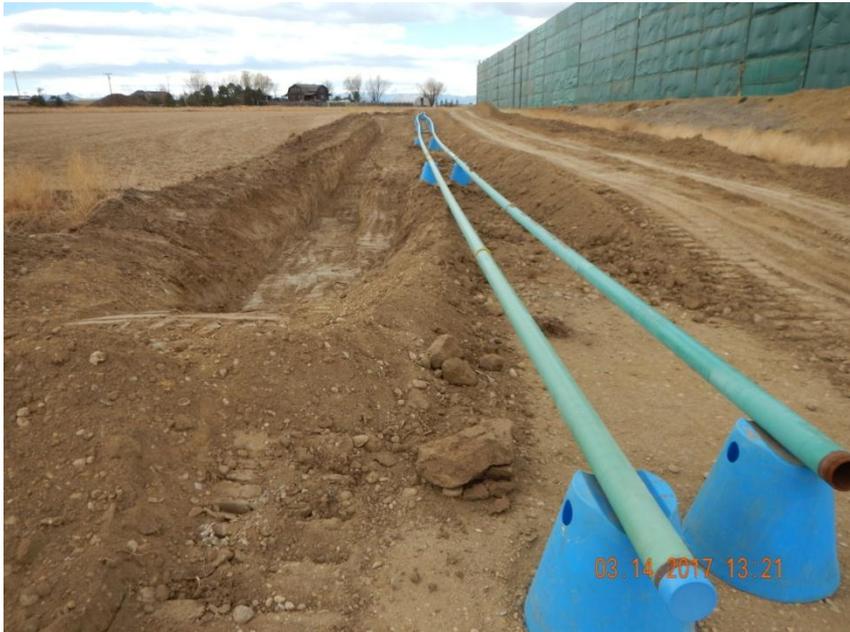
**Photo 11.** Photo taken from the southern location, facing West. Pipeline construction occurring during inspection. A ditch and berm BMP appeared to be installed around the southern of the location but may need additional maintenance from pipeline construction disturbance.

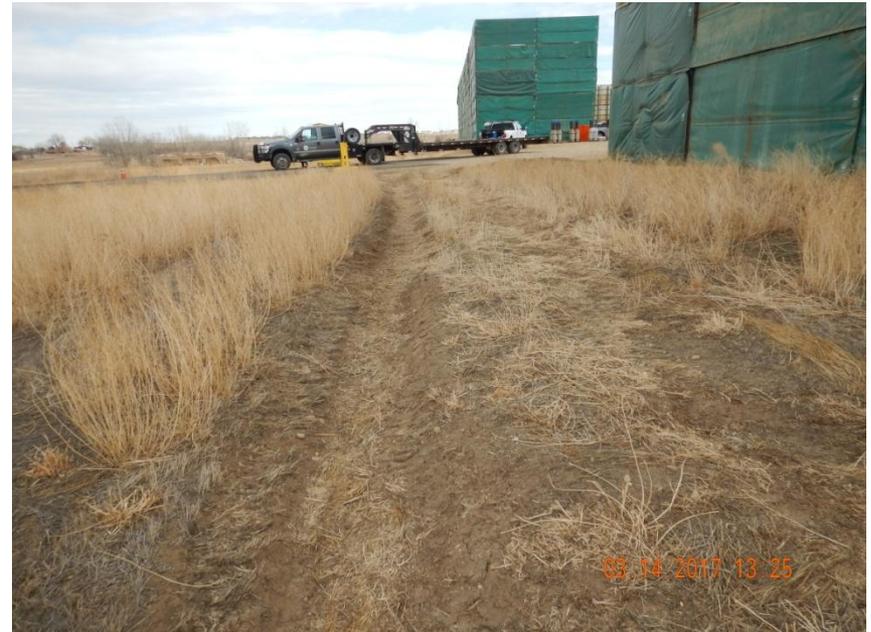
**Photo 12.** Photo taken from the entrance of the well site, facing East. A ditch and berm BMP has been installed around the perimeter of the location.
