# Reclamation and Stormwater Inspection

March 14, 2017

Operator: CRESTONE PEAK RESOURCES  
OPERATING LLC

Location ID: 434375

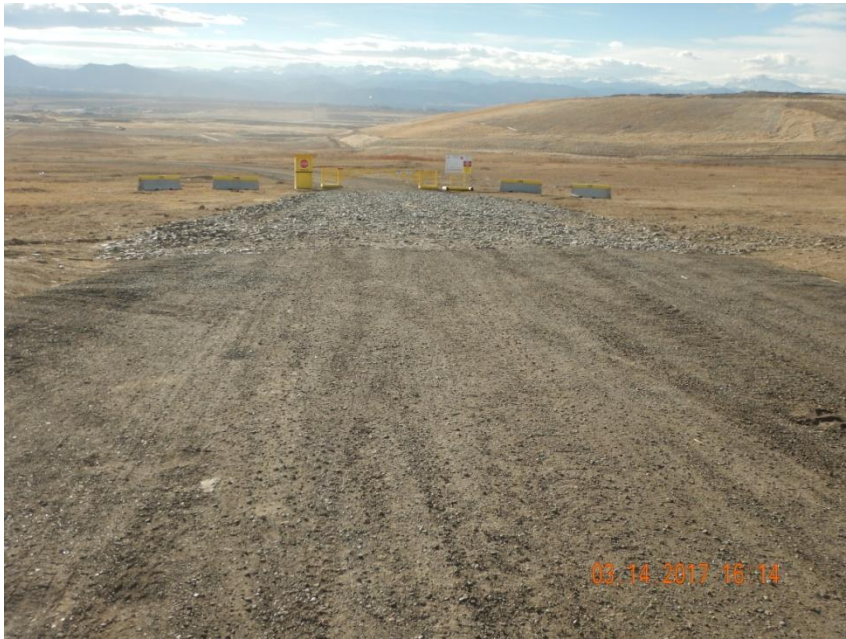
**Photo 1.** Photo taken from the entrance of location off Country Road 5, facing West. Vehicle tracking pad installed.

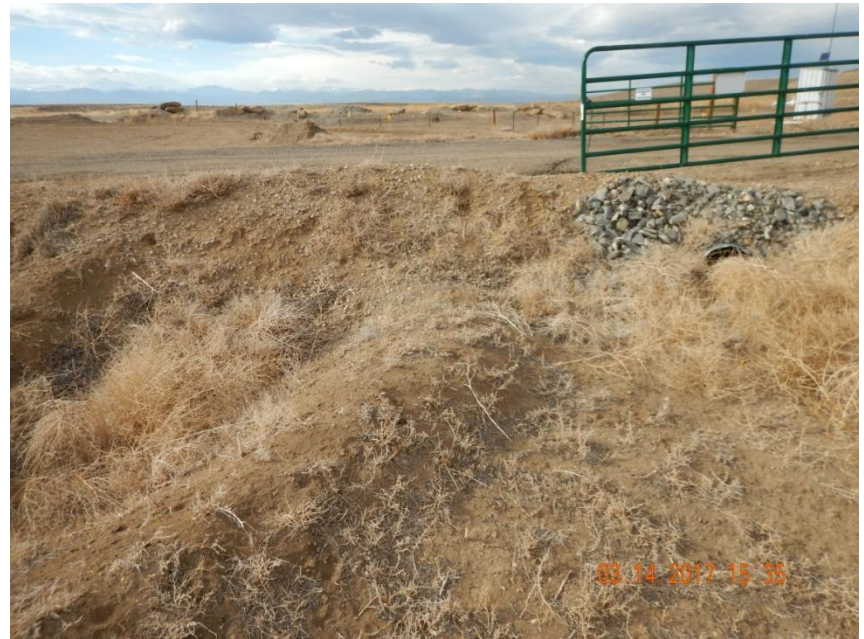
**Photo 2.** Photo taken from the well site entrance, facing North. Culvert has both inlet and outlet protection; however, the culvert doesn't appear to be directed to the ditch and berm BMP. May need to ensure culvert and ditch and berm BMP are connected to ensure containment of stormwater runoff.

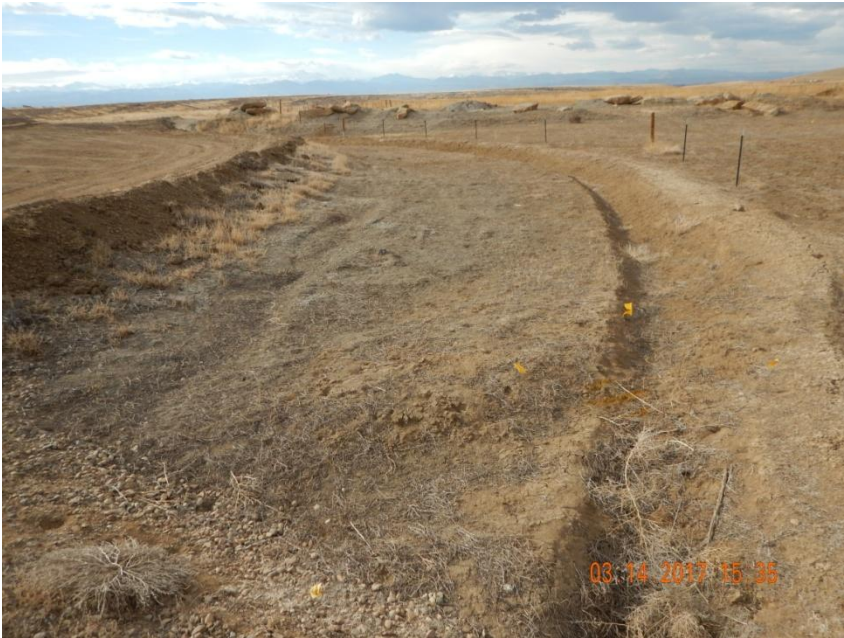
**Photo 3.** Photo taken from the northeastern location, facing Northwest. A ditch and berm BMP has been installed around the perimeter of the location.

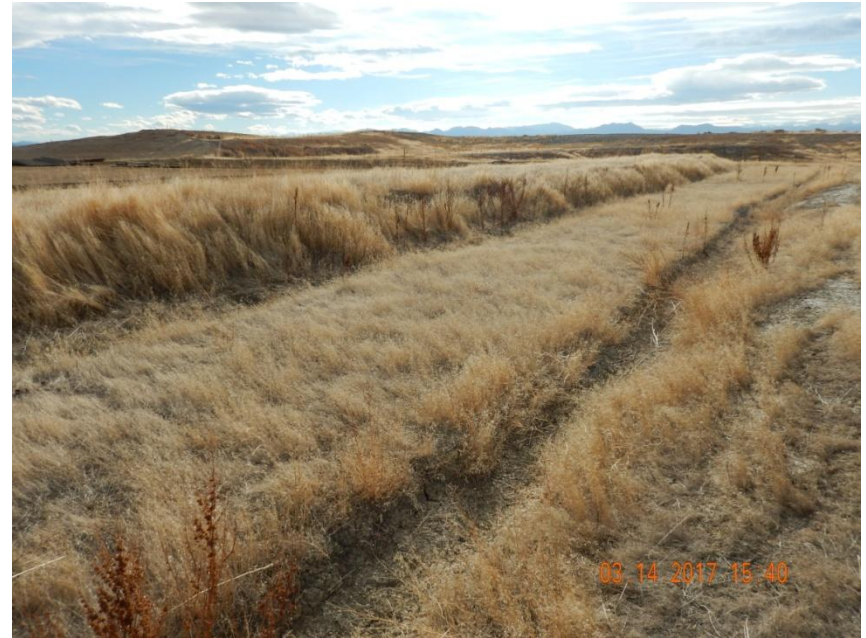
**Photo 4.** Photo taken from the northern location, facing West. A ditch and berm BMP has been installed around the perimeter of the location. There appears to be a buffer of vegetation between the well site and BMP to help control stormwater erosion. Topsoil stockpile appears to be stored along the northern location.

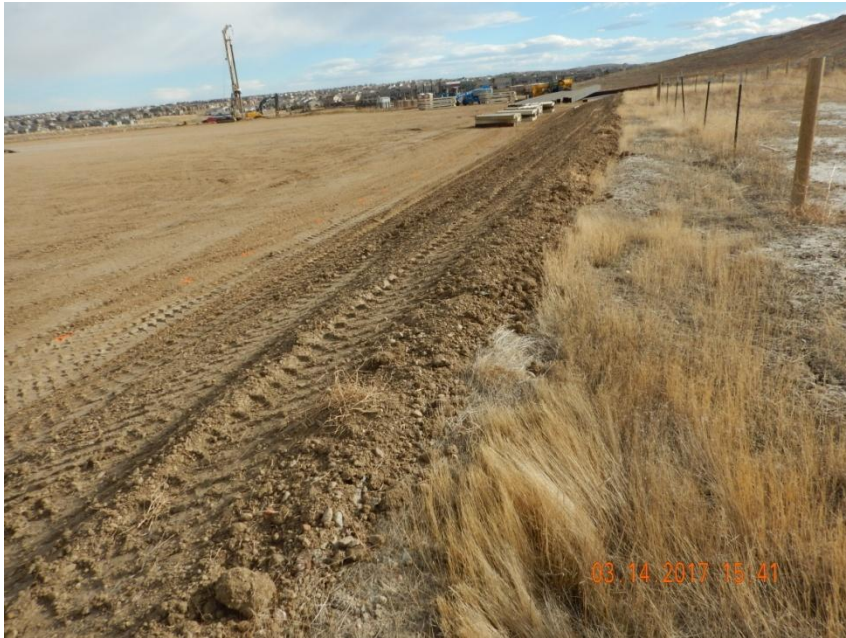
**Photo 5.** Photo taken from the western location, facing South. The east-facing cut slope appears to be stabilized.

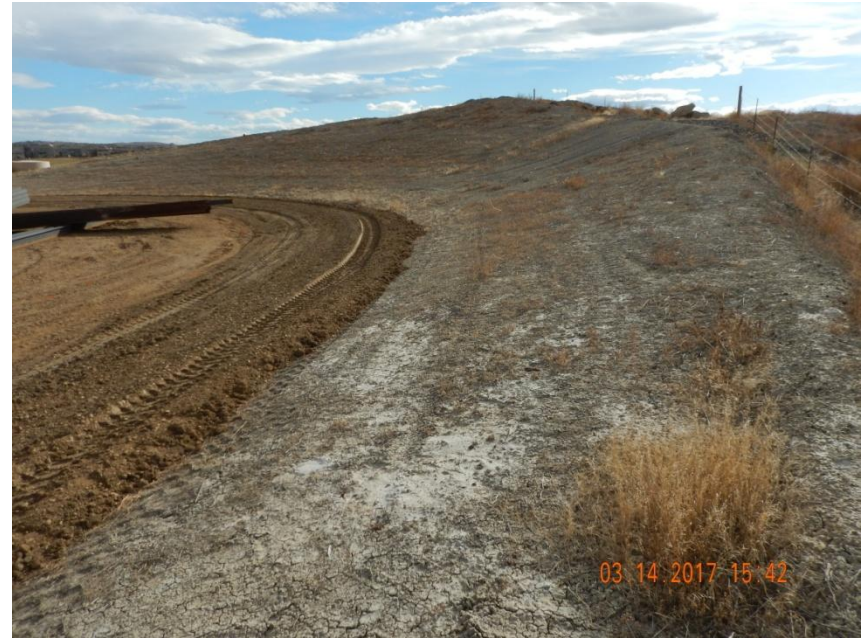
**Photo 6.** Photo taken from the southwestern location, facing South. The cut slope appears to be stabilized and BMPs have been installed on the uphill side- see following photos.

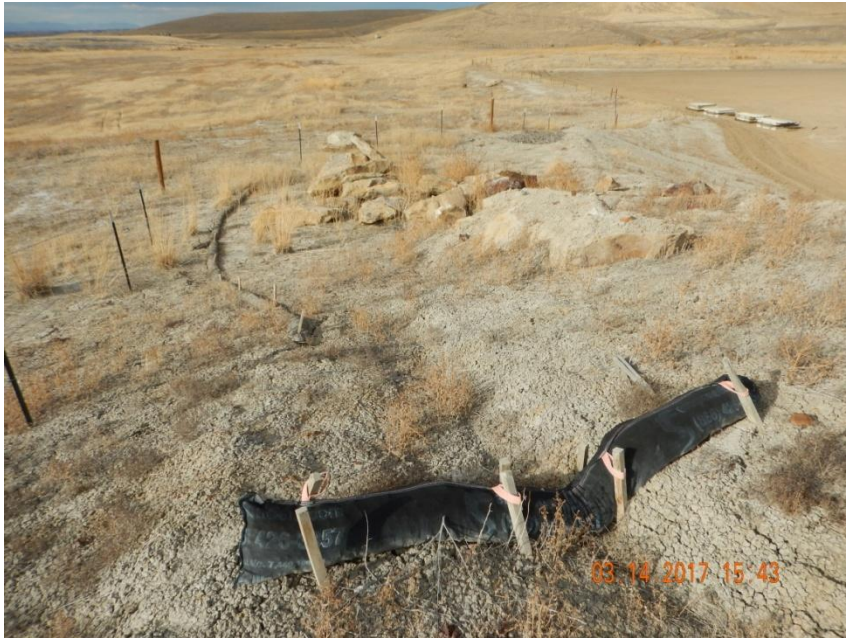
**Photo 7.** Photo taken from the southwestern location along the uphill side of the cut slope, facing North. Wattles have been installed in conjunction with the ditch BMP. Some of the straw wattles may need maintenance or repairs.

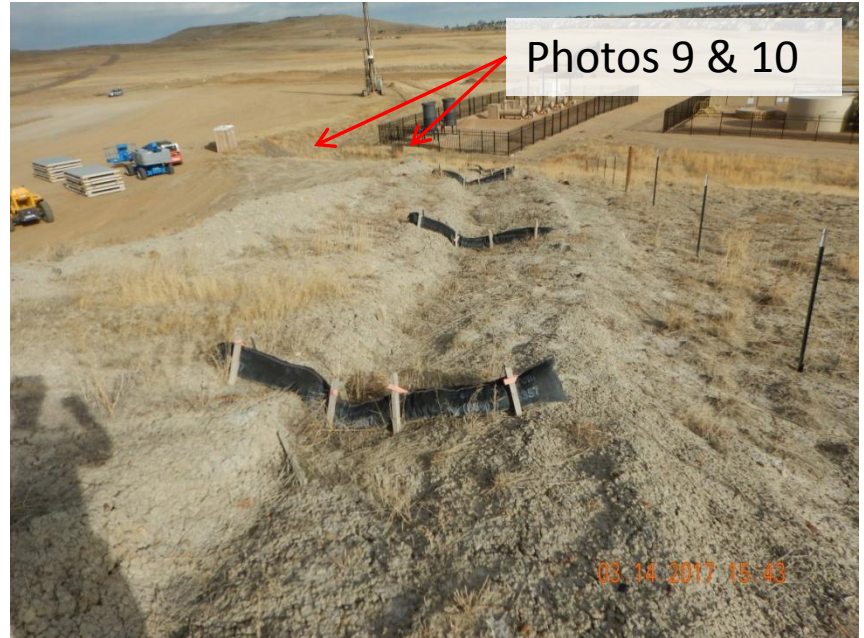
**Photo 8.** Photo taken from the southwestern location along the uphill side of the cut slope, facing East. Wattles have been installed in conjunction with the ditch BMP.

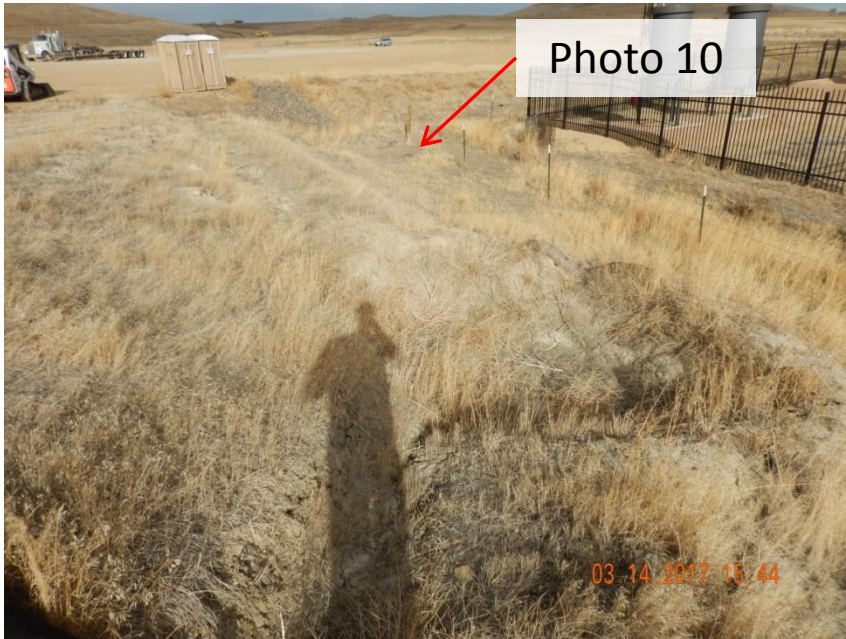
**Photo 9.** Photo taken from the downhill side of the cut slope, facing East. Vegetative growth makes it difficult to observe but outlet protection in the form of straw wattles may need maintenance or repair.

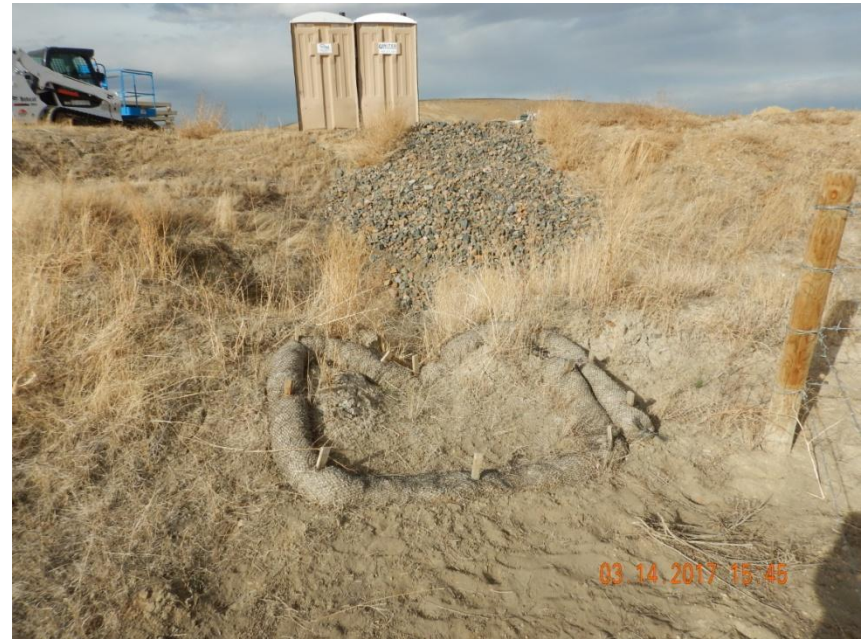
**Photo 10.** Photo taken just northeast of previous location, facing North. Sediment trap installed with outlet protection in the form of straw wattles. Straw wattles appear to need maintenance or repairs.

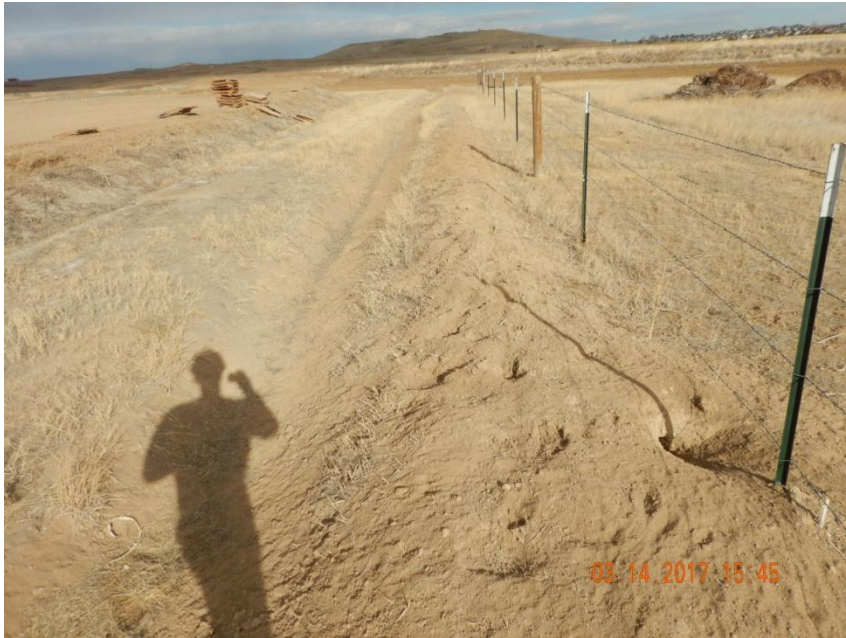
**Photo 11.** Photo taken from the southeast location, facing Northeast. A ditch and berm BMP has been installed around the perimeter of the location.

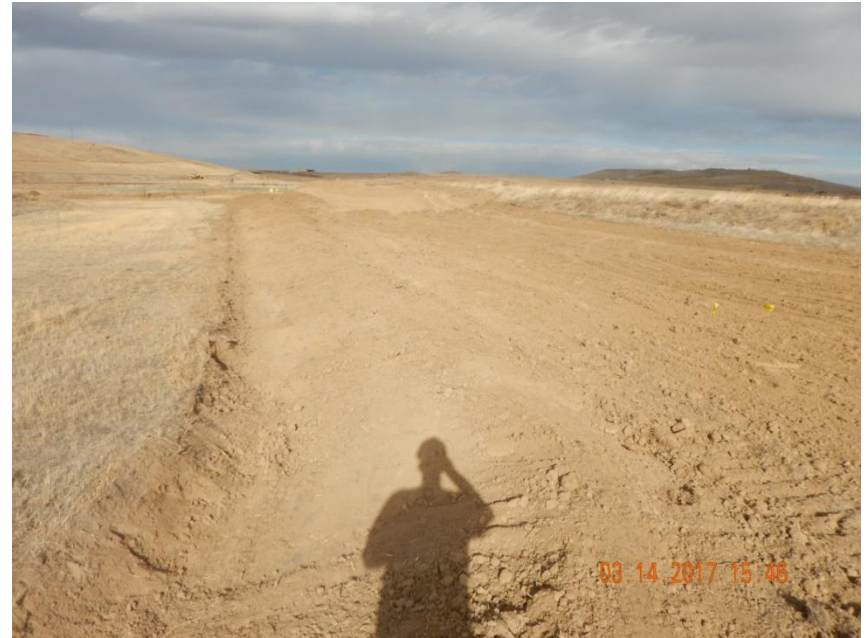
**Photo 12.** Photo taken from the eastern location, facing North. A ditch and berm BMP has been installed around the perimeter of the location.
