Inspection Photos
Location Name: Ball Ranch AC 15-65HN
API: 05-123-35074

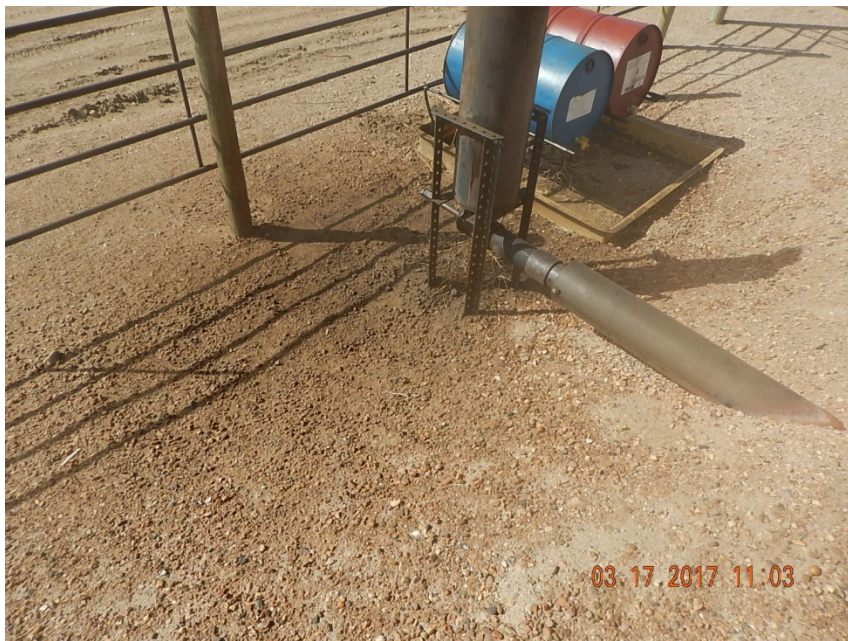
Photo 1: Stained soil at exhaust

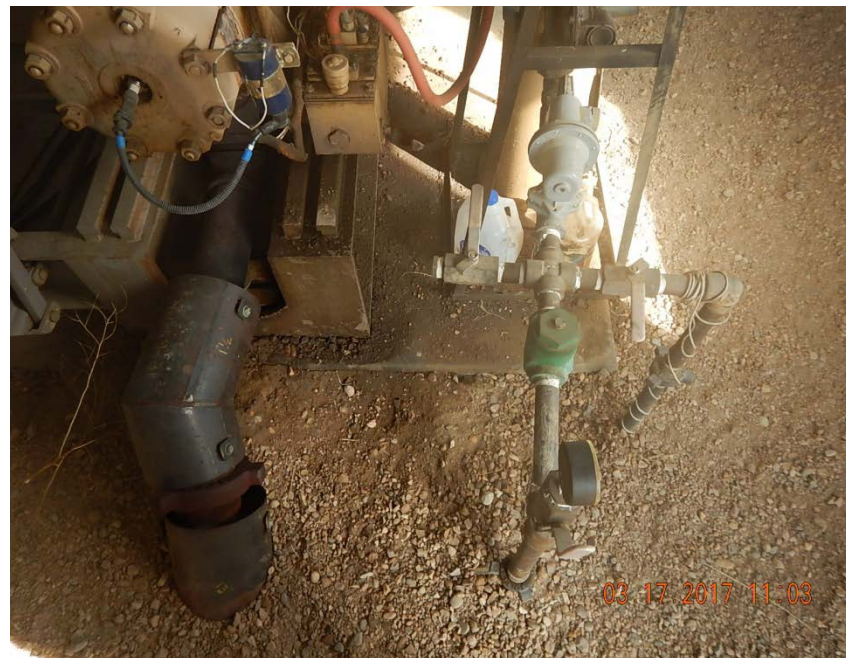
Photo 2: Stained soil at engine

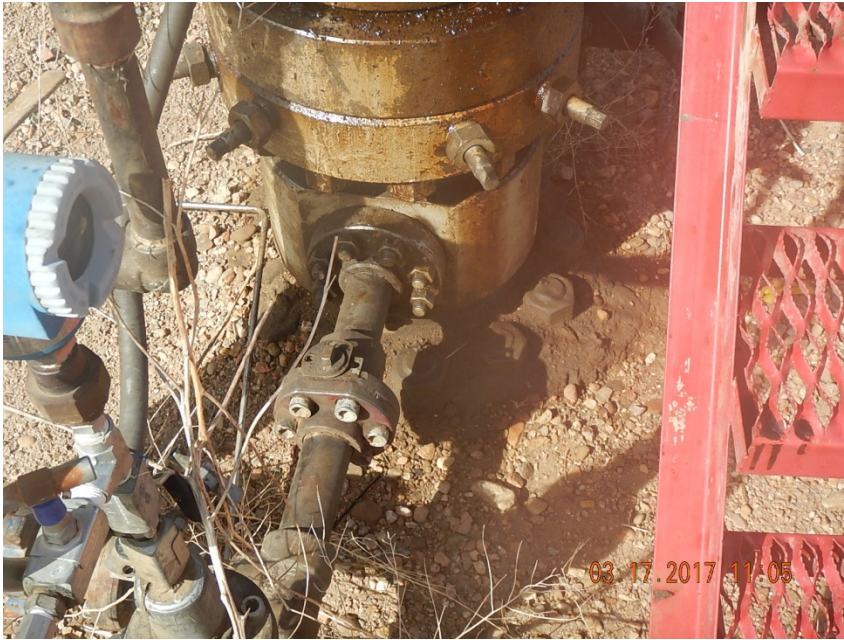
Photo 3: Stained soil at wellhead

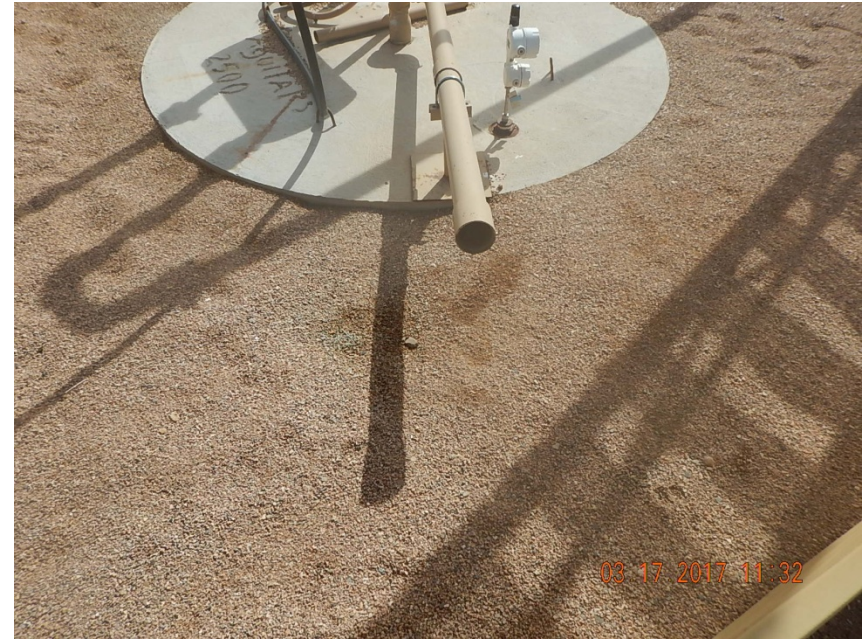
Photo 4: Stained soil at produced water

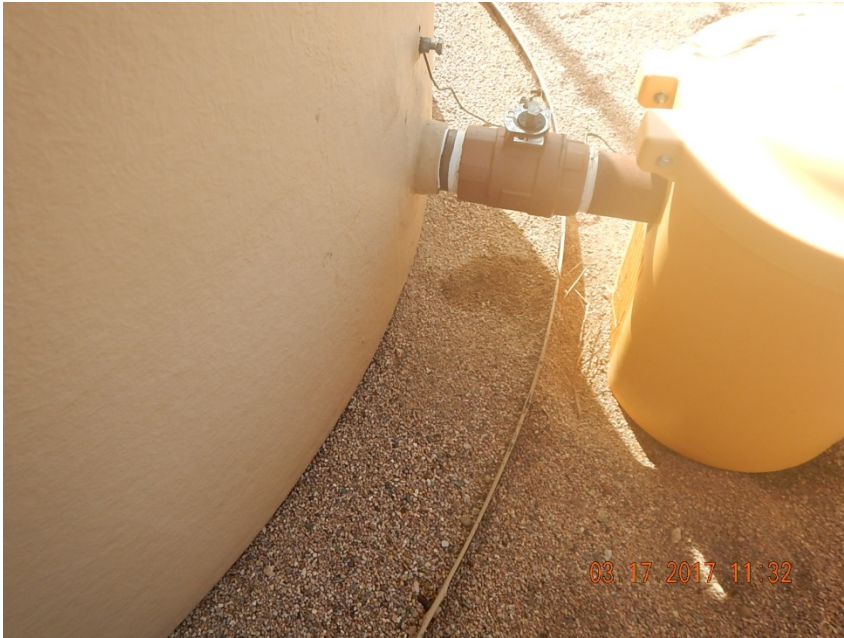
Photo 5: Stained soil at loadout
