Reclamation and Stormwater Inspection

March 14, 2017

Operator: CRESTONE PEAK RESOURCES
OPERATING LLC

Location ID: 438722

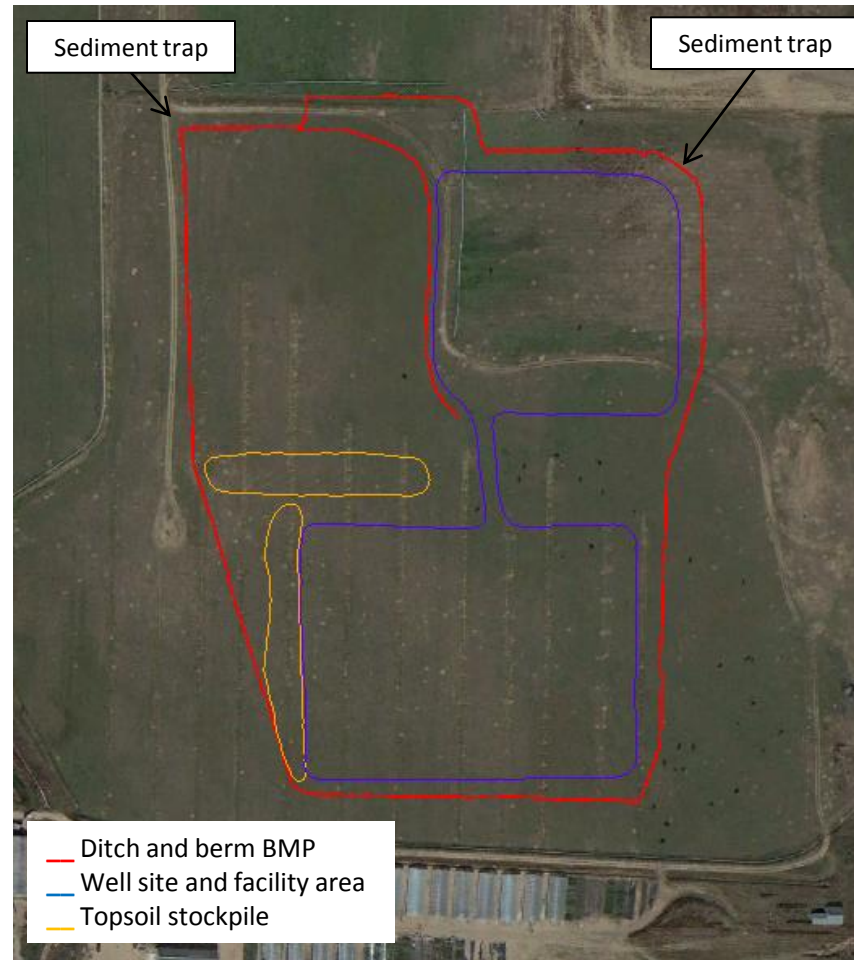
Google Earth aerial imagery taken October 6, 2014, and overlaid with field collected data on March 14, 2017 using a Trimble handheld GPS. Total construction disturbance of 18.93 acres was collected using the Trimble handheld GPS.

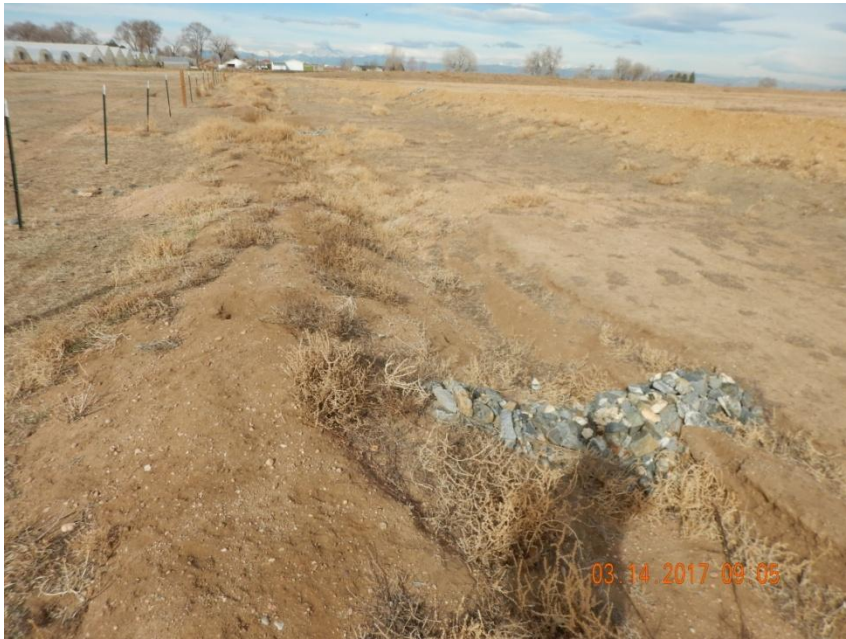
Photo 1. Photo taken from the southern location, facing West. A ditch and berm BMP has been installed around the perimeter of the location. Russian thistle found throughout ditch and berm BMP, acting as debris. Russian thistle accumulating in ditches.

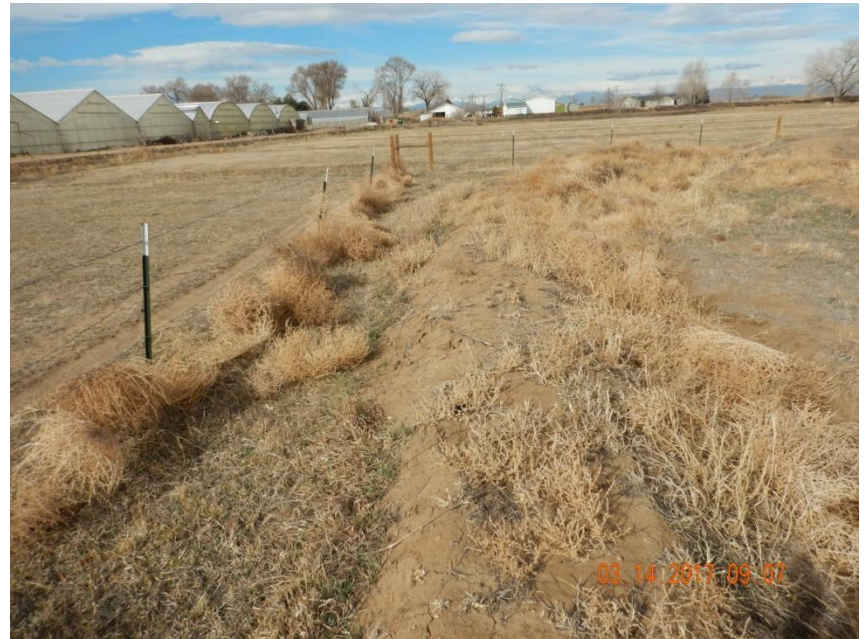
Photo 2. Photo taken from the southwest location, facing West. A ditch and berm BMP has been installed around the perimeter of the location. Russian thistle found throughout ditch and berm BMP, acting as debris. Russian thistle accumulating in ditches and perimeter fence.

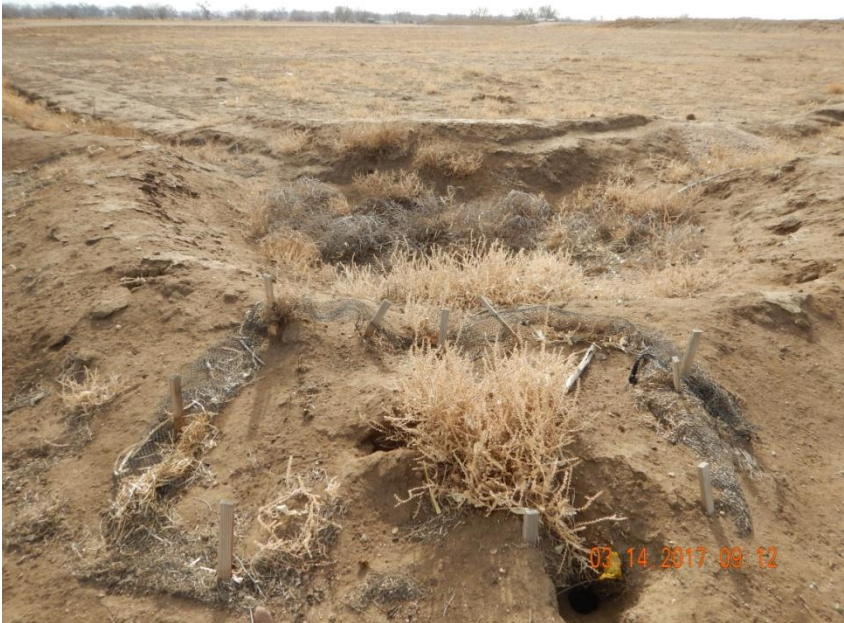
Photo 3. Photo taken from the northwest sediment trap, facing Southeast. Outlet protection in the form of straw wattles need to be repaired.

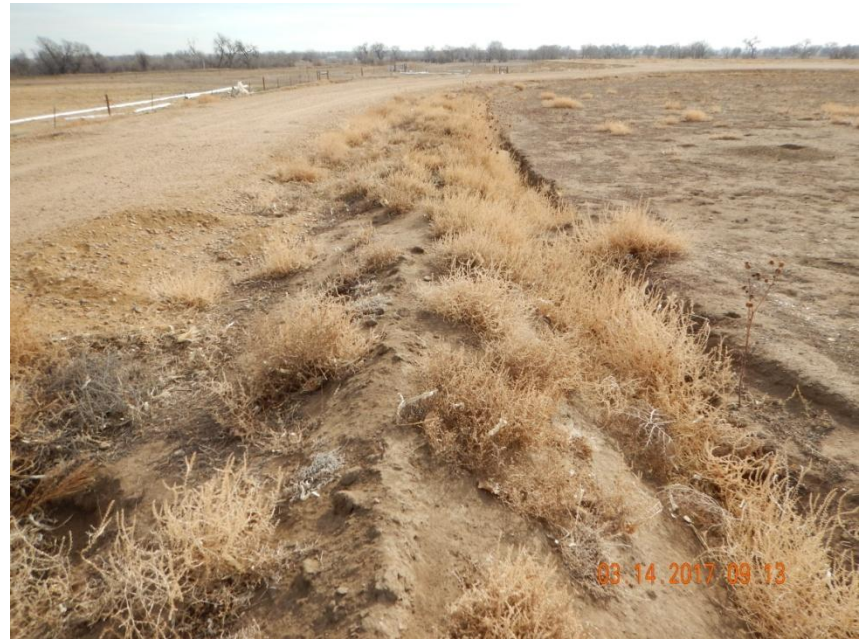
Photo 4. Photo taken from the northwestern location, facing East. A ditch and berm BMP has been installed around the perimeter of the location. Russian thistle found throughout ditch and berm BMP, acting as debris.

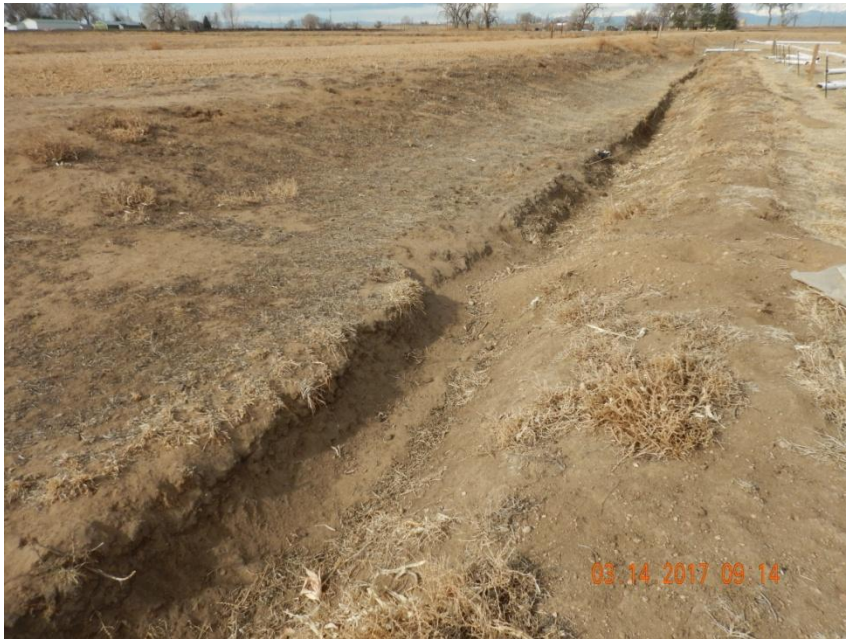
Photo 5. Photo taken from the northeastern location, facing West. A ditch and berm BMP has been installed around the perimeter of the location. Prairie dogs have established throughout the location, sometimes along the BMPs where maintenance is needed.

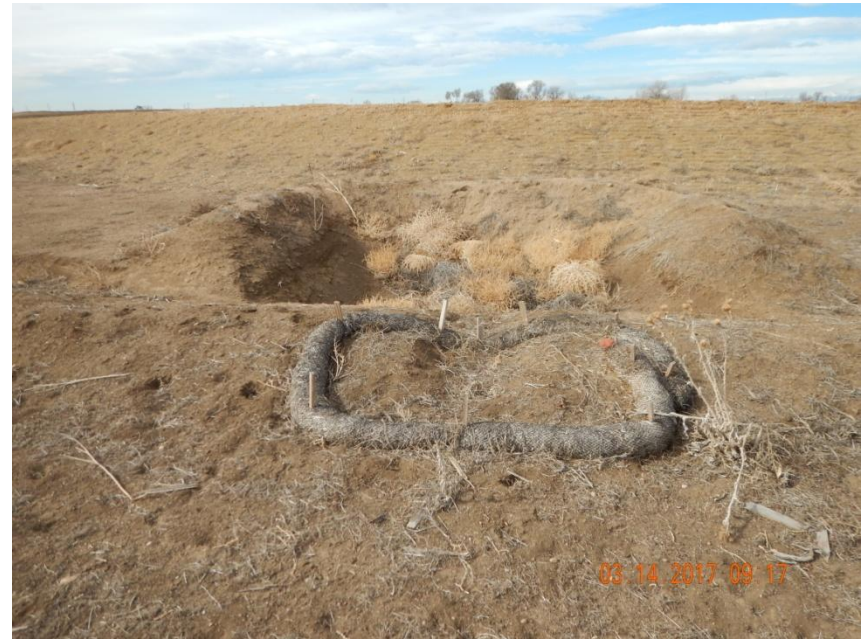
Photo 6. Photo taken from the northeast sediment trap, facing Southwest. Outlet protection in the form of straw wattles may need maintenance or repair.

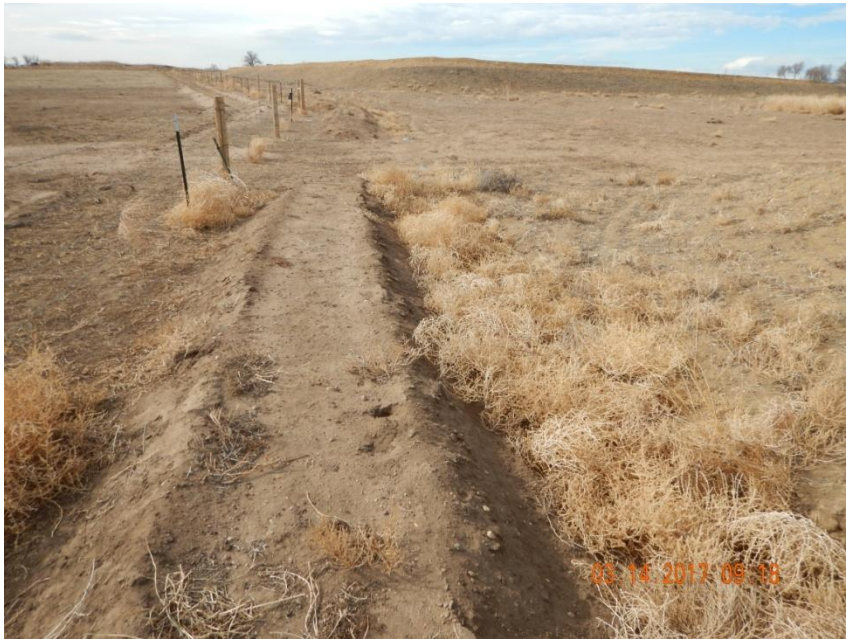
Photo 7. Photo taken along the eastern location, facing South. A ditch and berm BMP has been installed around the perimeter of the location. Russian thistle found throughout ditch and berm BMP, acting as debris. Russian thistle accumulating in ditches.

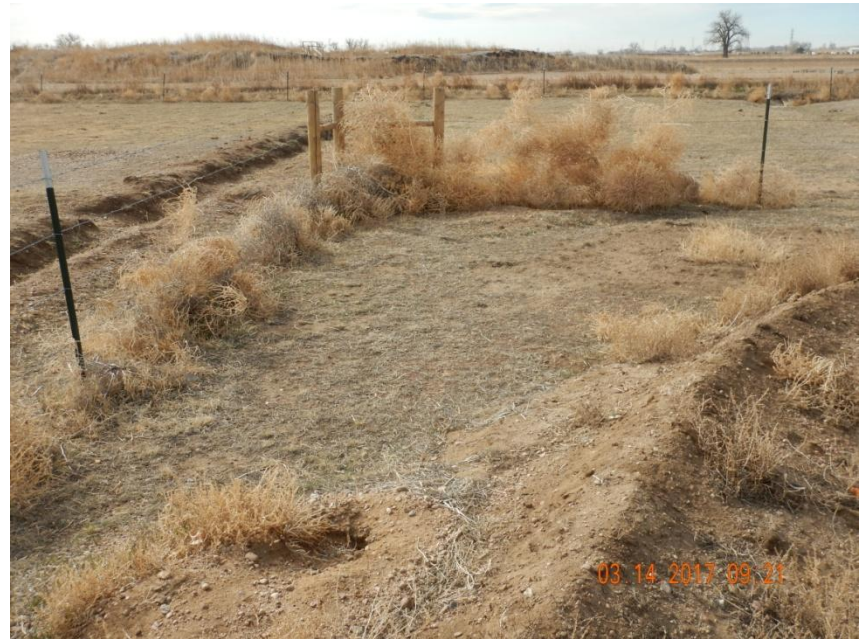
Photo 8. Photo taken from the southeast location, facing South. Russian thistle captured in the perimeter fence, acting as debris.

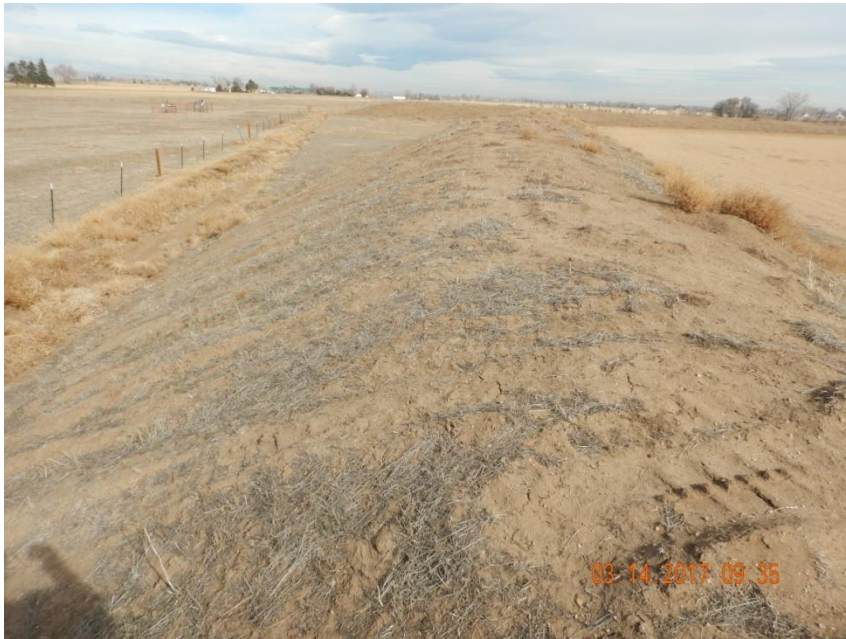
Photo 9. Photo taken from the western topsoil stockpile, facing North. Vegetative growth consists of puncture vine, Russian thistle and some cheatgrass growing throughout stockpile.

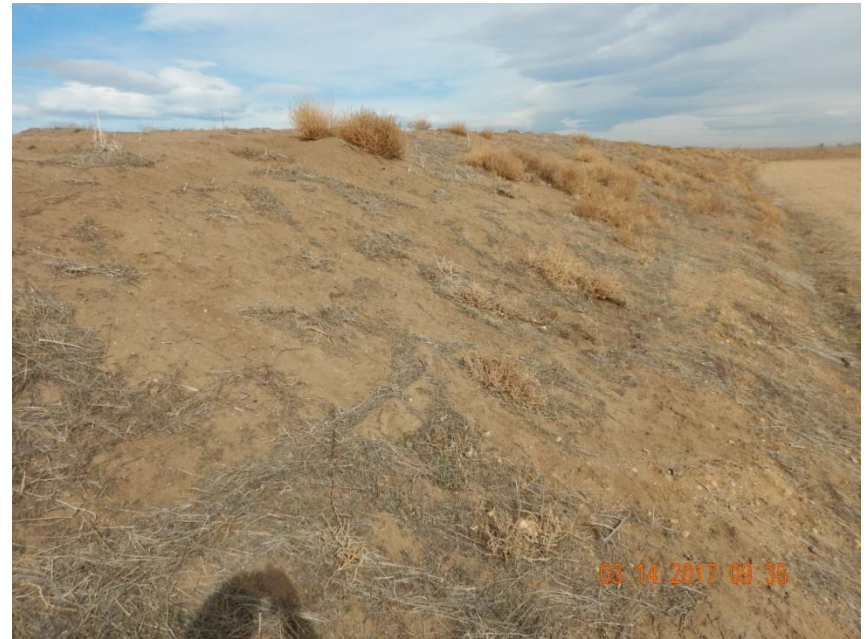
Photo 10. Photo taken from the western topsoil stockpile along the east-facing side, facing North. Vegetative growth consists of puncture vine, Russian thistle and some cheatgrass growing throughout stockpile.

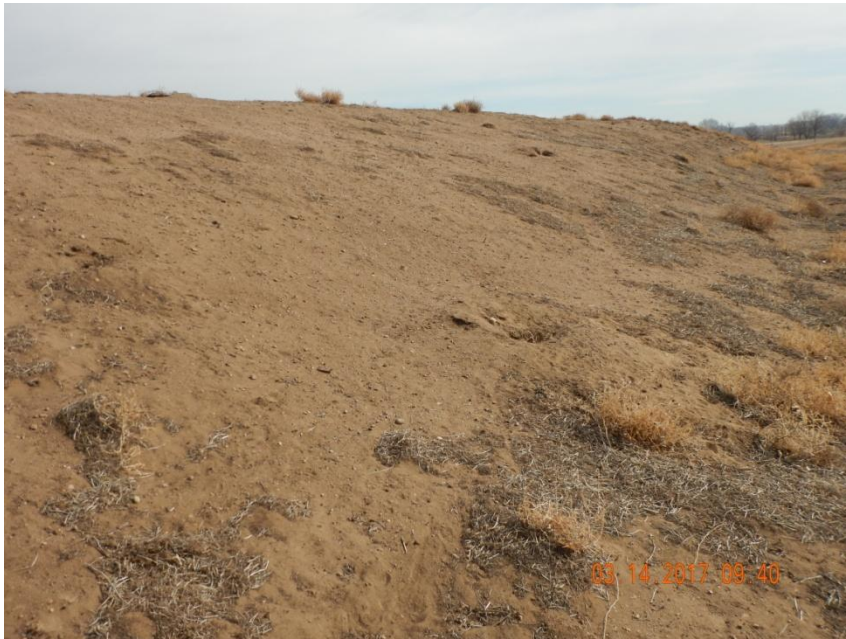
Photo 11. Photo taken from the northern topsoil stockpile along the south-facing side, facing East. More bare soil apparent but similar vegetative growth as the western topsoil stockpile.

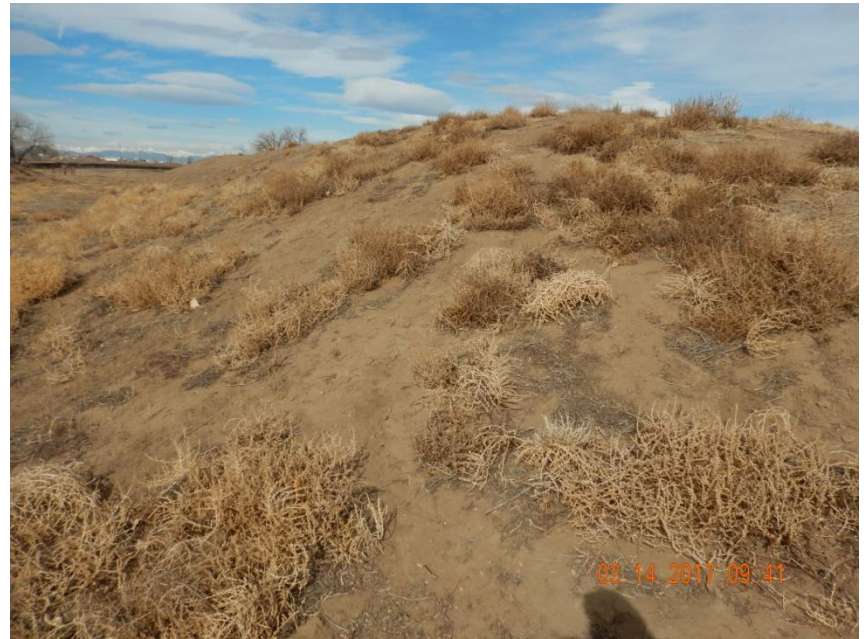
Photo 12. Photo taken from the northern topsoil stockpile along the eastern side, facing West. Vegetative growth consists of Russian thistle and puncture vine.

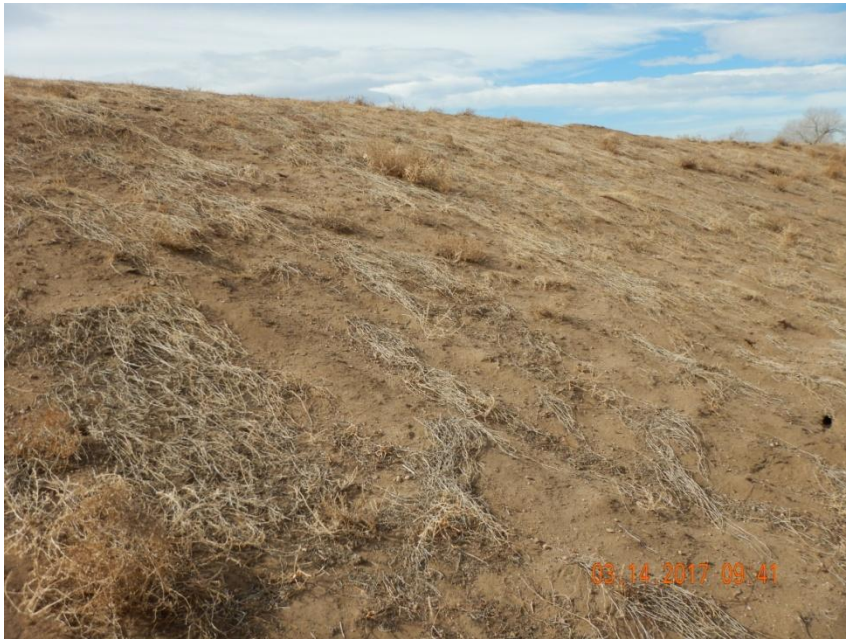
Photo 13. Photo taken from the northern topsoil stockpile along the north-facing side, facing West. Mostly puncture vine vegetative growth captured in the photo.

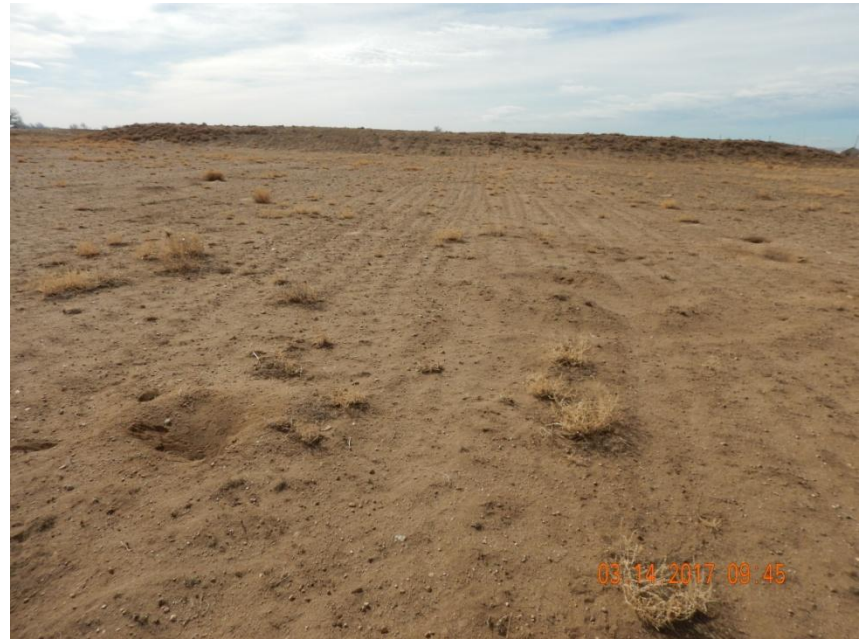
Photo 14. Photo taken from the northwest area, facing South. Approximately 4.0 acres have been disturbed but the area has not been compacted, covered, paved, or otherwise stabilized to minimize dust and erosion.
