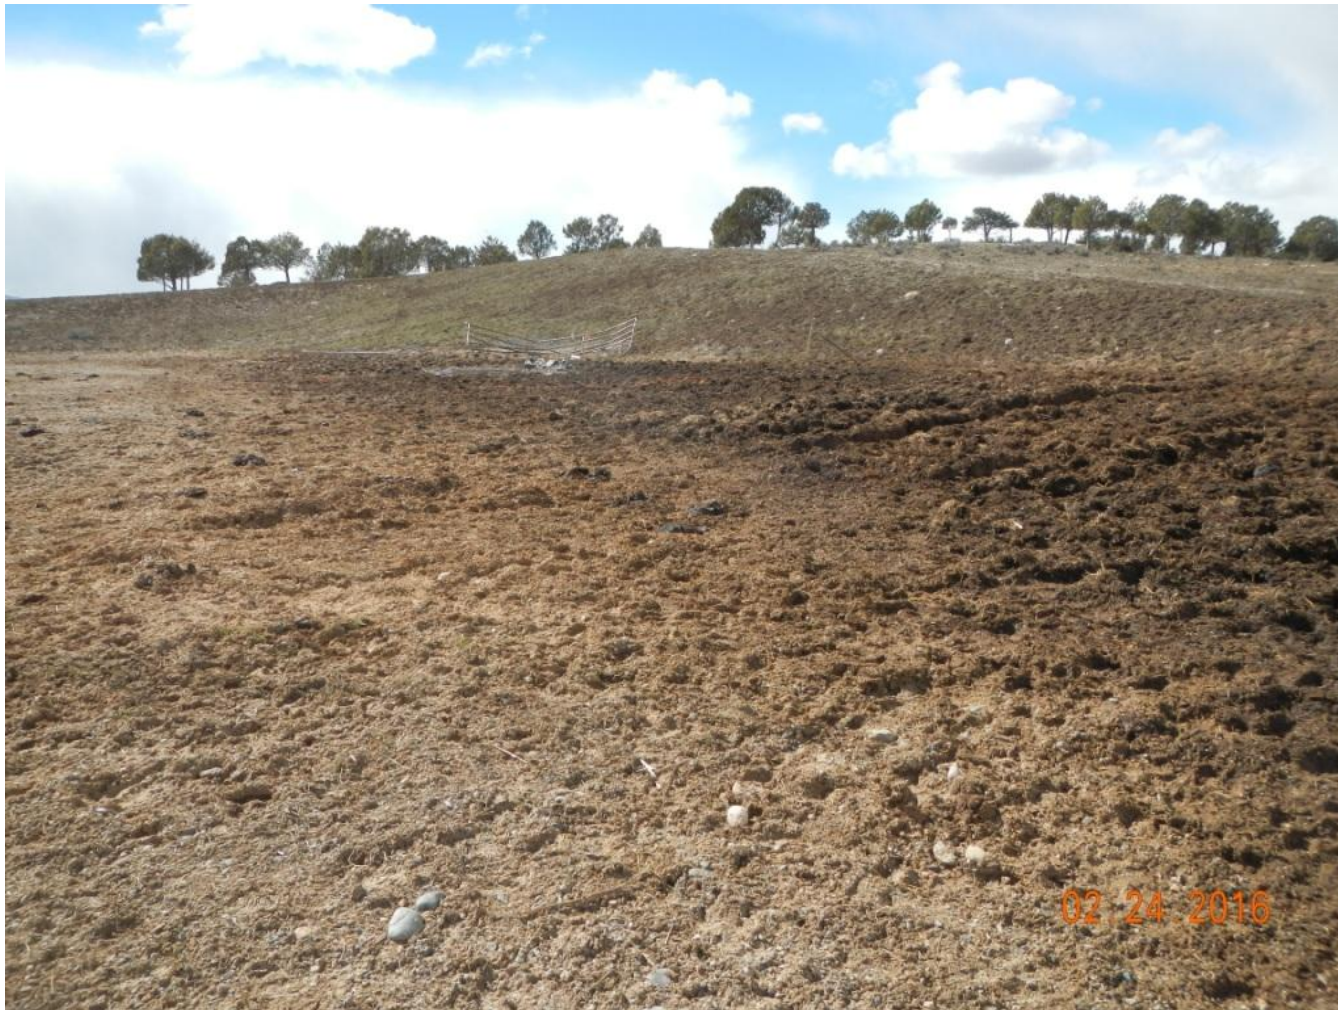
Photo 2: View of the northwestern portion of the project area from the northern corner facing southwestward. Revegetation is heavily grazed as it appears cattle concentrate on the well pad.

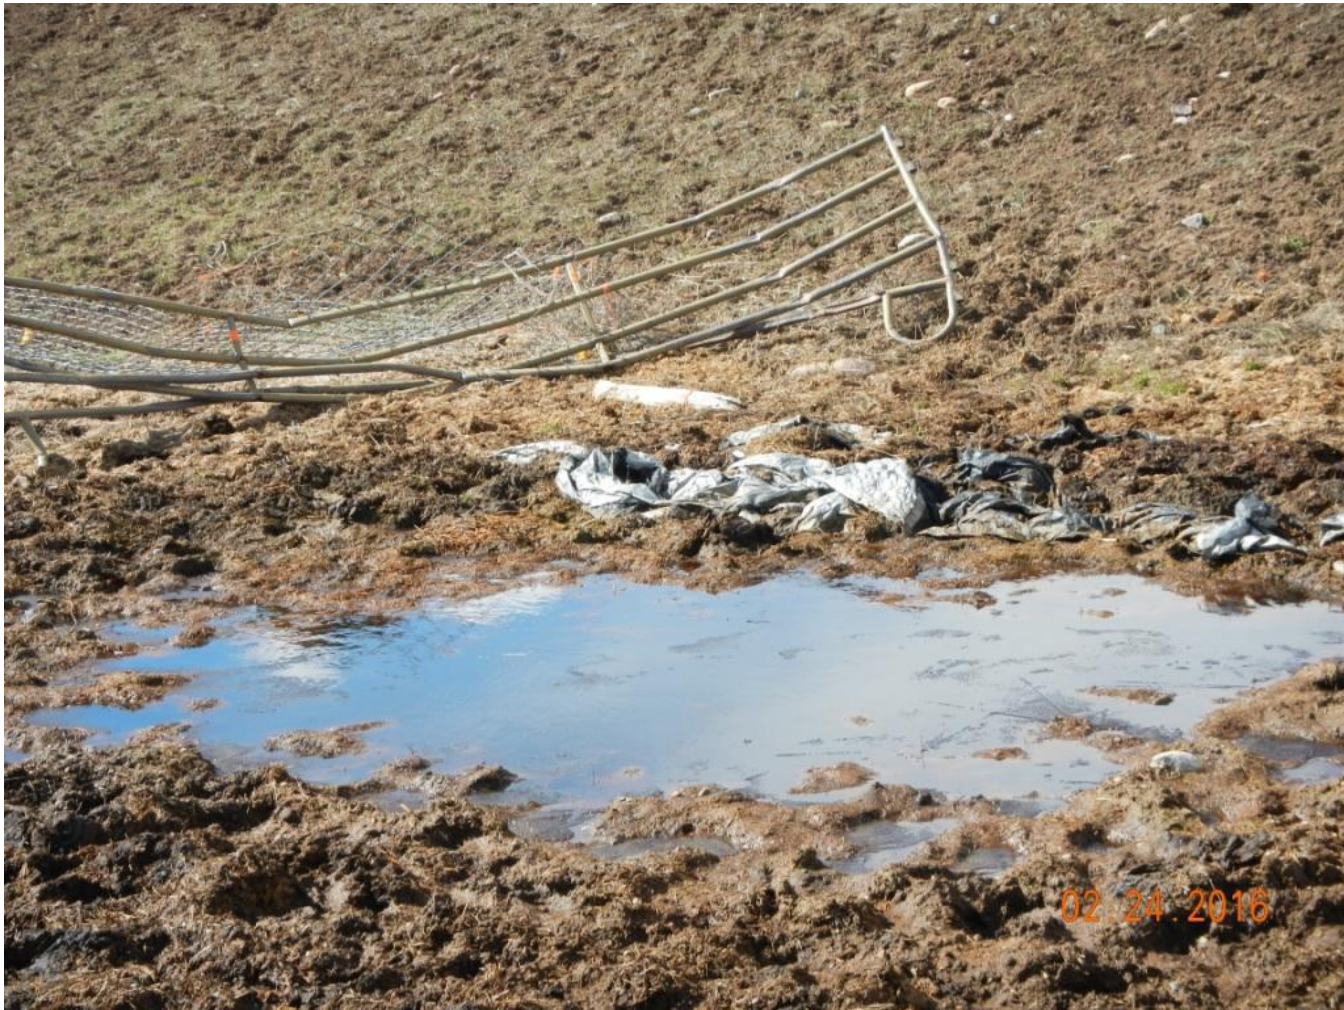
Photo 4: View of junk in the northwestern portion of the well pad.

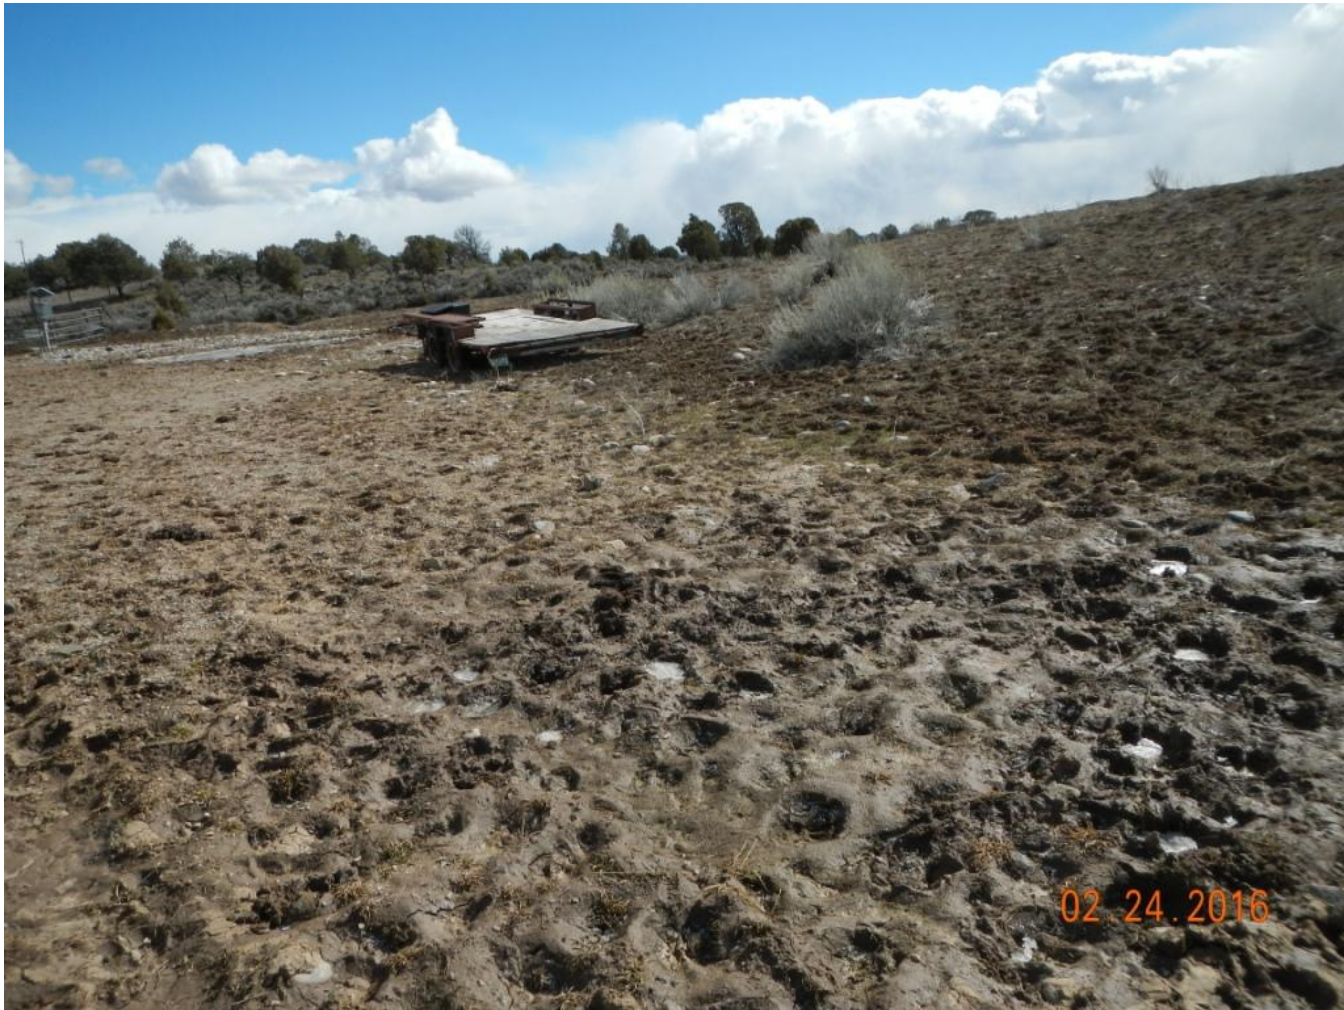
Photo 5: View of the southwestern portion of the project area from the western corner facing southeastward. Old trailer should be removed.

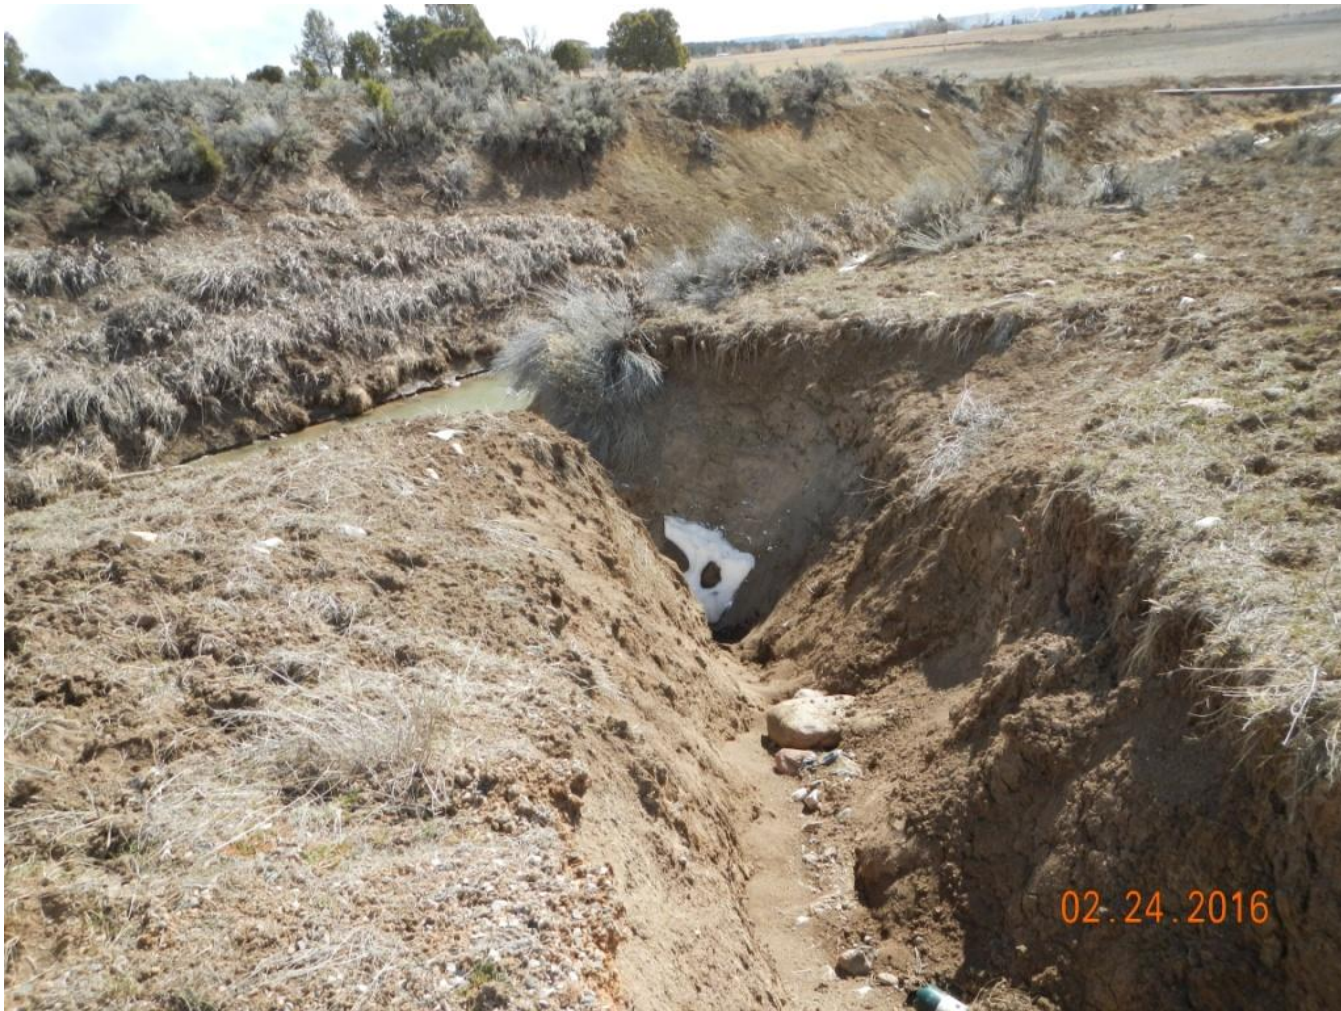
Photo 6: View of erosional channel approximately three feet wide and deep in the southern portion of the project area, flowing into an irrigation canal.
